Soils and Geology And Wastewater Treatment System Evaluation

For
Wyoming Estates
3050 N. Curtis Road
Final
February 27, 2020

Groundwater Investigations LLC
11590 Black Forest Road Ste 15
Colorado Springs, CO 80908
(719) 338-1805

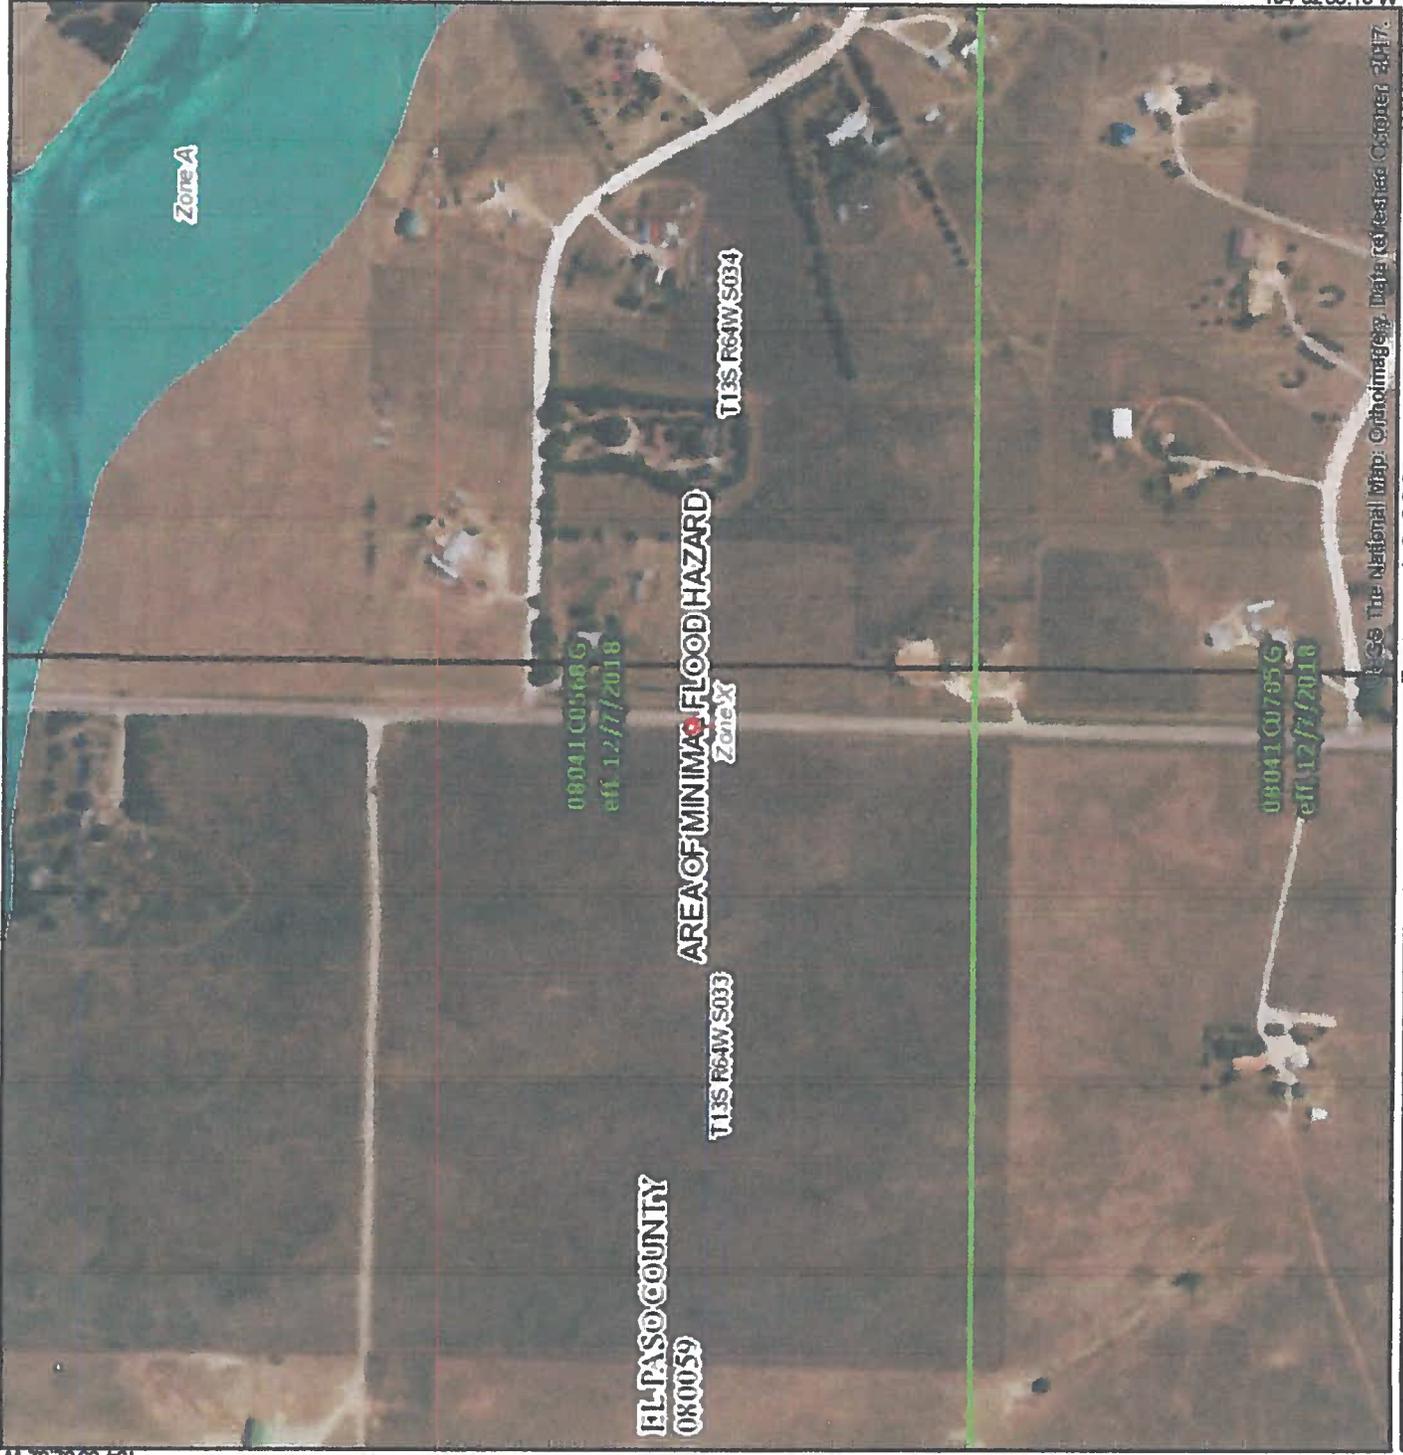
National Flood Hazard Layer FIRMette Figure 8

The Project Site was evaluated for geologic hazards that may impact development. Hazards identified in the El Paso County Land Development Code including: Mining, wildfire, highwater table or polluted water, landfills, fill areas, contamination; airports and major utility facilities, and landslides were not identified on the Project Site. The National Flood Hazard map delineated the Property and surrounding area an "area of Minimal Flood Hazard" (FEMA 2018). The Project Site is not located in a flood plain (Figure 8).
