EL PASO COUNTY CONSTRUCTION STORMWATER SITE INSPECTION REPORT

Facility Name: Sterling Ranch Homestead North	Permittee: SR Land LLC
Date of Inspection: 07/21/2022	Weather Conditions: Partly Cloudy
Permit Number: ESQ2222	Disturbed Acreage: 42.14 acres
Phase of Construction: Preconstruction	Site Qualified Stormwater Manager: Chaz Collins
Inspector Name: Molly Galloway	Site Contact Info: 719-491-8717

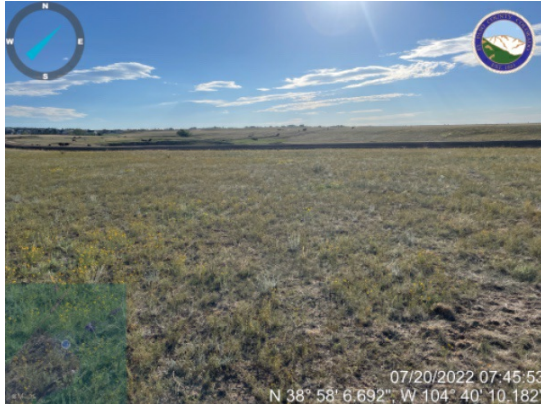
Compact Berm implemented around perimeter of Homestead North.

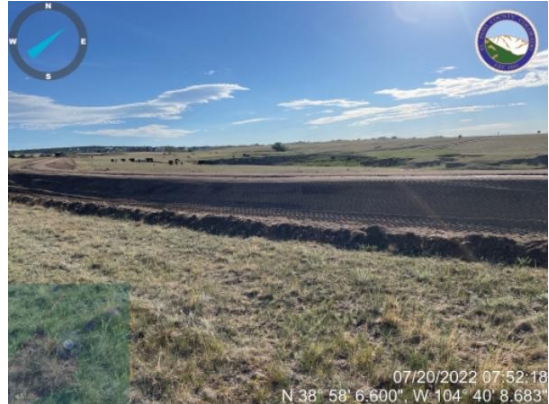
Compact Berm implemented around perimeter of Homestead North.

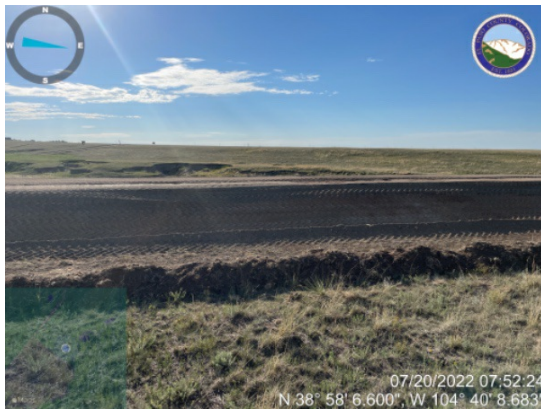
Compact Berm implemented around perimeter of Homestead North.

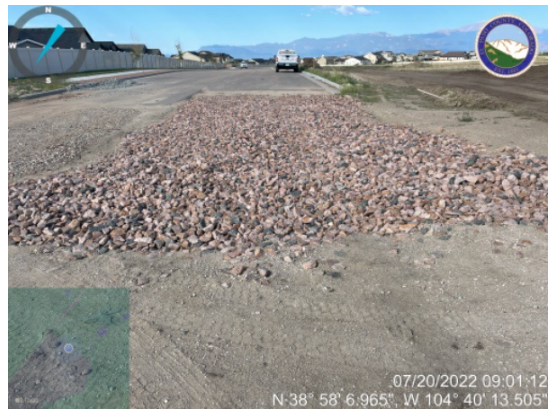
VTC has been lengthened and scarified.
