August 15, 2019

Project No: 19-3028

## SUBSURFACE INVESTIGATION AND SOILS REPORT

17055 Red Barn Road,  
El Paso County, Colorado

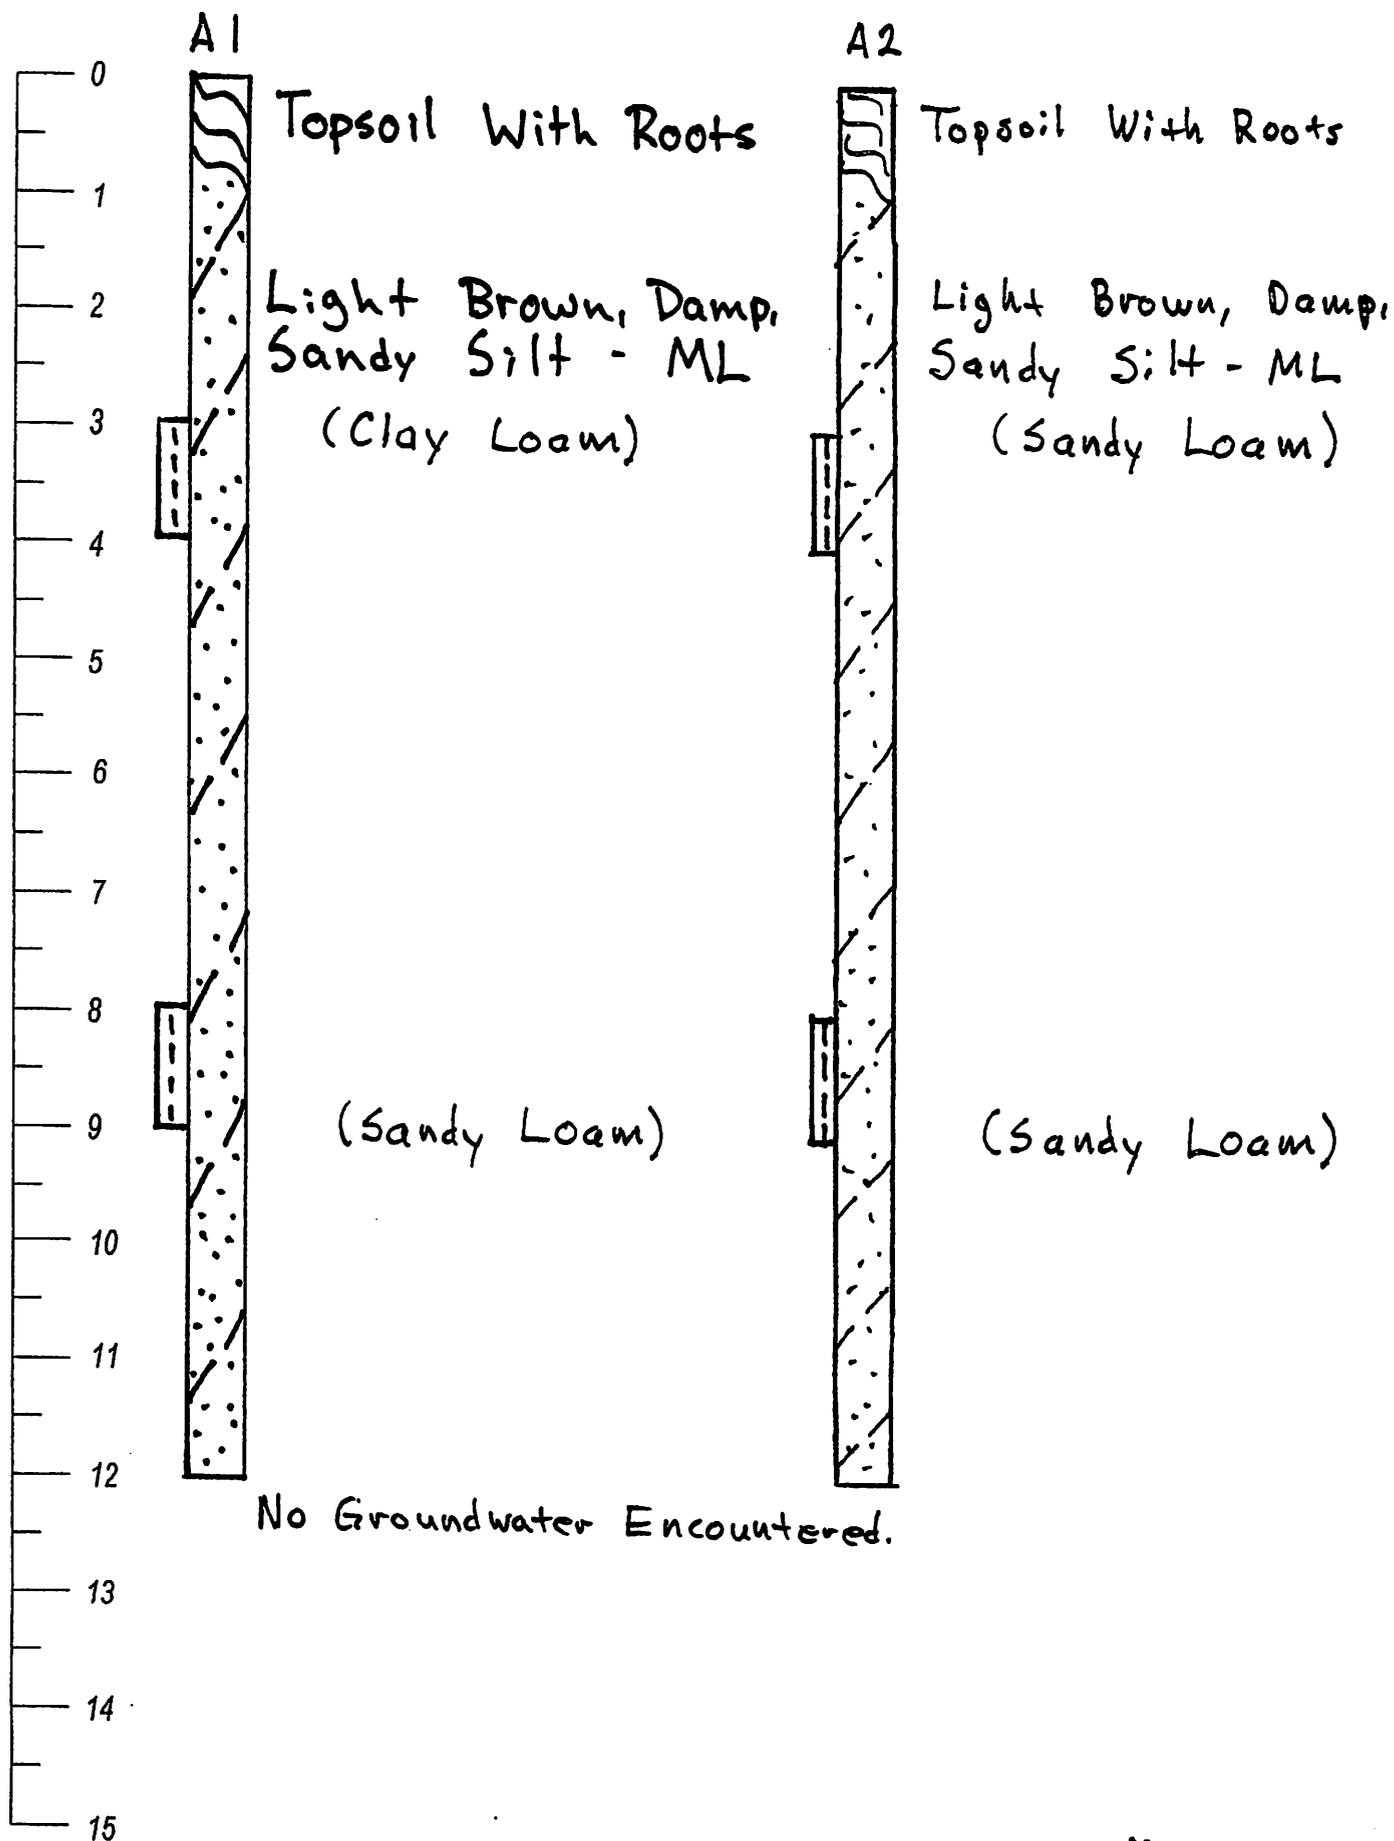
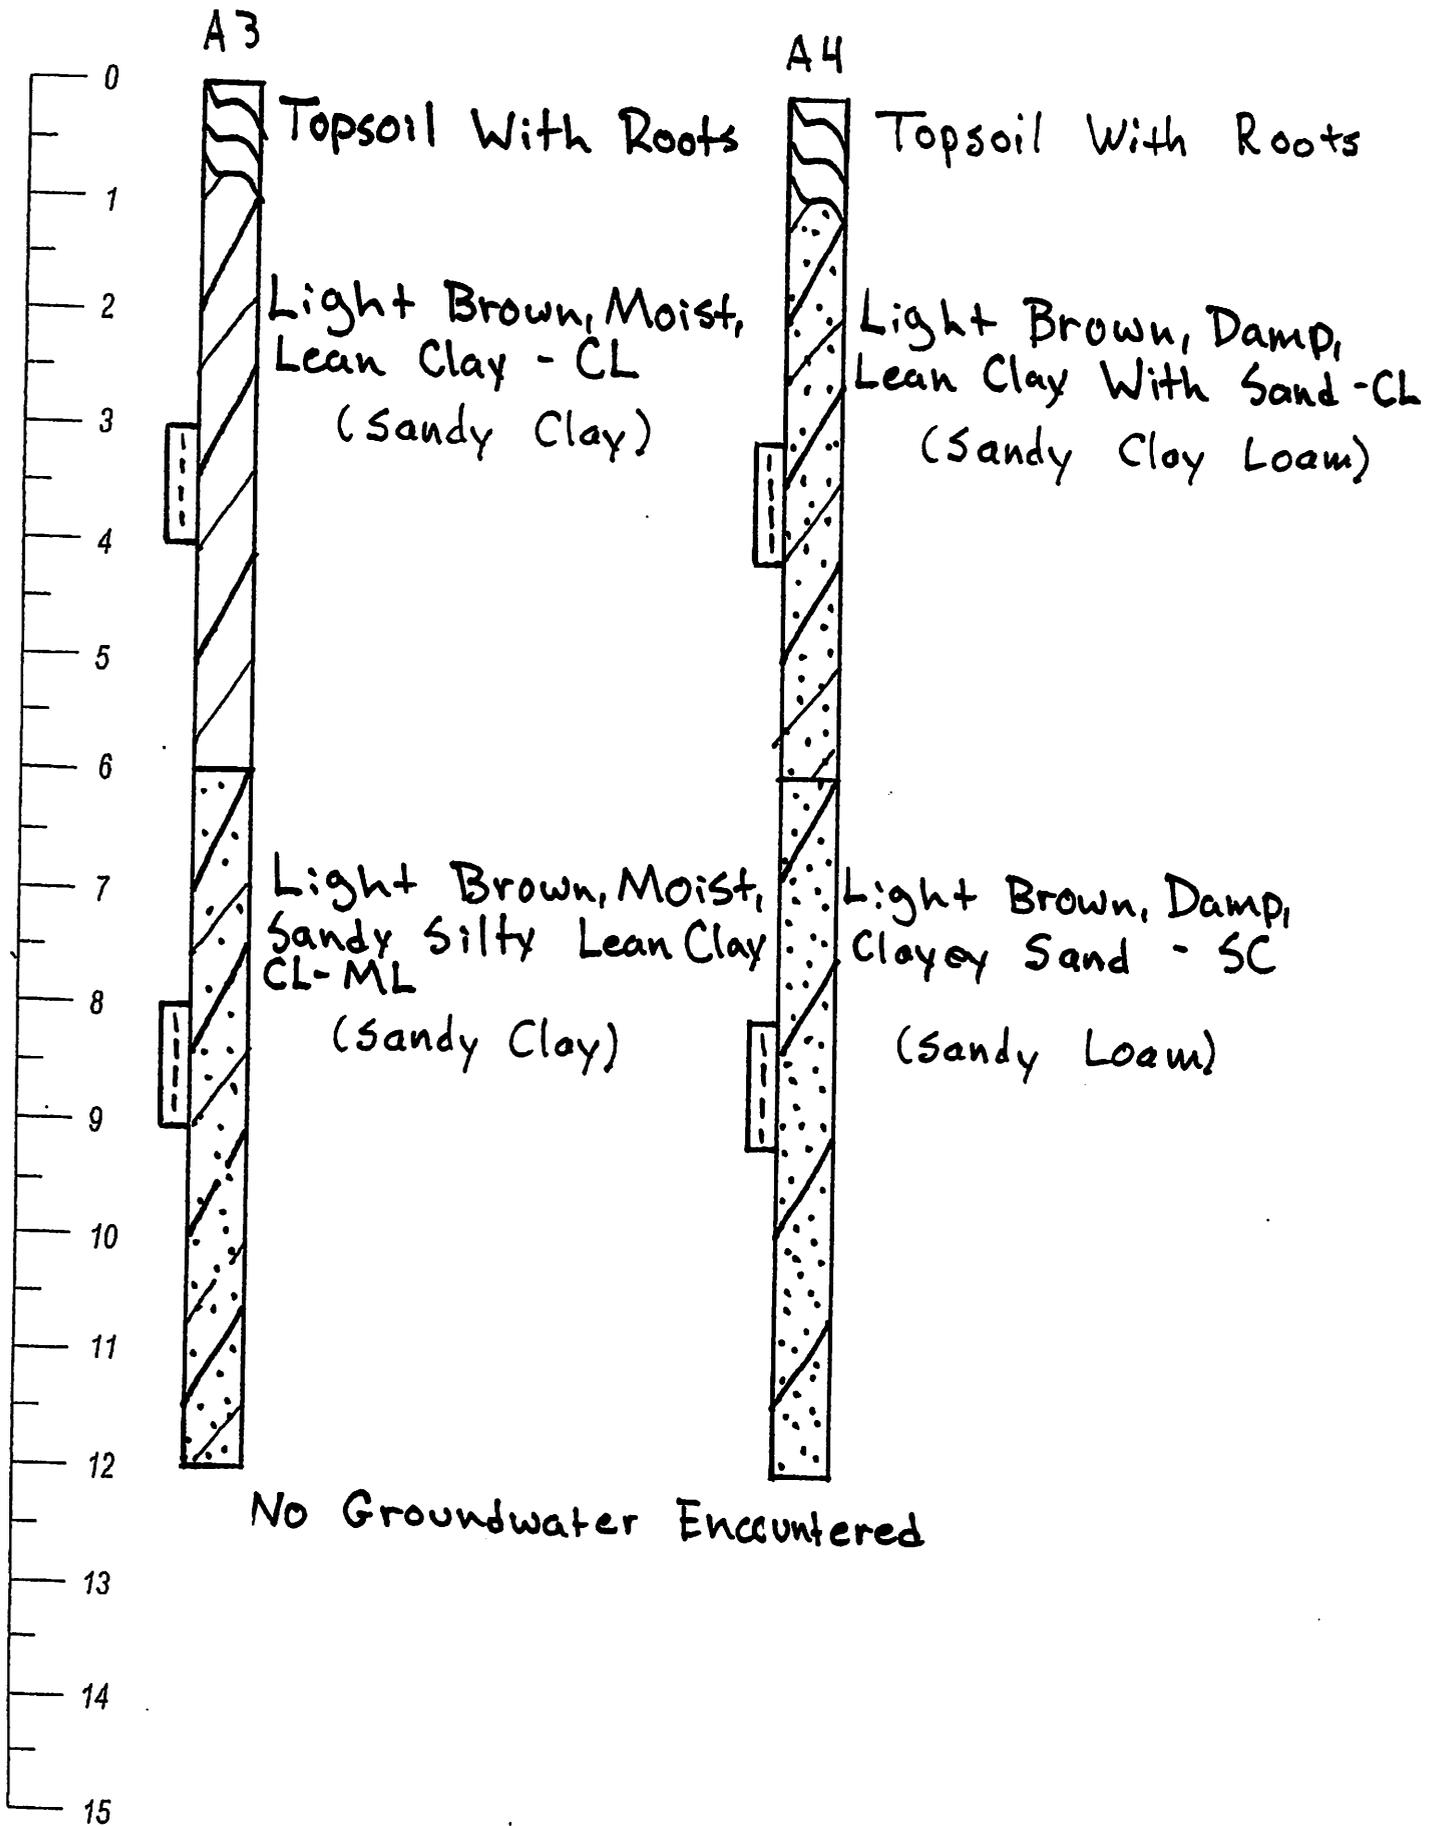
LOG OF TEST HOLES

On August 1, 2019 Test **Holes A-1** through **A-5** were drilled across the south portion of the property. *The test holes were all drilled to a depth of twelve feet (12'). Groundwater was not encountered to this depth. Samples were taken at 3'- 4' and 8'-9' depths. The 3'- 4' depth is to match the approximate depths of shallow crawl space and garage foundation footings. The 8'- 9' depth is to match the approximate depth of basement foundation footings.* The samples were tested for gradation, Atterberg Limits, moisture content, and NRCS tactile testing. The attached Location Map indicates the location of the test holes on the property. The attached Log of Test Holes shows the soils encountered in the test borings. Samples were taken and tested to determine preliminary soil recommendations for the proposed structure foundations and OWTS recommendations for the site. The attached Grain Size Distribution Curves indicates the laboratory test results of the soil samples acquired during drilling.

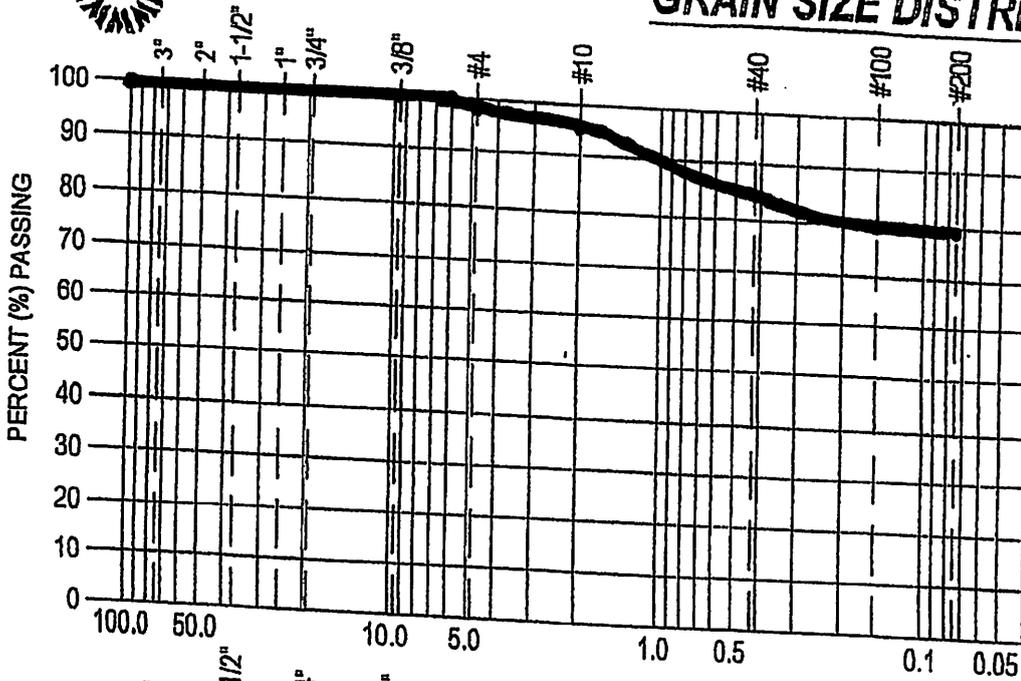
Laboratory tests indicate the soils at the **3'-4'** depth in **Hole A-1** are A-4(0) AASHTO, ML ASTM soils. These soils are IRC (PPRBD) 2017 sandy silt. The soils are Low-swelling. No ground water was observed in the test hole to this depth.

**AI @ 3'-4' LEVEL**  
 A-4 (0) AASHTO  
 ML ASTM  
 SIEVE % PASSING  
 3/4" 100  
 3/8" 100  
 #4 98  
 #10 95  
 #40 84  
 #100 80  
 #200 79  
 LL-31, PL-27, PI-4  
 Low SWELLING  
 NATURAL MOISTURE  
 CONTENT = 10.2 %

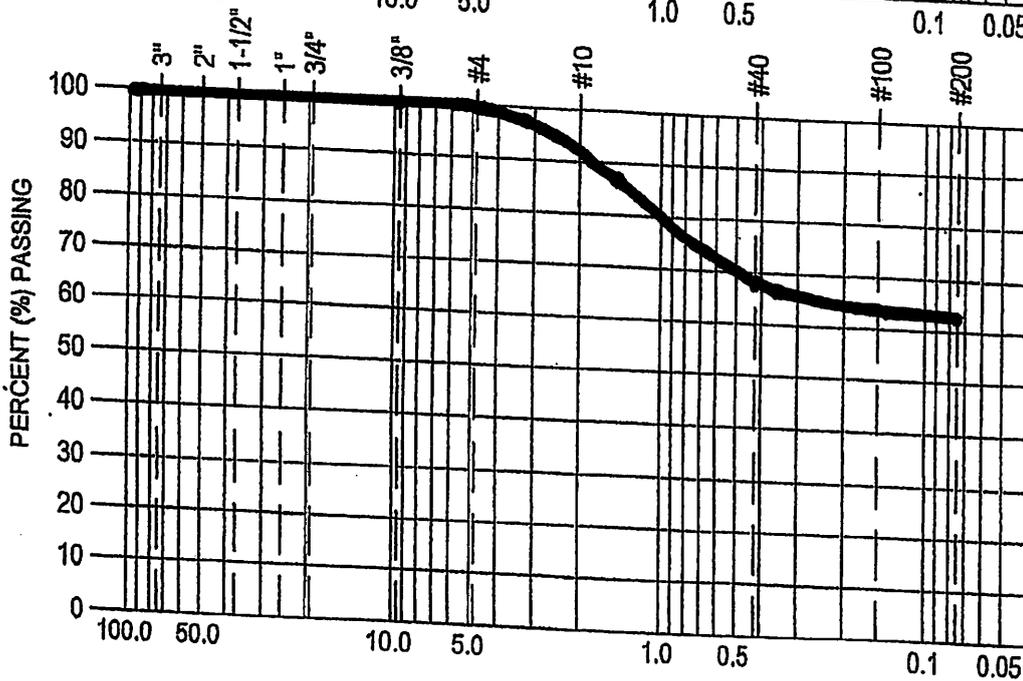
Laboratory tests indicate the soils at the 8'-9' depth in **Hole A-1** are A-4(0) AASHTO, ML ASTM soils. These soils are IRC (PPRBD) 2017 sandy silt. The soils are Low-swelling. No ground water was observed in the test hole to this depth.

**AI @ 8'-9' LEVEL**  
 A-4 (0) AASHTO  
 ML ASTM  
 SIEVE % PASSING  
 3/4" 100  
 3/8" 100  
 #4 99  
 #10 92  
 #40 67  
 #100 63  
 #200 62  
 LL-31, PL-27, PI-4  
 Low SWELLING  
 NATURAL MOISTURE  
 CONTENT = 8.9 %

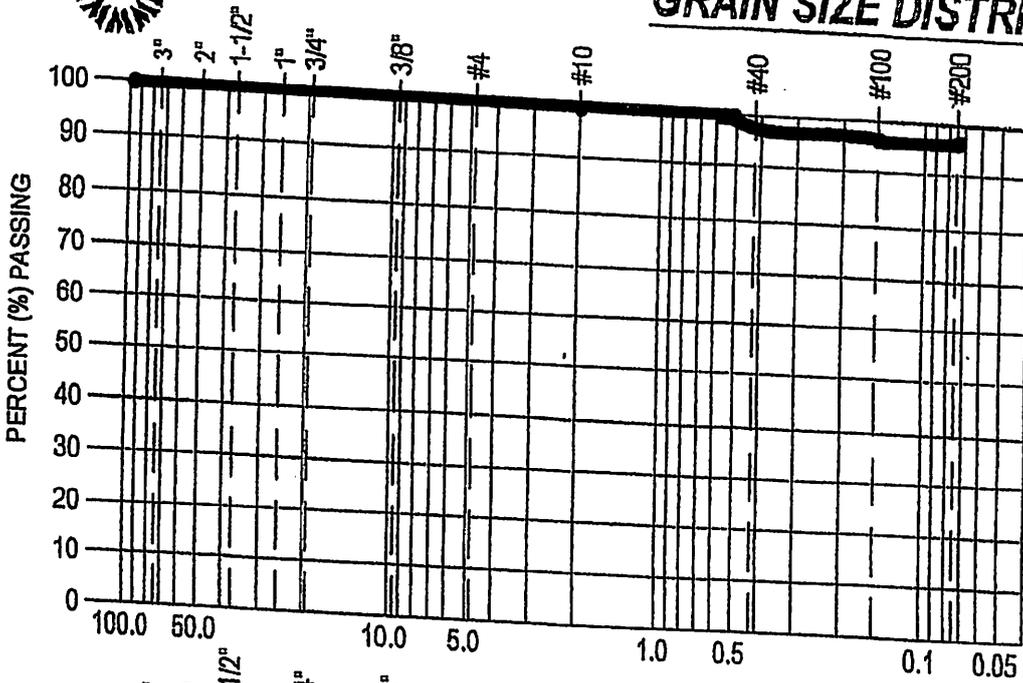
Laboratory tests indicate the soils at the 3'-4' depth in **Hole A-3** are A-4(0) AASHTO, CL ASTM soils. These soils are IRC (PPRBD) 2017 lean clay. The soils are Low-swelling. No ground water was observed in the test hole to this depth.

**A3 @ 3'-4' LEVEL**  
 A-4 (0) AASHTO  
 CL ASTM  
 SIEVE % PASSING  
 3/4" 100  
 3/8" 100  
 #4 100  
 #10 100  
 #40 97  
 #100 96  
 #200 96  
 LL - 30, PL - 21, PI - 9  
 Low SWELLING  
 NATURAL MOISTURE  
 CONTENT = 20.4 %

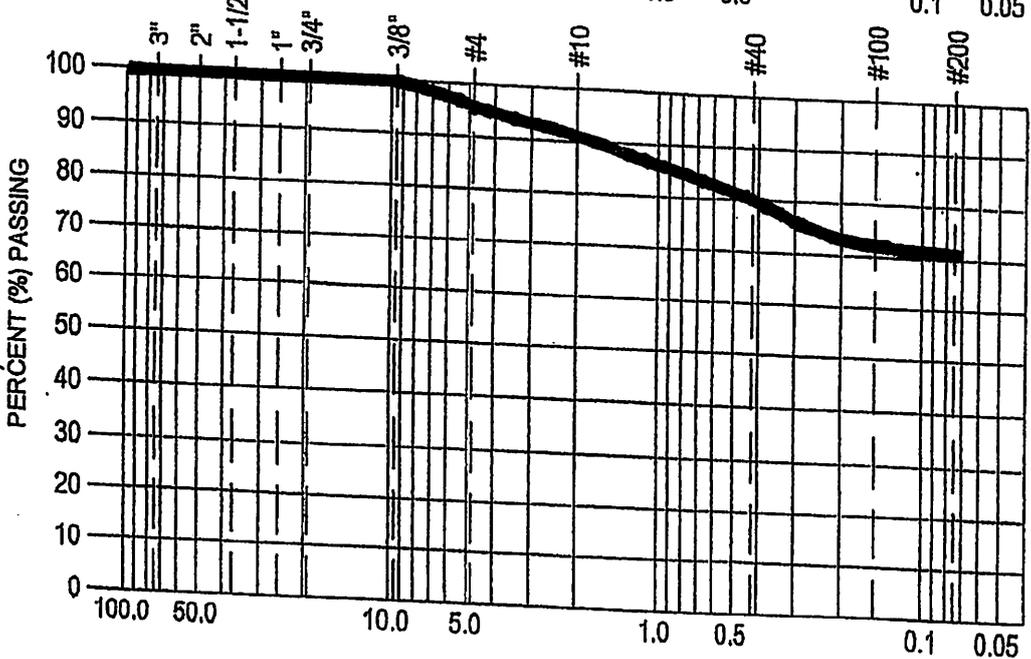
Laboratory tests indicate the soils at the 8'-9' depth in **Hole A-3** are A-4(0) AASHTO, CL-ML ASTM soils. These soils are IRC (PPRBD) 2017 sandy silty lean clay. The soils are Low-swelling. No ground water was observed in the test hole to this depth.

**A3 @ 8'-9' LEVEL**  
 A-4 (0) AASHTO  
 CL-ML ASTM  
 SIEVE % PASSING  
 3/4" 100  
 3/8" 100  
 #4 95  
 #10 91  
 #40 80  
 #100 72  
 #200 71  
 LL - 25, PL - 20, PI - 5  
 Low SWELLING  
 NATURAL MOISTURE  
 CONTENT = 20.7 %

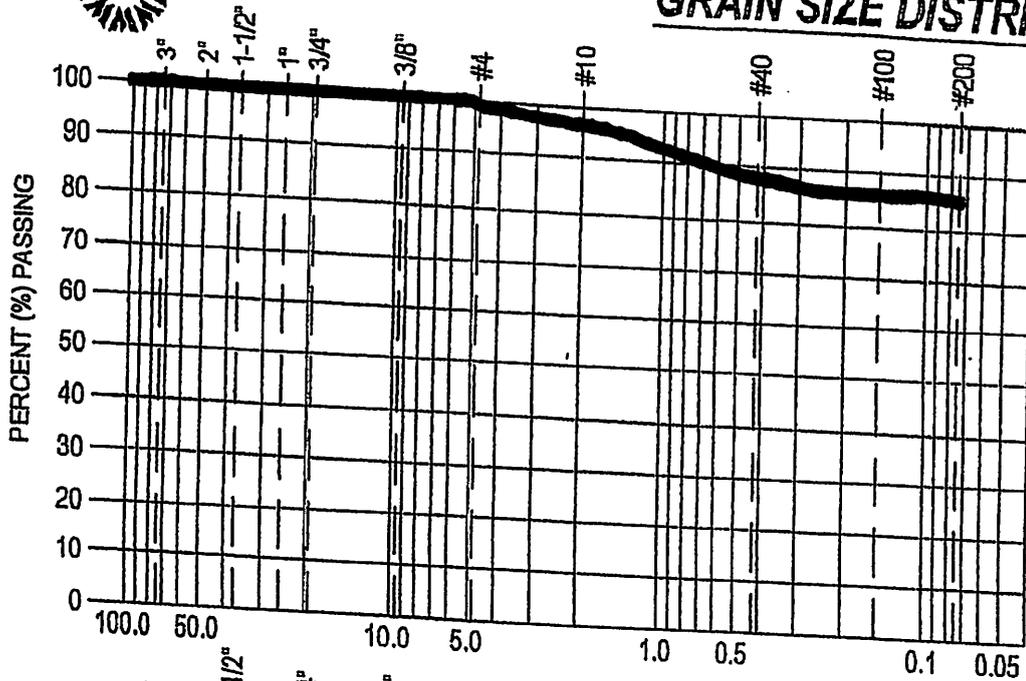
Laboratory tests indicate the soils at the **3'-4'** depth in **Hole A-4** are A-6(1) AASHTO, CL ASTM soils. These soils are IRC (PPRBD) 2017 lean clay with sand. The soils are Low-swelling. No ground water was observed in the test hole to this depth.

**A4@3'-4' LEVEL**  
 A-G (1) AASHTO  
 CL ASTM  
 SIEVE % PASSING  
 3/4" 100  
 3/8" 100  
 #4 99  
 #10 96  
 #40 88  
 #100 86  
 #200 85  
 LL-32 PL-21, PI-11  
 Low SWELLING  
 NATURAL MOISTURE  
 CONTENT = 7.7 %

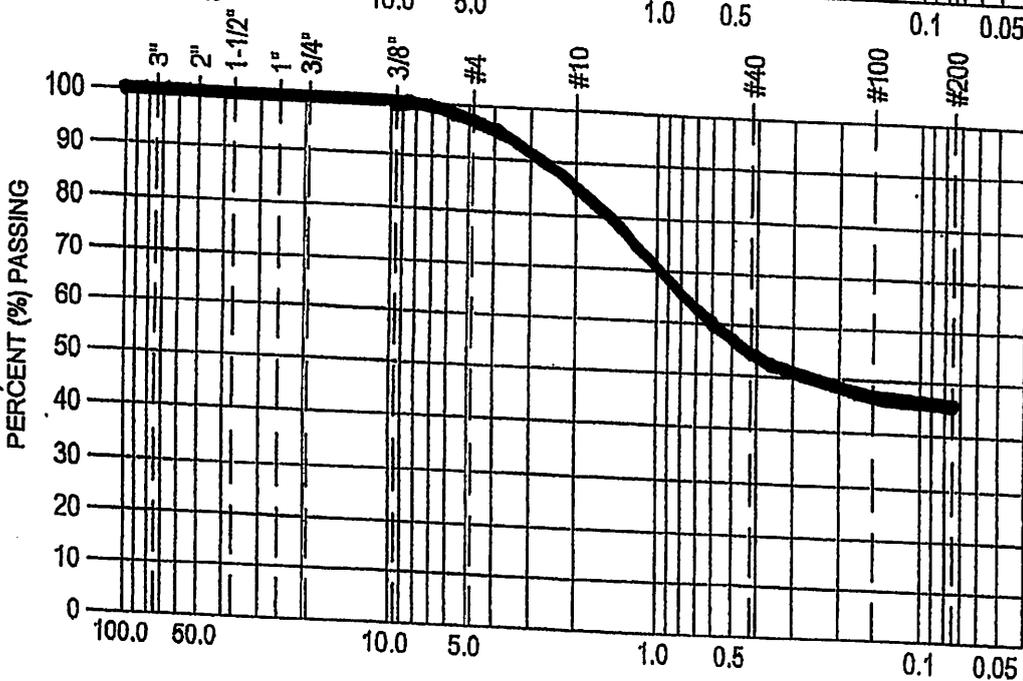
Laboratory tests indicate the soils at the **8'-9'** depth in **Hole A-4** are A-6(2) AASHTO, SC ASTM soils. These soils are IRC (PPRBD) 2017 sandy clay. The soils are Low-swelling. No ground water was observed in the test hole to this depth.

**A4@8'-9' LEVEL**  
 A-G (2) AASHTO  
 SC ASTM  
 SIEVE % PASSING  
 3/4" 100  
 3/8" 100  
 #4 97  
 #10 84  
 #40 53  
 #100 47  
 #200 46  
 LL-32, PL-15, PI-17  
 Low SWELLING  
 NATURAL MOISTURE  
 CONTENT = 5.9 %
