March 11, 2026

Subject: Geologic Hazards Evaluation and Preliminary Geotechnical Investigation  
Update - North Bay at Woodmoor  
Deer Creek Way and Burning Oak Way  
Woodmoor, Colorado  
CTL|T Project No. CS18589.001-105

**GEOLOGIC HAZARDS EVALUATION AND  
PRELIMINARY GEOTECHNICAL INVESTIGATION  
NORTH BAY AT WOODMOOR  
DEER CREEK WAY AND BURNING OAK WAY  
WOODMOOR, COLORADO**

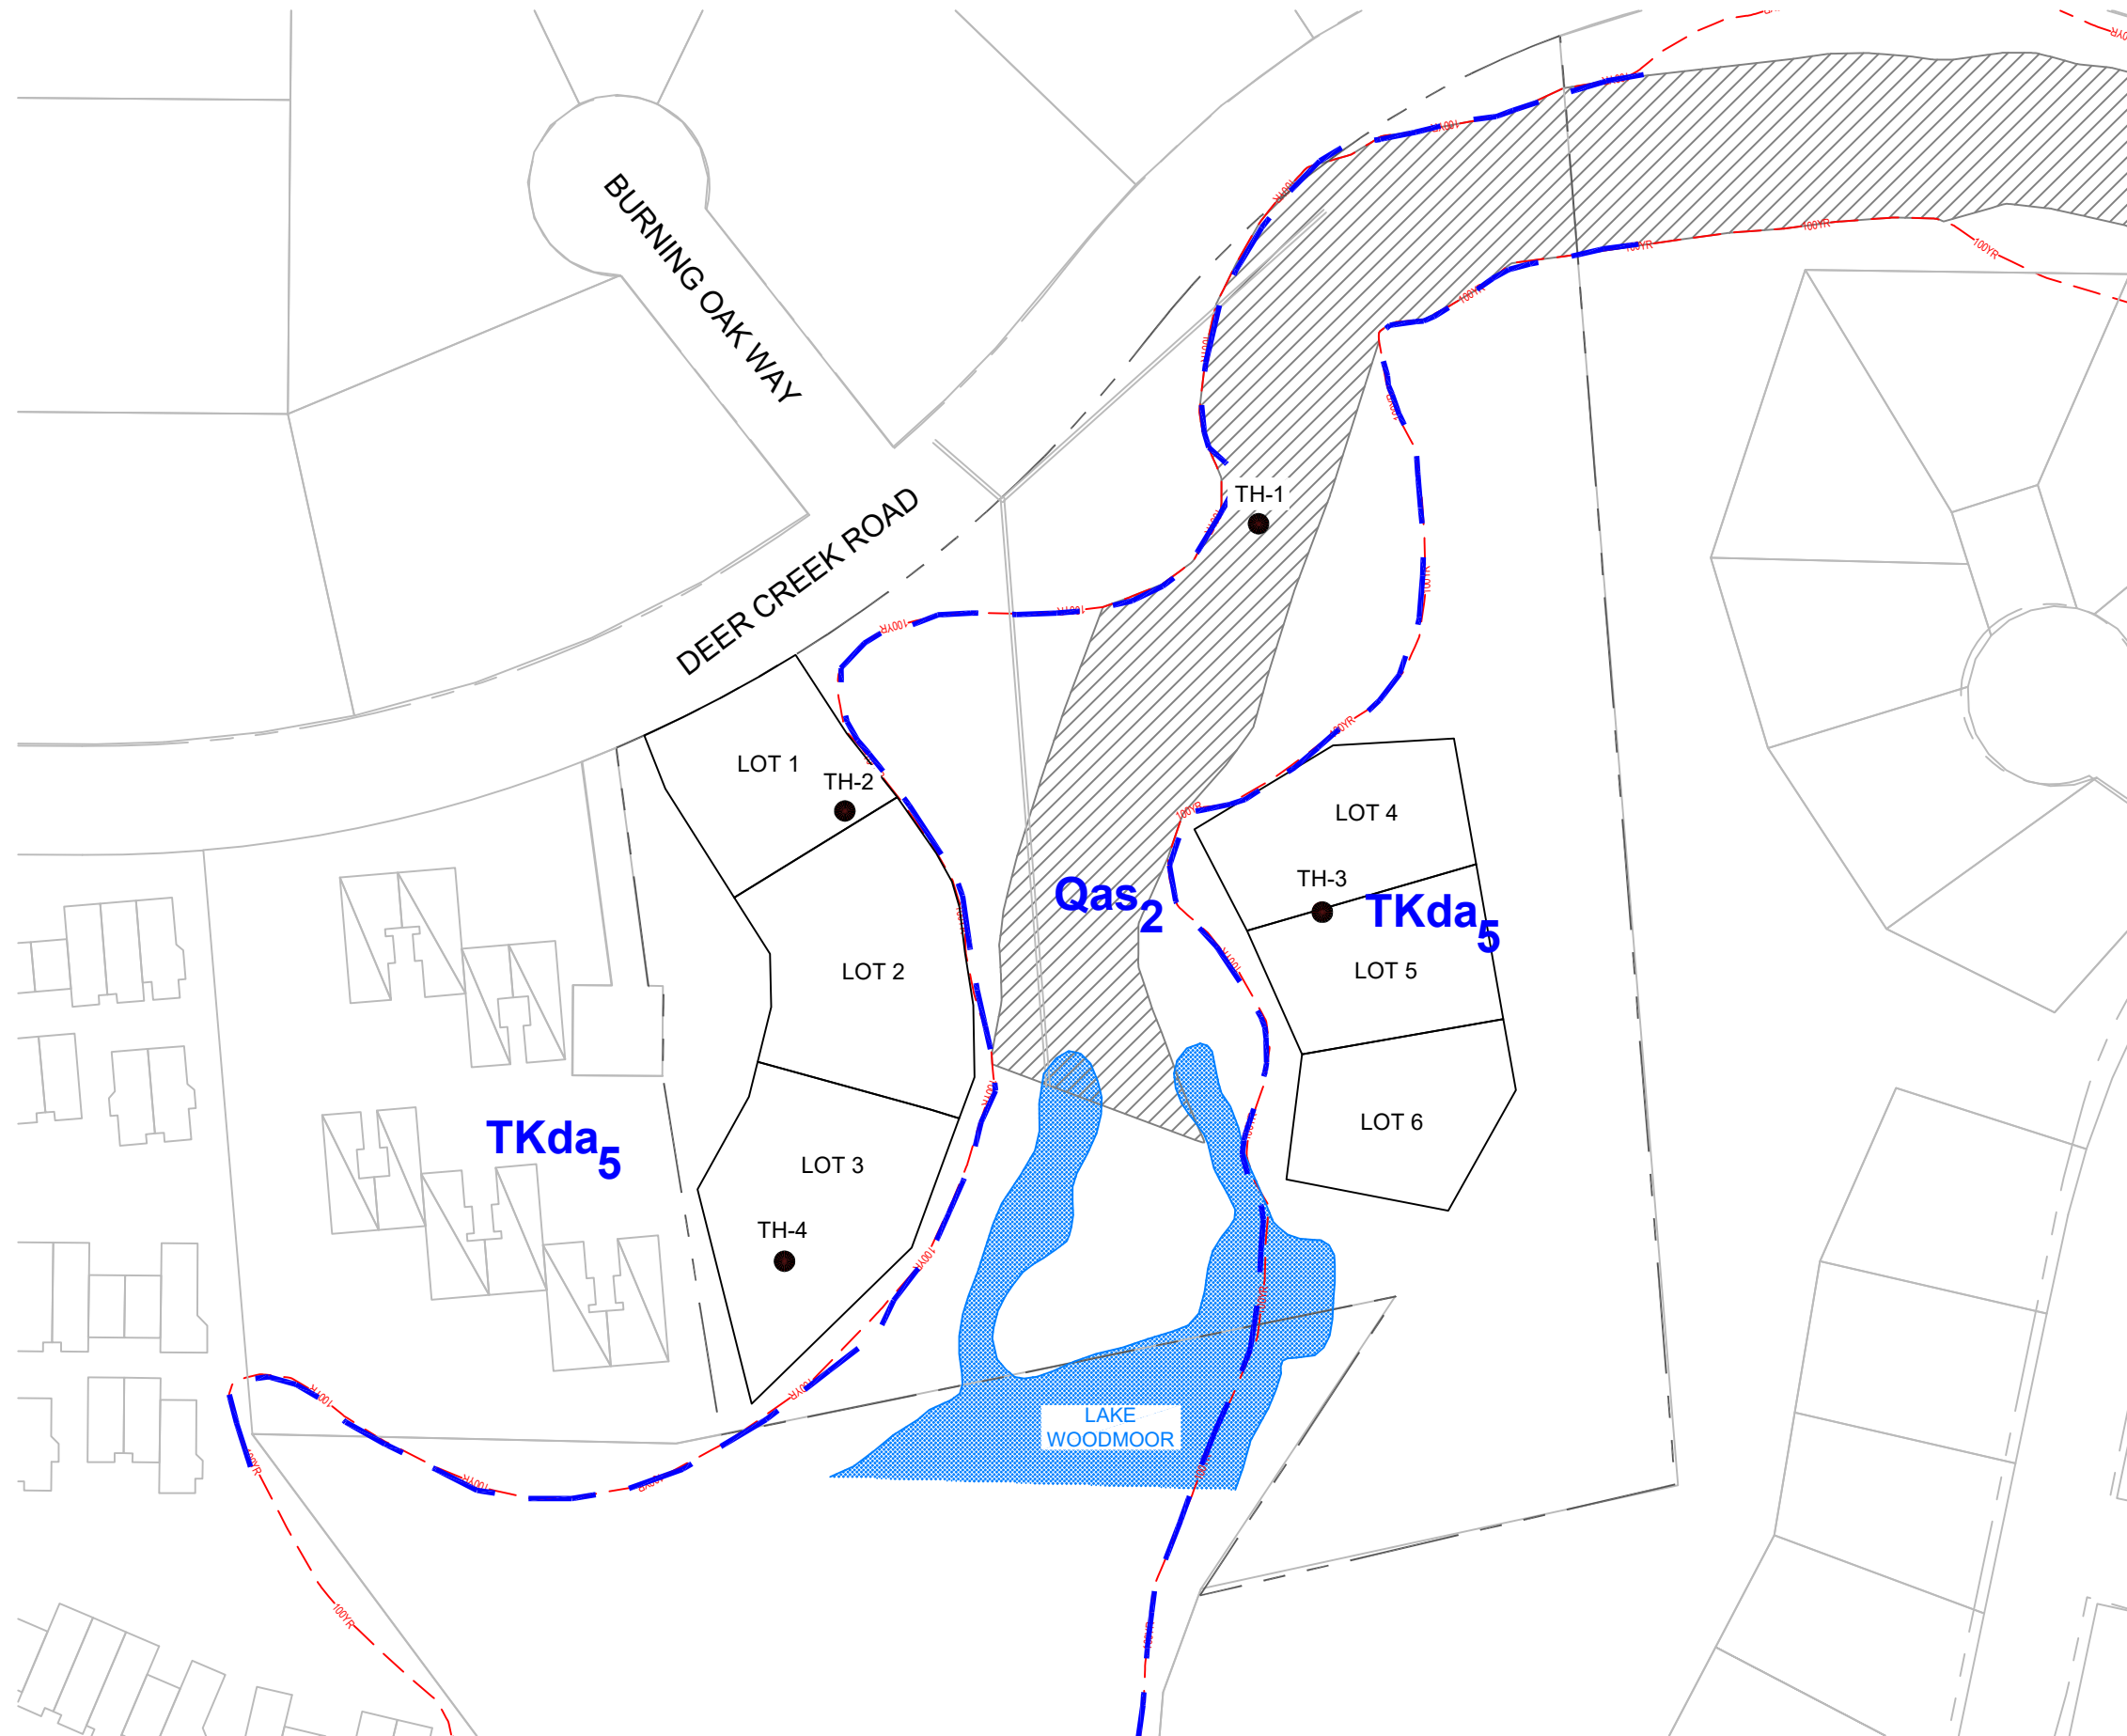
FIG. 2 – SURFICIAL GEOLOGIC CONDITIONS

The site includes an area mapped by FEMA in the Flood Insurance Rate Maps as Zone AE, as shown on FIRM Community Map Number 08041C0278G, where base flood elevations have been determined. The area of the site expected to be impacted by a 100-year flood event is depicted on Figs. 2 and 3 based on information provided by HR Green.

Our interpretation of the surficial geology and geologic hazards is presented in Fig. 2 and is described above. Our interpretation of the engineering geologic conditions is presented in Fig. 3. The site is shown as containing Map Units 2A, 3B, and 7A per the classification system described in Robinson's "El Paso County, Colorado - Potential Geologic Hazards and Surficial Deposits, Environmental and Engineering Geologic Maps and Tables for Land Use," 1977.

We recommend maintaining at least 3 feet of separation between basement level foundations and the 100-year flood levels. Underdrain systems were discussed in our 2016 report. Installation of active underdrain systems can be considered within the proposed roadways during the development phase to lower groundwater levels. Additionally, below-slab drain systems (Fig. 4) within the residences are recommended at Lots 1, 2, 4, and 5. Alternatively, raising foundation elevations by adjusting site grades can be considered. Mitigation options should be addressed in more detail at the time of a design-level investigation.

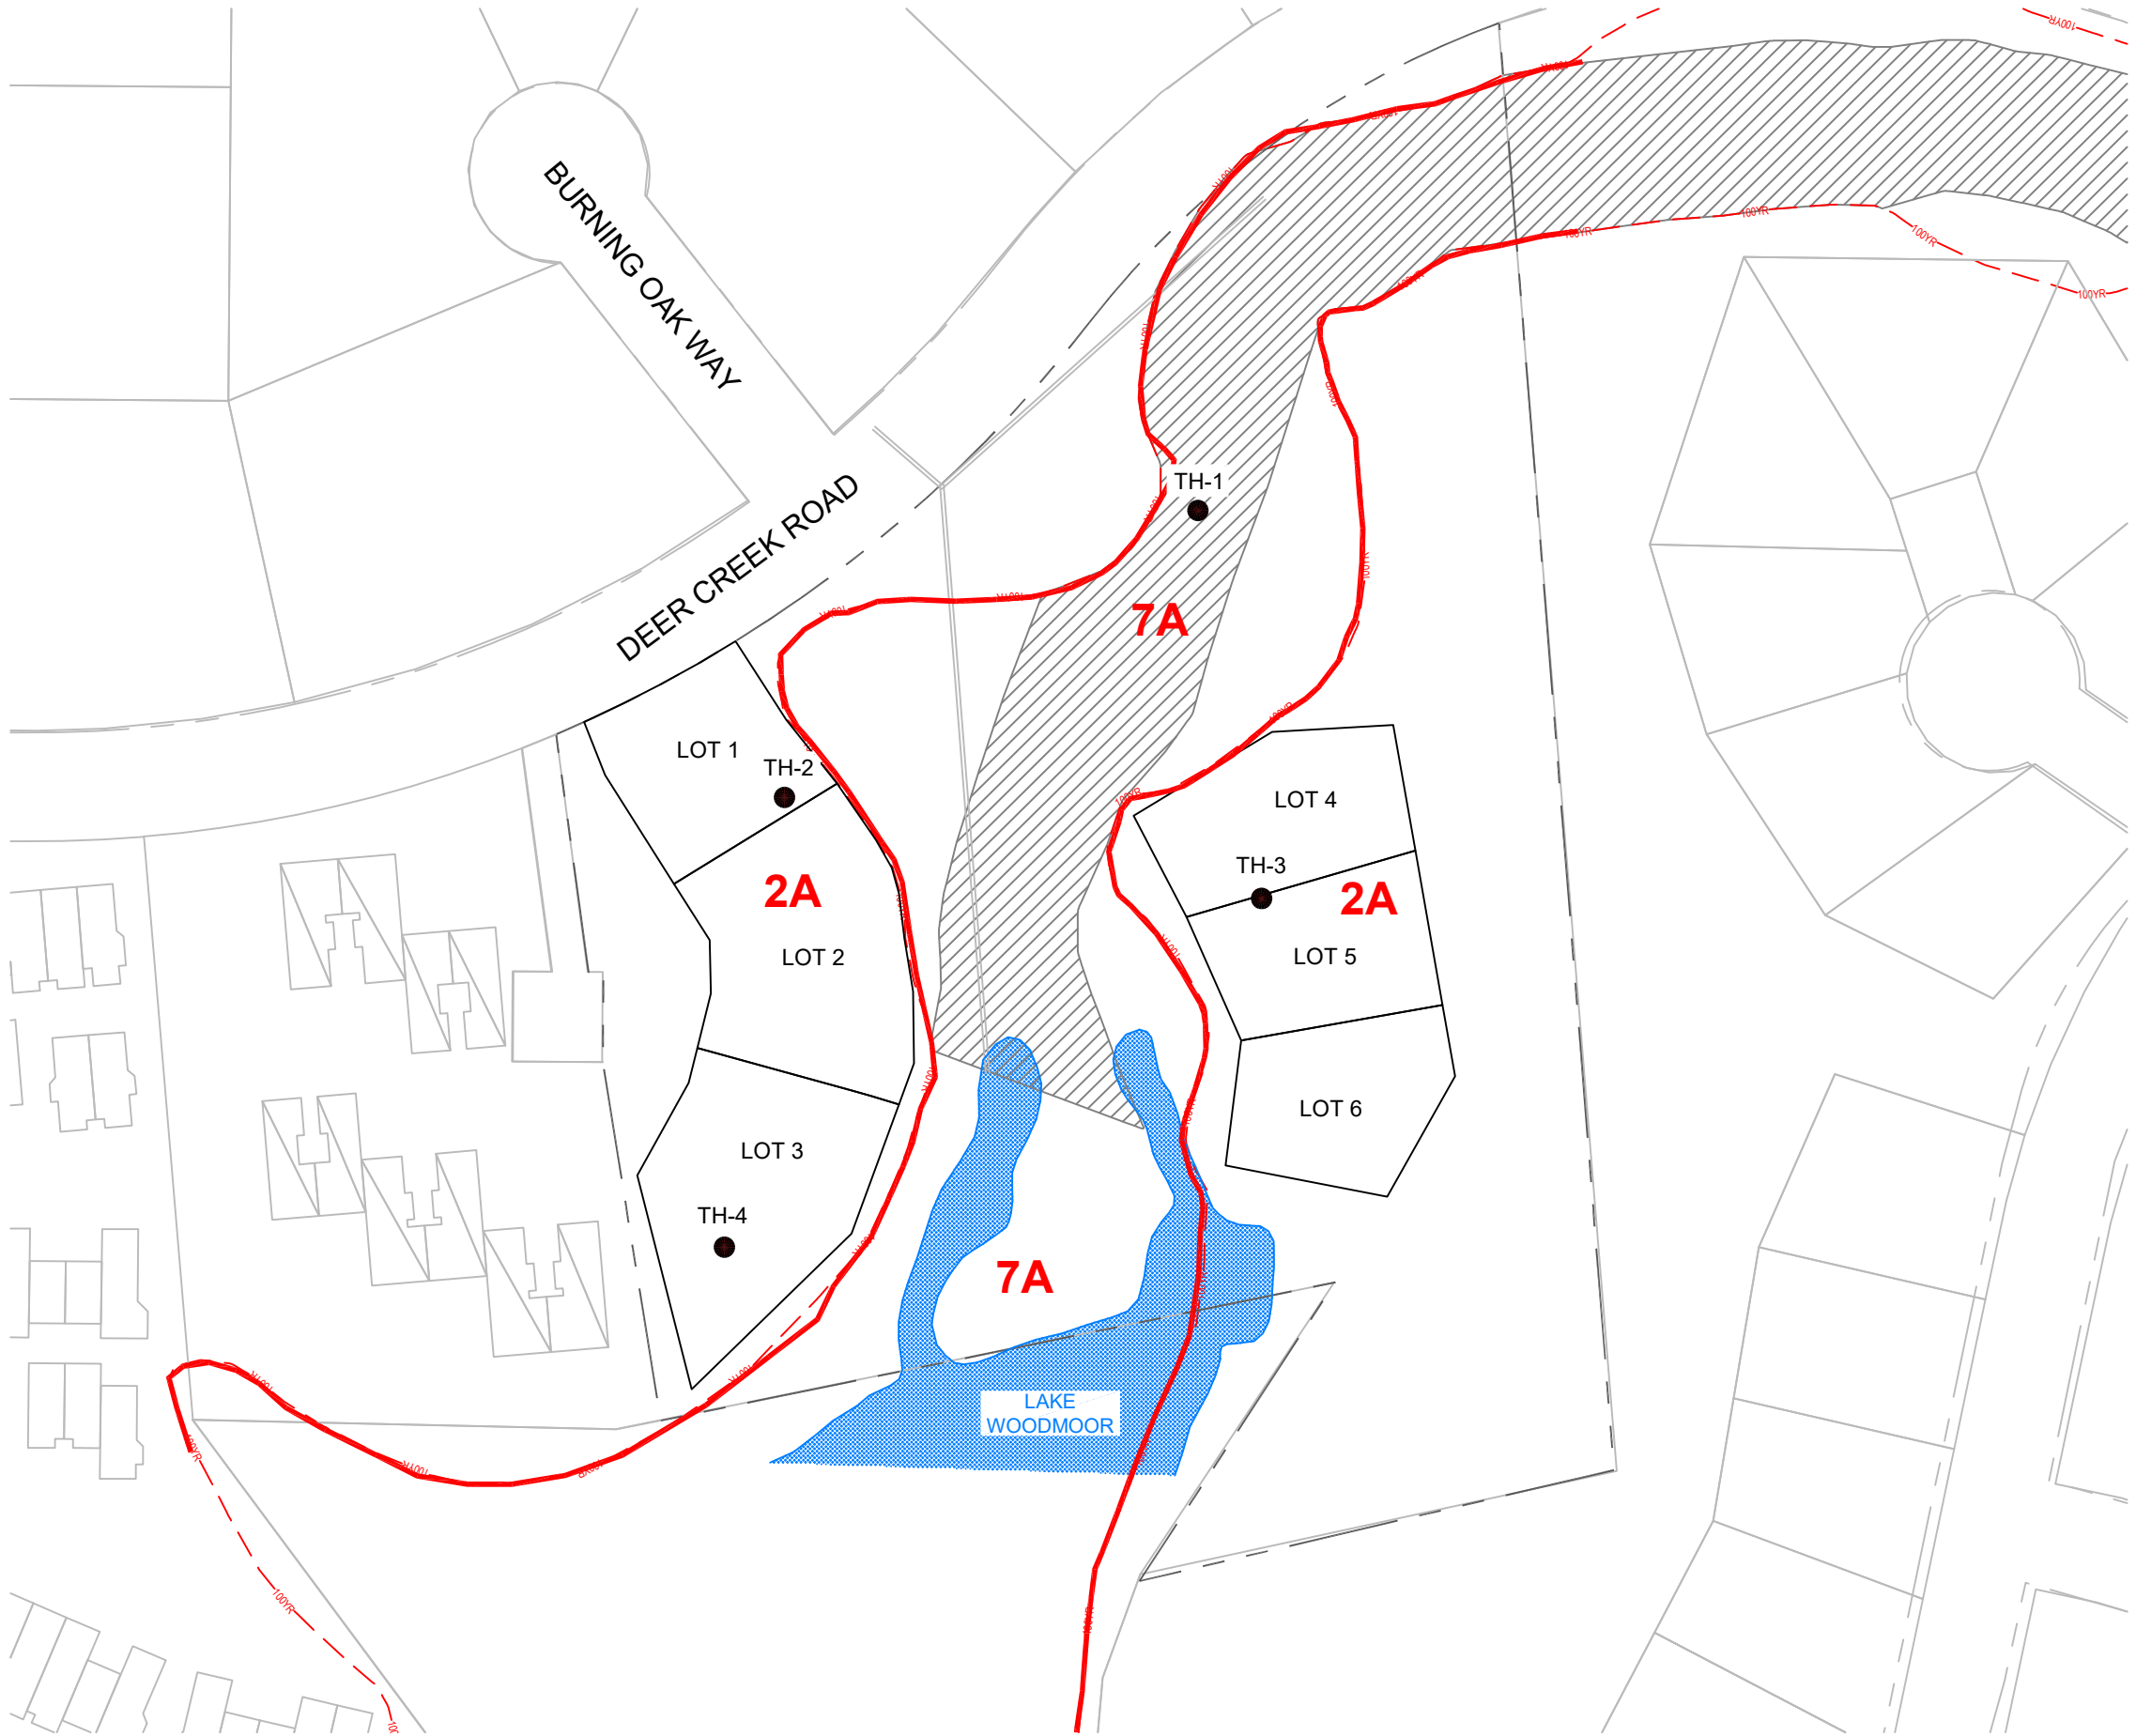
FIG. 3 – ENGINEERING CONDITIONS

**7A**      PHYSIOGRAPHIC FLOODPLAIN WHERE EROSION AND DEPOSITION PRESENTLY OCCUR AND IS GENERALLY SUBJECT TO RECURRENT FLOODING. INCLUDES 100 YEAR FLOODPLAIN ALONG MAJOR STREAMS WHERE STUDIES HAVE BEEN CONDUCTED.

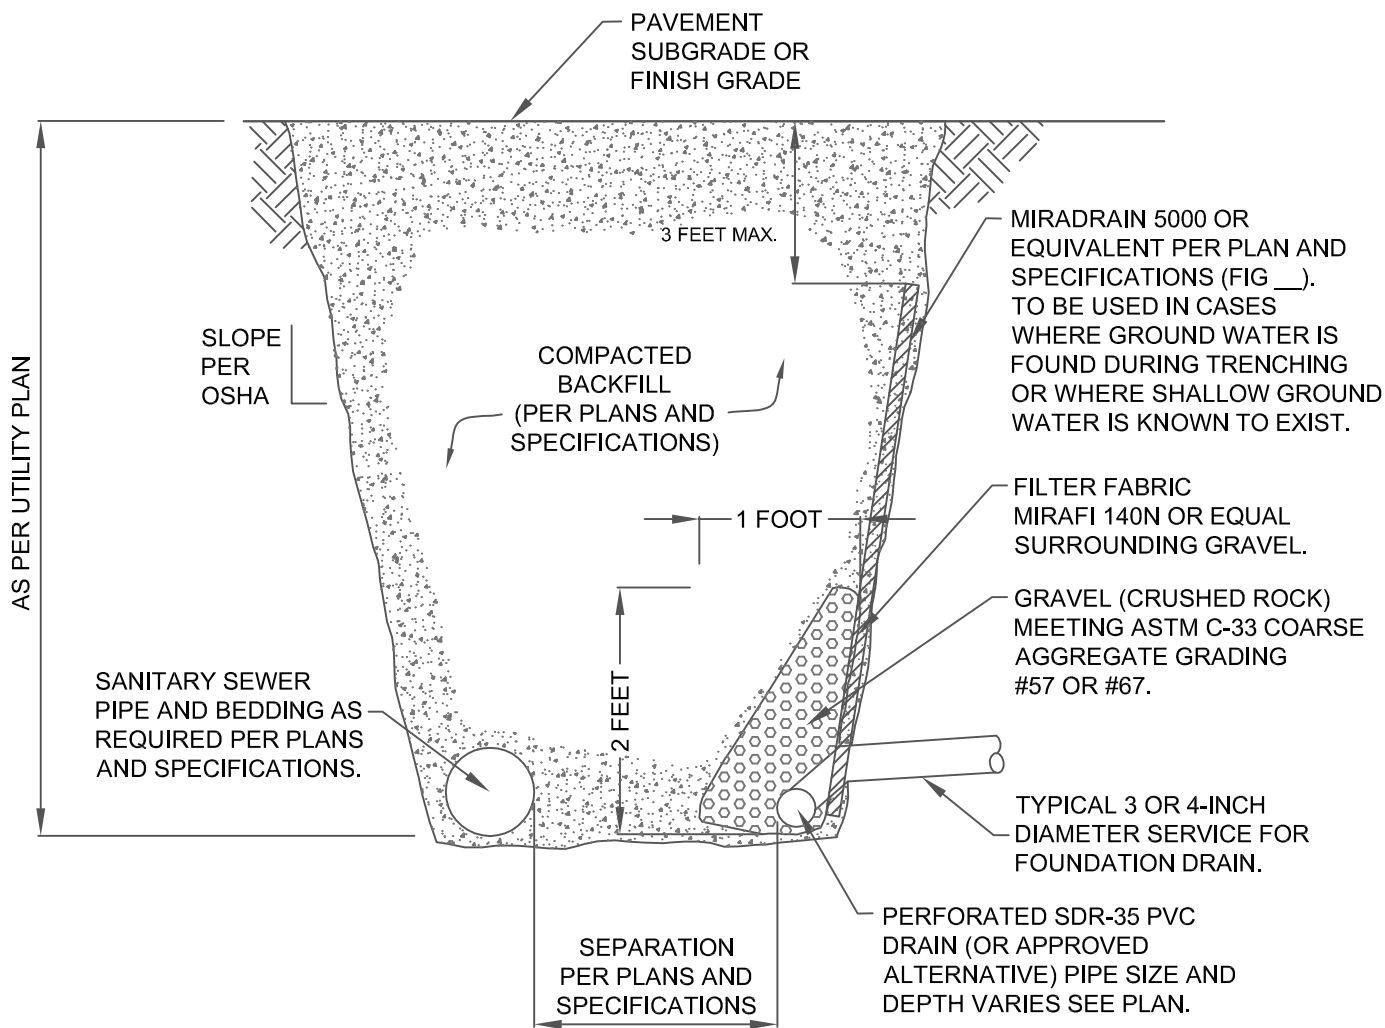
If wet conditions or free water are encountered in the sanitary sewer trenches, we recommend an active underdrain system with perforated or slotted pipe for these

areas. A conceptual drain detail is shown in Fig. 4. A cutoff collar should be constructed around the sewer pipe and underdrain pipe immediately downstream of the point the underdrain pipe exits the sewer trench or changes from active to passive. Solid pipe should be used down gradient of this cutoff collar to the point of discharge. The underdrain should be maintained at least 3 to 5 feet below the lowest nearby foundation elevation. Where no groundwater is encountered in sanitary sewer excavations, passive underdrains may be used as presented on Fig. 5.

NOTE:  
TO BE USED IN CASES WHERE GROUND WATER IS FOUND DURING TRENCHING OR WHERE SHALLOW GROUND WATER IS KNOWN TO EXIST, AND UPSTREAM OF MANHOLES.
