Subject: Geologic Hazards Evaluation and Preliminary Geotechnical Investigation  
Update - North Bay at Woodmoor  
Deer Creek Way and Burning Oak Way  
Woodmoor, Colorado  
CTL|T Project No. CS18589.001-105

**GEOLOGIC HAZARDS EVALUATION AND  
PRELIMINARY GEOTECHNICAL INVESTIGATION  
NORTH BAY AT WOODMOOR  
DEER CREEK WAY AND BURNING OAK WAY  
WOODMOOR, COLORADO**

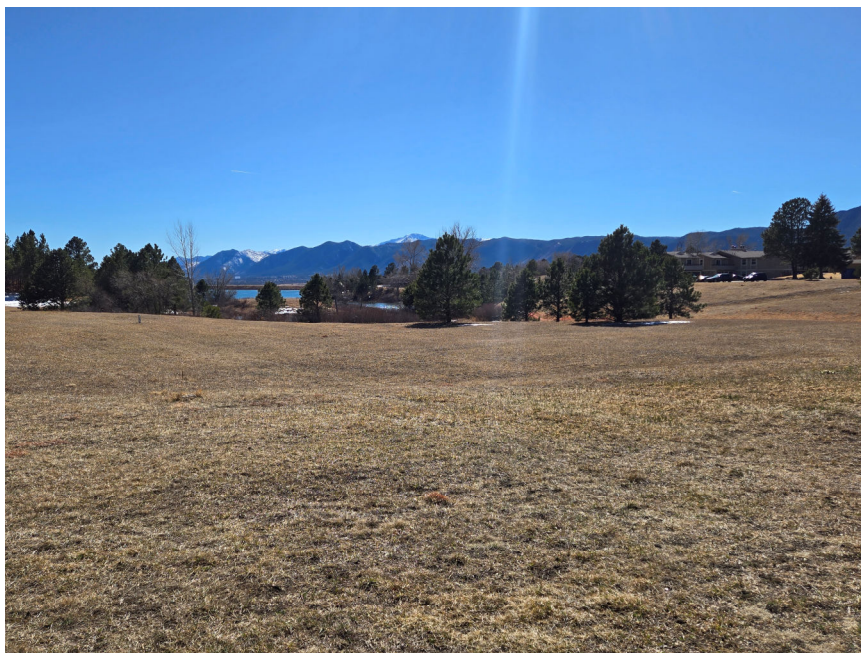
**Overview of Site Looking South – March 9, 2026**

A site visit was performed by a representative of our office on March 9, 2026, to observe the existing conditions. The site has not significantly changed since our 2016 evaluation, and no additional geologic hazards have been identified at the site that are expected to affect the proposed development.

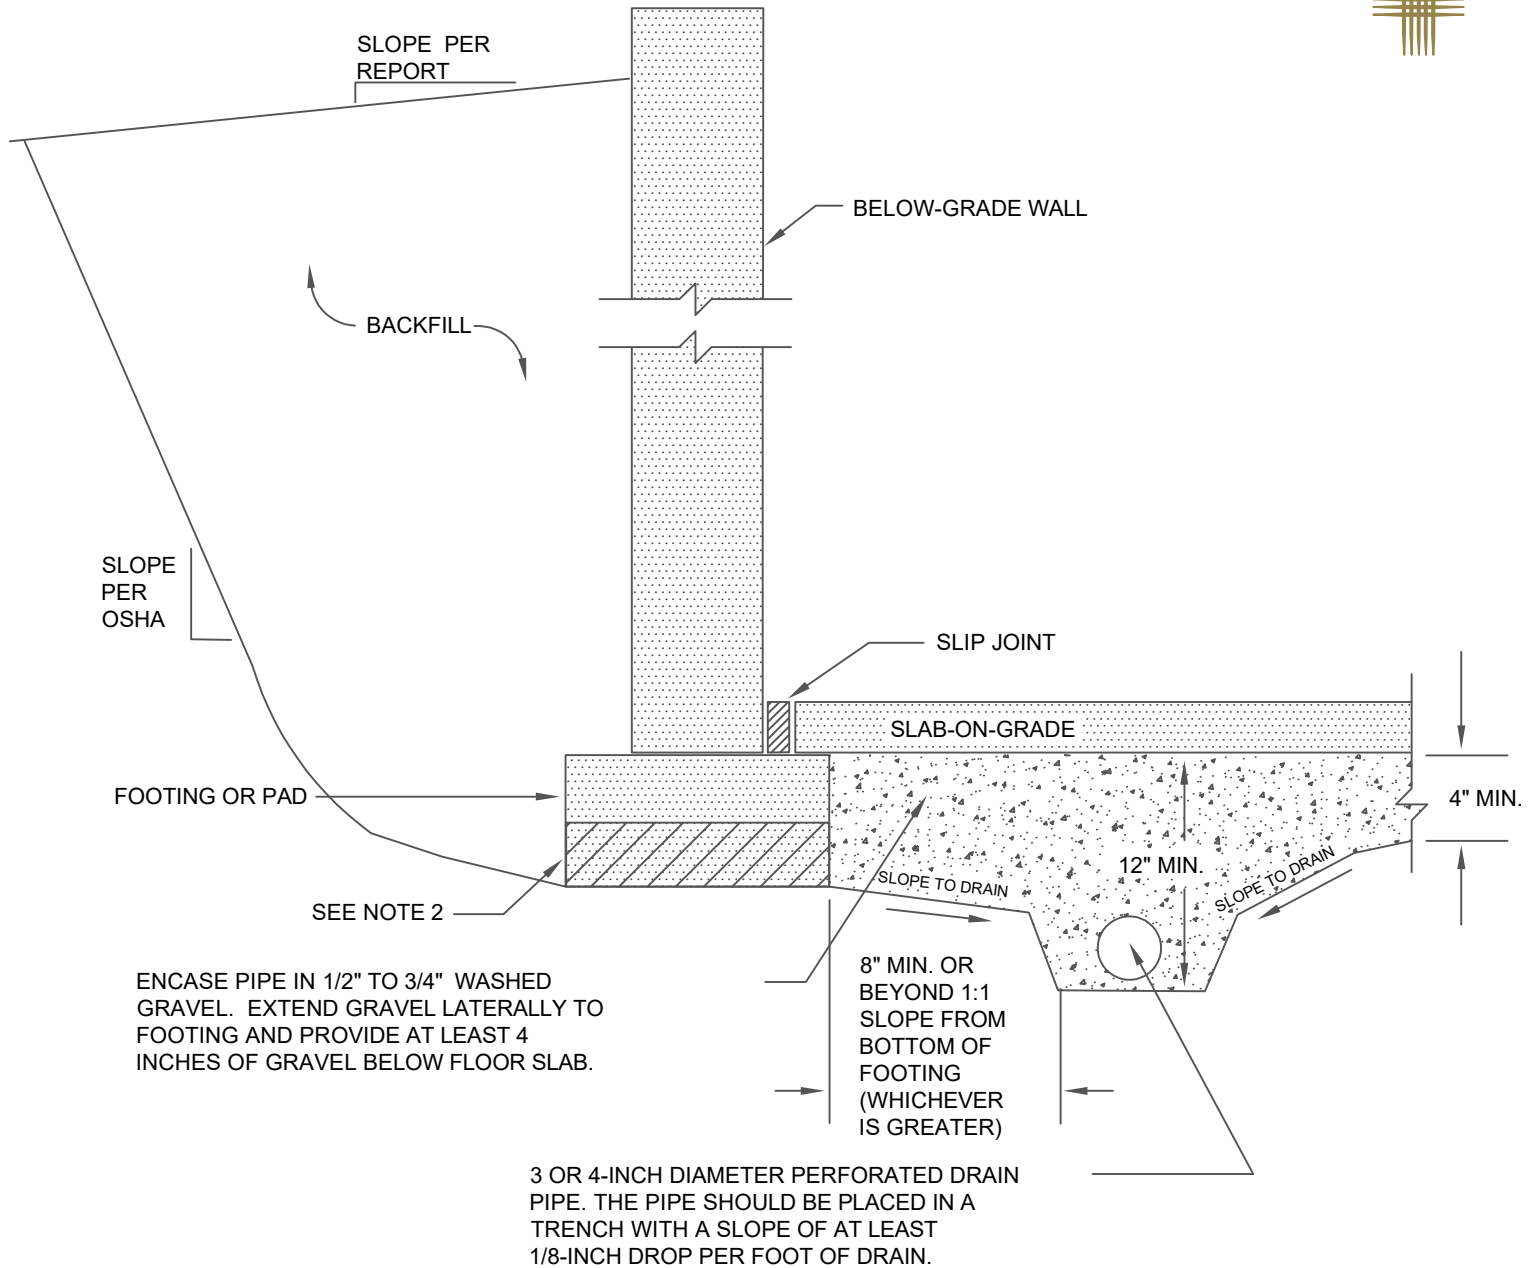
- 1) THE BOTTOM OF THE DRAIN SHOULD BE AT LEAST 12 INCHES BELOW BOTTOM OF SLAB AT THE HIGHEST POINT AND SLOPE DOWNWARD TO A POSITIVE GRAVITY OUTLET OR TO A SUMP WHERE WATER CAN BE REMOVED BY PUMPING.
- 2) FOR CONTINUOUS FOOTINGS, PARTICULARLY ON SUB-EXCAVATED LOTS, IN BASEMENT AREAS, WE RECOMMEND PLACING A 4-INCH THICK, 8-INCH WIDE SECTION OF VOID FORM PERPENDICULAR TO FOOTING LINE ABOUT EVERY 10 TO 15 FEET AND AT WINDOW WELLS, TO ALLOW WATER IN WALL BACKFILL TO PASS BENEATH THE FOOTING INTO THE INTERIOR DRAIN. THIS CAN ALSO BE ACCOMPLISHED BY "TUNNELING" UNDER FOOTINGS AT THE TIME OF DRAIN INSTALLATION. THIS DETAIL SHOULD BE REVIEWED BY THE STRUCTURAL ENGINEER DURING FOUNDATION DESIGN AND INCORPORATED INTO THE FOUNDATION PLAN. ALTERNATIVELY, AN EXTERIOR FOUNDATION DRAIN CAN BE USED.

areas. A conceptual drain detail is shown in Fig. 4. A cutoff collar should be constructed around the sewer pipe and underdrain pipe immediately downstream of the point the underdrain pipe exits the sewer trench or changes from active to passive. Solid pipe should be used down gradient of this cutoff collar to the point of discharge. The underdrain should be maintained at least 3 to 5 feet below the lowest nearby foundation elevation. Where no groundwater is encountered in sanitary sewer excavations, passive underdrains may be used as presented on Fig. 5.

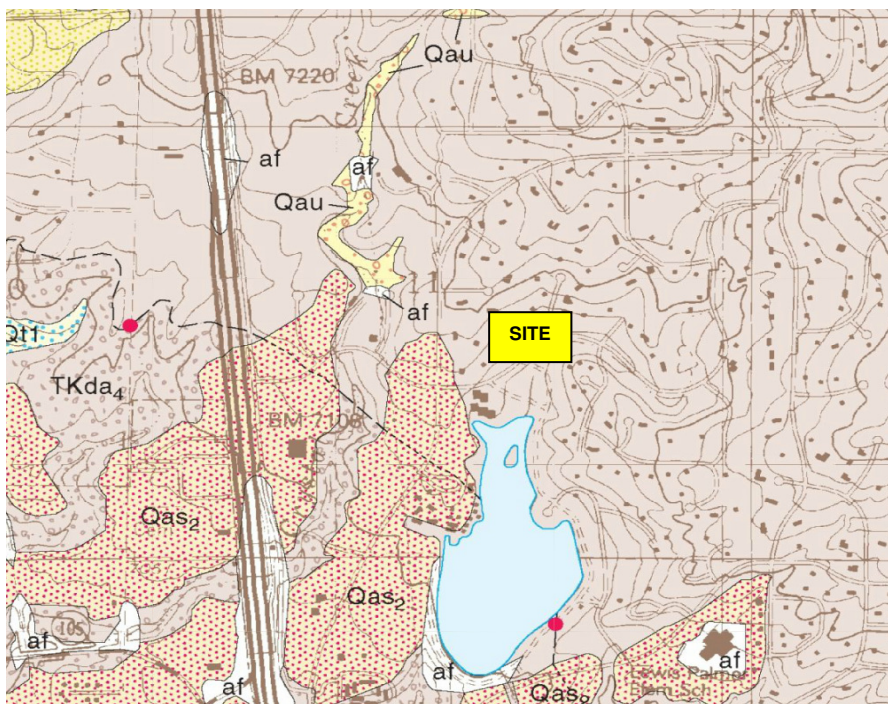
Excerpt from CGS 2004 Geologic Map of the Monument Quadrangle

found in the flood plain to also consist of an alluvial deposit. A list of references is included at the end of the text of this report. The following sections discuss the mapped units.
