Job No. 167719

December 10, 2018

Re: Geologic Hazard Report
975 Oak Ridge Rd
Site 346 Crystal Park, Filing No. 2
Manitou Springs, Colorado

Re: Subsurface Soil Investigation
Site #346, Crystal Park Filing No. 2
Manitou Springs, Colorado

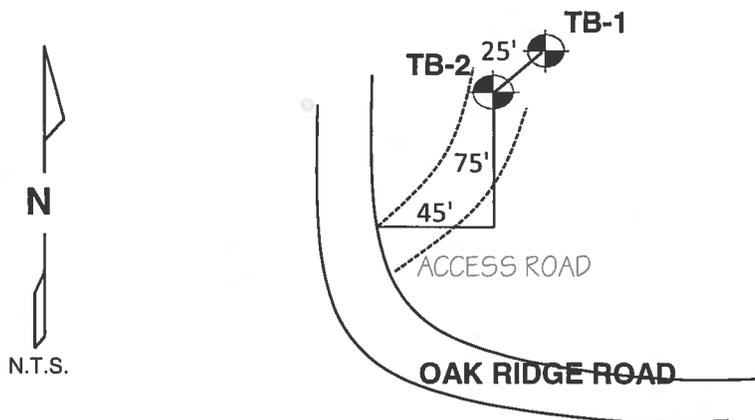
TEST BORING LOG

Based on the review of the soil report referenced above, two test borings were performed on May 3, 2018. The test borings encountered approximately 1-foot of silty sand overlying silty sandstone extending to the 20-foot termination depth of the test borings. Groundwater was not encountered at the time of drilling.

REMARKS	Depth (ft)	Symbol	Samples	Blows per foot	Watercontent %	Soil Type	REMARKS	Depth (ft)	Symbol	Samples	Blows per foot	Watercontent %	Soil Type
DRY TO 20', 5/3/18							DRY TO 20', 5/3/18						
SAND, SILTY, TAN							SAND, SILTY, TAN						
SANDSTONE, SILTY, FINE TO MEDIUM GRAINED, RED BROWN, VERY DENSE, MOIST TO DRY							SANDSTONE, SILTY, FINE GRAINED, RED BROWN, VERY DENSE, DRY TO MOIST						
	5			50 3"	2.9			5			50 10"	1.2	
				50 2"	2.4						50 4"	2.3	
	10			50 2"	2.5			10			50 2"	2.8	
	15			*	1.7			15			50 1"	2.0	
	20			50 2"	1.8			20			50 2"	3.4

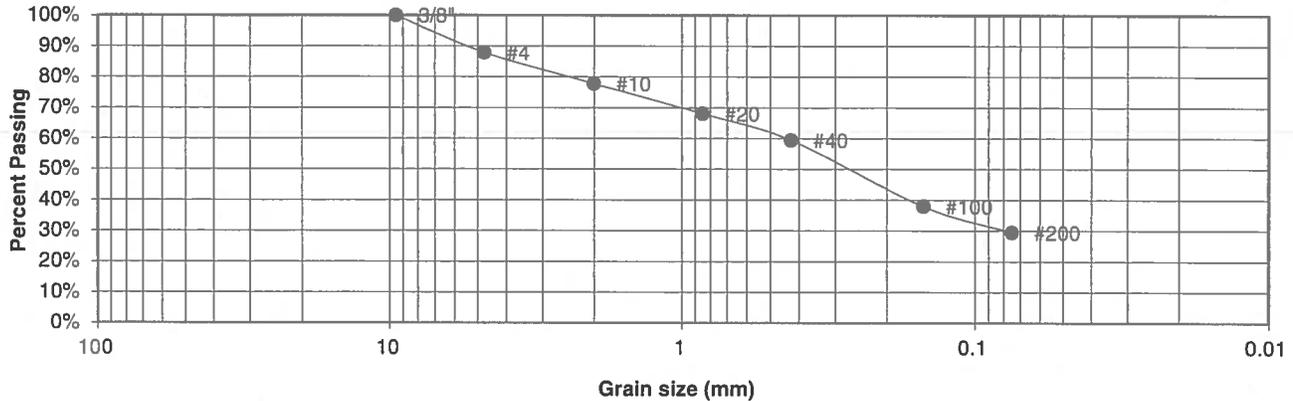
**LABORATORY TEST
RESULTS**

BORING NO.	1	UNIFIED CLASSIFICATION	SM	TEST BY	BL
DEPTH(ft)	2-3	AASHTO CLASSIFICATION		JOB NO.	180779
CLIENT	PALACE HOMES				
PROJECT	346 OAK RIDGE ROAD

U.S. Sieve #	Percent Finer
3"	
1 1/2"	
3/4"	
1/2"	
3/8"	100.0%
4	87.9%
10	77.8%
20	68.1%
40	59.4%
100	37.9%
200	29.5%

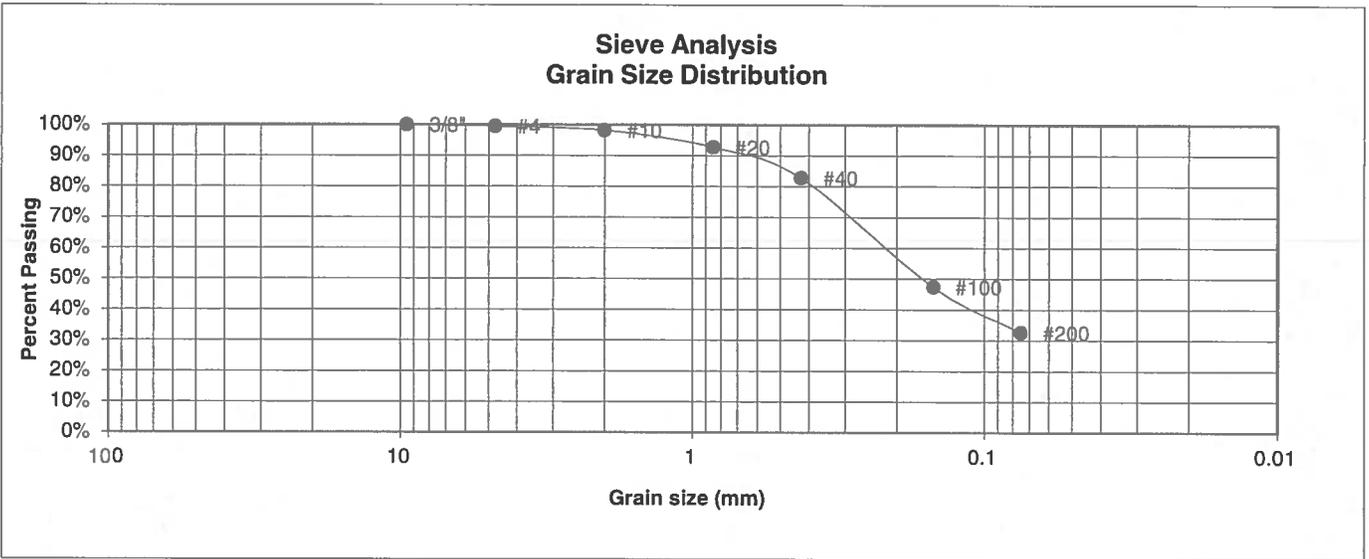
LABORATORY TEST RESULTS

BORING NO.	2	UNIFIED CLASSIFICATION	SM	TEST BY	BL
DEPTH(ft)	5	AASHTO CLASSIFICATION		JOB NO.	180779
CLIENT	PALACE HOMES				
PROJECT	346 OAK RIDGE ROAD

U.S. Sieve #	Percent Finer
3"	
1 1/2"	
3/4"	
1/2"	
3/8"	100.0%
4	99.5%
10	98.2%
20	92.8%
40	82.7%
100	47.4%
200	32.6%
