## **Final Acceptance (FA) – Punchlist from EPC Stormwater**

Project Name:	Winding Walk Filing 1
PCD Filing Number:	SF182
ESQ #:	ESQ187
EPC Stormwater Personnel:	Christina Prete, Dylan Finley and Joshua Augustenborg
Date of Walk-Thru:	10/10/2022
PA Walk-Thru #:	12/02/2019 (PCD Only)

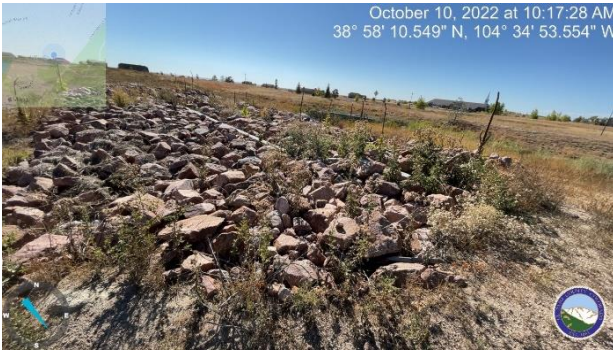
Photo 1: Remove weeds from spillway at Pond H

- Remove all weeds from the emergency spillway.
- Clean out sediment and debris from outlet structure and trickle channels.
- Outlet riprap protection has not been installed per plan (see Construction Drawings, Sheet 20).

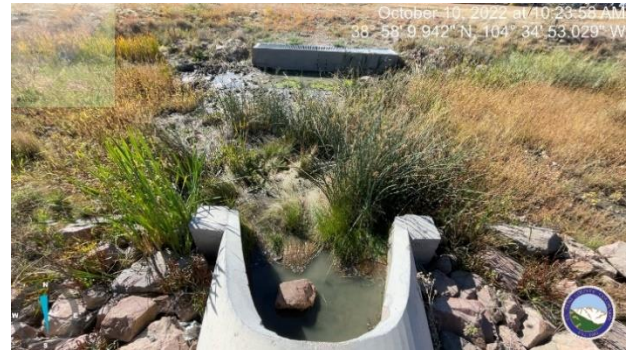
Photo 2: Riprap outlet protection is inadequate at Pond H outlet

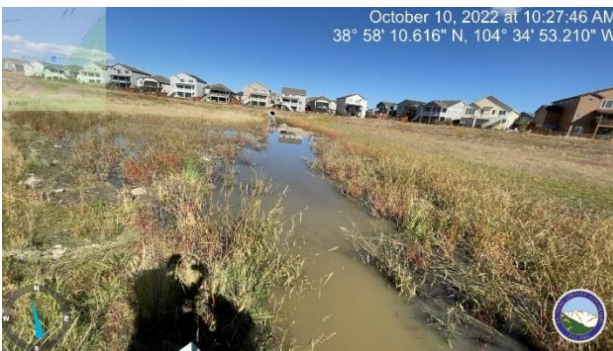
- Standing water throughout bottom of pond. Pond must release or infiltrate at least 99% of the captured runoff within 120 hours (5 days) of a storm (0.06-inches of precipitation on 10/6/2022, wunderground.com). The initial FA was completed 4 days after the last rain event in the area. Stormwater Personnel completed an additional visual inspection 7 days after the last rain event and noted standing water in Pond H remained (10/13/2022).

Photo 3: Standing water at Pond H

- Raise pond bottom to top of trickle channel curb with a 3% slope towards trickle channel for positive drainage.
- Standing water at forebay must be addressed to promote positive drainage.

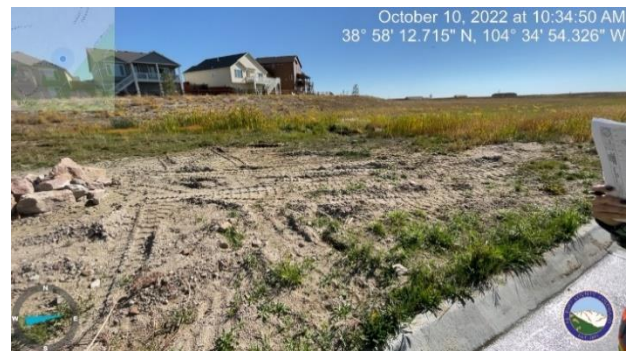
Photo 4: Mowing needed throughout Pond H. Seeding and stabilization needed.

- Remove weeds from pond embankments and pond bottom.
- Mow all overgrown vegetation and seed and mulch all bare areas within the pond embankments and pond bottom.

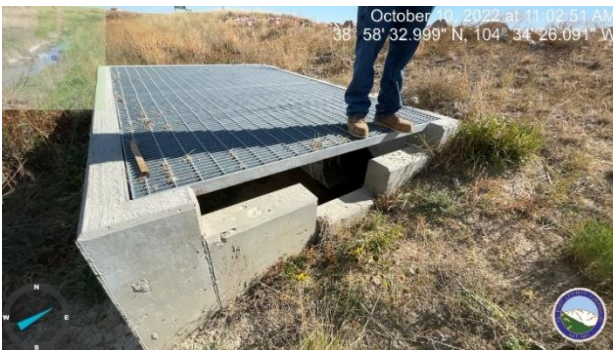
- Clean out sediment and debris from outlet structure and trickle channels.
- North outlet structure weir opening is not built to design (GEC, Sheet 19, Detail 2.1). Include modification on the as-built drawings and Pond Certification Letter with revised MHFD Detention Spreadsheet (v4.06).

Photo 5: Weir notch was not built per plan at Pond E

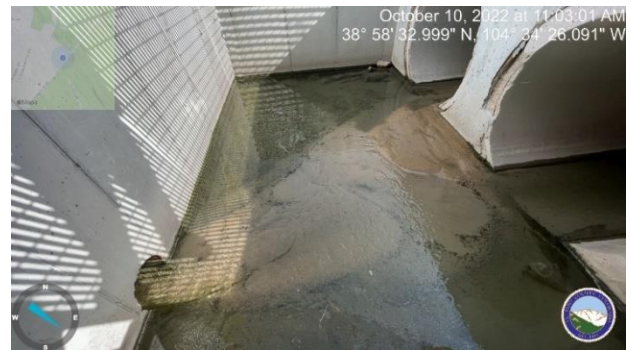
Photo 6: Cleanout of sediment at North outfall structure at Pond E

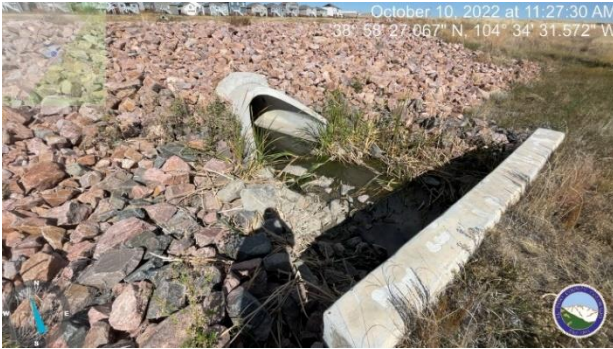
Photo 7: Riprap outlet protection inadequate at Pond E

- The South trickle channel is damaged and will need to be repaired.
- Outlet riprap protection is not adequate and should be installed per plan (see Construction Drawings Sheet 20).

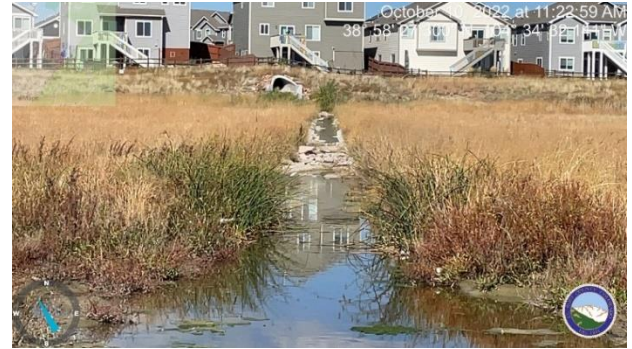
Photo 8: South trickle channel needs repair at Pond E

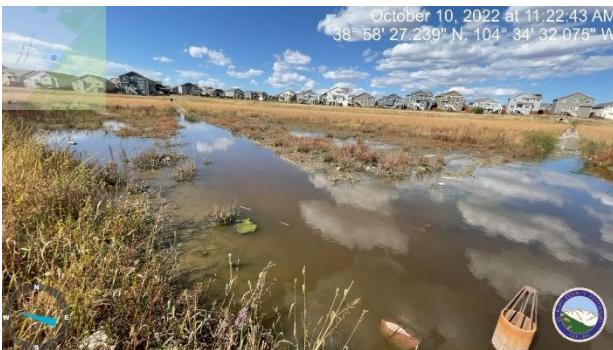
Photo 9: Excess standing water throughout Pond E

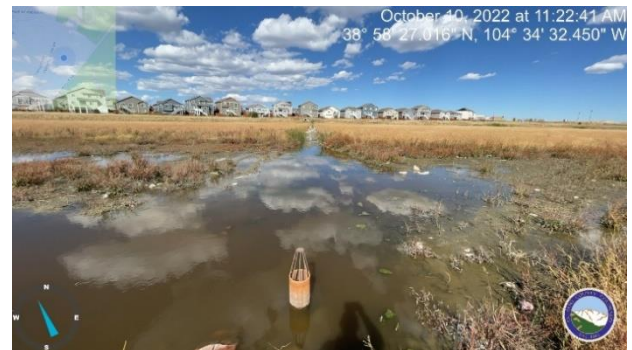
Photo 10: Excess standing water throughout Pond E

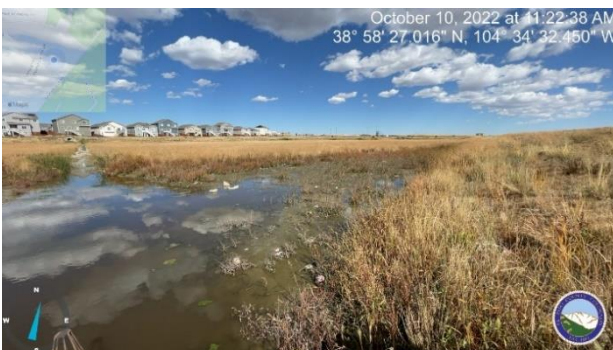
Photo 11: Excess standing water throughout Pond E.  
Mowing needed

- Remove weeds from pond embankments and pond bottom.
- Mow all overgrown vegetation and seed and mulch all bare areas within the pond embankments and pond bottom.

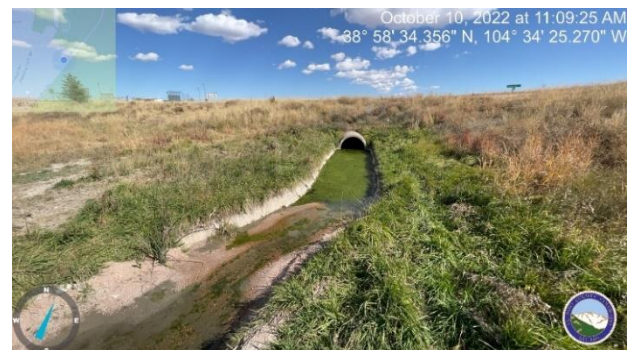
Photo 12: Excess standing water throughout Pond E.  
Northern most inlet pipe

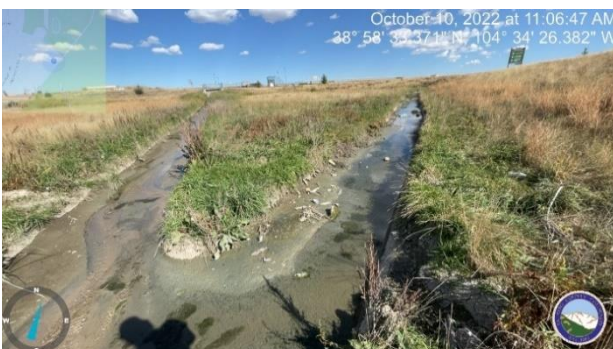
Photo 13: Trickle channel needs cleaned out at Pond E

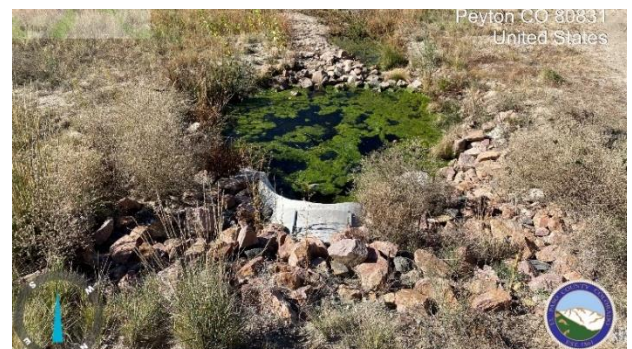
Photo 14: Storm #1 outlet standing water.

- Storm #1, Storm #4, Storm #7 inlets must be cleaned out and temporary BMPs removed.
- Fine grade outlet riprap at Storm #7 to promote positive drainage.

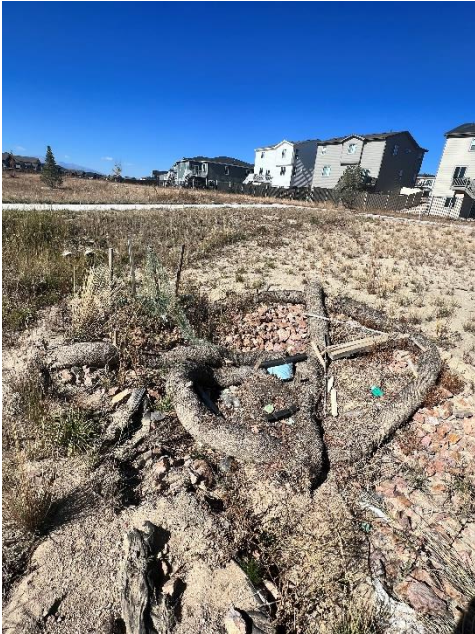
Photo 15: Storm #4 inlet needs to be cleaned and temporary BMPs removed.

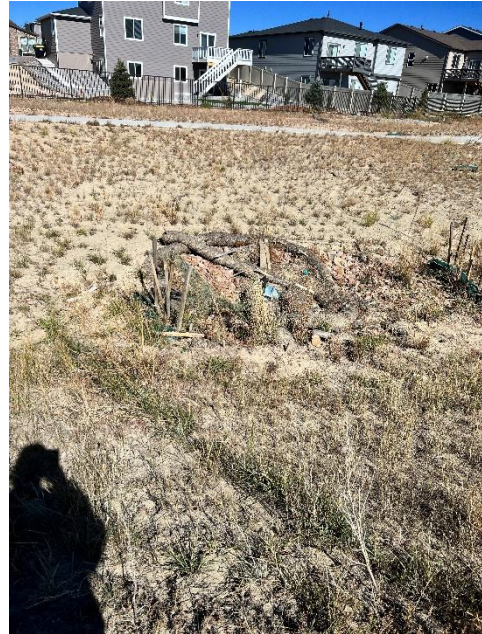
Photo 16: Storm #4 outlet needs to be cleaned and temporary BMPs removed.

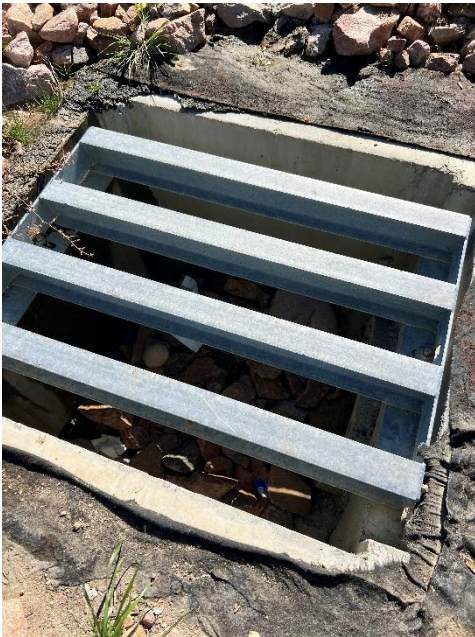
Photo 17: Storm #7 inlet needs to be cleaned out.

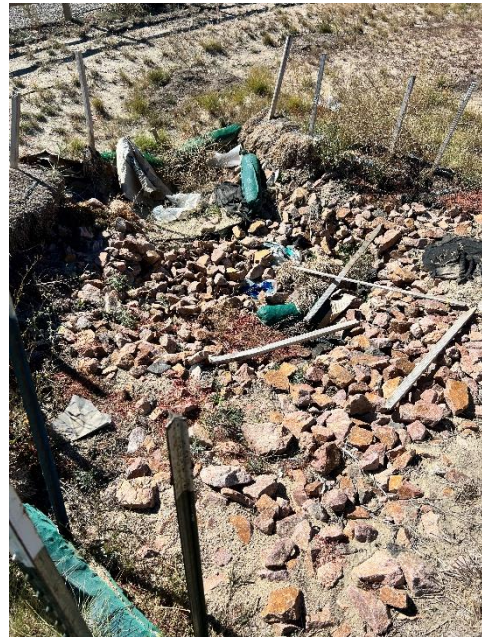
Photo 18: Storm #7 outlet needs to be cleaned and temporary BMPs removed.

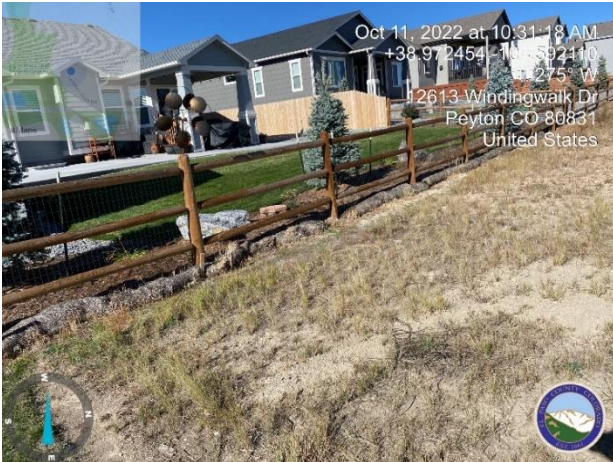
Photo 19: Ensure all temporary control measure are removed

- All temporary BMPs must be removed now that 70% vegetation has been achieved.

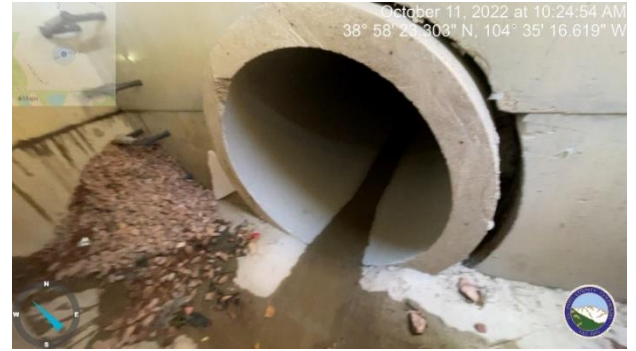
Photo 20: Inlets throughout filing need to be cleaned out and debris removed

- Inlets that need to be cleaned of sediment and debris: Inlet #6, 13, 19, 20, 23, 24, 26, 27, 31
- Inlets that still have wood forms that need to be removed: Inlet #9
- Inlets that need to be cleaned out and the forms need to be removed: Inlet #11
