August 15, 2025  
Revised May 11, 2026

Re: Soils and Geology Study  
12120 Casey Lane – 7-Lot Subdivision  
Parcel No. 62130-00-006  
El Paso County, Colorado  
Entech Job No. 213150

The project consists of subdividing 35.955-acres into seven rural residential lots. The site is located southwest of the intersection of Shoup Road and Casey Lane in the northern portion of El Paso County, Colorado.

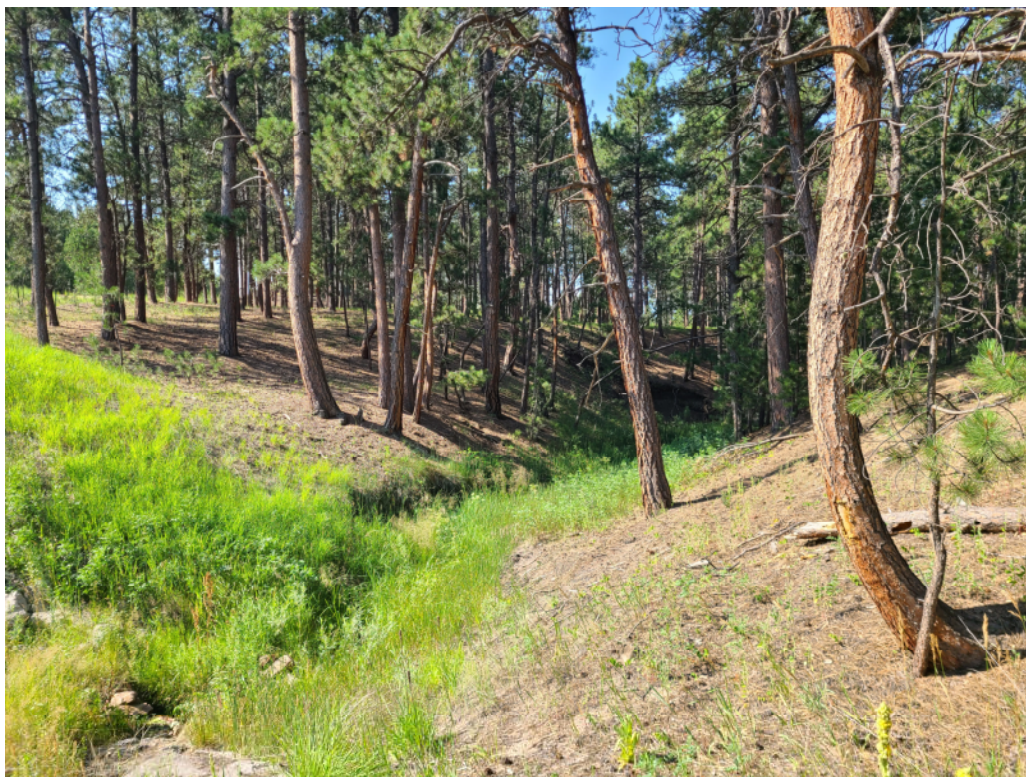
July 25, 2025

**Looking southwest  
along drainage from  
the eastern side of the  
site.**

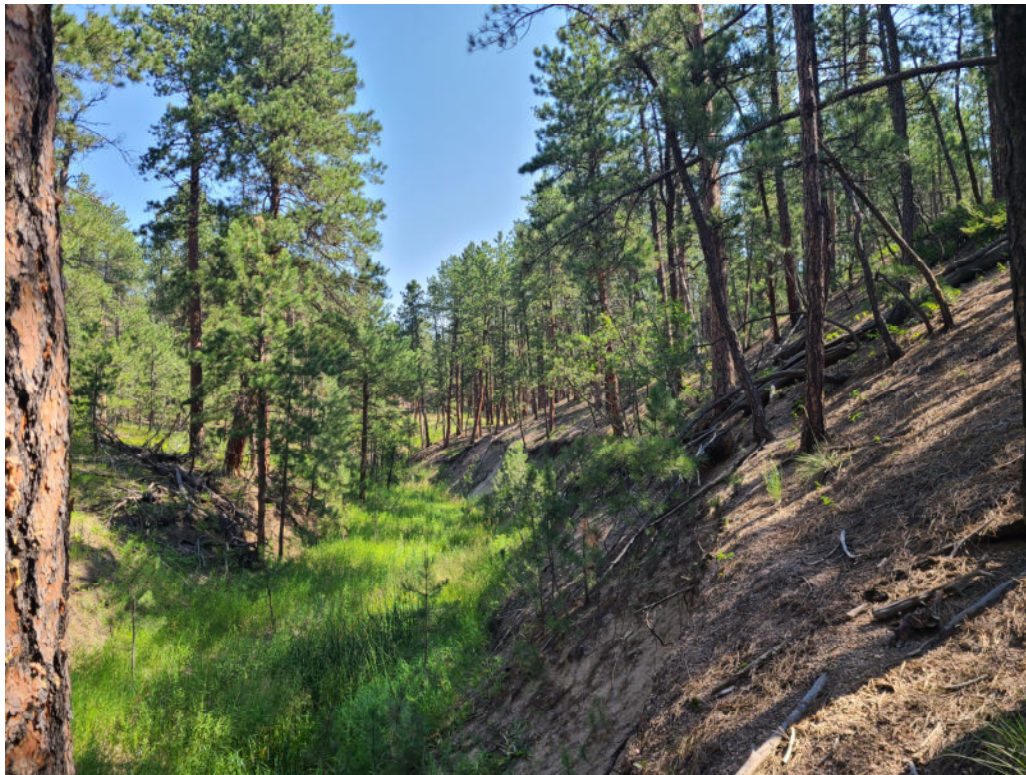
July 25, 2025

The areas identified with this hazard include the steep slopes along the main drainage in the central and southwestern portions of the site have been mapped as potentially unstable. These slopes are considered stable in their present condition, however, considerable care must be exercised in these areas not to create a condition which would tend to activate instability. Due to the lot size this area will be avoided by the proposed structures.

**Looking north along  
potentially unstable  
slopes along drainage  
in the southwestern  
portion of the site.**

Mitigation: A minimum 30-foot setback is recommended from the crest of the potentially unstable slopes. Building should be avoided in these areas. Proper control of drainage at both the surface and the subsurface is extremely important. Areas of ponded water at the surface should be avoided. Utility trenches, basement excavations and other subsurface features should not be permitted to become water traps which may promote saturation of the subsurface materials. Drainage should not be permitted over the potentially unstable slope but directed in a non-erosive manner away from the slope. Irrigation above these slopes should be kept to a minimum to prevent saturation of the subsurface soils.

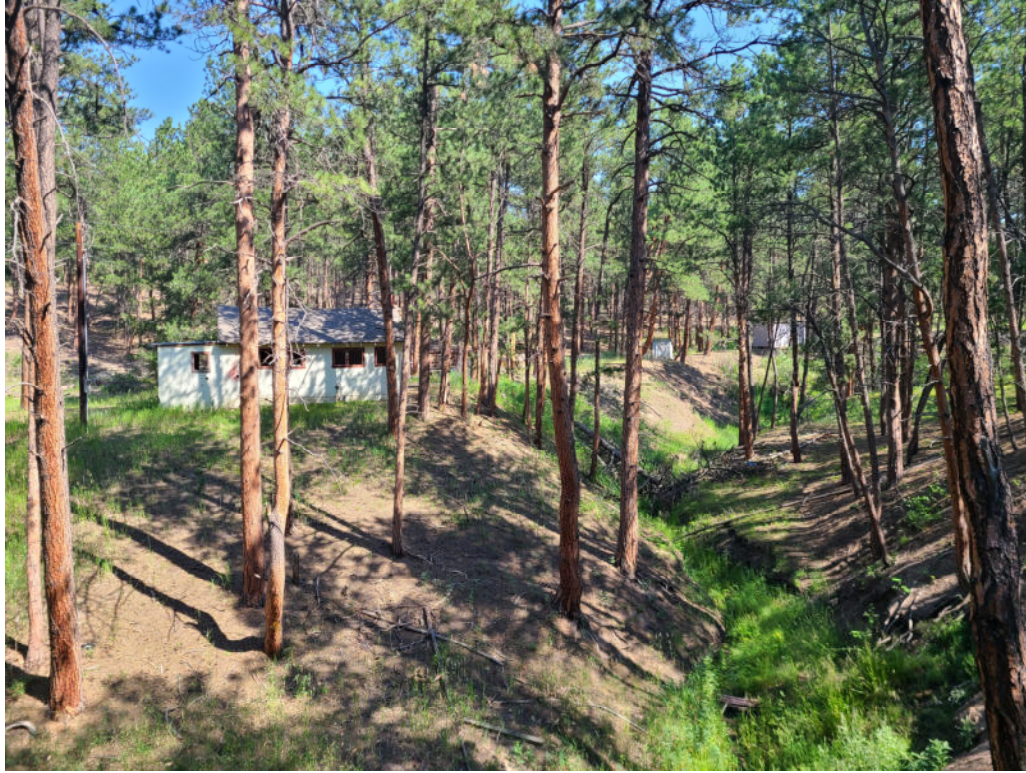
July 25, 2025

**Looking north along  
drainage in the central  
portion of the site.**

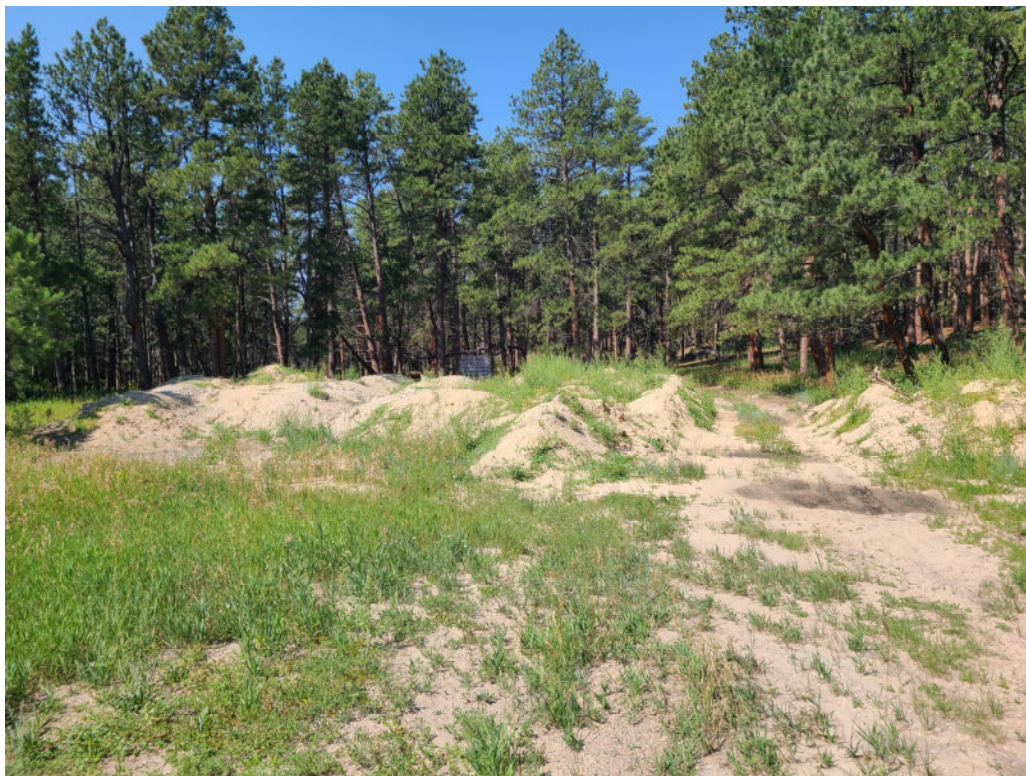
July 25, 2025

**Looking west towards  
fill piles located on  
proposed Lot 3.**

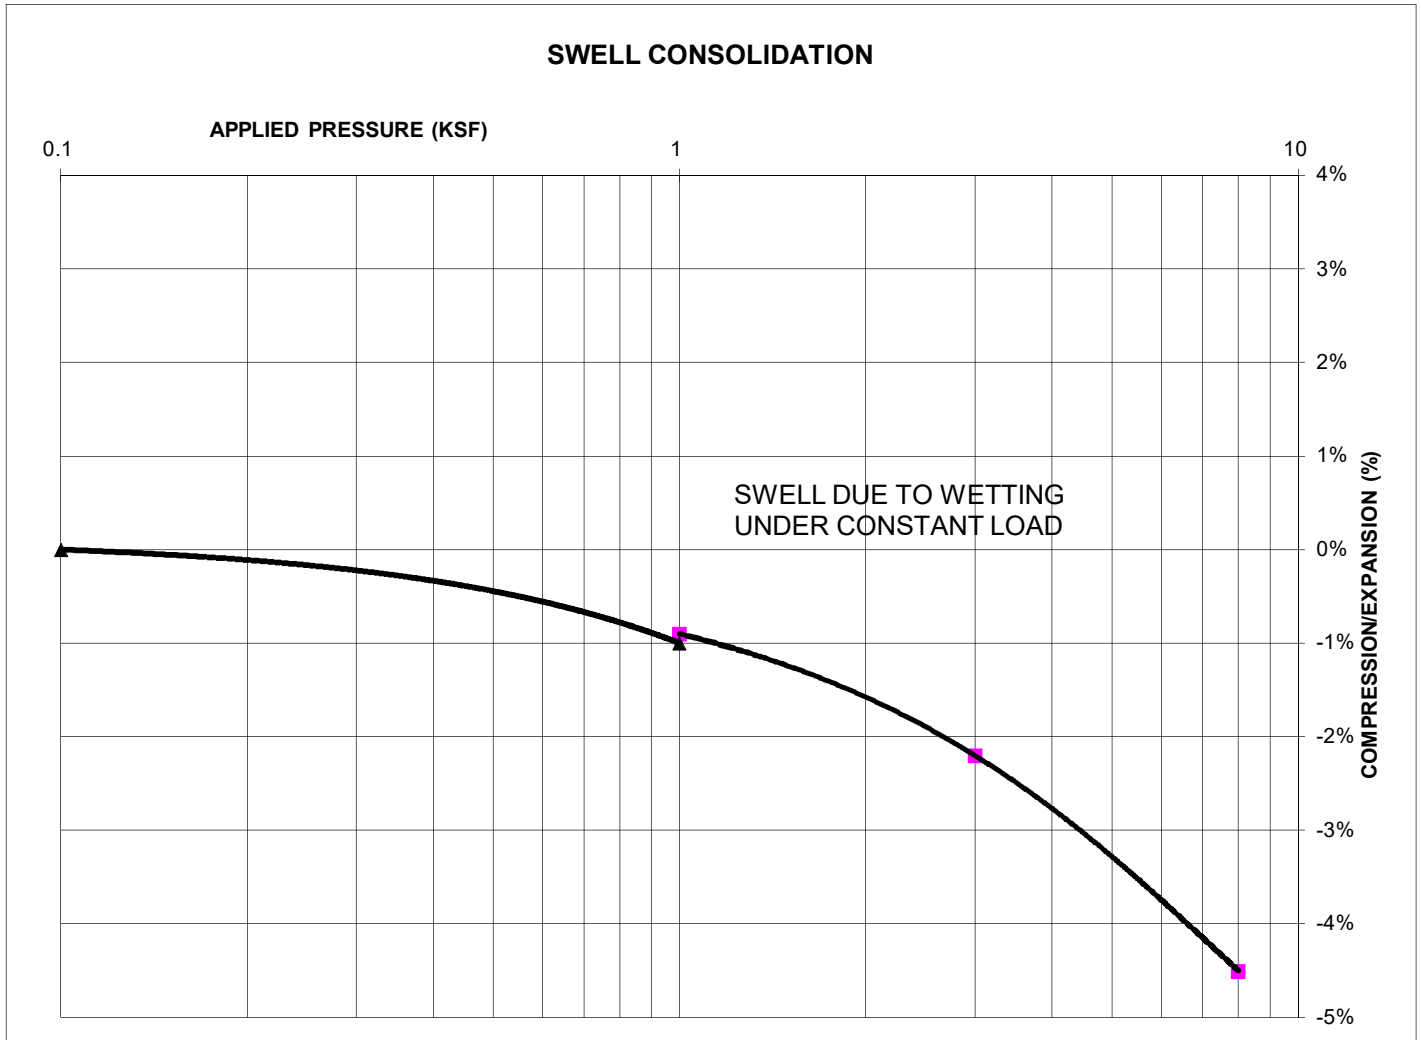
**SWELL/COLLAPSE TEST RESULTS**

Soil Type 3 is a sandy claystone (CL). Soil Type three was encountered both of the test borings at depths ranging from 4 to 9 feet bgs and extended to depths ranging from 9 feet to the termination of the test boring (15 feet). These soils were encountered at hard consistencies and at moist conditions. Samples tested had approximately 68 to 84 of the soil sized particles passing the No. 200 Sieve. Swell/Consolidation Testing resulted in a volume change of 0.1 percent, indicated a low expansion potential. Highly expansive claystone is common in the area.

NATURAL UNIT DRY WEIGHT (PCF): 118  
NATURAL MOISTURE CONTENT: 11.9%  
SWELL/COLLAPSE (%): 0.1%
