**GEOLOGIC HAZARD ASSESMENT
ADVANCED STORAGE BARNES
5560 BARNES ROAD
PARCEL NO. 63251-06-040
COLORADO SPRINGS, COLORADO**

Prepared for:
**Advanced Storage Barnes, LLC
5001 South Windermere Street, #100
Littleton, Colorado 80120**

September 22, 2023

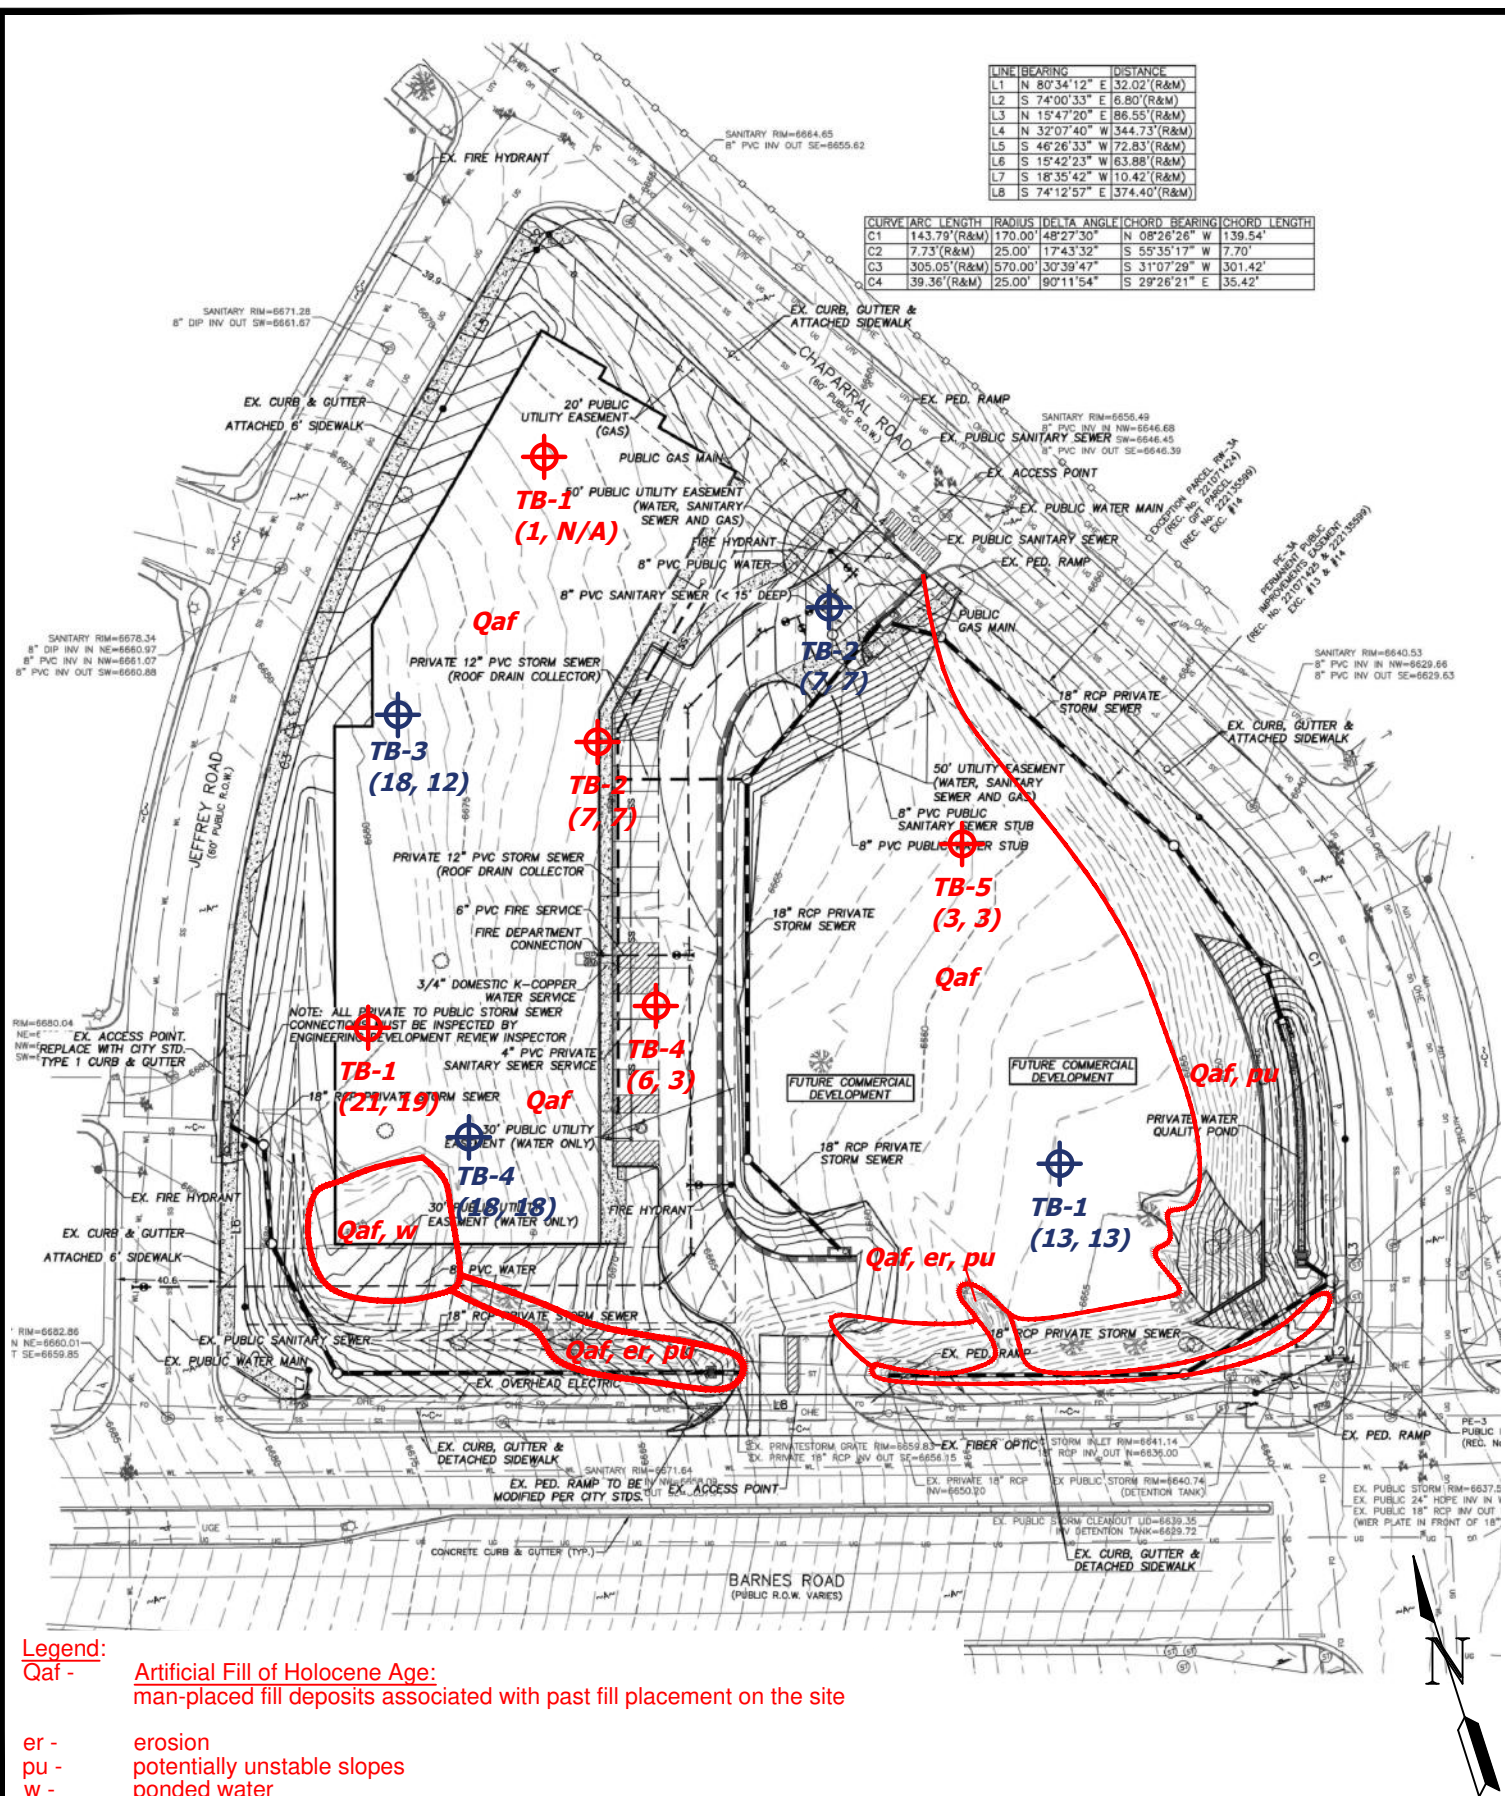
FIG. 6

Detailed mapping has been performed on this site to produce an Engineering Geology Map Figure 6. This map shows the location of various geologic conditions of which the developers should be cognizant during the planning, design and construction stages of the project. These hazards and the recommended mitigation techniques are as follows:

Fill was observed on the site and was encountered in eight of the nine test borings drilled on the site. The fill was encountered to depths ranging from 3 to 19 feet across the site. An embankment was also observed along the eastern side of the small, ponded area in the southwestern portion of the site. The fill is considered uncontrolled for construction purposes and will require mitigation. Mitigation: Any uncontrolled fill encountered beneath foundations will require removal and recompaction at a minimum of 95% of its maximum Modified Proctor Dry Density, ASTM D-1557. Most of the fill will be mitigated with the proposed site development and construction of the storage facility.

The potentially unstable slopes are located along the drainage in the southern portion of the site and along the steeper slopes in the eastern portion of the site. A storm water quality pond is proposed in the southeastern portion on the site along the slope. Considerable care should be taken in construction of the pond and related retaining walls. The retaining wall should be designed by a qualified engineer and should account for the additional lateral pressures from the slope above. A lateral pressure diagram is presented in Figure 7. Lining the pond is recommended to prevent saturation of the subgrade materials at the toe of the slope. Development plans for the future commercial pad site were not available at this time. Construction along the crest of the slope should be avoided unless properly mitigated, and a building setback of a minimum of 15 feet from the crest of the slope is recommended. Site specific slope stability analysis was conducted for the proposed storage building and storm water quality pond and is presented below. The pond and drainage along the southern side of the site will be regraded and piped during the proposed grading operations.

Mitigation: The fill should be removed to native soils and recompact at 95% of its Modified Proctor Dry Density, ASTM D-1557. The ground surface around all permanent structures should be positively sloped away from the structure to all points, and water must not be allowed to stand or pond anywhere on the site. We recommend that the ground surface within 10 feet of the structures be sloped away with a minimum gradient of ten percent. If this is not possible on the upslope side of the structures, then a well-defined swale should be created to intercept the surface water and carry it quickly and safely around and away from the structures. Roof drains should be made to discharge well away from the structures and into areas of positive drainage.

Mitigation: The potentially unstable slopes will be mitigated with site grading and proposed retaining walls (designed by qualified personnel). The majority of the potentially unstable slopes can be avoided by development. Areas where the structures should be located a minimum distance to allow for a 3:1 projection from the toe of the slope and the excavation for the foundation. Steep cuts should be avoided in areas of potentially unstable slopes unless analyzed for the global slope stability. This includes cuts of landscaping and terracing. The potentially unstable slopes in the eastern portion of the site will be regraded and retaining walls constructed as a part of the development. Walls up to 17 feet in exposed height are proposed for the storage building and walls up to 7 feet for the stormwater quality pond. The building foundation will be stiffened with buttresses and tie-beams, and a minimum 10-inch thick floor slab is proposed. The slope analysis was based on these conditions. Site retaining walls should be designed for the existing site conditions by a qualified professional engineer. **Due to the sloping conditions retaining walls on this site must be designed for internal and external global slope stability.** Unretained slopes inside the recommended 3:1 for sand soils to slopes that are analyzed for global slope stability.

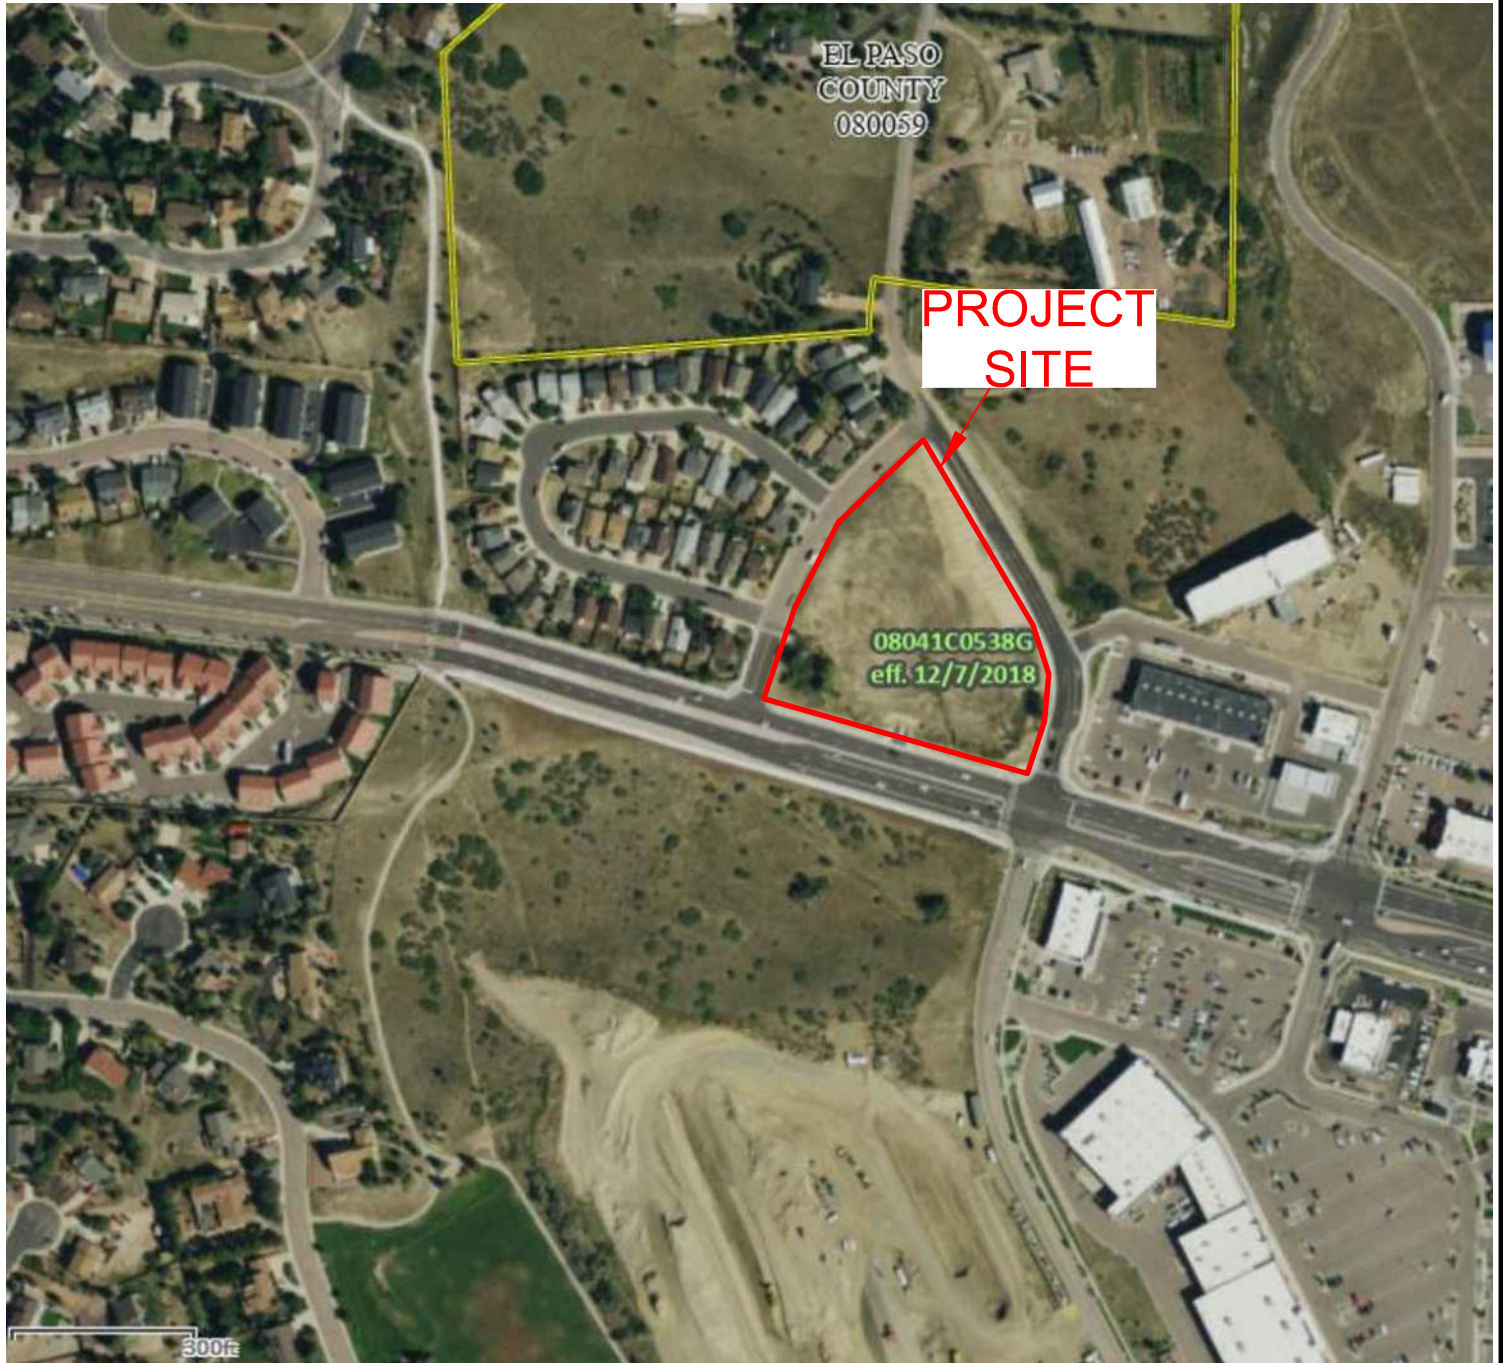
FIG. 9

The site is not mapped within floodplain zones according to the FEMA Map No. 08041CO538G, (Figure 9, Reference 13). The drainage on the site flows in an easterly direction, and a small, ponded area lies in the southwest corner of the site. This pond is dammed with an outlet culvert which drains into the erosion gully that flows along the southern side of the site. Other areas of erosion were observed in the southeastern portion of the site. Water was observed in the pond at the time of our site investigation. Groundwater was not encountered in the test borings at depths ranging from 10 to 25 feet below the existing surface grade.

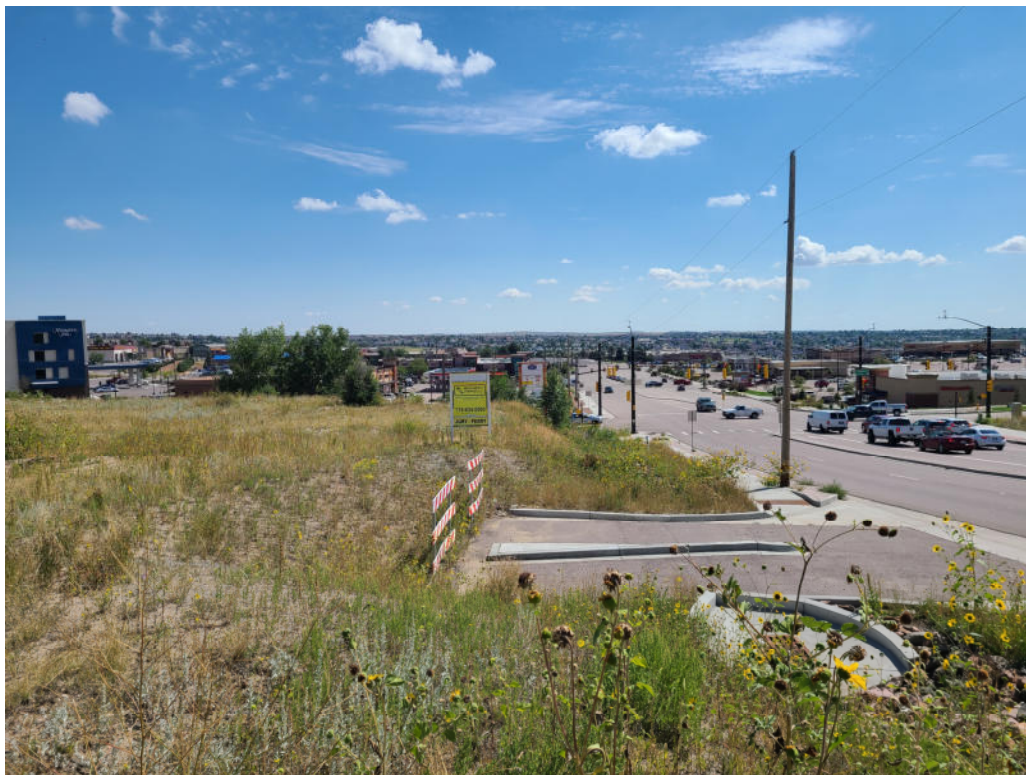
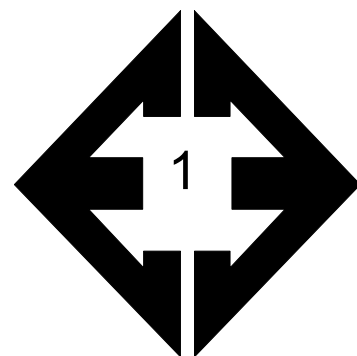
**Looking east from the
southern side of the
site.**

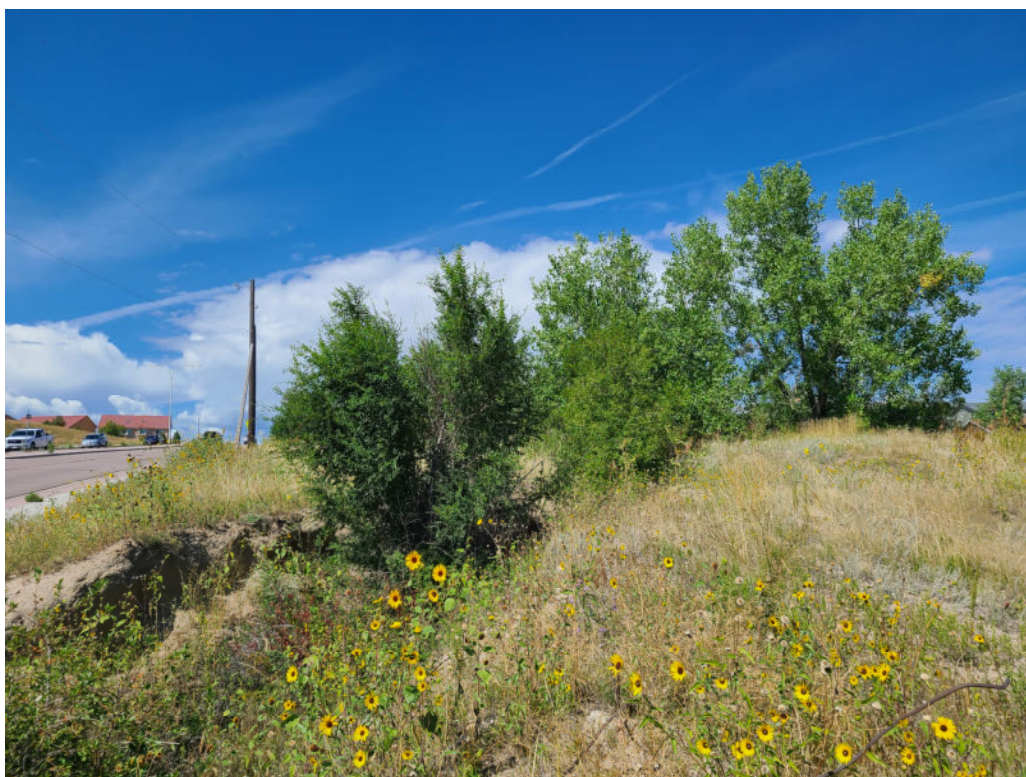
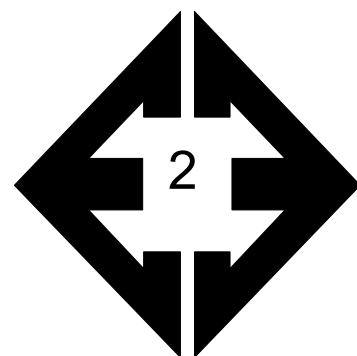
**Looking west from the
southern side of the
site.**

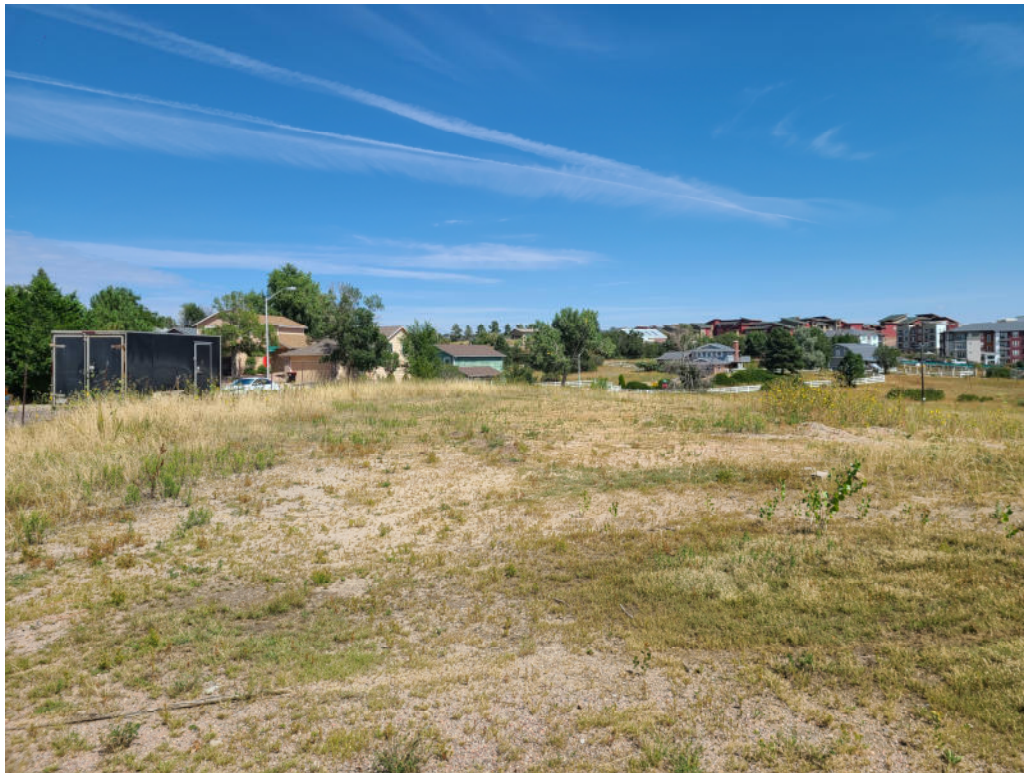
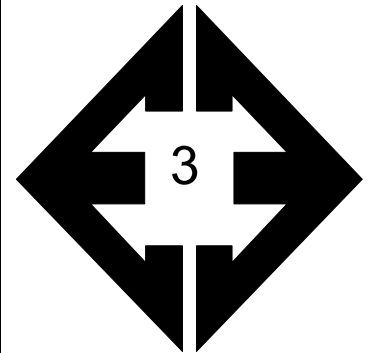
**Looking north from the
western side of the
site.**

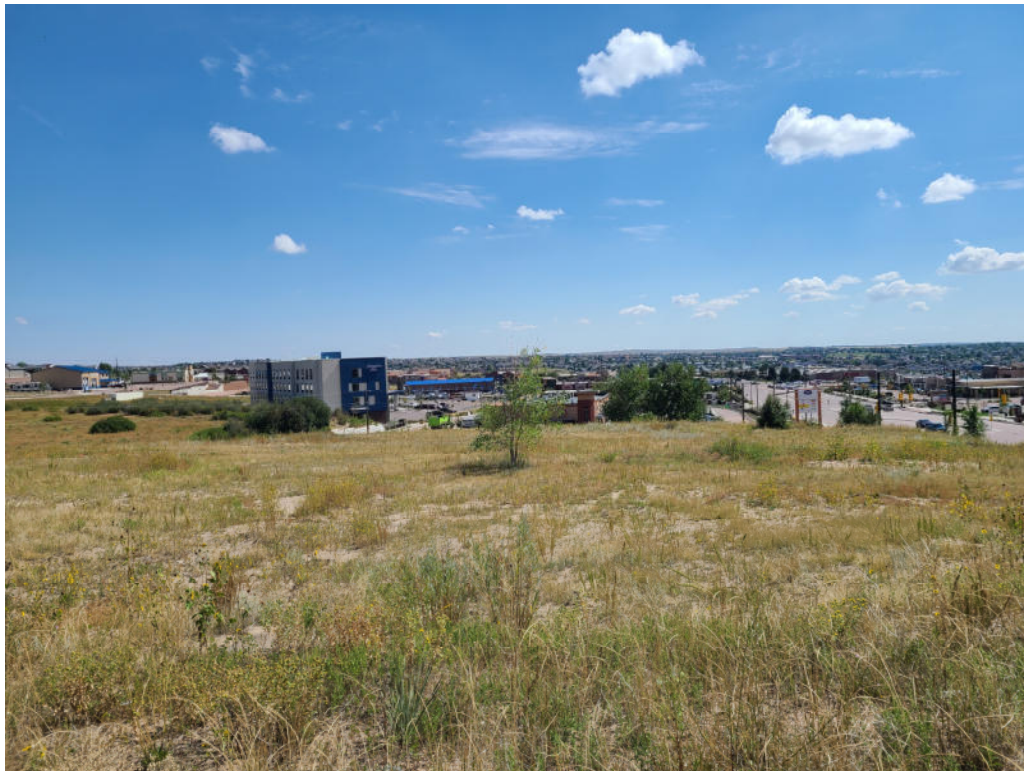
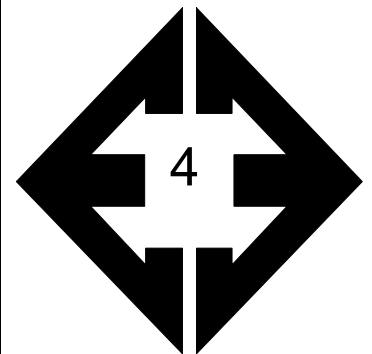
**Looking east from the
western side of the
site.**

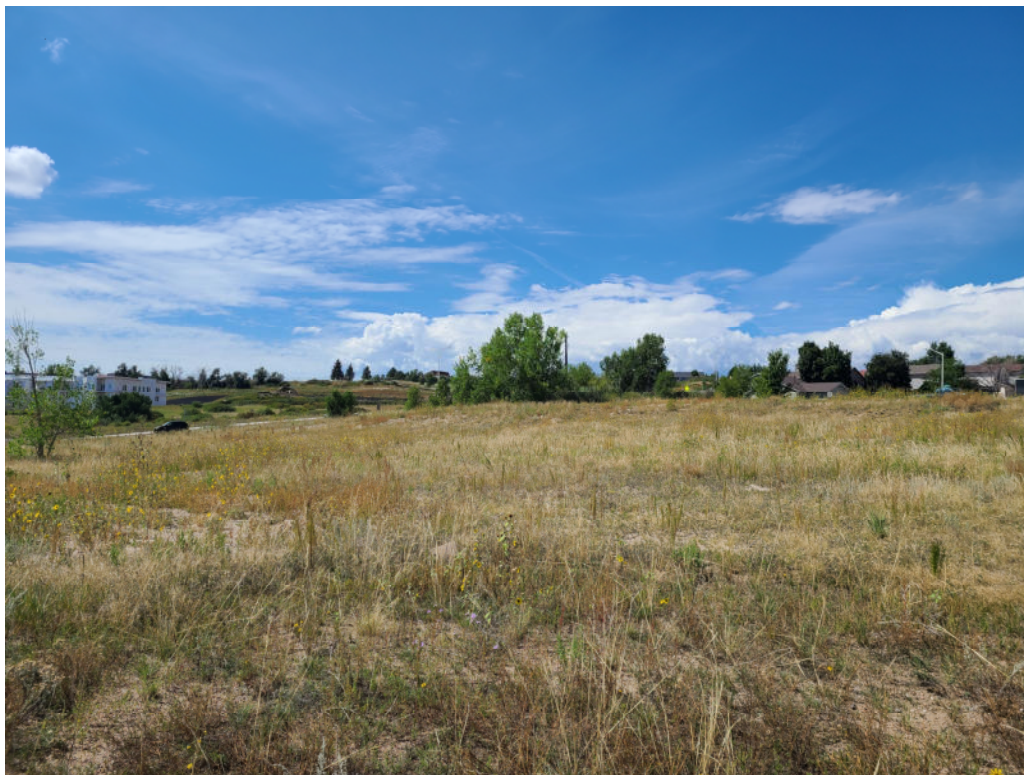
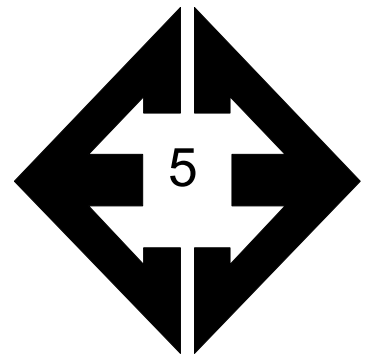
**Looking southwest
from the northeastern
side of the site.**

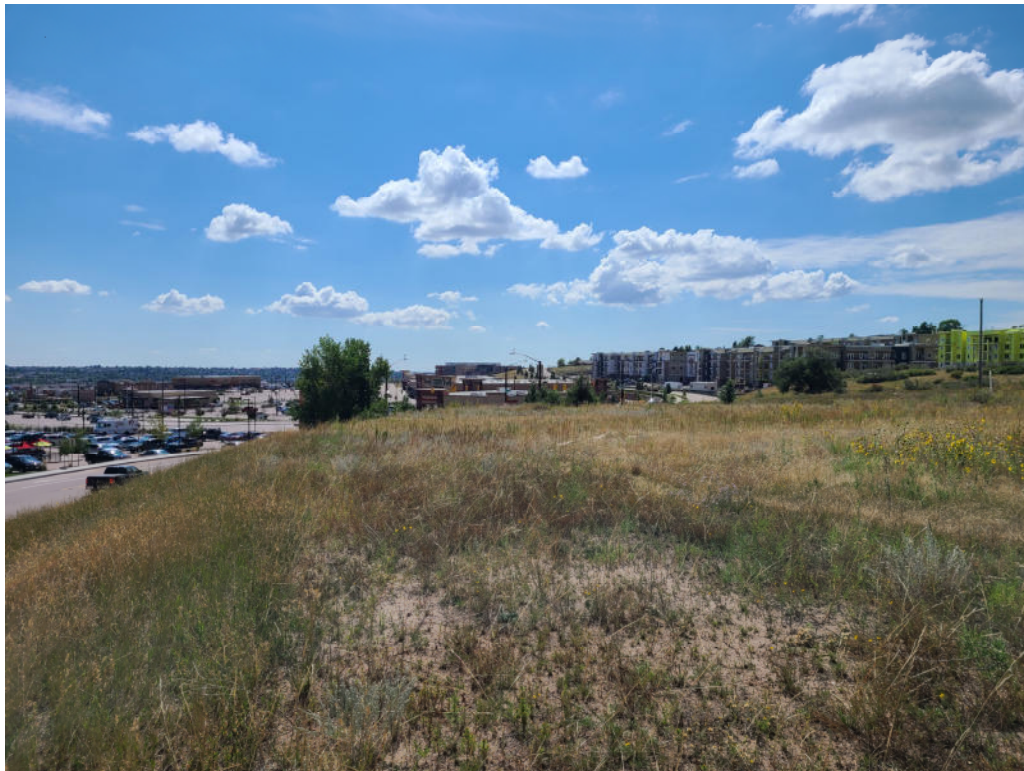
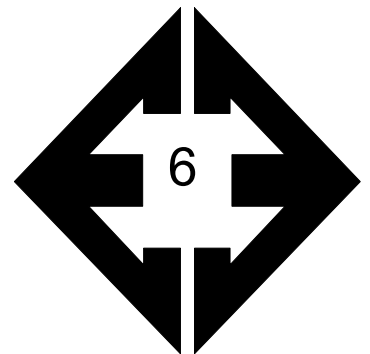
**Looking south from
the eastern side of the
site.**

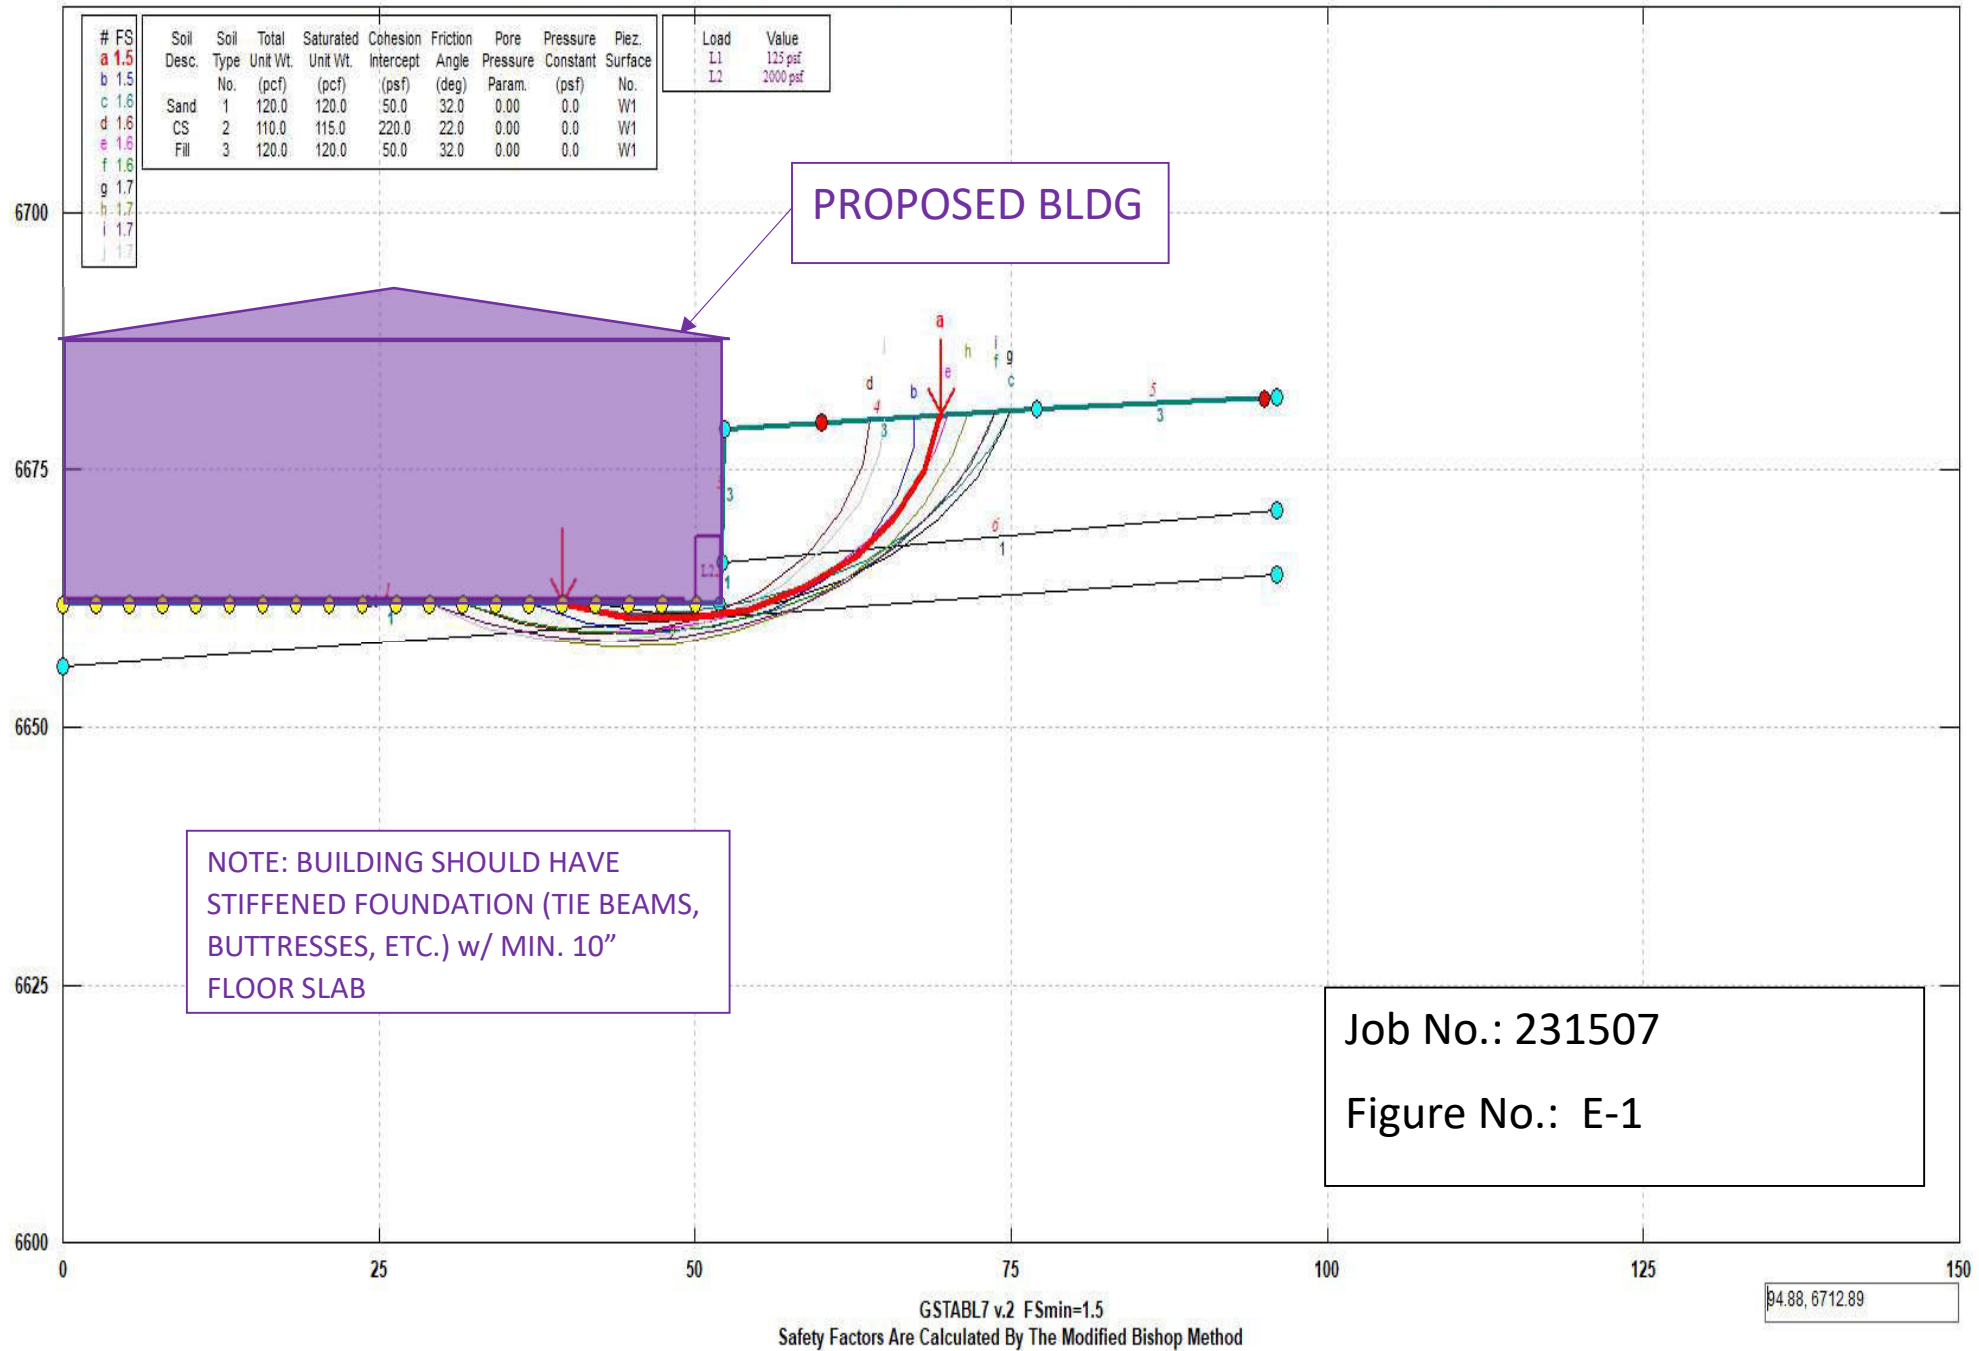
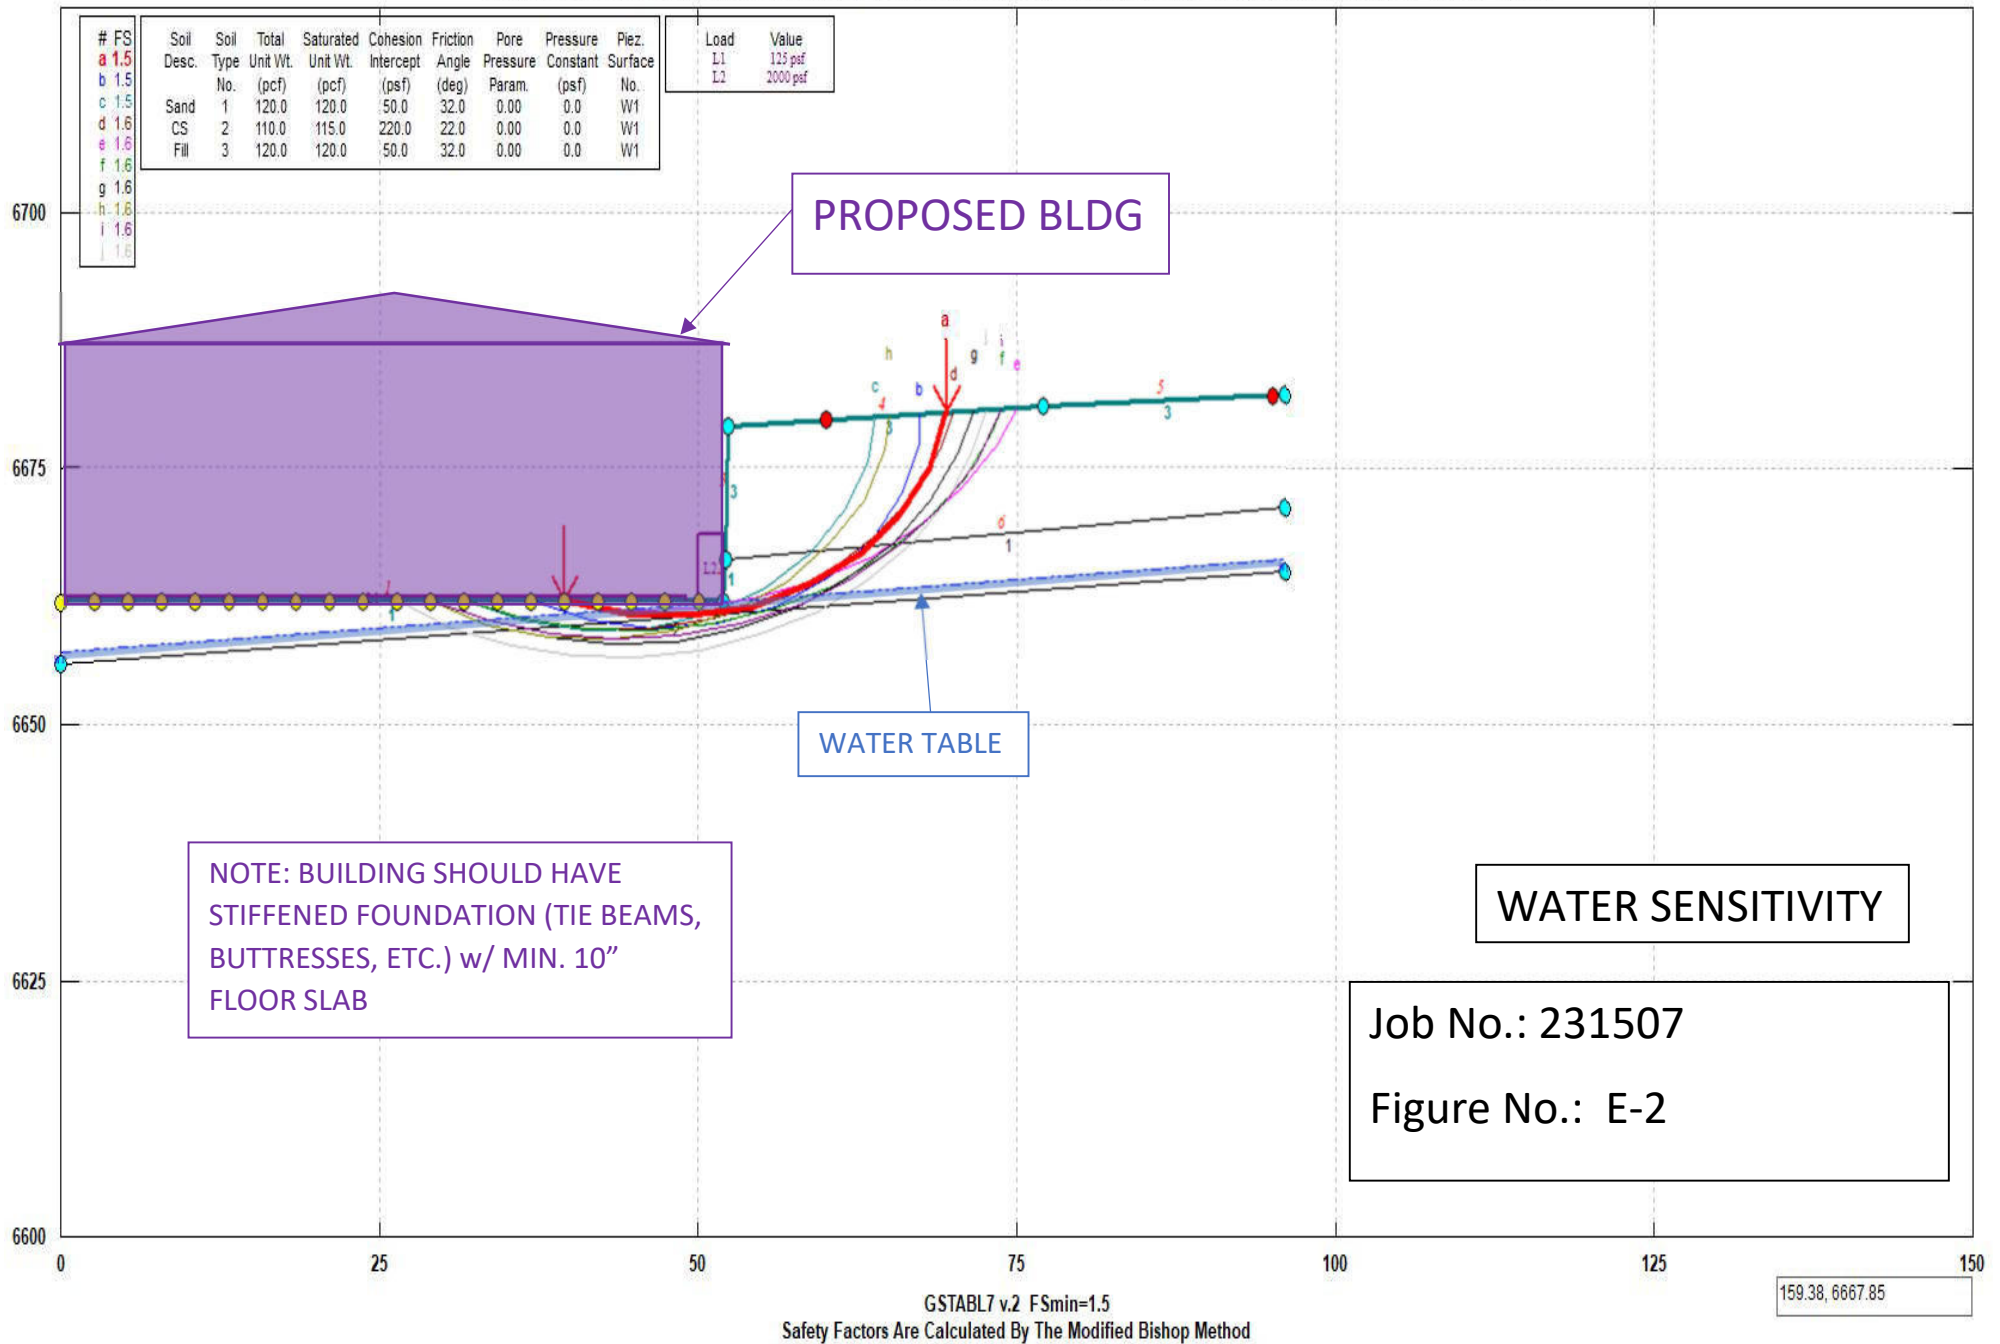
ADVANCED STORAGE BARNES – 5560 BARNES – A-A

Factors of safety of 1.3 to 1.5 were obtained based on the proposed development plan, provided excavation/overexcavation drains and retaining walls (**designed for local and global stability with geogrid used in the analysis**) are installed as recommended. **All slopes should be evaluated for local and global stability for final designs.** Results of the slope stability analysis are presented in Appendix E. A factor of safety of 1.5 is recommended for areas of critical structures such as buildings, and a factor of safety of 1.3 for non-critical structures such as roadways, ponds, and parking areas. Preliminary analysis of the proposed development show that adequate factors of safety can be achieved.

Figure #	Section	Water Table	F.O.S.	Description
E-1	A-A	Low	1.5	Proposed site analyzed with circular failure surface with stiffened foundation. Nominal loads of 2000 psf (exterior foundation) and 150 psf (minimum 10" thick floor slab) are provided for analysis.
E-2	A-A	High	1.5	Proposed site analyzed with circular failure surface with stiffened foundation. Nominal loads of 2000 psf (exterior foundation) and 150 psf (minimum 10" thick floor slab) are provided for analysis. Elevated water table.
E-3	A-A	Low	1.3	Proposed site analyzed with circular failure surface with lined detention pond.
E-4	A-A	High	1.3	Proposed site analyzed with circular failure surface with lined detention pond. Elevated water table
