**GEOLOGIC HAZARD ASSESMENT
ADVANCED STORAGE BARNES
5560 BARNES ROAD
PARCEL NO. 63251-06-040
COLORADO SPRINGS, COLORADO**

Prepared for:
**Advanced Storage Barnes, LLC
5001 South Windermere Street, #100
Littleton, Colorado 80120**

September 22, 2023

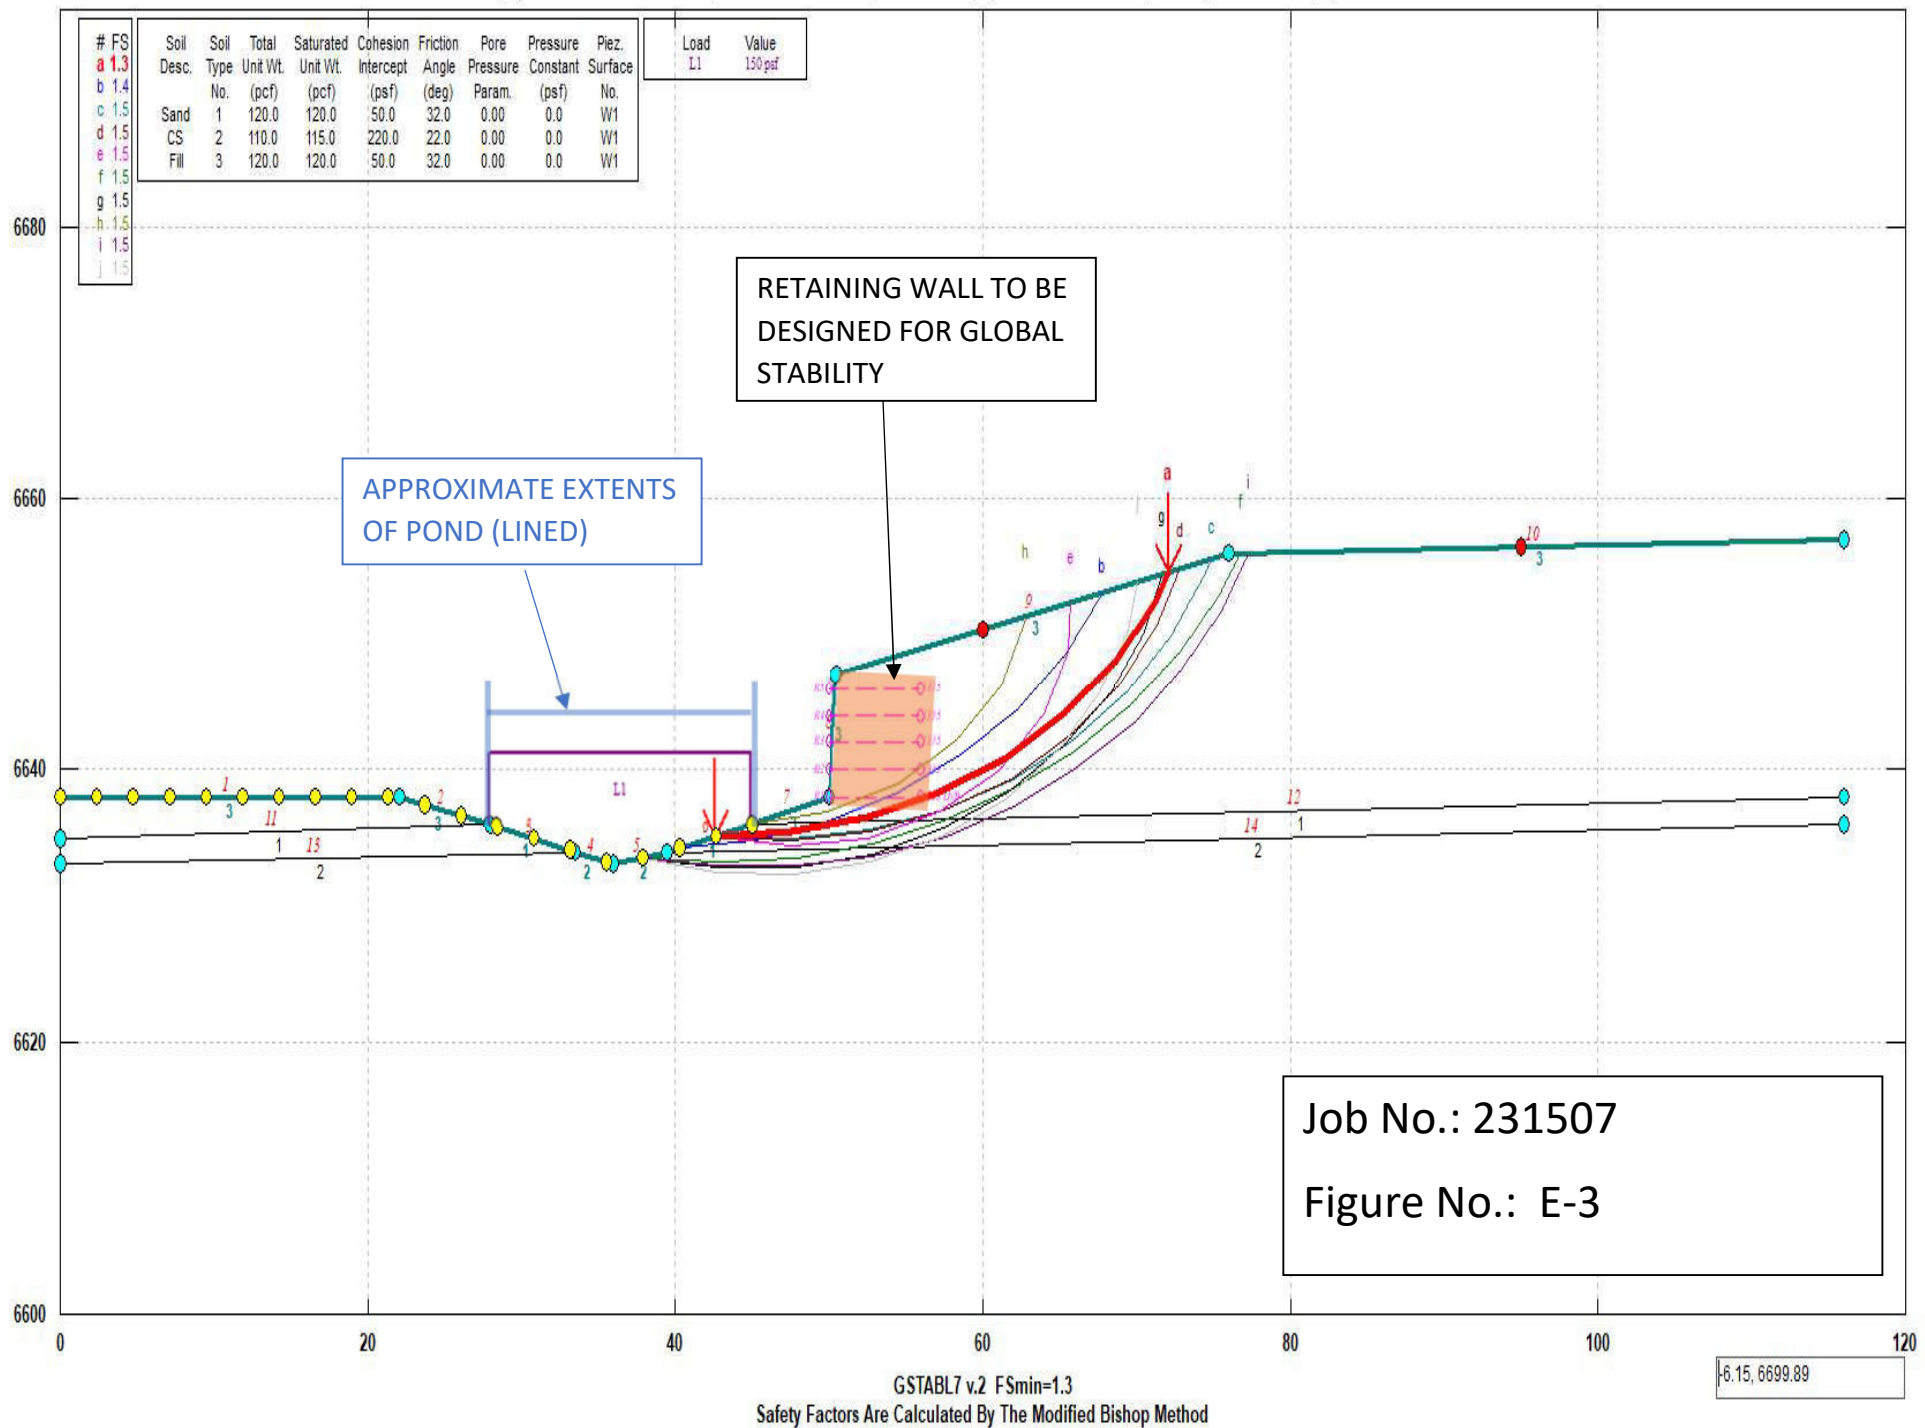
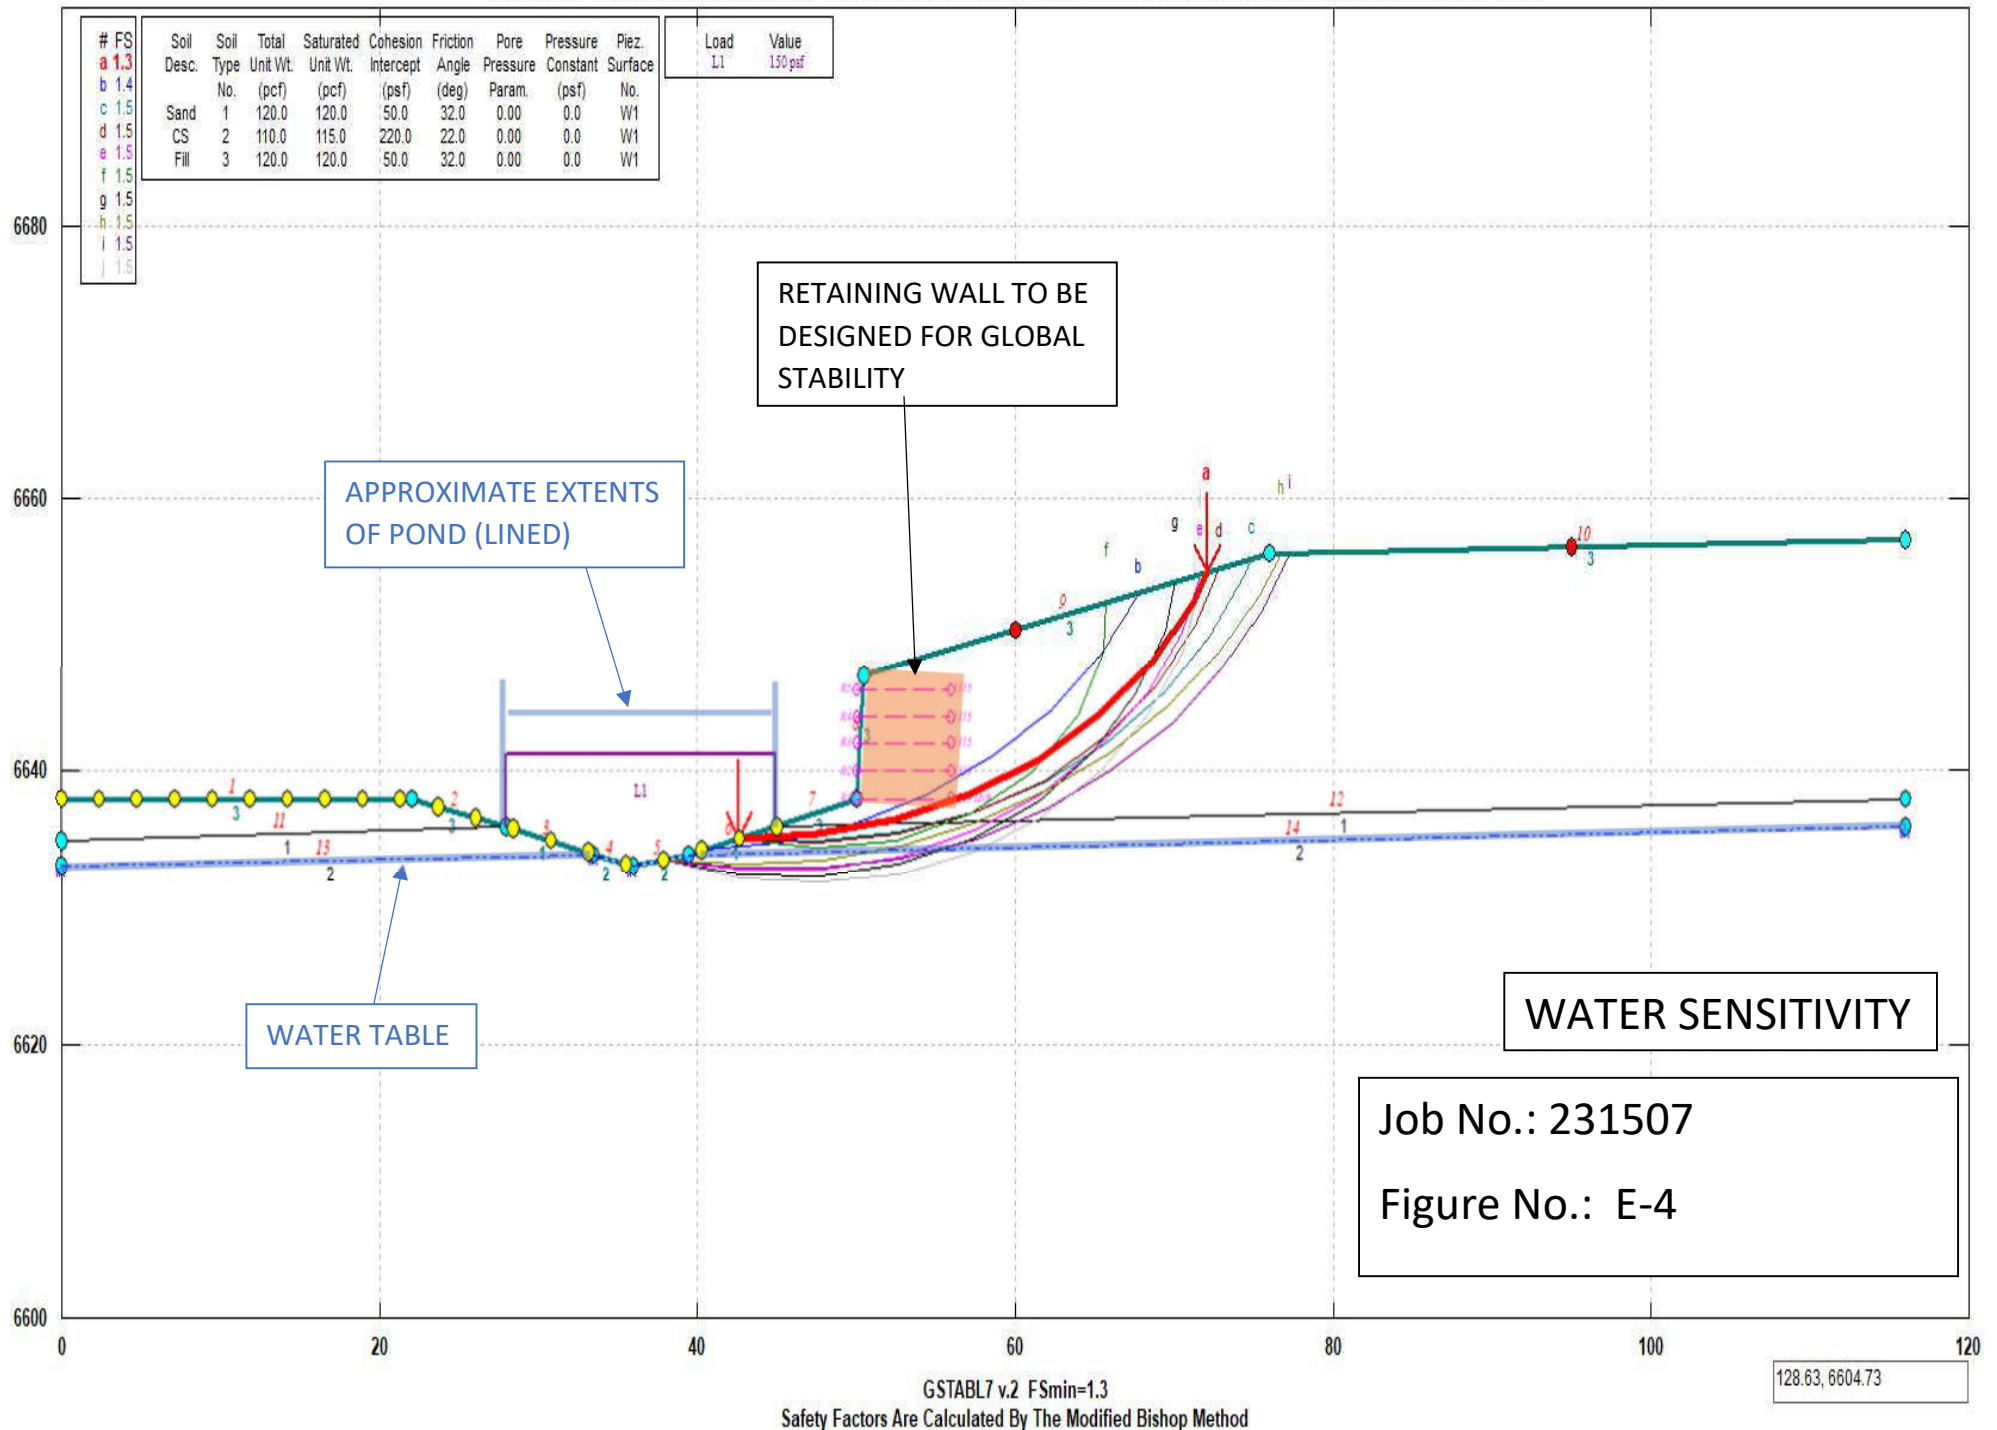
ADVANCED STORAGE BARNES – 5560 BARNES – B-B

Factors of safety of 1.3 to 1.5 were obtained based on the proposed development plan, provided excavation/overexcavation drains and retaining walls (**designed for local and global stability with geogrid used in the analysis**) are installed as recommended. **All slopes should be evaluated for local and global stability for final designs.** Results of the slope stability analysis are presented in Appendix E. A factor of safety of 1.5 is recommended for areas of critical structures such as buildings, and a factor of safety of 1.3 for non-critical structures such as roadways, ponds, and parking areas. Preliminary analysis of the proposed development show that adequate factors of safety can be achieved.

Figure #	Section	Water Table	F.O.S.	Description
E-1	A-A	Low	1.5	Proposed site analyzed with circular failure surface with stiffened foundation. Nominal loads of 2000 psf (exterior foundation) and 150 psf (minimum 10" thick floor slab) are provided for analysis.
E-2	A-A	High	1.5	Proposed site analyzed with circular failure surface with stiffened foundation. Nominal loads of 2000 psf (exterior foundation) and 150 psf (minimum 10" thick floor slab) are provided for analysis. Elevated water table.
E-3	A-A	Low	1.3	Proposed site analyzed with circular failure surface with lined detention pond.
E-4	A-A	High	1.3	Proposed site analyzed with circular failure surface with lined detention pond. Elevated water table
