Subject: Response to Review Comments, Geologic Hazard Evaluation
Mayberry Development
aka Ellicott Town Center, Filings 1 through 4
Highway 94 and Log Road
Ellicott, Colorado
CTL|T Project No. CS18969-105

Subject: Geologic Hazard Evaluation
Mayberry Development
aka Ellicott Town Center, Filings 1 through 4
Highway 94 and Log Road
Ellicott, Colorado
CTL|T Project No. CS18969-105R1

This letter presents the results of our Geologic Hazard Evaluation for the Mayberry Development aka Ellicott Town Center Community, Filings No. 1 through 4. The site is located west of Ellicott, Colorado. We have previously conducted Preliminary Geotechnical Investigations on this parcel (CTL|T Project Nos. CS16091-115, dated July 13, 2006 and CS18969 dated August 9, 2018).

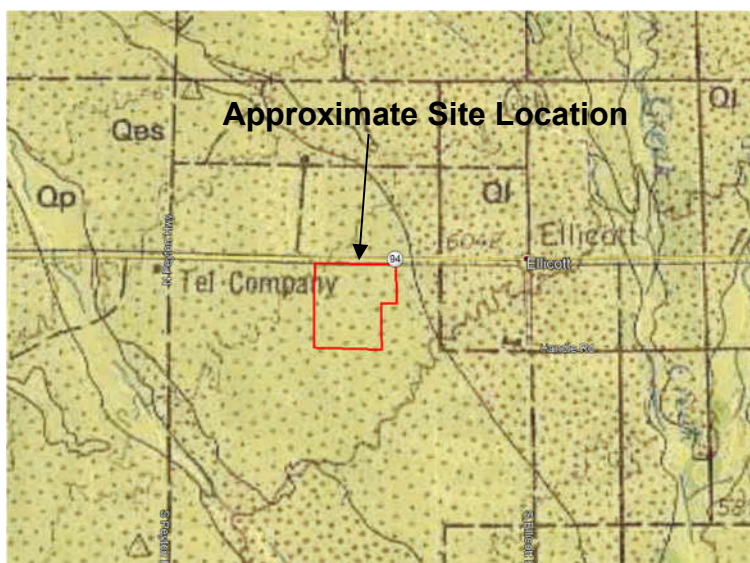
Geologic Map

The site is mapped as Holocene and Pinedale Glaciation of the Pleistocene age eolian sand (wind-deposited sediment), overlying the Dawson Formation. The Dawson Formation typically consists of

sandstone interbedded with claystone in this area. Our subsurface investigation and observations generally confirm the mapping, although no bedrock was encountered to depths of up to 30-feet. Some areas in the northeast portion of the site have been disturbed by previous development activities.
