## **Final Acceptance Punchlist**

### **El Paso County – Department of Public Works - Stormwater Section**

Project Name:	Falcon Marketplace
EDARP Filing Number(s):	SF191, CON204, ASB233
ESQCP Number:	ESQ209
Attendees:	DPW SW: Christina Prete, Ben Jones, Erica Rylander, Joshua Augustenborg DPW Development Services: Jeff Rice, Brad Walters, Gilbert LaForce Developer: Karen Levitt Ortiz, Doug McNeal, Kate Varnum, Chris Heilbrun
Date of Walk-through:	10-22-2024
Walk-through Number:	1st

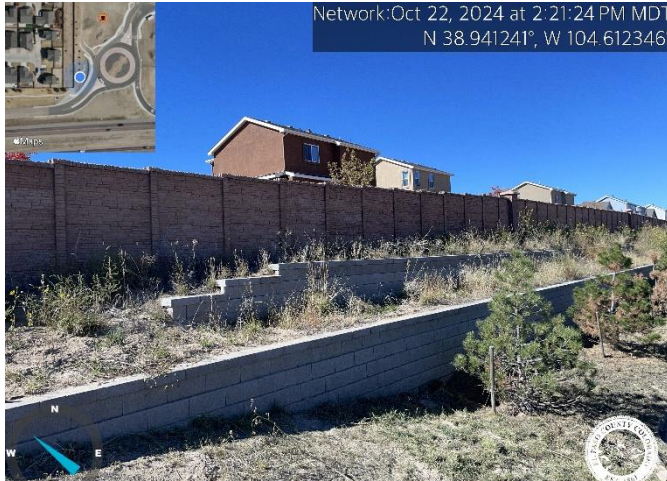
1. Additional seeding needed in areas along western perimeter of site to meet final stabilization requirements (Photo 1).
2. Additional seeding needed throughout area south of the SW roundabout to meet final stabilization requirements (Photo 2).

**Photo 1:** Additional seeding needed in areas along western perimeter of site.

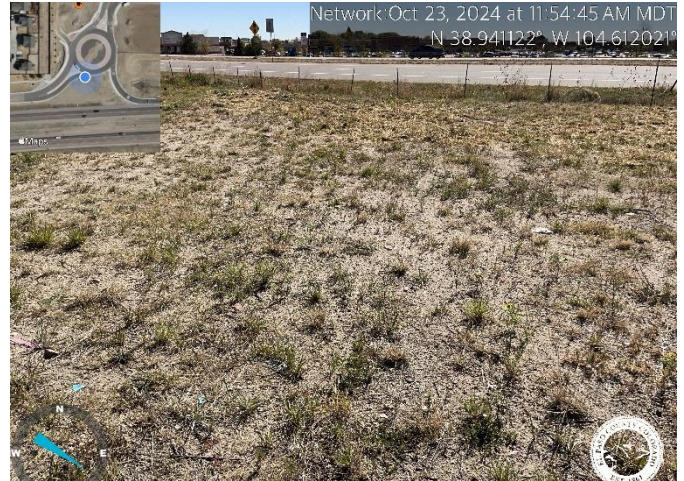
**Photo 2:** Additional seeding needed throughout area south of the SW roundabout.

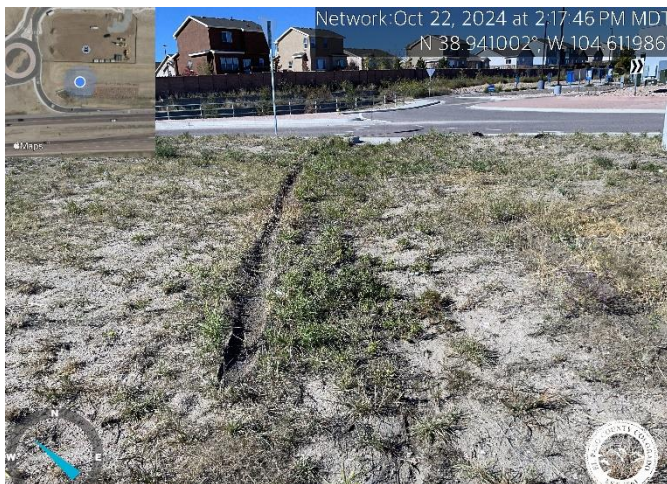
3. Backfill and seed trench line where wattles were removed throughout area south of the SW roundabout (Photo 3).
4. Remove rock socks from in front of culvert under roundabout entrance from Woodmen Rd (Photo 4).

**Photo 3:** Backfill and seed trench line where wattles were removed throughout area south of the SW roundabout.

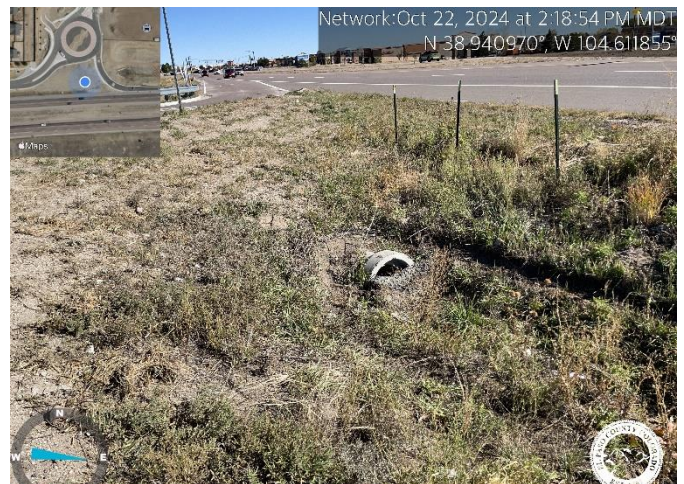
**Photo 4:** Remove rock socks from in front of culvert under roundabout entrance from Woodmen Rd.

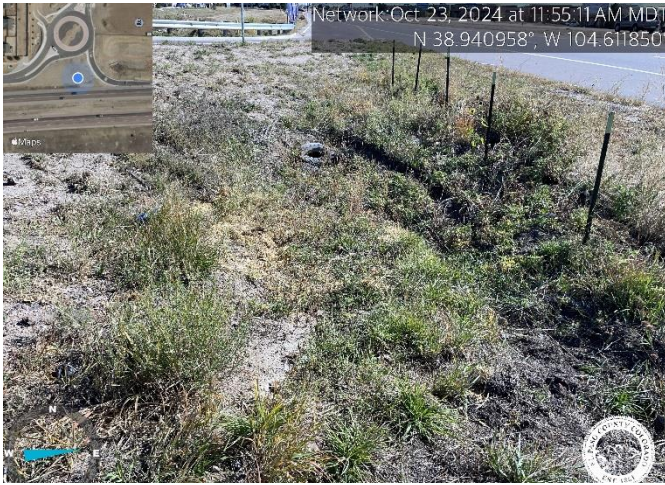
5. Repair minor erosion just upstream of culvert under roundabout entrance from Woodmen Rd (Photo 5).
6. Remove concrete debris and sediment from inlets throughout site (Photo 6).

**Photo 5:** Repair minor erosion just upstream of culvert under roundabout entrance from Woodmen Rd.

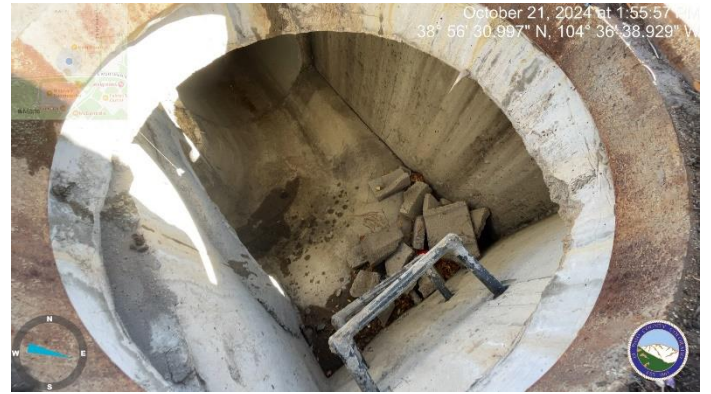
**Photo 6:** Remove concrete debris and sediment from inlets throughout site.

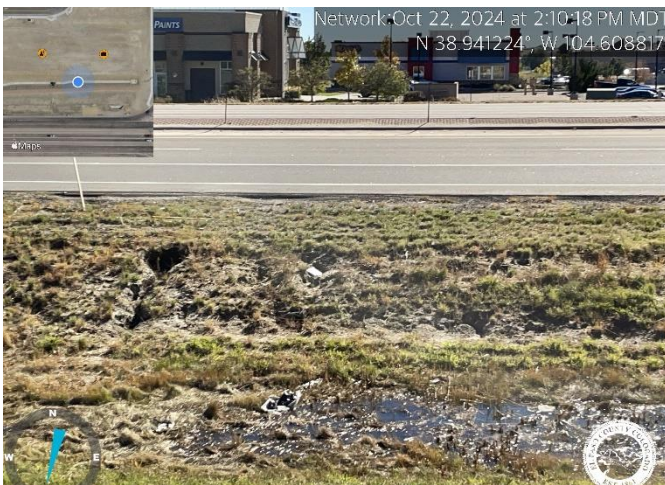
7. Repair rill erosion in several areas along southern embankment of drainage channel along Woodmen Rd (Photo 7).
8. Additional seeding needed in several areas along northern and southern embankments of drainage channel along Woodmen Rd to meet final stabilization requirements (Photos 8, 9, 10).

**Photo 7:** Repair rill erosion in several areas along southern embankment of drainage channel along Woodmen Rd.

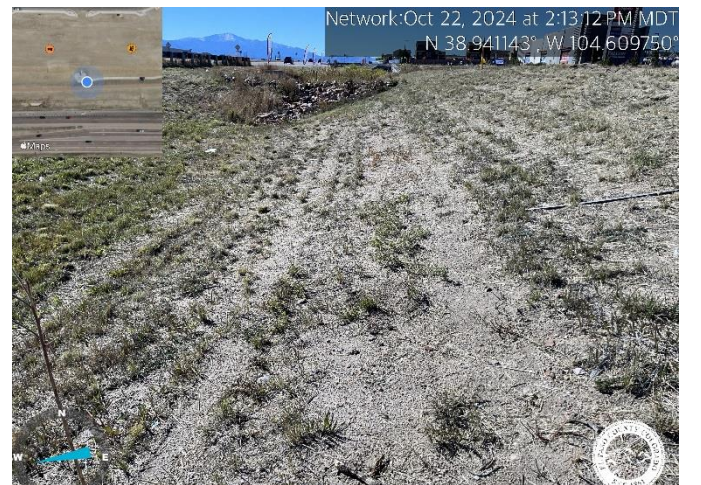
**Photo 8:** Additional seeding needed in several areas along northern and southern embankments of drainage channel along Woodmen Rd.

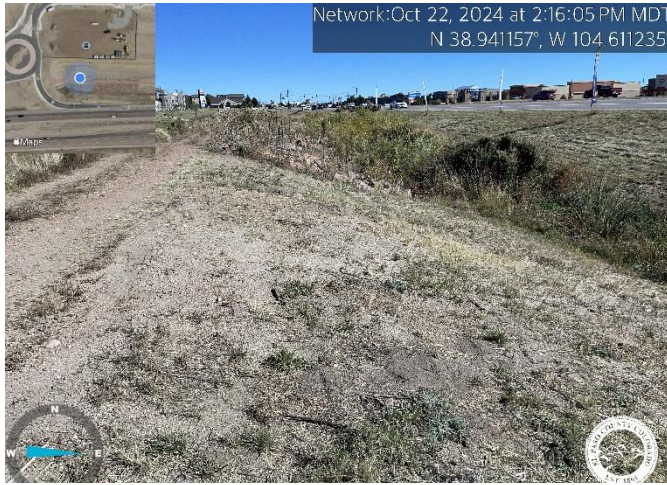
**Photo 9:** Additional seeding needed in several areas along northern and southern embankments of drainage channel along Woodmen Rd.

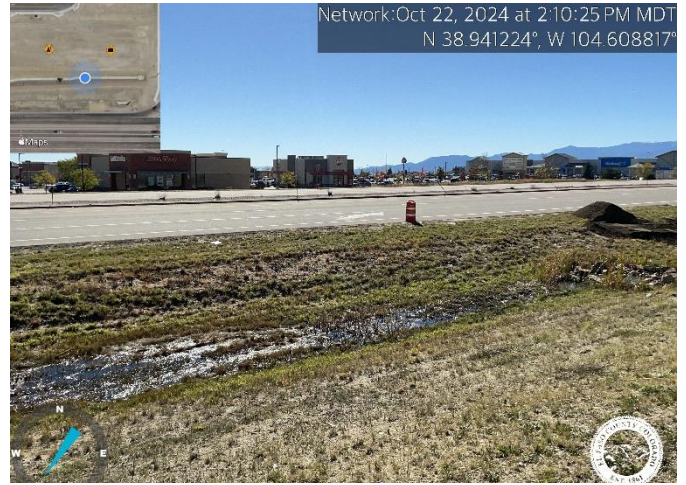
**Photo 10:** Additional seeding needed in several areas along northern and southern embankments of drainage channel along Woodmen Rd.

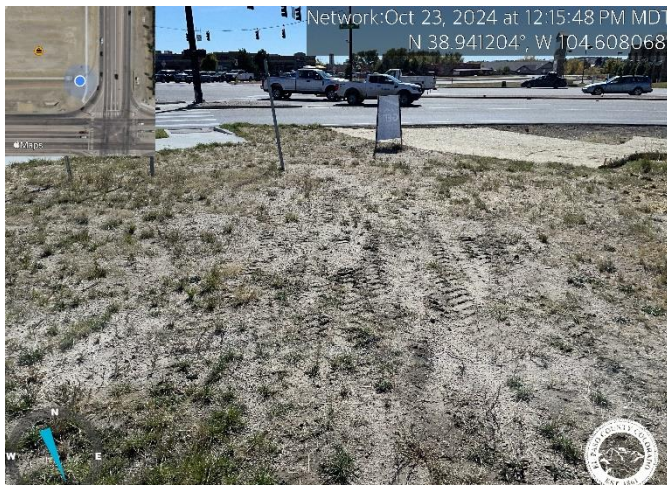
9. Additional seeding needed throughout SE corner of site to meet final stabilization requirements (Photo 11).
10. Additional seeding needed throughout NE corner of site to meet final stabilization requirements (Photos 12, 13).

**Photo 11:** Additional seeding needed throughout SE corner of site.

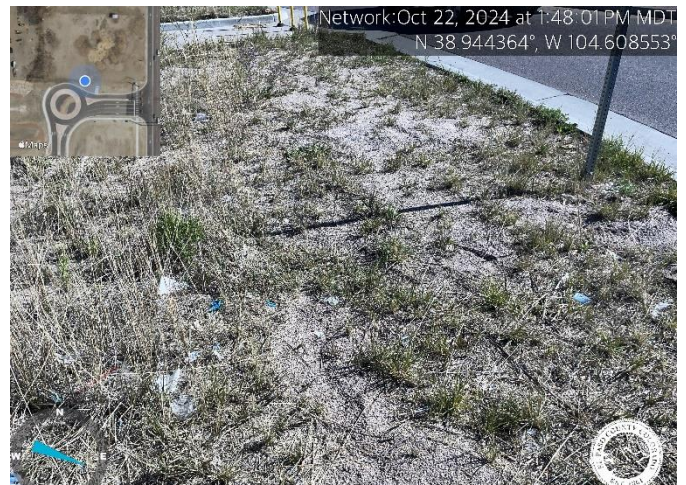
**Photo 12:** Additional seeding needed throughout NE corner of site.

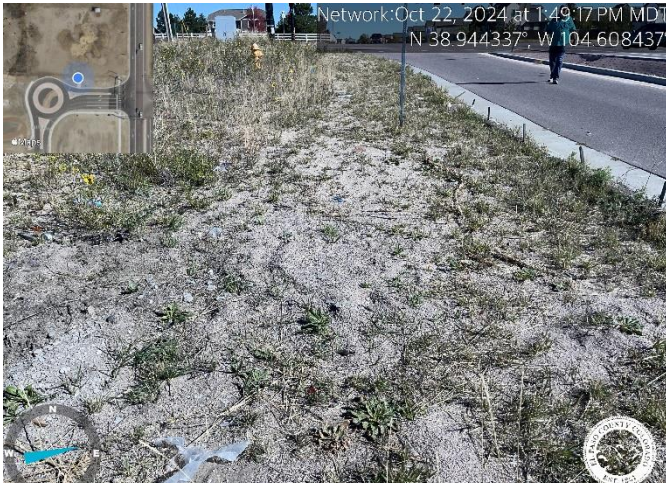
**Photo 13:** Additional seeding needed throughout NE corner of site.

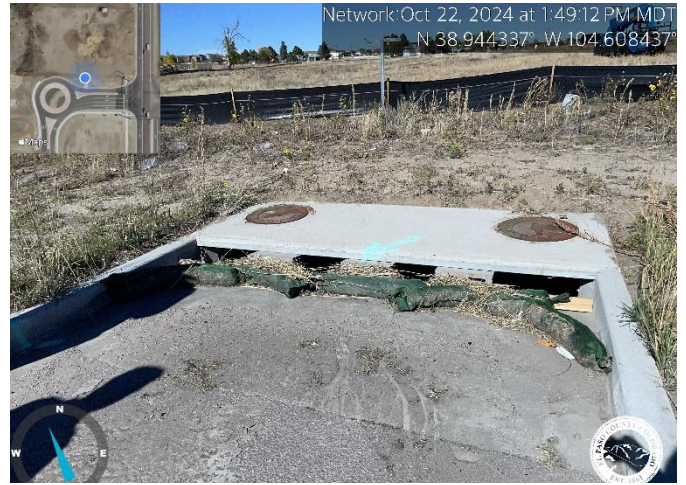
11. Remove rock socks from curb inlet near NE roundabout (Photo 14).
12. Remove sediment & rock just west of curb inlet at NE corner of site (Photo 15).

**Photo 14:** Remove rock socks from curb inlet near NE roundabout.

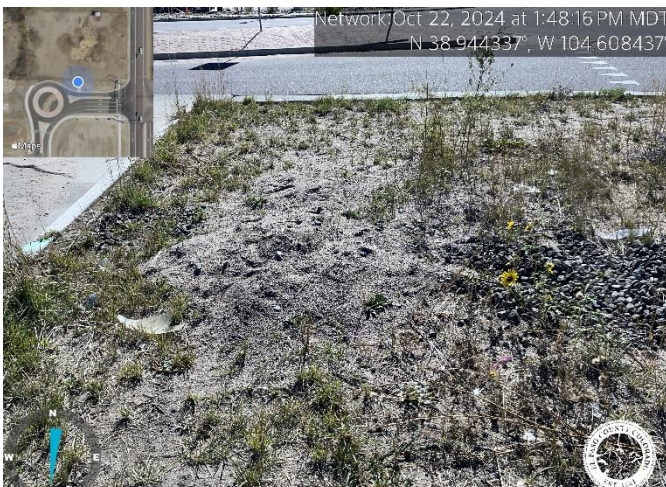
**Photo 15:** Remove sediment & rock just west of curb inlet at NE corner of site. Additional seeding needed throughout NE corner of site.

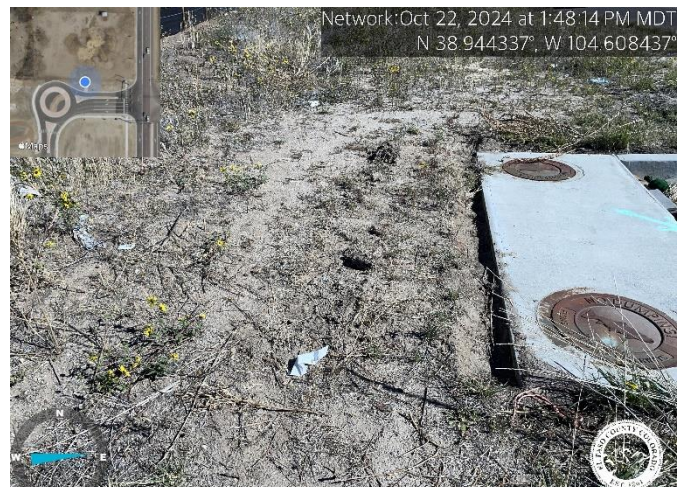
13. Remove straw wattles from back of curbs at NE corner of site. Backfill and seed trench line where straw wattles are removed (Photos 16, 17).
14. Submit a spec sheet and PO/receipt for the grass seed mix that was purchased and used.

**Photo 16:** Backfill and seed trench line where straw wattles were removed. Additional seeding needed throughout NE corner of site.

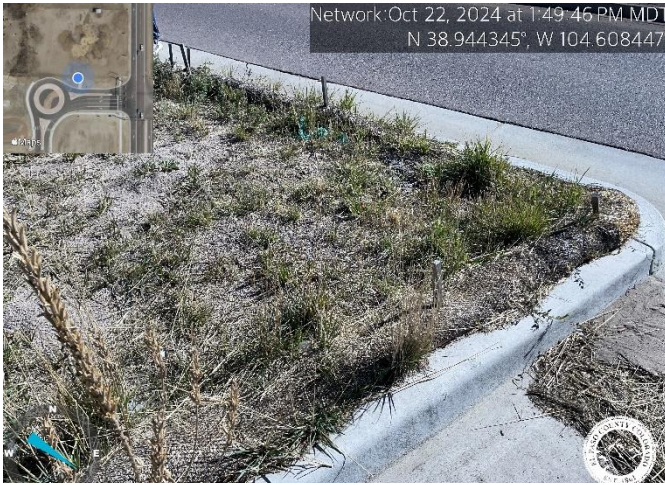
**Photo 17:** Remove straw wattles from back of curbs at NE corner of site. Backfill and seed trench line where straw wattles are removed.

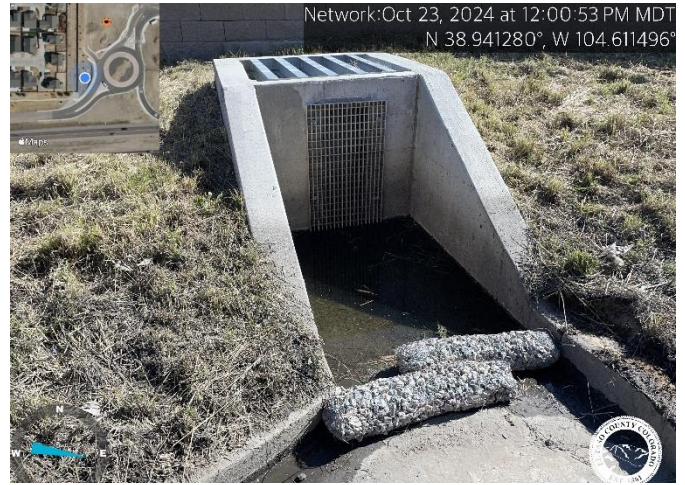
18. Remove and properly dispose of sediment from micropool (Photo 18).
19. Remove rock socks from trickle channel in front of micropool (Photo 18).
20. Remove rock socks from forebay (Photo 19).
21. Remove and properly dispose of sediment from inside of inflow pipe (Photo 19).
22. Reestablish maintenance access road (Photo 20).
23. Additional seeding needed on northern embankment to meet final stabilization requirements (Photo 21).

**Photo 18:** Remove and properly dispose of sediment from micropool. Remove rock socks from trickle channel in front of micropool (Pond 3).

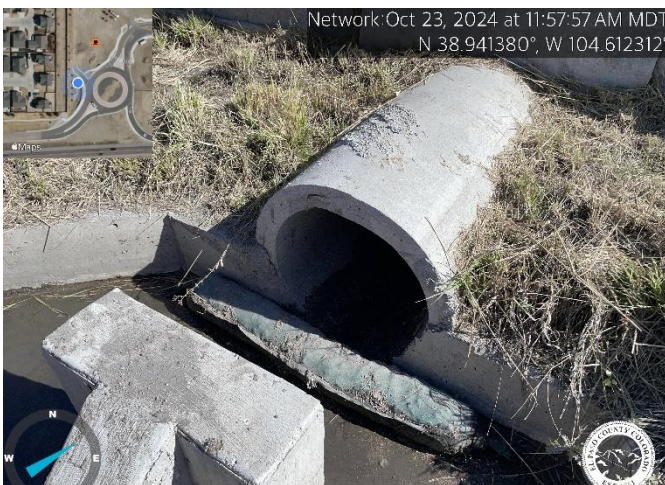
**Photo 19:** Remove rock socks from forebay. Remove and properly dispose of sediment from inside of inflow pipe (Pond 3).

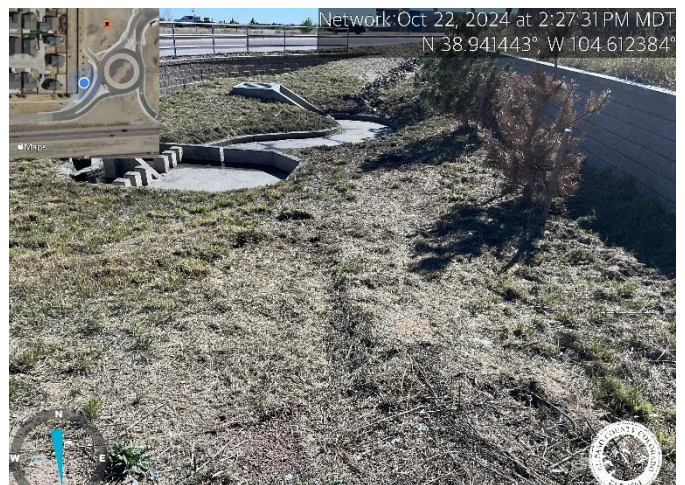
**Photo 20:** Reestablish maintenance access road (Pond 3).

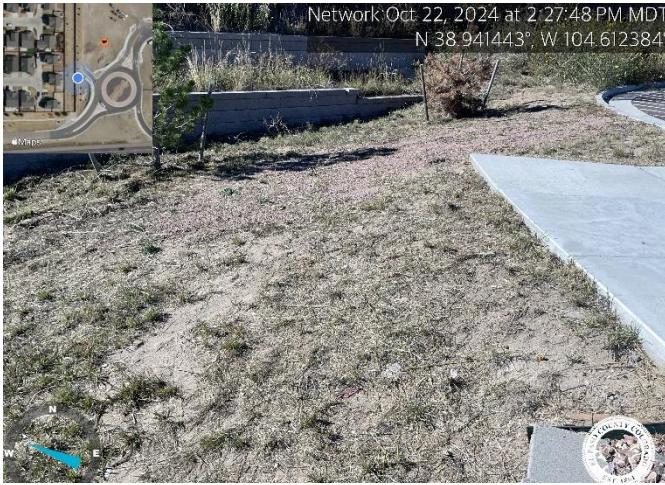
**Photo 21:** Additional seeding needed on northern embankment (Pond 3).

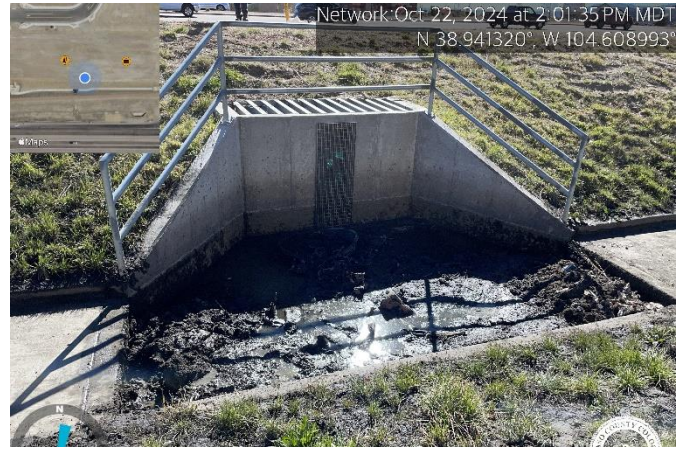
24. Remove and properly dispose of sediment and debris from micropool (Photo 22).
25. Repair disturbance on embankments/bottom of EDB from equipment accessing EDB for maintenance. Seed disturbed areas (Photos 23, 24).
26. Additional seeding needed in several areas along northern embankment to meet stabilization requirements (Photo 25).

**Photo 22:** Remove and properly dispose of sediment and debris from micropool (Pond 2).

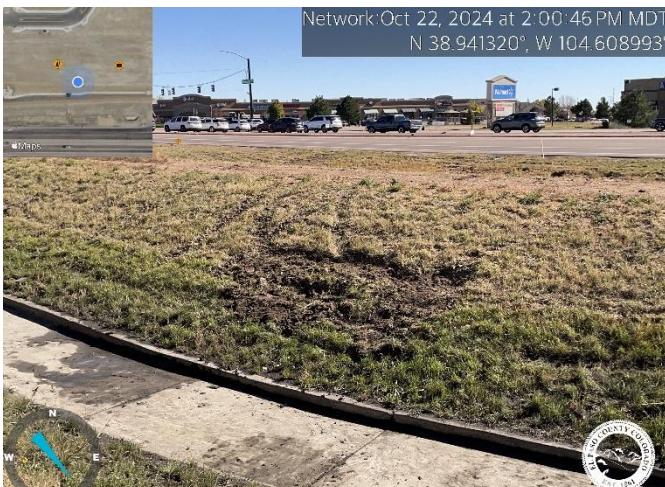
**Photo 23:** Repair disturbance from equipment accessing EDB for maintenance on northern embankment. Seed disturbed areas (Pond 2).

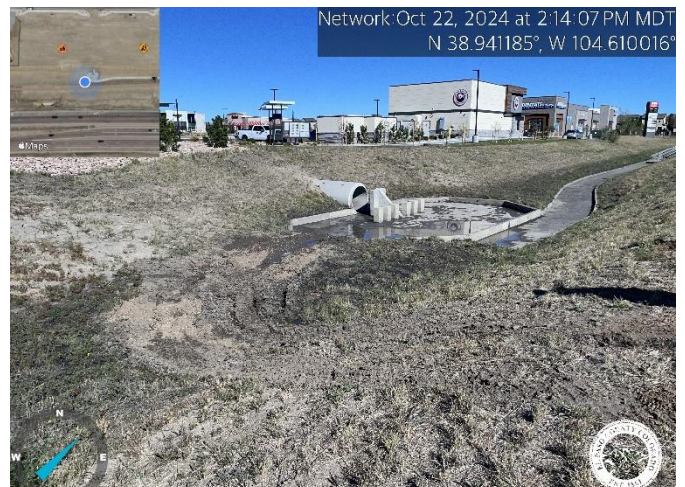
**Photo 24:** Repair disturbance from equipment accessing EDB for maintenance on northern embankment/EDB bottom. Seed disturbed areas (Pond 2).

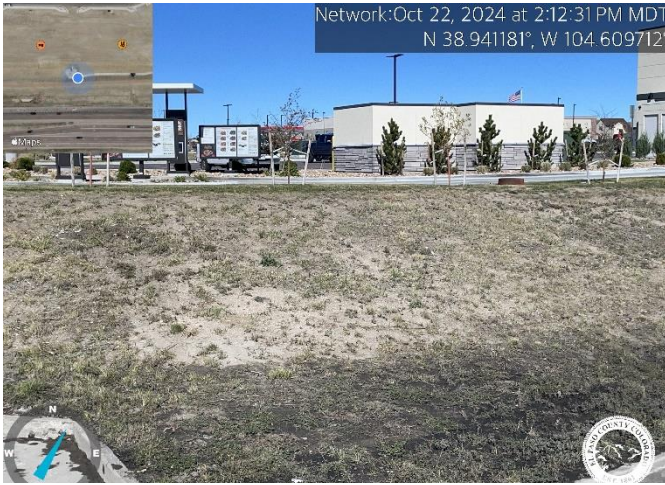
**Photo 25:** Additional seeding needed in several areas along northern embankment (Pond 2).

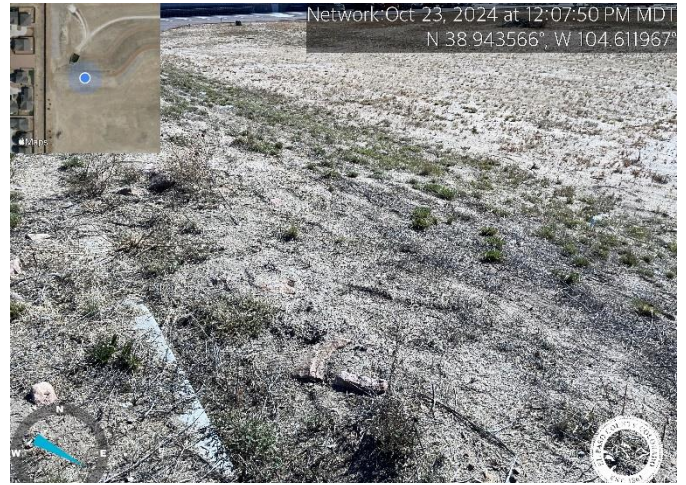
27. Additional seeding needed throughout EDB to meet stabilization requirements (Photos 26-32):
28. Remove rock socks at eastern forebay (Photo 33).
29. Repair rill erosion on embankment along outlet structure (Photo 34).

**Photo 26:** Additional seeding needed in several areas throughout EDB (Pond SR4).

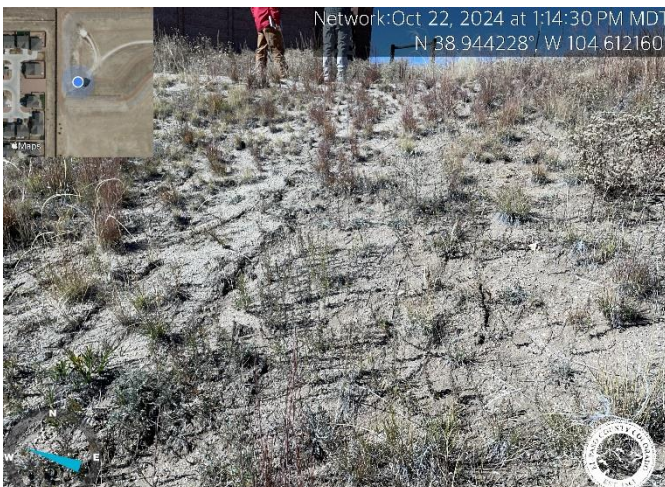
**Photo 27:** Additional seeding needed in several areas throughout EDB (Pond SR4).

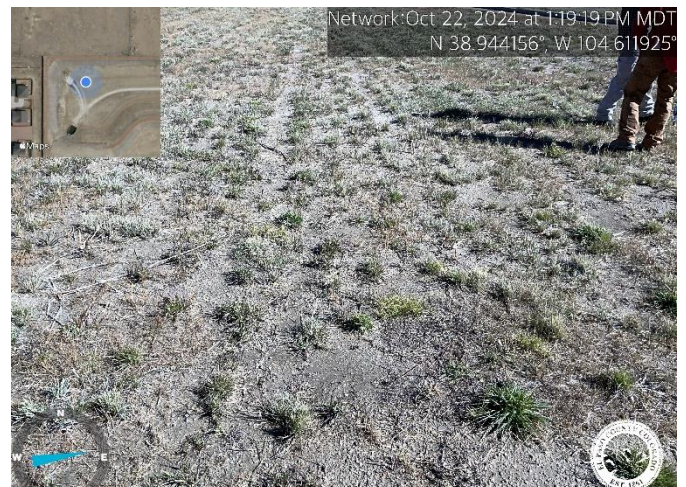
**Photo 28:** Additional seeding needed in several areas throughout EDB (Pond SR4).

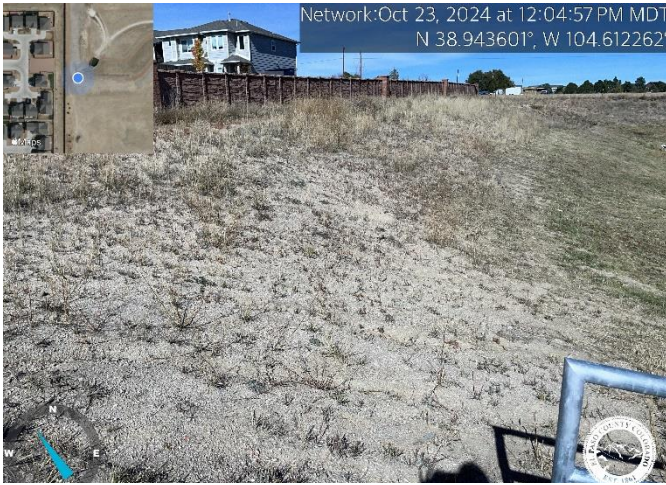
**Photo 29:** Additional seeding needed in several areas throughout EDB (Pond SR4).

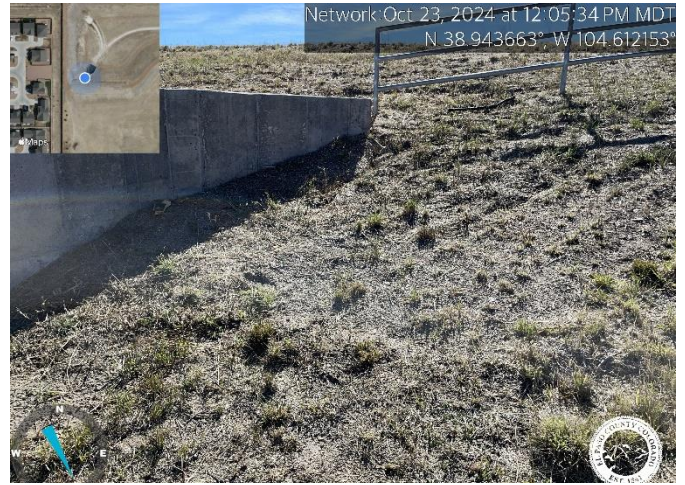
**Photo 30:** Additional seeding needed in several areas throughout EDB (Pond SR4).

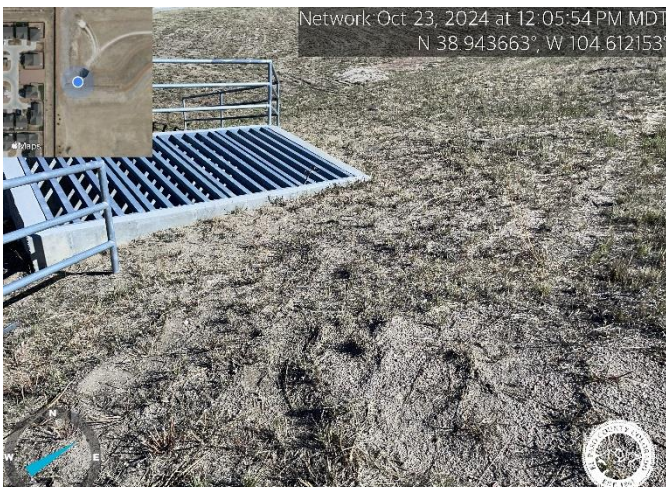
**Photo 31:** Additional seeding needed in several areas throughout EDB (Pond SR4).

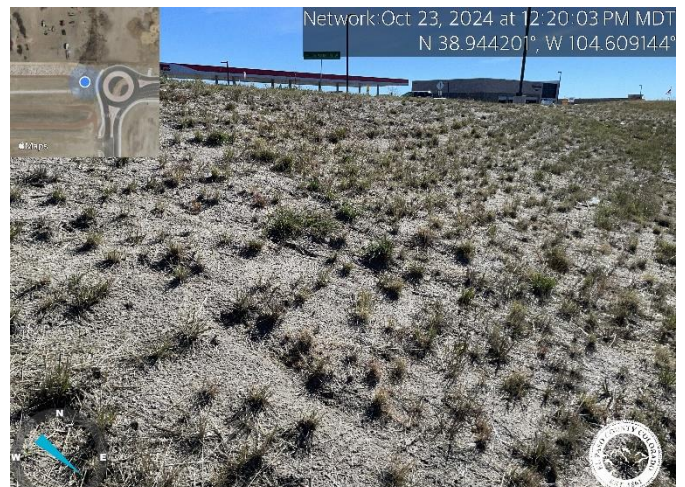
**Photo 32:** Additional seeding needed in several areas throughout EDB (Pond SR4).

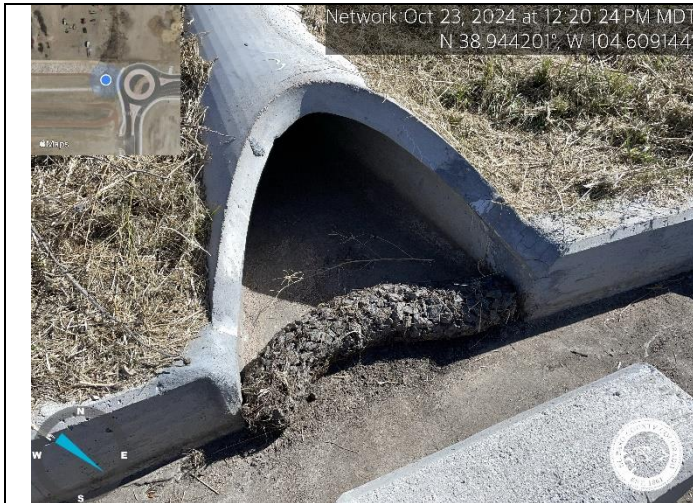
**Photo 33:** Remove rock socks at eastern forebay (Pond SR4).

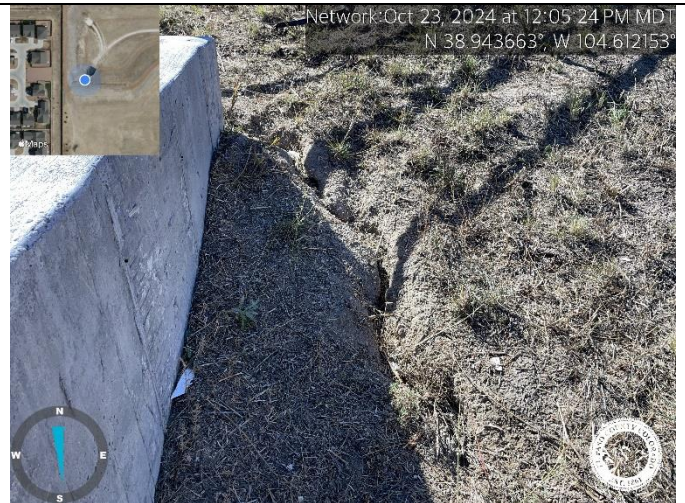
**Photo 34:** Repair rill erosion on embankment along outlet structure (Pond SR4).

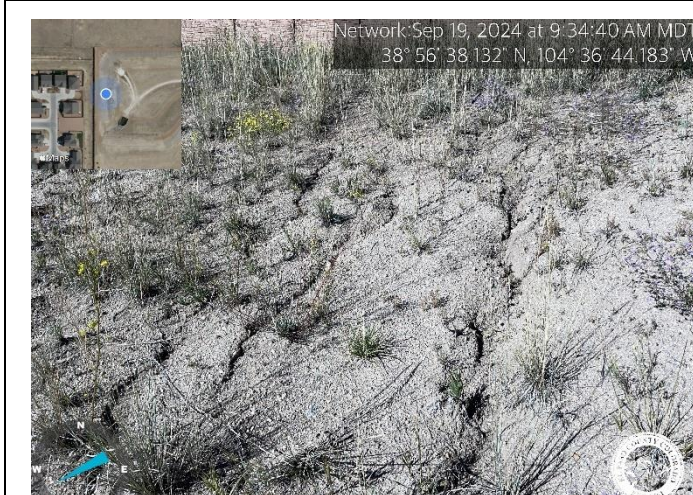
30. Repair rill erosion on western embankment (Photo 35).
31. Remove sediment accumulation within EDB micropool.
32. Remove sediment and reestablish maintenance access road to trickle channel east of outlet structure (Photo 36).

**Photo 35:** Repair rill erosion on western embankment (Pond SR4).

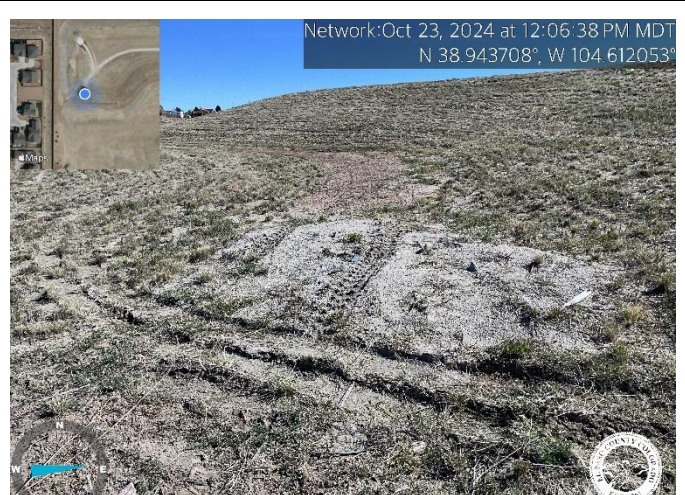
**Photo 36:** Remove sediment and reestablish maintenance access road to trickle channel east of outlet structure (Pond SR4).

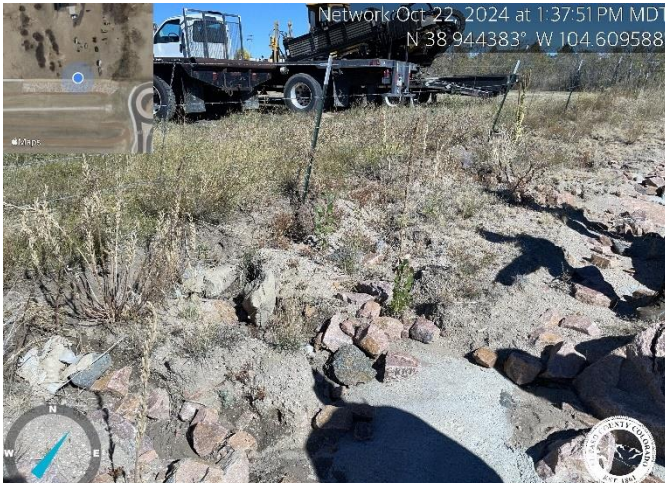
33. Repair erosion and stabilize areas above grouted riprap (Photo 37).
34. Remove rock socks from inflow above grouted riprap at NE corner of EDB (Photo 38).

**Photo 37:** Repair erosion and stabilize areas above grouted riprap (Pond SR4).

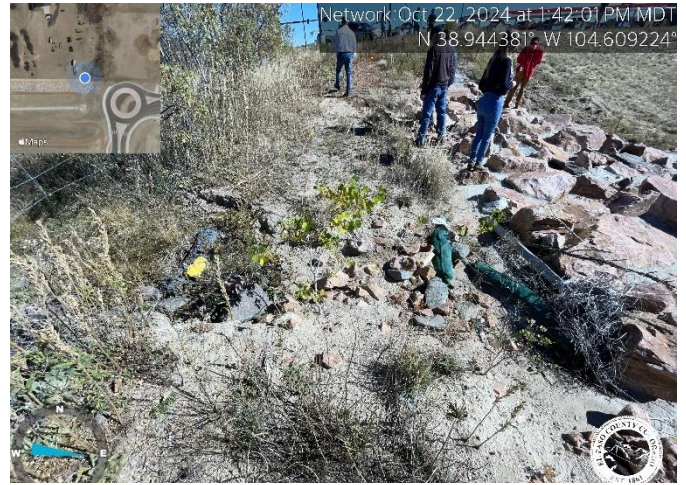
**Photo 38:** Remove rock socks from inflow above grouted riprap at NE corner of EDB (Pond SR4).

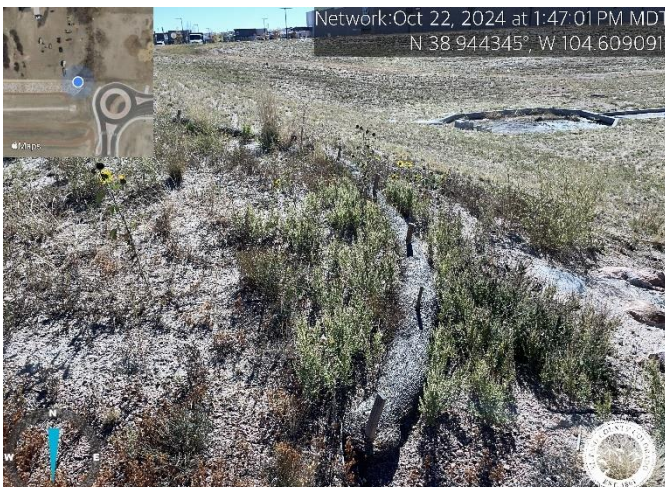
35. Remove straw wattles at NE corner of EDB (at top of embankment). Backfill and seed trench line where straw wattles are removed (Photo 39).
36. Remove vegetation from grouted riprap and repair grout as needed following removal of vegetation (Photo 40).

**Photo 39:** Remove straw wattles at NE corner of EDB (at top of embankment). Backfill and seed trench line where straw wattles are removed (Pond SR4).

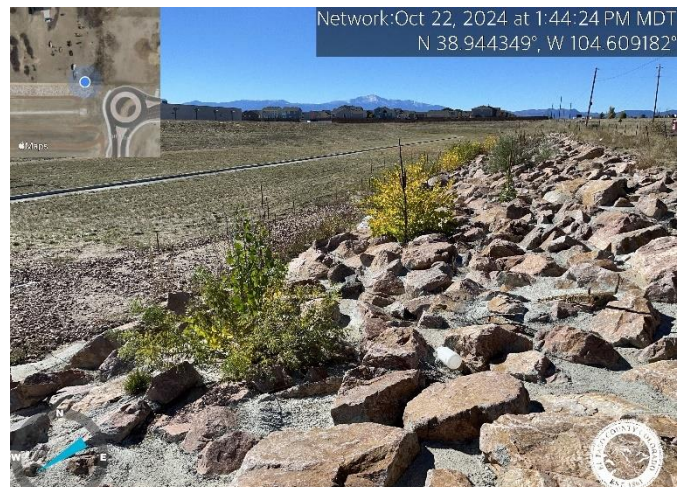
**Photo 40:** Remove vegetation from grouted riprap and repair grout as needed following removal of vegetation (Pond SR4).

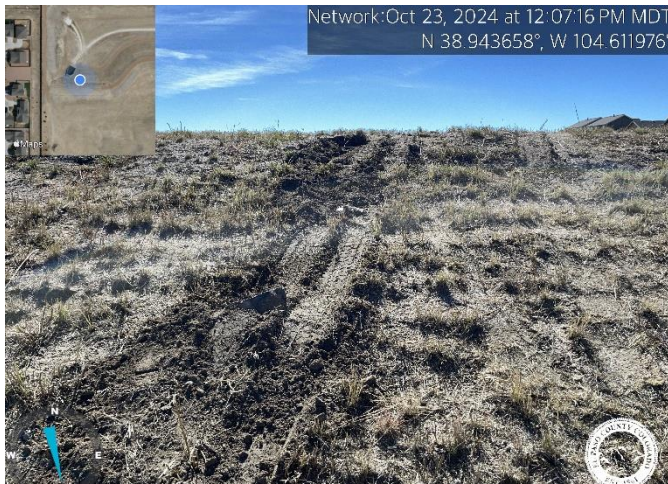
37. Repair disturbance from equipment accessing EDB for maintenance on northern and southern embankments. Reseed areas following repair (Photos 41 and 42).

**Photo 41:** Repair disturbance from equipment accessing EDB for maintenance on northern and southern embankments. Reseed areas following repair (Pond SR4).

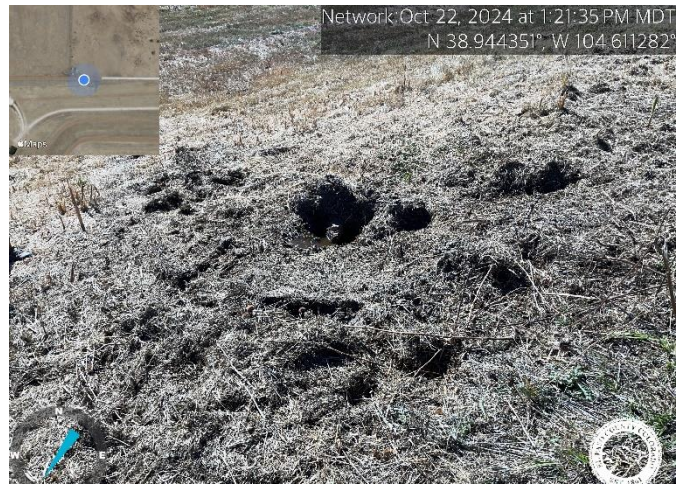
**Photo 42:** Repair disturbance from equipment accessing EDB for maintenance on northern and southern embankments. Reseed areas following repair (Pond SR4).

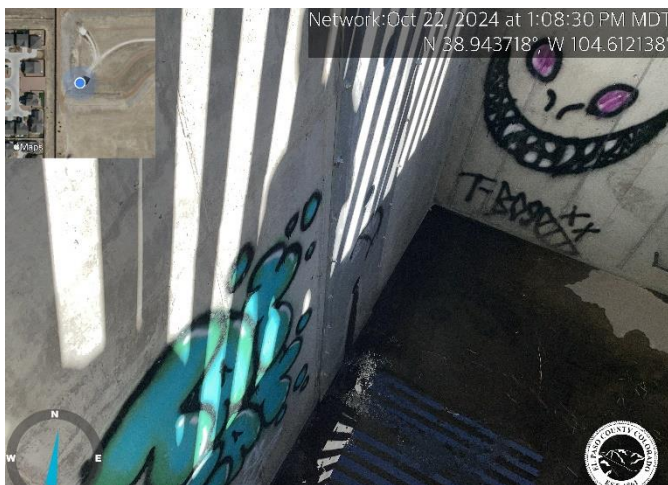
38. Ensure watertight seal at orifice plate. Water was observed entering outlet structure at bottom of orifice plate (Photo 43).
39. Ensure outlet structure is watertight. Groundwater was observed entering the outlet structure through a crack in the concrete wall, adjacent to the outlet pipe.

**Photo 43:** Install gasket at orifice plate for watertight seal. Water was observed entering outlet structure from bottom of orifice plate (Pond SR4).

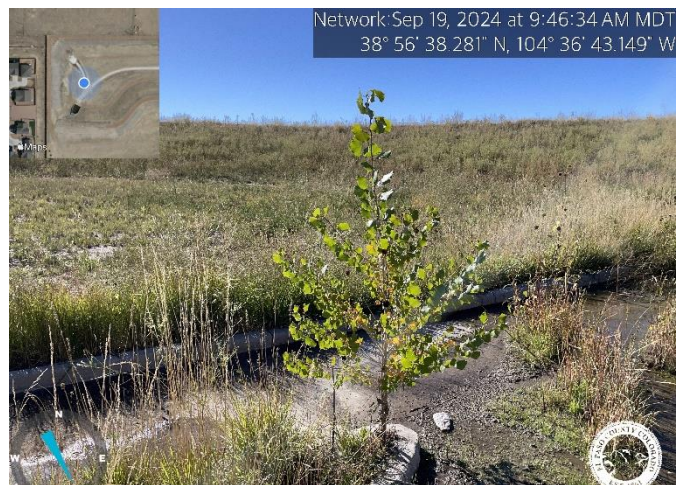
40. Remove woody vegetation adjacent to trickle channel on west side of EDB (Photo 44).
41. Address groundwater infiltration throughout pond, including but not limited to areas discussed during the FA walk (i.e., around trickle channel on west side of EDB, saturated soils on western and northern embankments, and saturated soils in bottom of EDB on west side of EDB and below grouted riprap, etc.). Additional Final Acceptance items related to the extent and function of the clay liner may be required, pending engineer of record (EOR) determination.

**Photo 44:** Remove tree adjacent to trickle channel on west side of EDB (Pond SR4).
