December 23, 2020

Re: Soil, Geology and Geologic Hazard Addendum  
Waterbury, Filings 1 and 2  
PUD Amendment and Preliminary Plan  
El Paso County, Colorado

**SOIL, GEOLOGY,  
GEOLOGIC HAZARD AND  
PRELIMINARY SUBSURFACE SOIL INVESTIGATION  
WATERBURY, PHASE I  
EL PASO COUNTY, COLORADO**

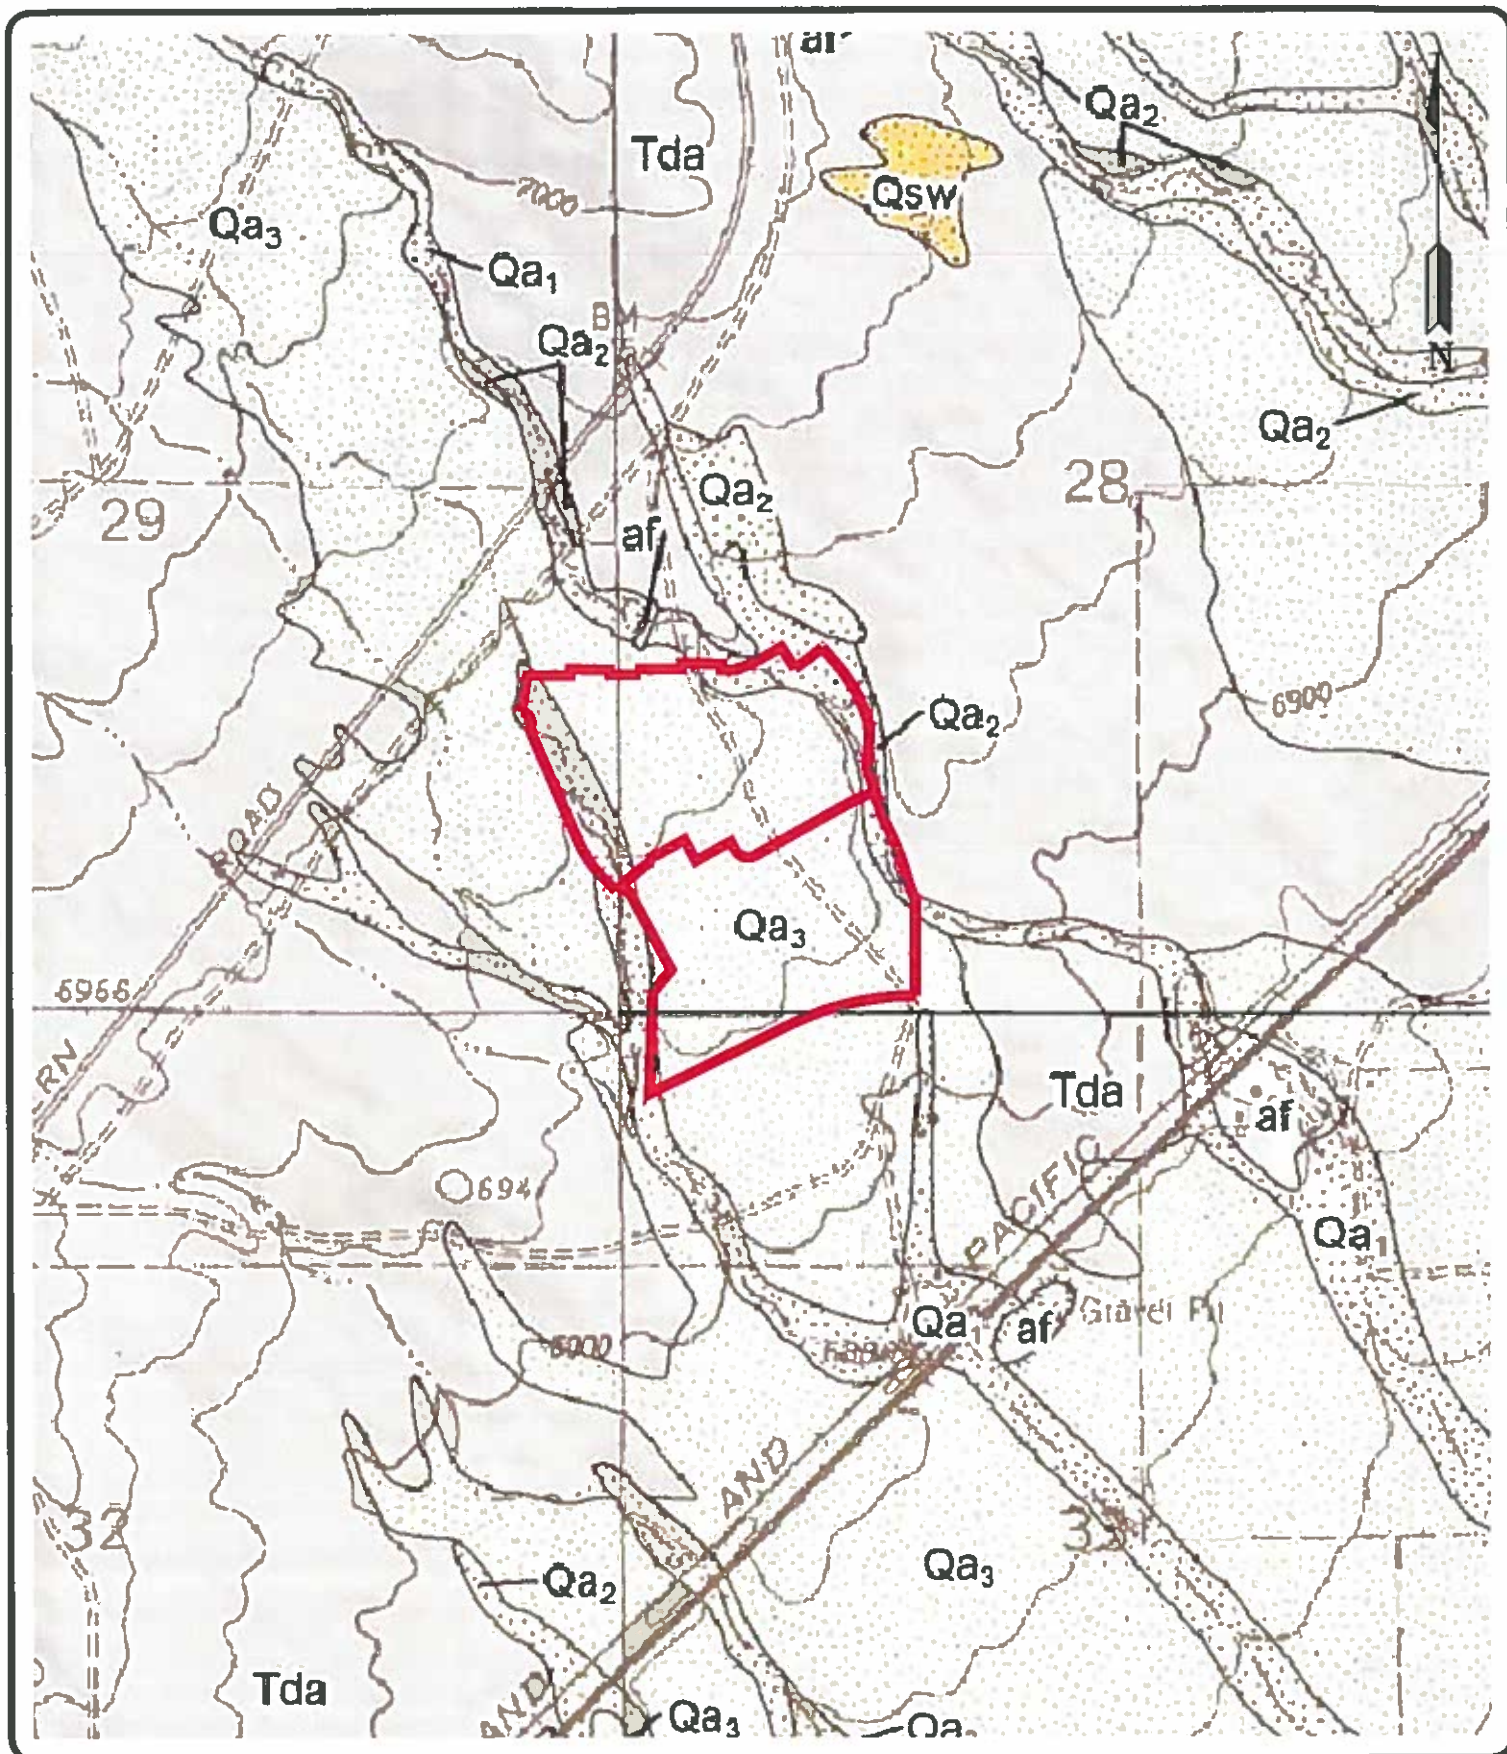
TRAIN	JAC	
CHECKED	KAH	
DATE	12/22/20	
SQUAD	AS SHOWN	
JOB NO.	202770	
FIGURE NO.	3

Current site conditions in the area of the proposed structure are consistent with what is described in the original Geologic Hazard Study by Entech (Reference 1, Appendix B). The grading and topography in the area of the proposed site appears to be relatively unchanged. The *Geologic Map of the Falcon Quadrangle* distributed by the Colorado Geological Survey in 2012, is presented in Figure 2. (Reference 2). Site-specific geologic mapping was performed as a part of the Geologic Hazard Study by Entech (Reference 1) and revised based off recent mapping by the Colorado Geological Survey (Reference 2, Figure 2). The site is mapped as Qa1: Recent Alluvium of Quaternary Age along the drainages and Qa3: Alluvium Three of Quaternary Age which consists of stream terrace deposits. The bedrock underlying the site is the Dawson Formation of Tertiary to Cretaceous Age (References 1 through 3). The updated Geology/Engineering Geology Map is presented in Figure 3.

The geologic hazards identified on this site include physiographic floodplains and seasonal and potentially seasonal shallow groundwater areas. These hazards and recommended mitigation have been addressed in the Geologic Hazard Investigation, Appendix B and are briefly discussed below. These areas can be either avoided or mitigated through grading and proper design and construction practices.

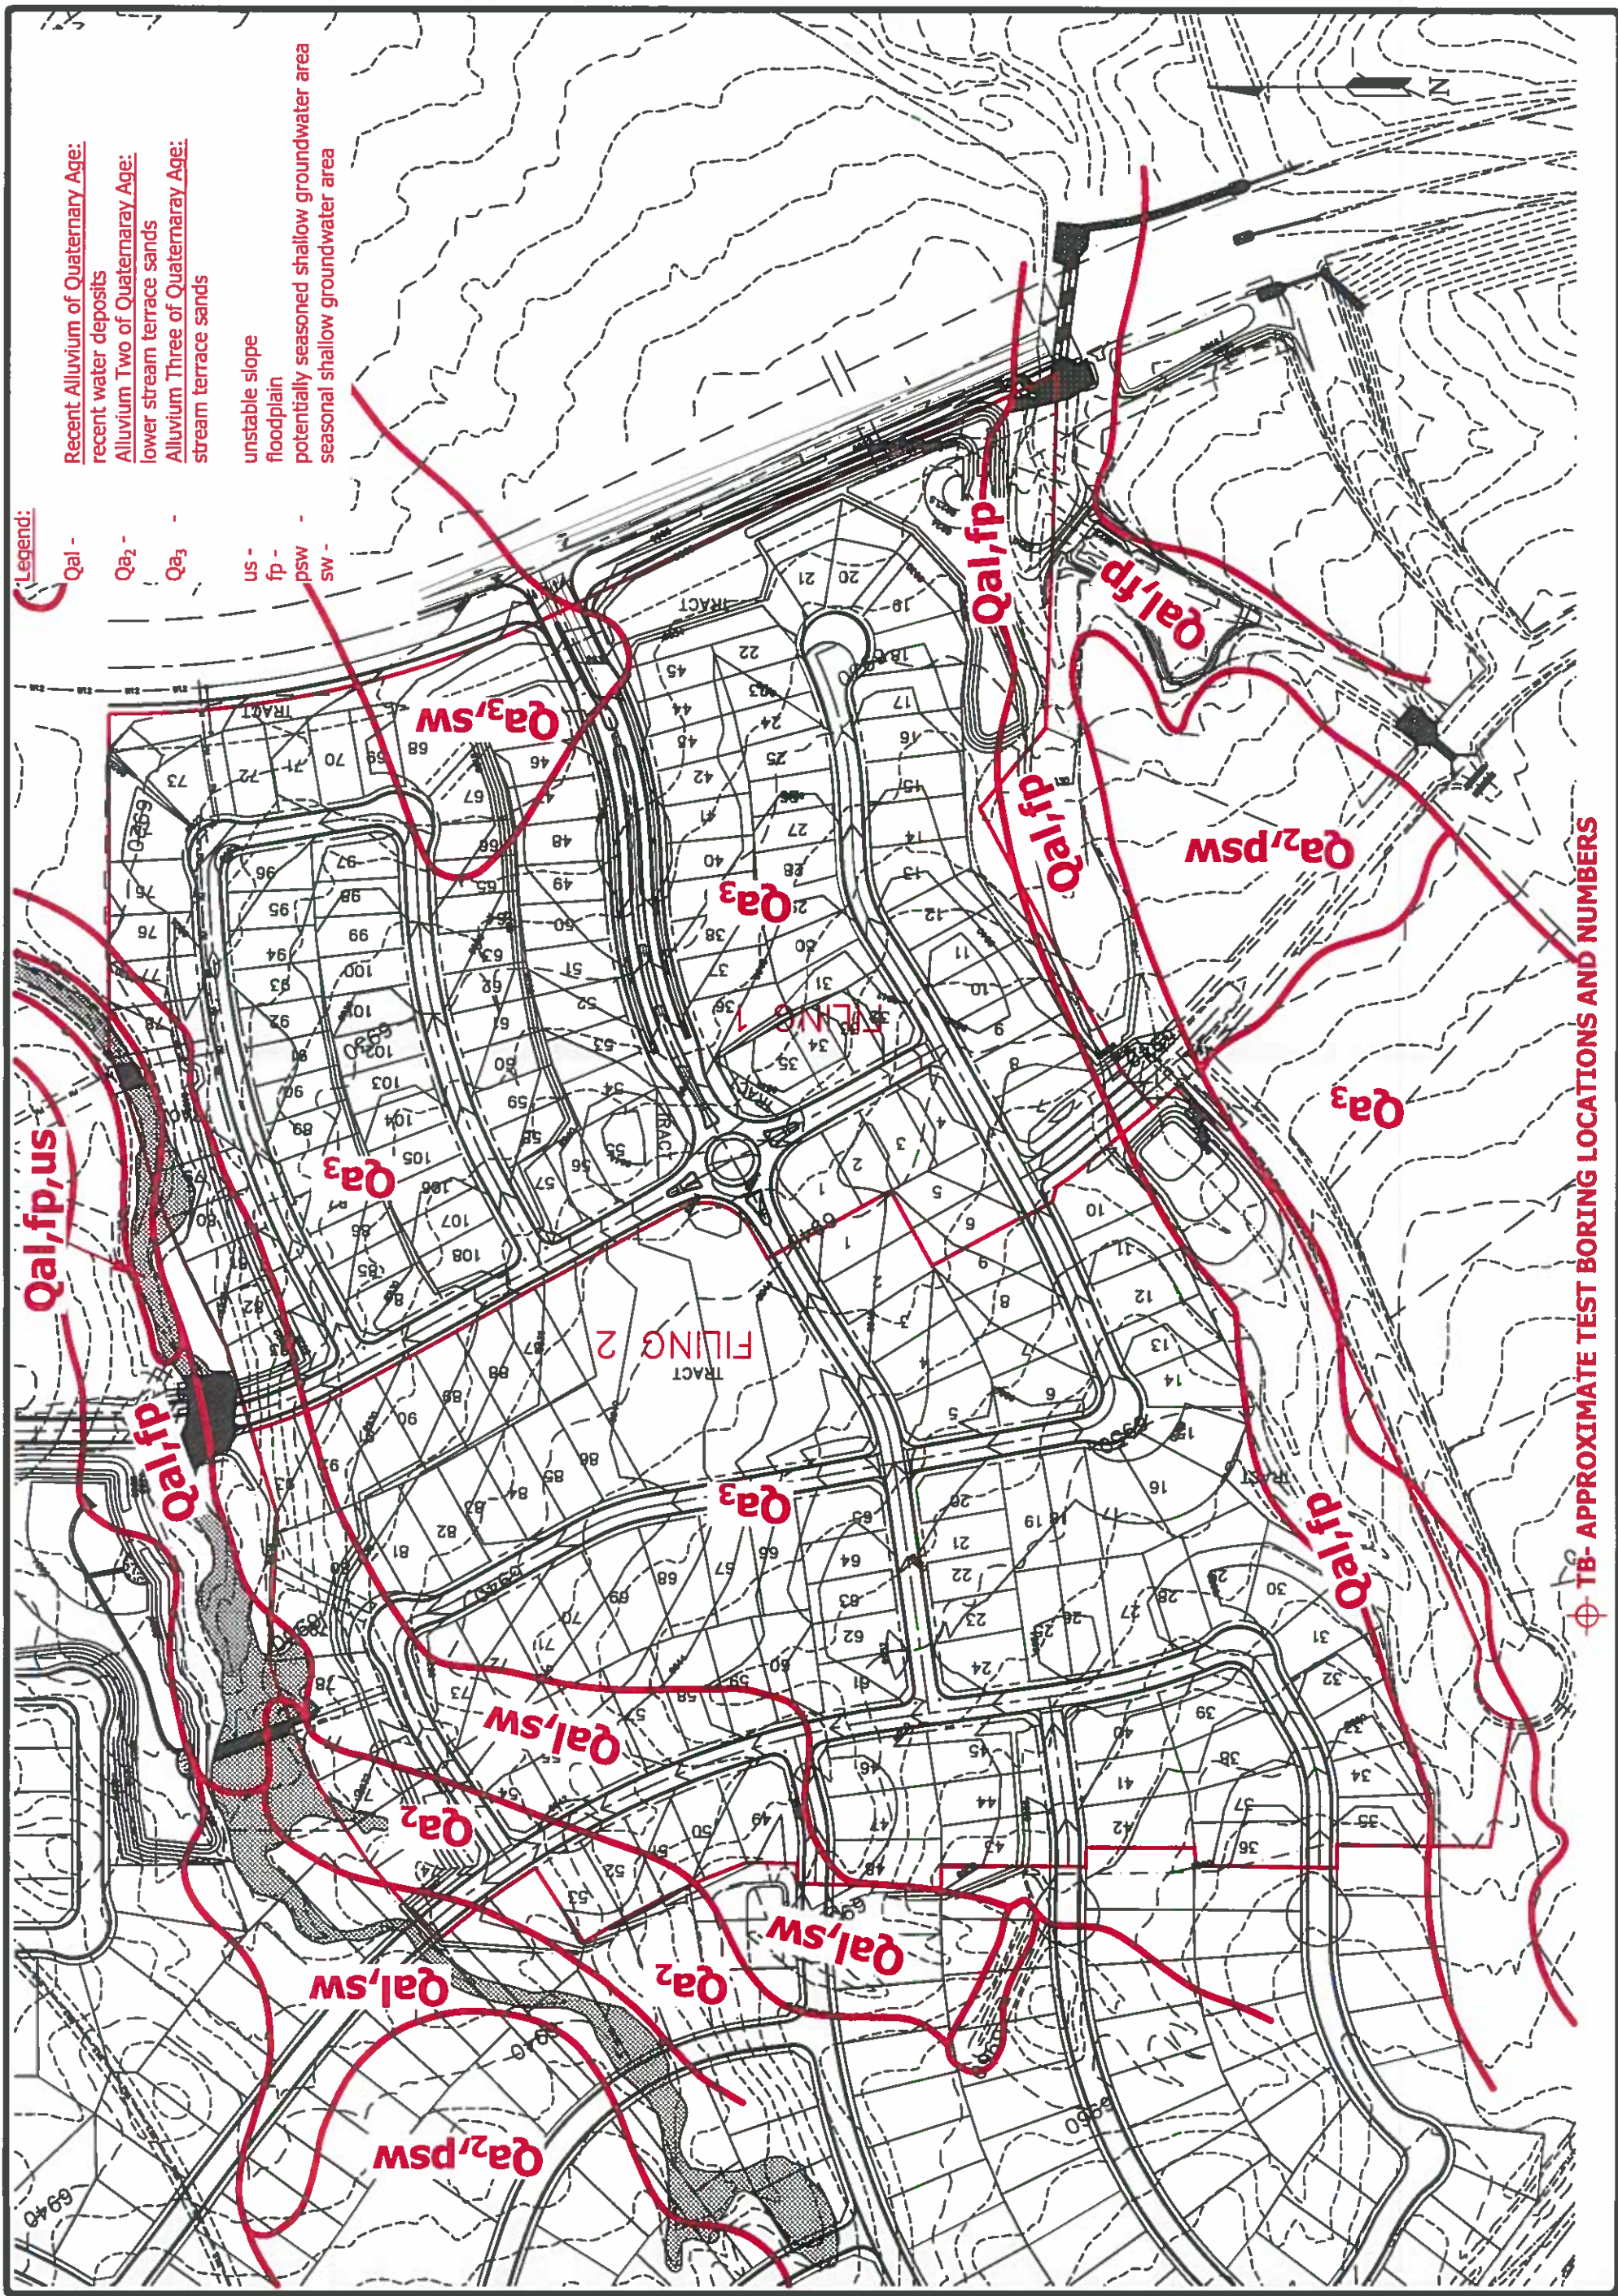
The proposed building areas of the site are not mapped in any floodplain zones according to the FEMA Map No. 08041CO552G, December 7, 2018 (Reference 4, Figure 4). A drainage located along the western side of the site has been mapped in a floodplain zone that will be avoided by building sites. Lots adjacent to the floodplain may require drains to mitigate the potential for shallow groundwater during periods of high runoff. Finished floor must be a minimum of one foot above floodplain levels. Exact floodplain locations and drainage studies are beyond the scope of this report. Specific recommendations have been made in the Soil, Geology and Geologic Hazard Investigation (Reference 1, Appendix B).

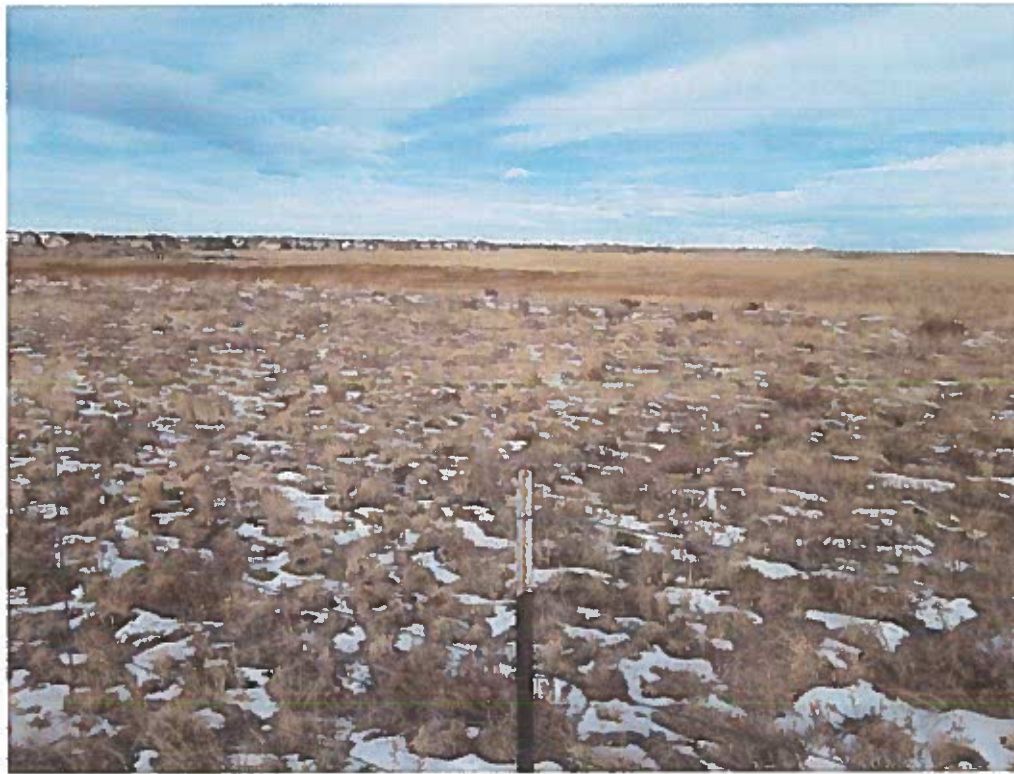
**Looking northwest  
from the south-central  
portion of the lot.**

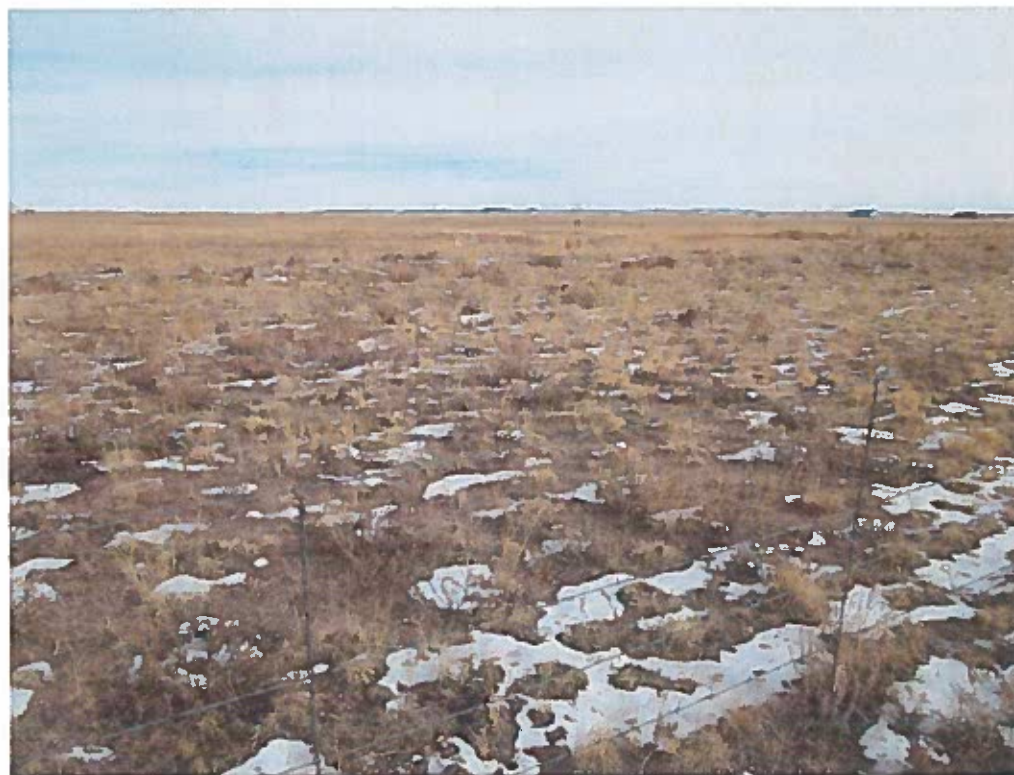
**Looking northeast  
from the south-central  
portion of the lot.**

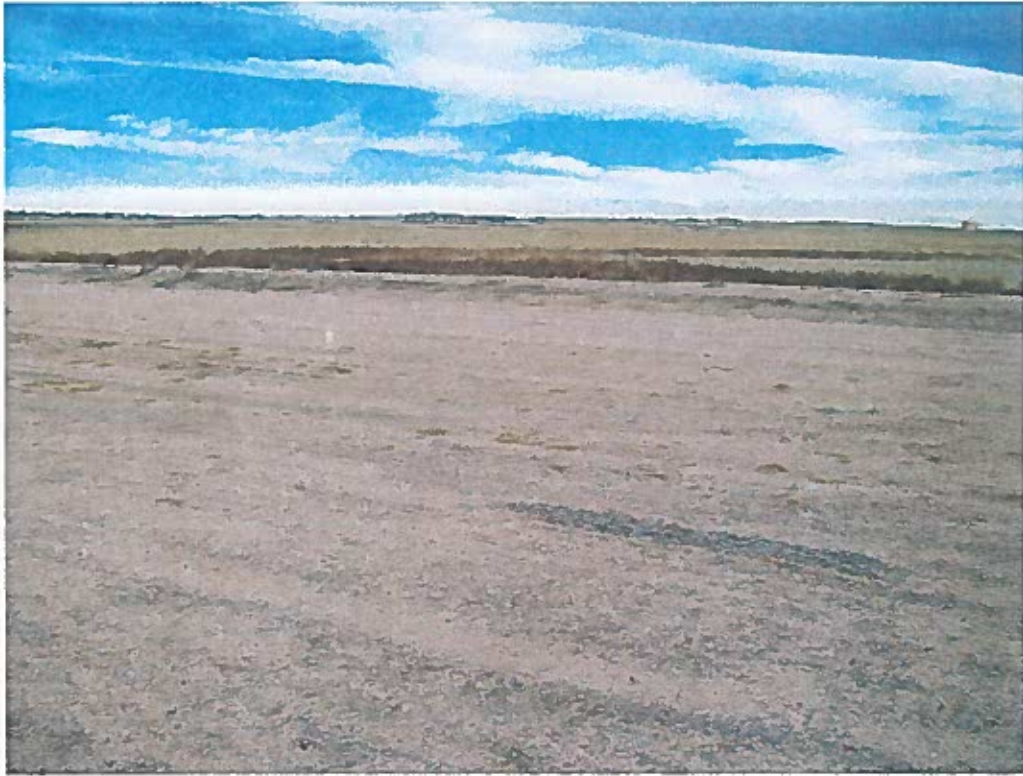
**Looking northwest  
from the southeast  
portion of the site.**

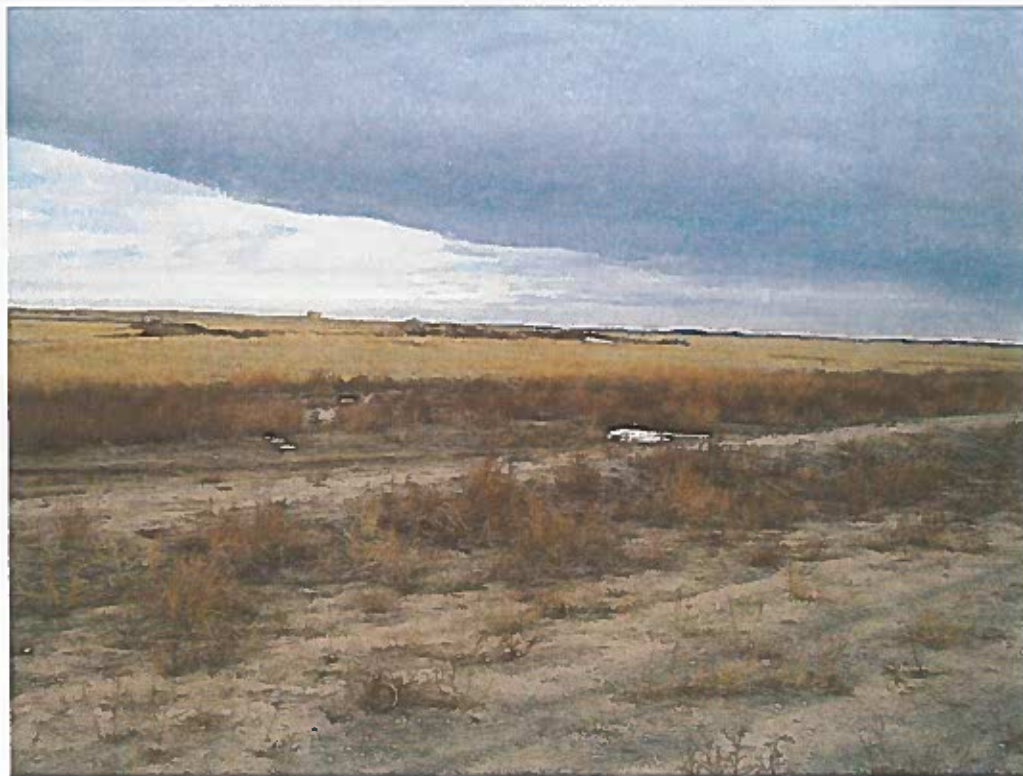
**Looking northeast  
from the southwest  
portion of the site.**

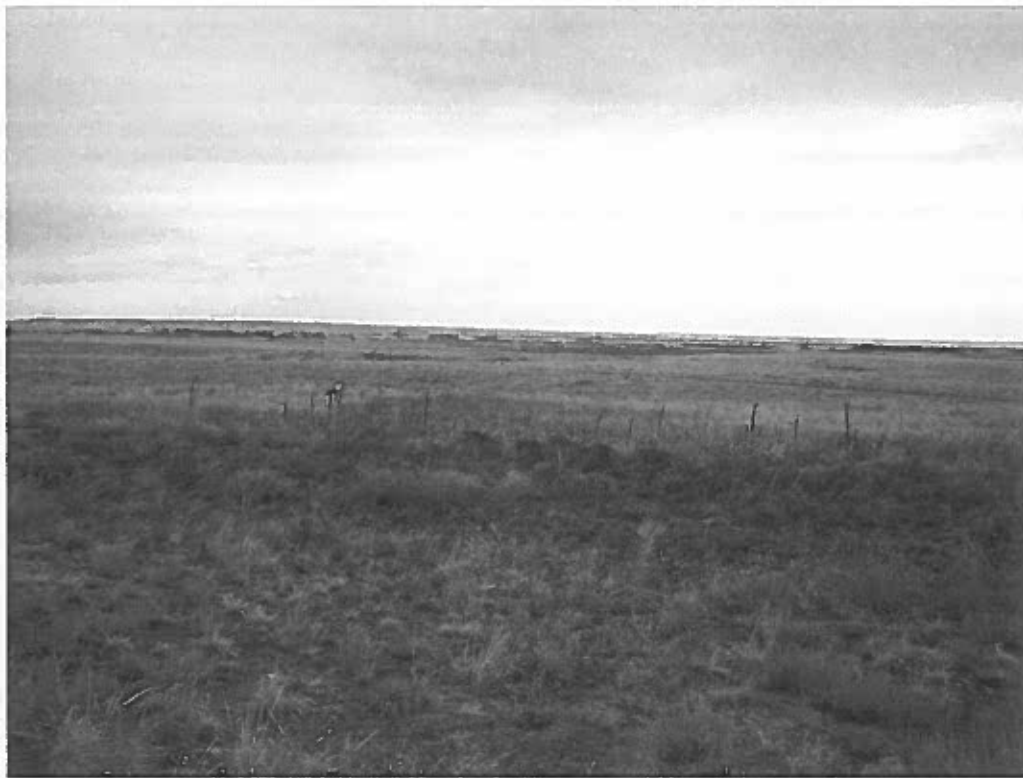
**Looking southeast  
from the northwest  
portion of the site.**

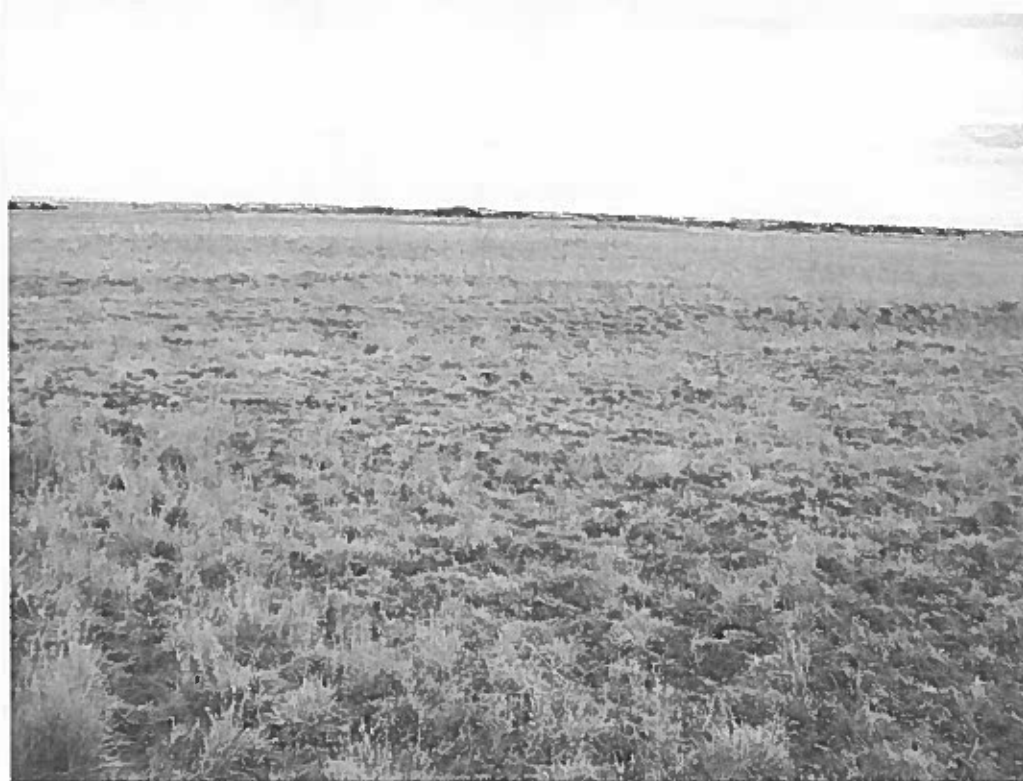
**Looking southwest  
from the northeast  
portion of the site.**
