ENTECH
ENGINEERING, INC.

Re: Soil, Geology and Geologic Hazard Addendum
Waterbury, Filings 1 and 2
PUD Amendment and Preliminary Plan
El Paso County, Colorado

**SOIL, GEOLOGY,
GEOLOGIC HAZARD AND
PRELIMINARY SUBSURFACE SOIL INVESTIGATION
WATERBURY, PHASE I
EL PASO COUNTY, COLORADO**

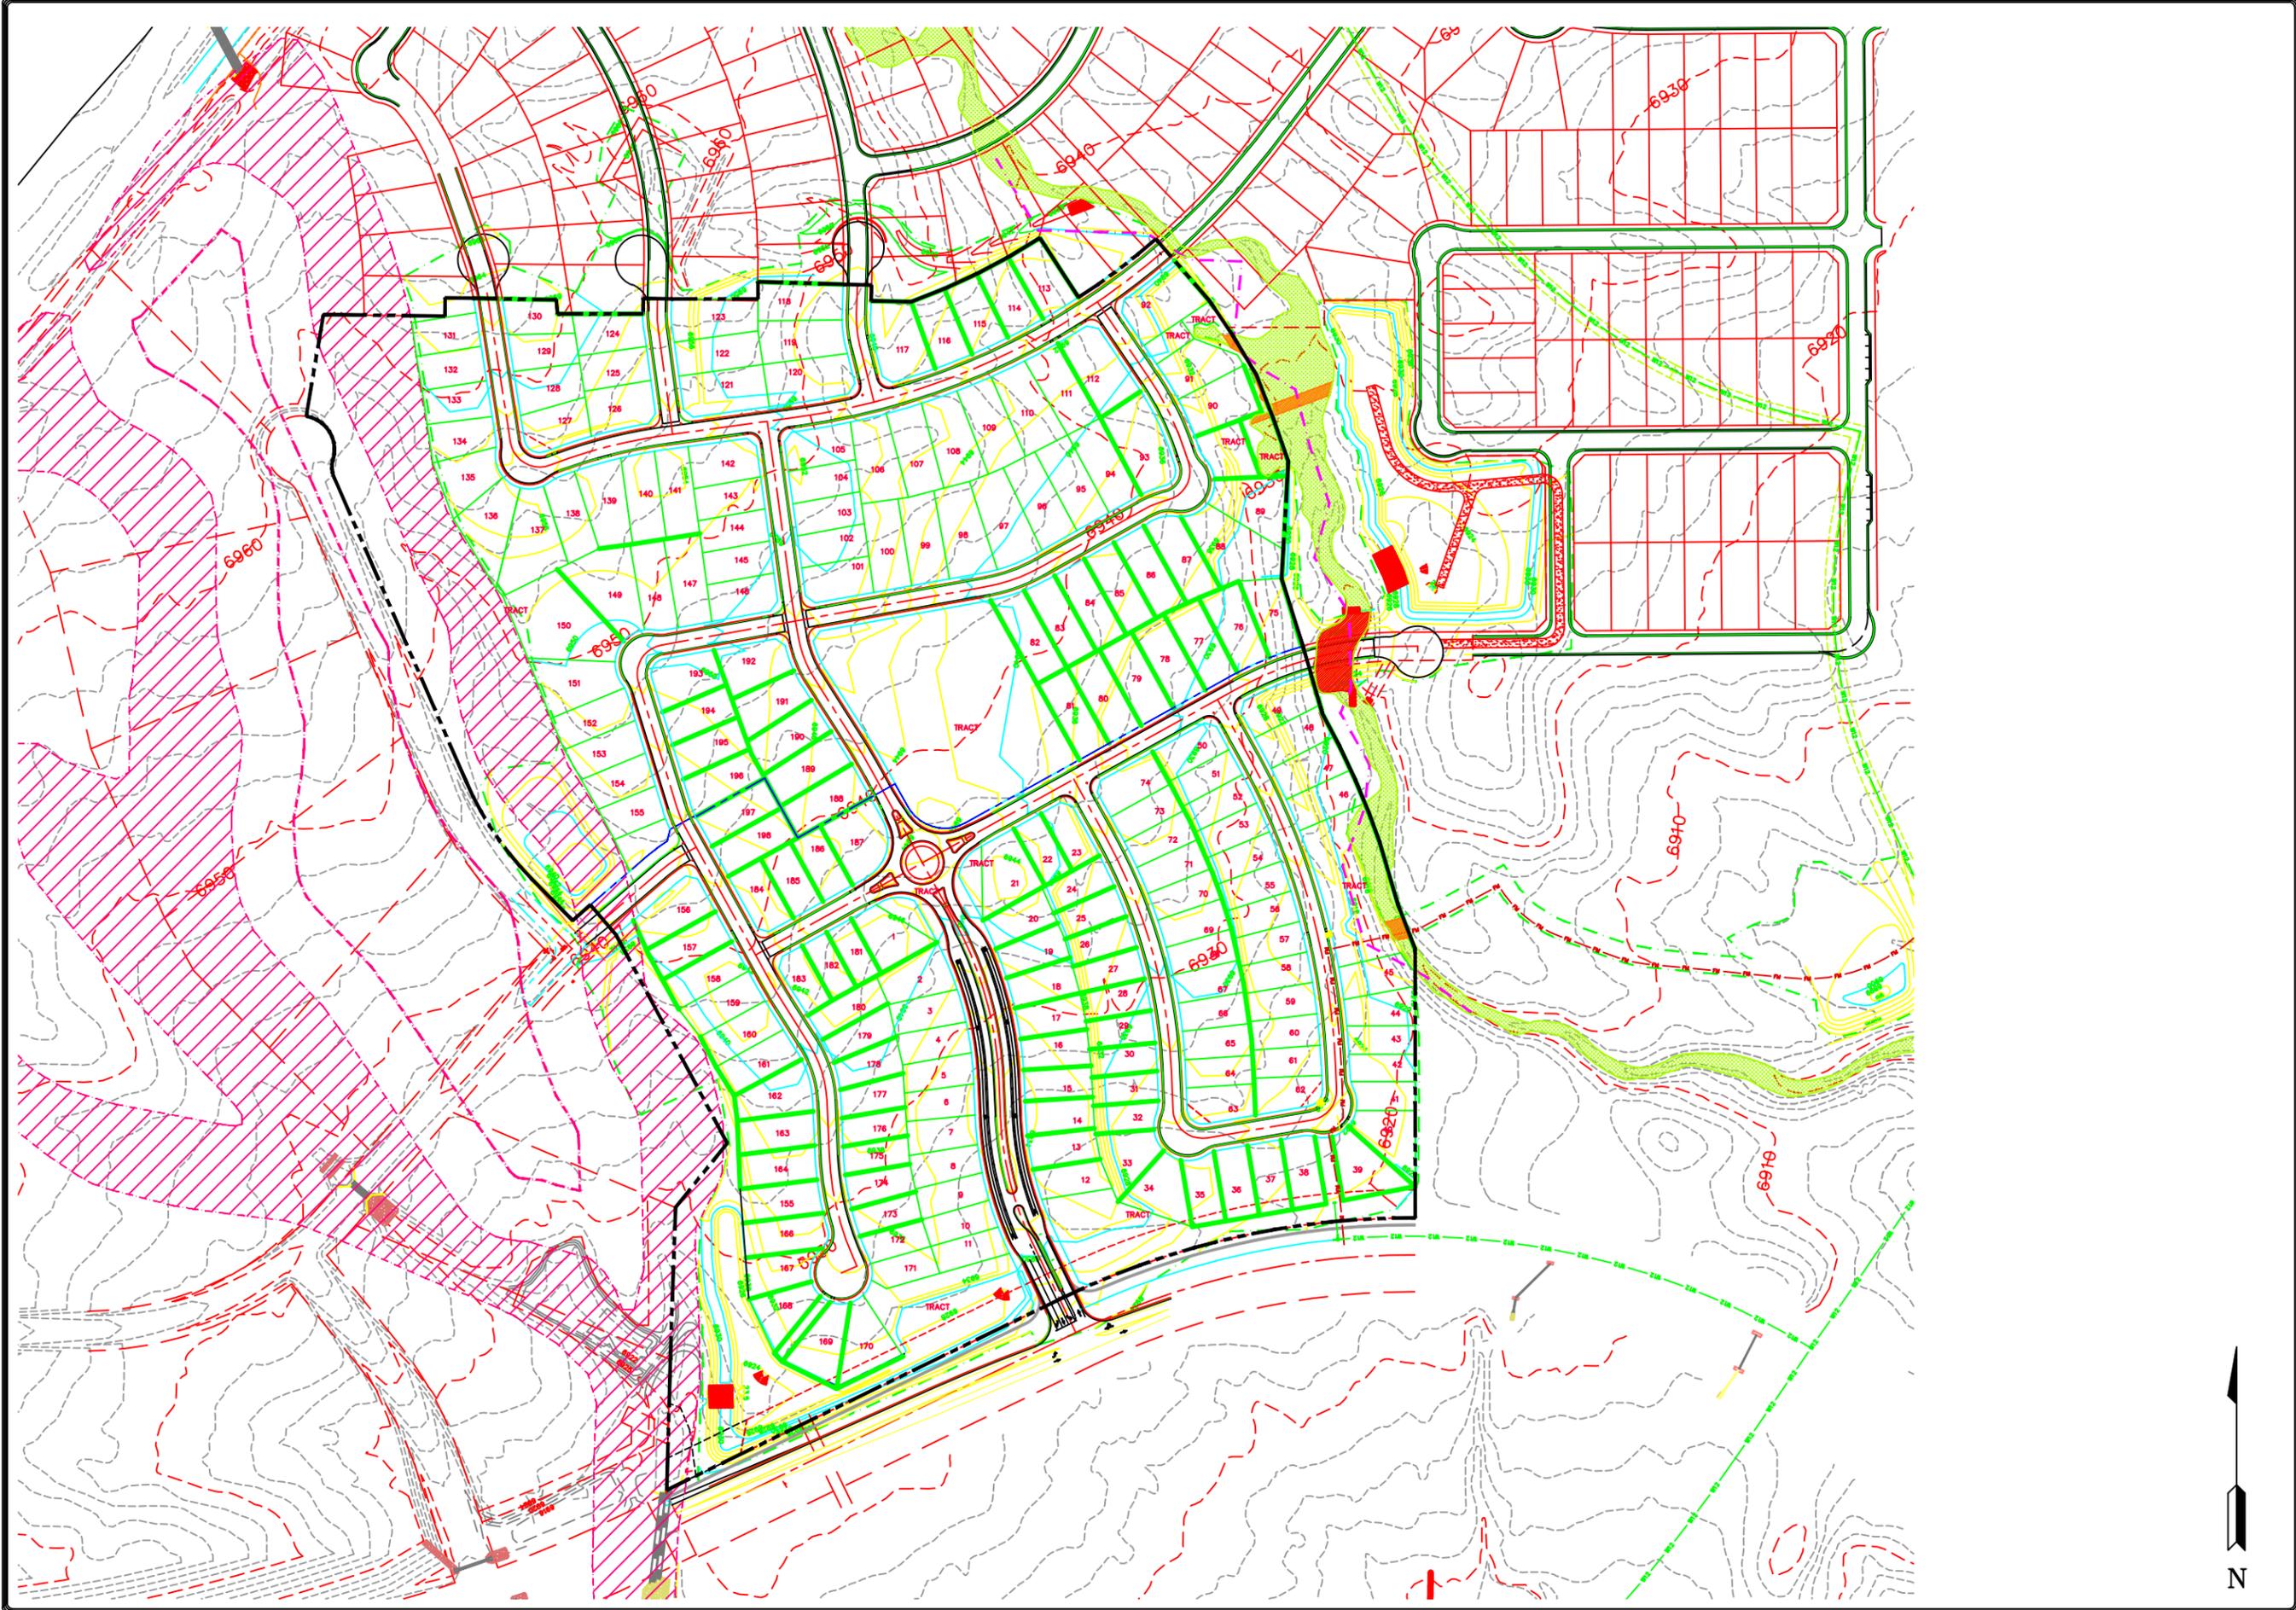
DRAWN L.L.
CHECKED
DATE 1/27/22
SCALE AS SHOWN
JOB NO. 212803
FIGURE No. 1

According to the proposed grading plan, Figure 1, fill depths of 2 to 10 feet are proposed on the site with approximately 4 feet of fill proposed across the majority of the site. Drainages along the eastern and western portions of the site are to be contained in drainage tracts. A minor drainage that enters the site below an earthen dam immediately north of the site will be regraded during future filings. The drainage area from where it enters the subject site (Filing 2) is to be regraded and water collected and directed via storm sewer. A detention basin is proposed in the southwest corner of the site. Additionally, areas of seasonal shallow groundwater have been mapped in the southern portion of the site that are to be regraded with 4 to 10 feet of fill to be placed. The drainage areas along the eastern and western side of the site have been mapped as physiographic floodplains. These are to be avoided by development or modified with minor grading. Proposed site grading will further raise foundation above the groundwater level. Any fill placed on the site should be compacted at a minimum of 95% of its maximum Modified Proctor Dry Density ASTM D-1557. Where structures encroach on these areas, drains may be necessary to help prevent the intrusion of water into areas below grade. Recommendations and drain details have been provided in the Soil, Geology, and Geologic Hazard Investigation (Reference 1, Appendix B) and remain valid.

Any areas to receive new fill should have all topsoil, organic material or debris removed. Fill must be properly benched and compacted to minimize potentially unstable conditions in slope areas. Fill slopes should be 3:1 or flatter. The subgrade should be scarified and moisture conditioned to within 2% of optimum moisture content and compacted to a minimum of 95% of its maximum Modified Proctor Dry Density, ASTM D-1557, prior to placing new fill. Areas receiving fill may require stabilization with shotrock or fabric if water is encountered or approached. Any soft/loose areas should be removed and recompacted.

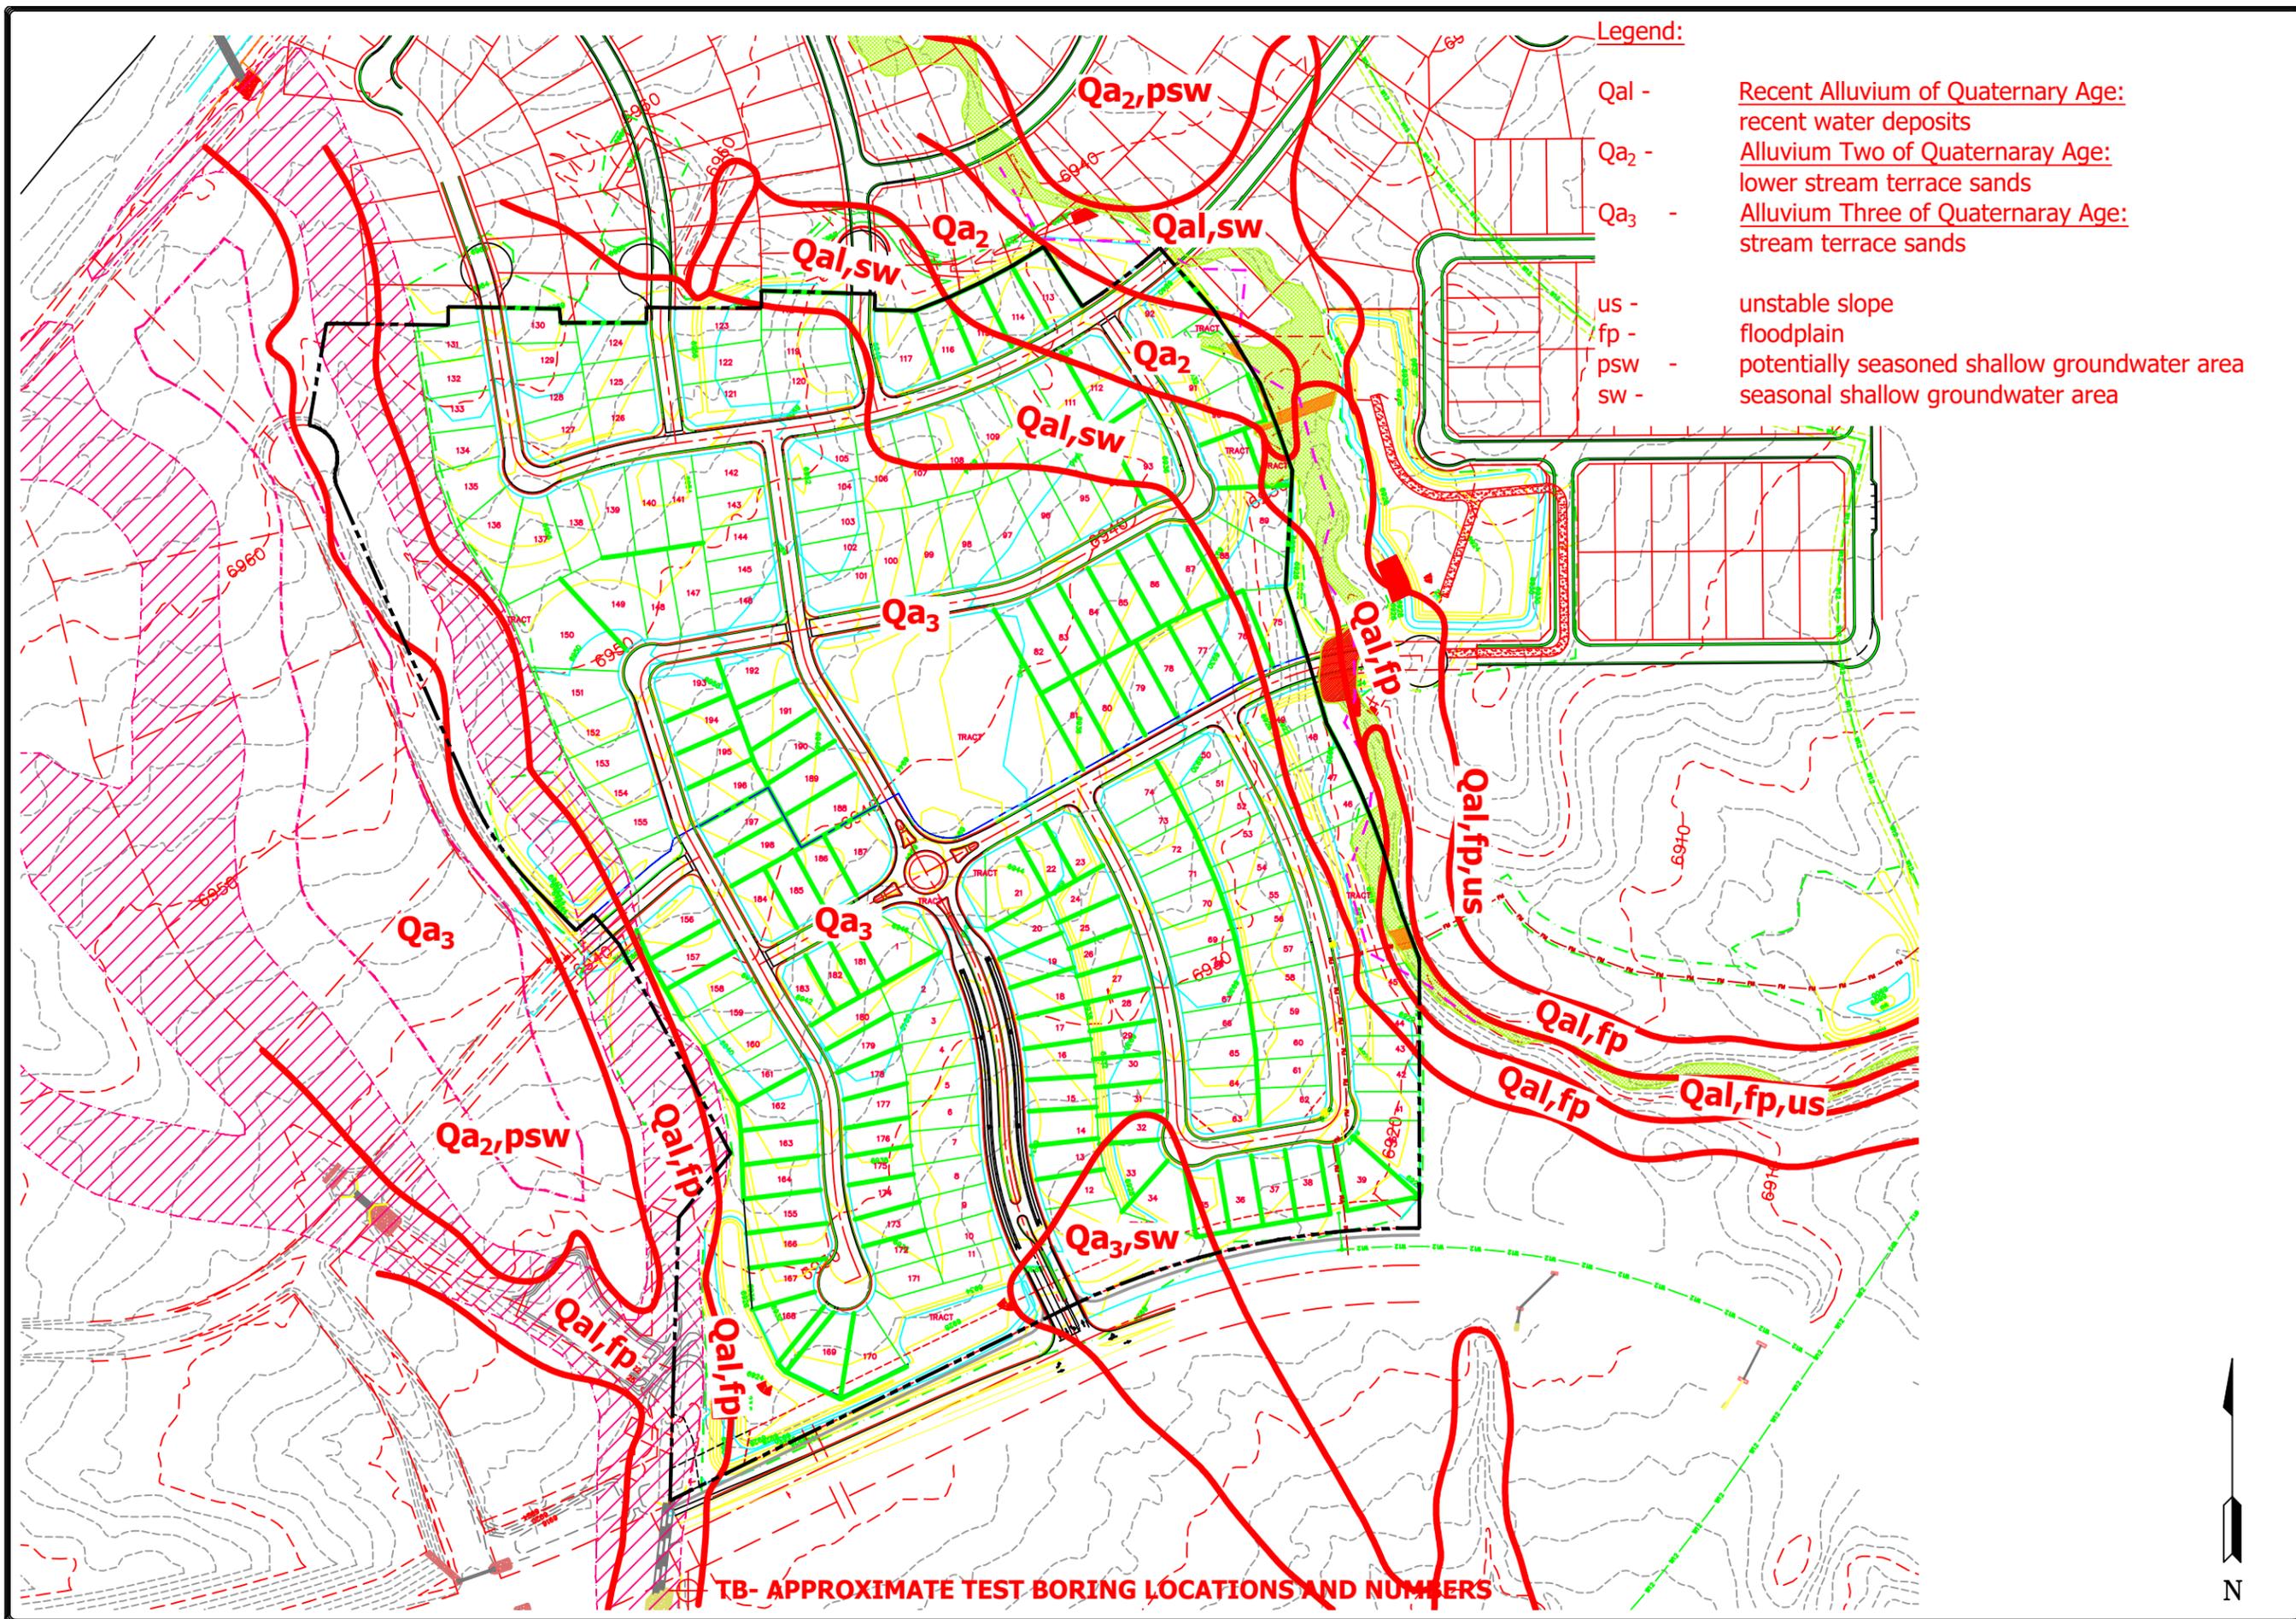
DRAWN L.L.
CHECKED
DATE 1/27/22
SCALE AS SHOWN
JOB NO. 212803
FIGURE No. 3

Current site conditions in the area of the proposed structure are consistent with what is described in the original Geologic Hazard Study by Entech (Reference 1, Appendix B). The grading and topography in the area of the proposed site appears to be relatively unchanged. The *Geologic Map of the Falcon Quadrangle* distributed by the Colorado Geological Survey in 2012, is presented in (Reference 2, Figure 2). Site-specific geologic mapping was performed as a part of the Geologic Hazard Study by Entech (Reference 1) and revised based off recent mapping by the Colorado Geological Survey (Reference 2, Figure 2). The site is mapped as Qal: Recent Alluvium of Quaternary Age along the drainages and Qa₃: Alluvium Three of Quaternary Age which consists of stream terrace deposits. The bedrock underlying the site is the Dawson Formation of Tertiary to Cretaceous Age (References 1 through 3). The updated Geology/Engineering Geology Map is presented in Figure 3.

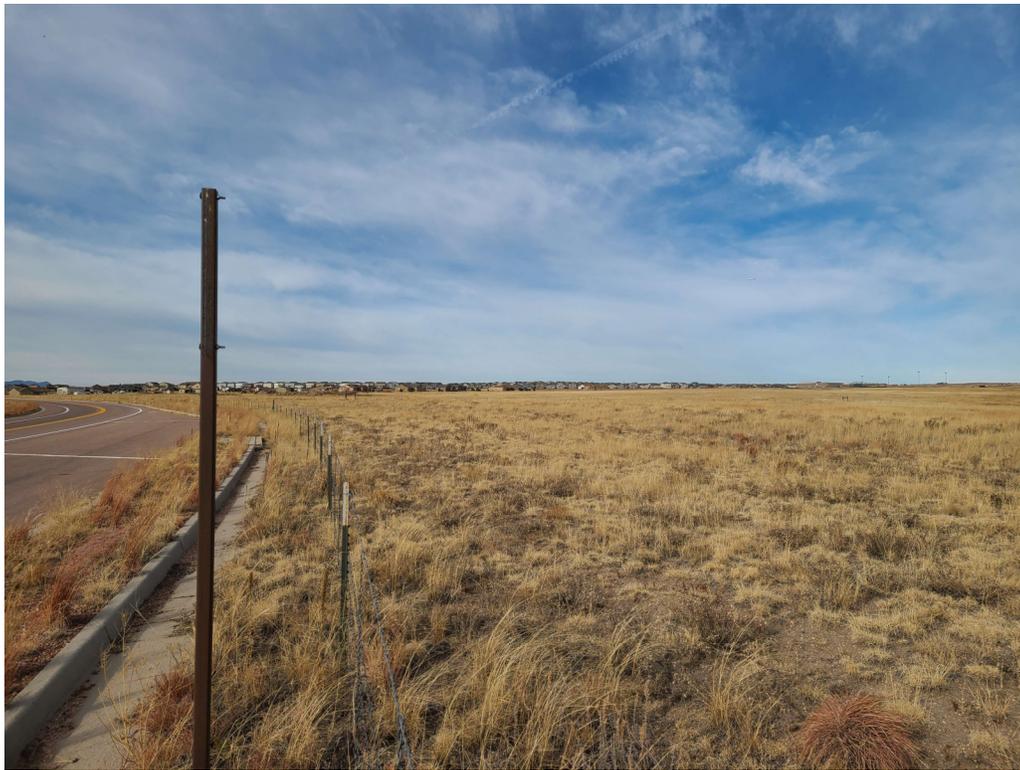
Looking west from the south-central side of the site.

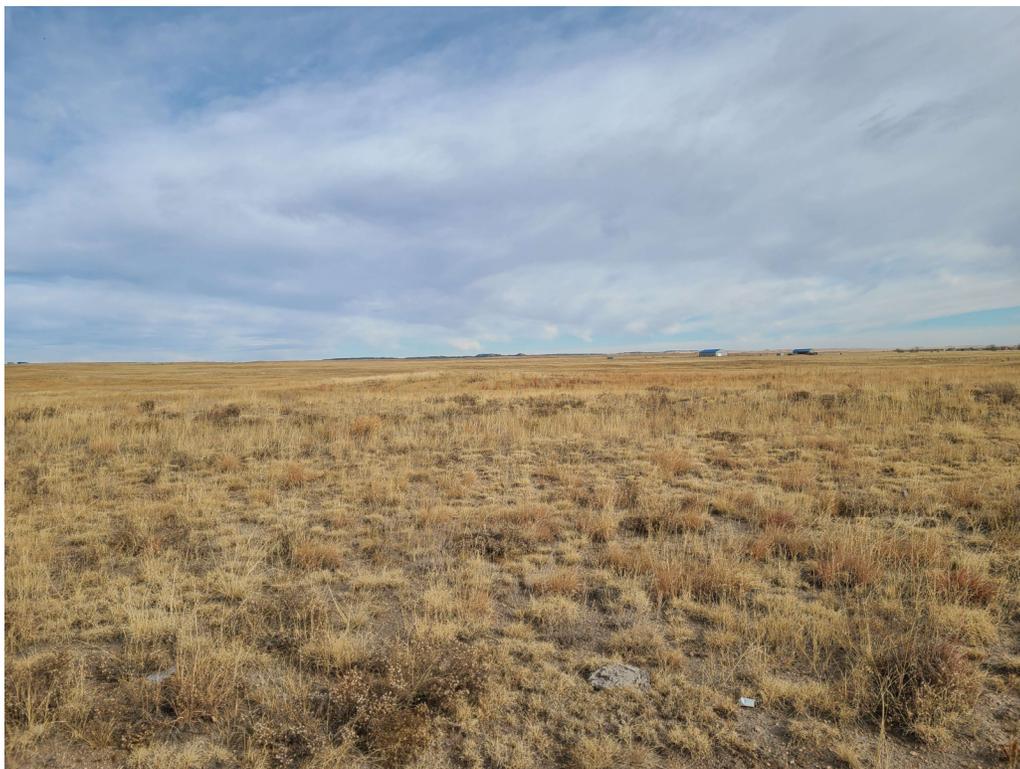
Looking north from the south-central side of the site.

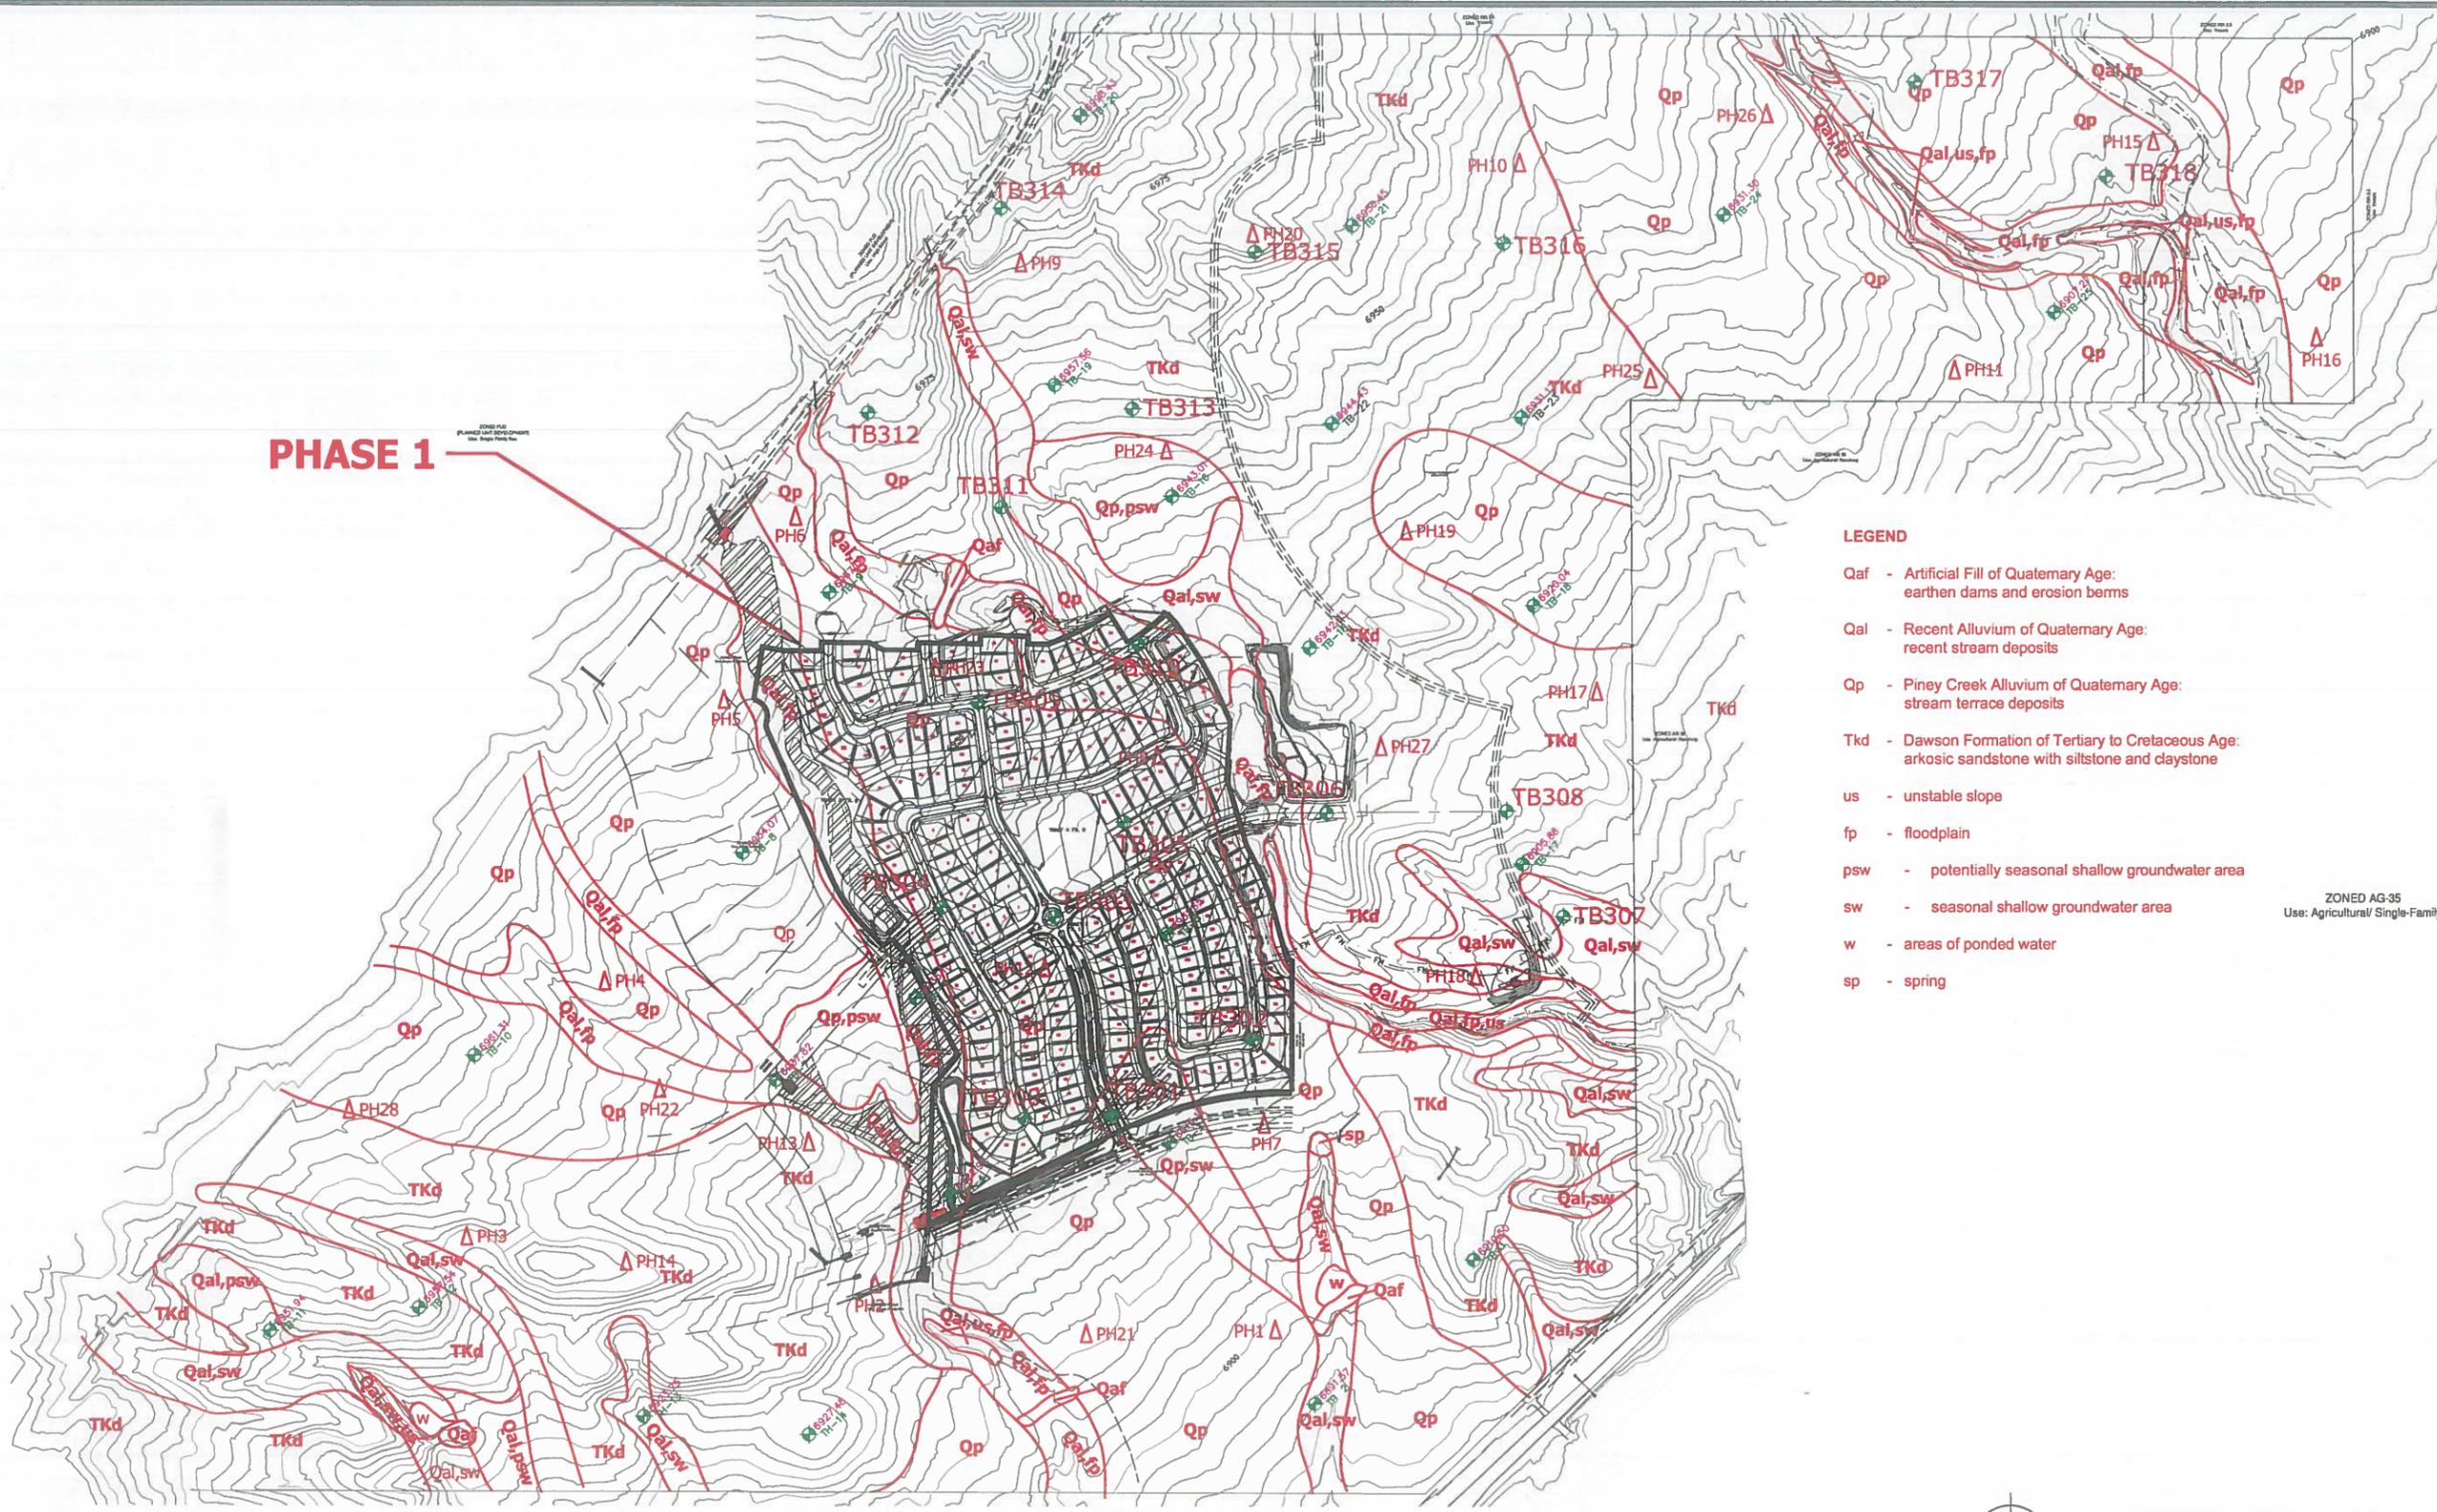
DRAWN BY: R. MCBRIDE
DESIGNED BY: KAH
CHECKED BY:
DATE: 10/19/21
SCALE: 1" = 300'
JOB NO.: 130377
FIGURE NO.:
9

are subject to failure due to erosion by the creeks. These areas lie east of Phase I. According to the grading plan (Figure 9), much of this area is to be filled and the drainage rerouted through a drainage easement. No known past landslides have been mapped on the site (References 7, 8, 9).

Mitigation: Due to the location of these slopes associated with the floodplains and a drainage easement, these areas are avoided by development. A minimum setback of 20 feet should be maintained between buildings and the crest of any remaining unstable slopes. Other options to stabilize the slopes include regrading to no steeper than 3:1 or the use of engineer designed retaining walls. According to the development plan, there appears to be sufficient room on the affected lots to allow building areas outside the recommended setback limits. Site grading will mitigate the slopes in many of these areas as well. Some erosion protection may be necessary in order to prevent further erosion by the creeks during high water.
