March 15, 2024
Project No. 502907001

Subject: Geologic Hazard Evaluation
Proposed Reagan Ranch Industrial Development
Marksheffel Road & Space Village Avenue
Colorado Springs, Colorado

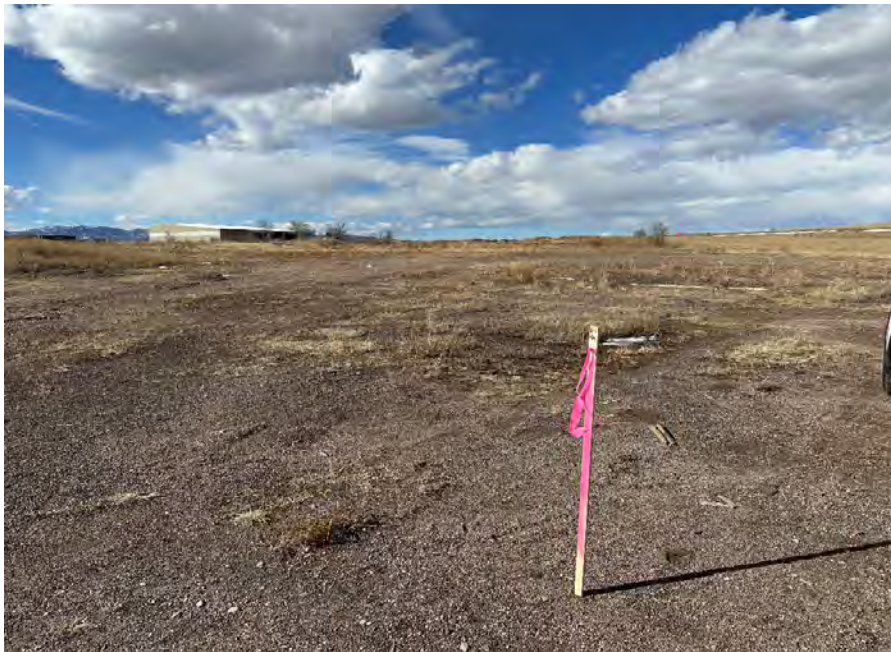
Photo No. 1 **Location: Boring B-2** **Date: 02/14/2024**
Overview of Boring B-2, looking north to northwest. Fill was observed at the surface.

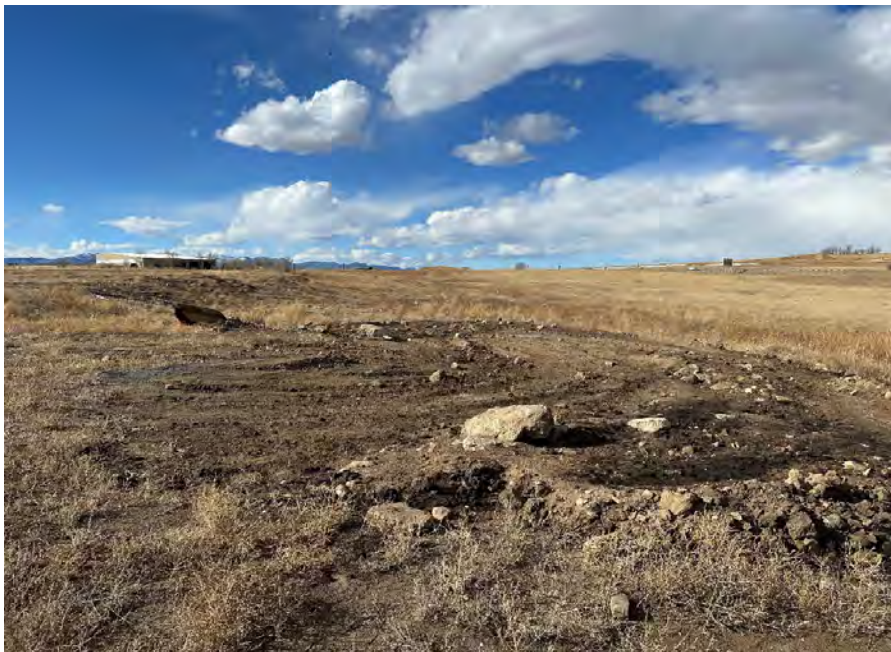
Photo No. 2 **Location: Boring B-3** **Date: 02/14/2024**
Demolition refuse was typical throughout the southwest half of the site.

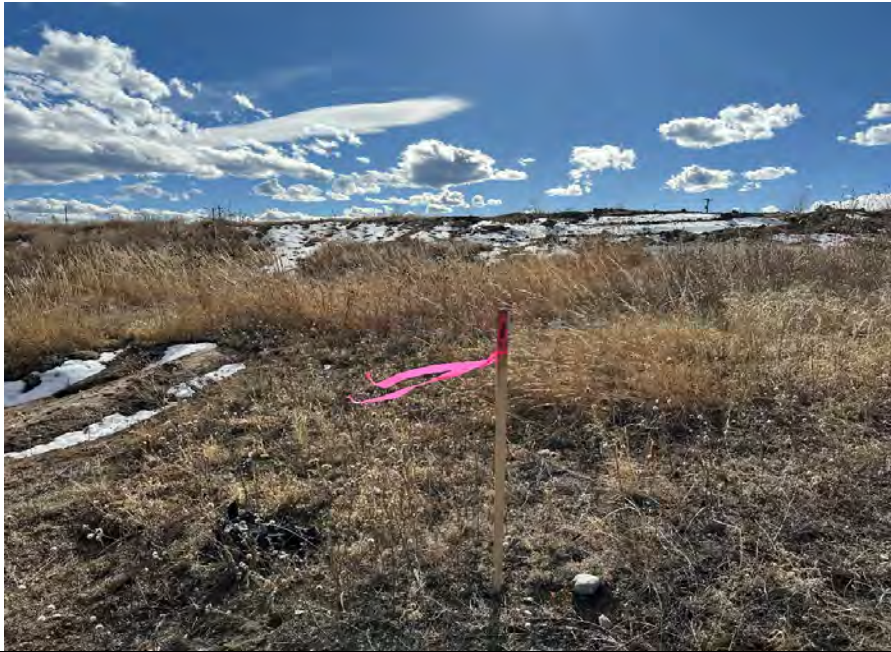
Slope stability is not considered a design consideration for the project site due to the relatively gently sloping site topography and surrounding site topography. During the site reconnaissance a grade change of approximately 12 to 14 feet existed between the southwest and northeast half of the site. The grade change occurred where the observed fill material ended and native ground began and the slope was estimated to be at an approximate inclination of 2H (Horizontal):1V (Vertical) (Google Earth, 2024).

Photo No. 3 **Location: Boring B-5** **Date: 02/14/2024**
Overview of Boring B-5, looking south. A relatively rapid topographic change was observed between the fill area and native area.

The fill material making the slope on-site is recommended to be removed and replaced with moisture-conditioned and compacted engineered fill.

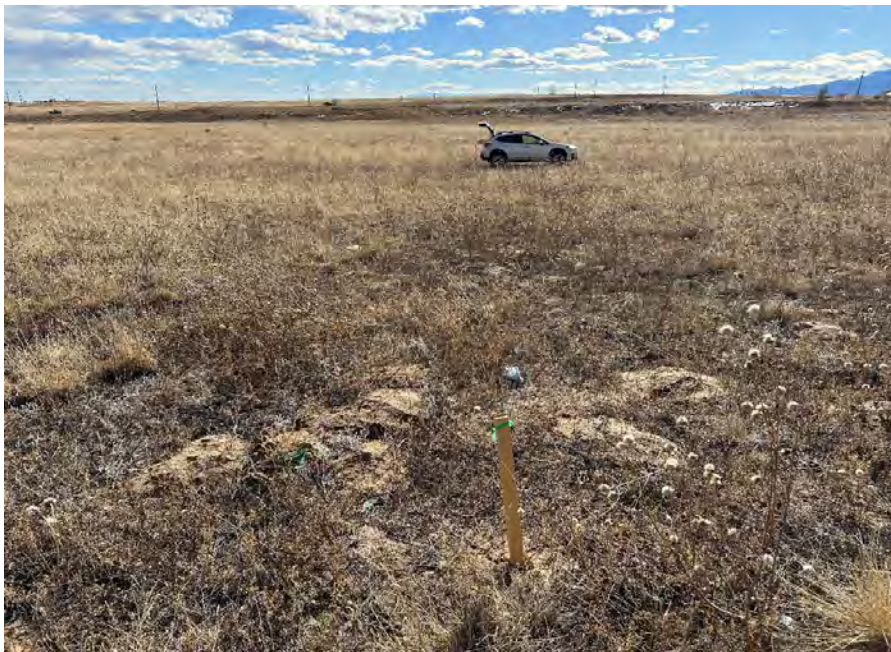
Photo No. 4 **Location: Boring B-8** **Date: 02/14/2024**
Survey markers were observed throughout the site.

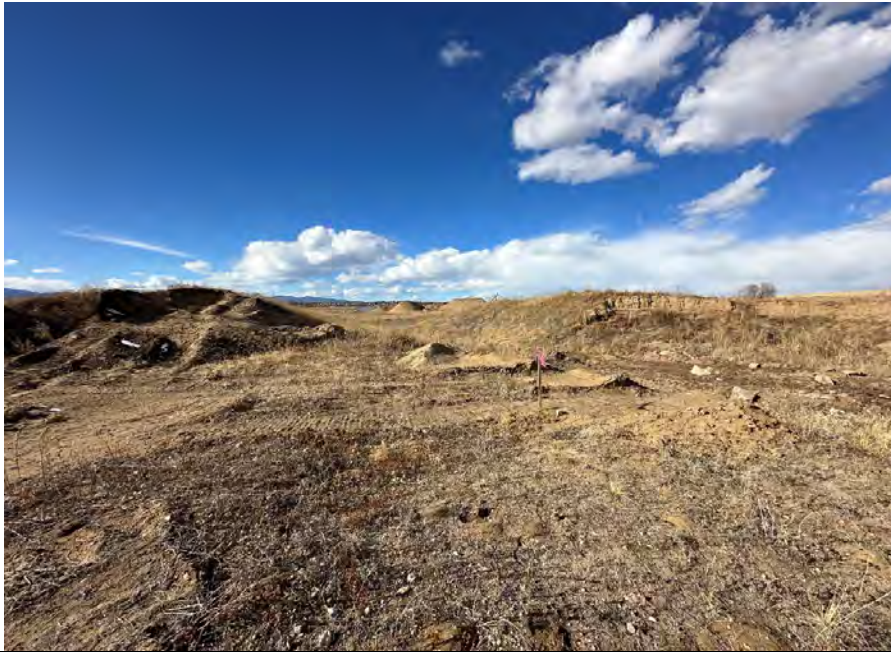
Photo No. 5 Location: Boring B-10 Date: 02/14/2024
Apparent stockpiled material and an excavation pit was observed near Boring B-10.

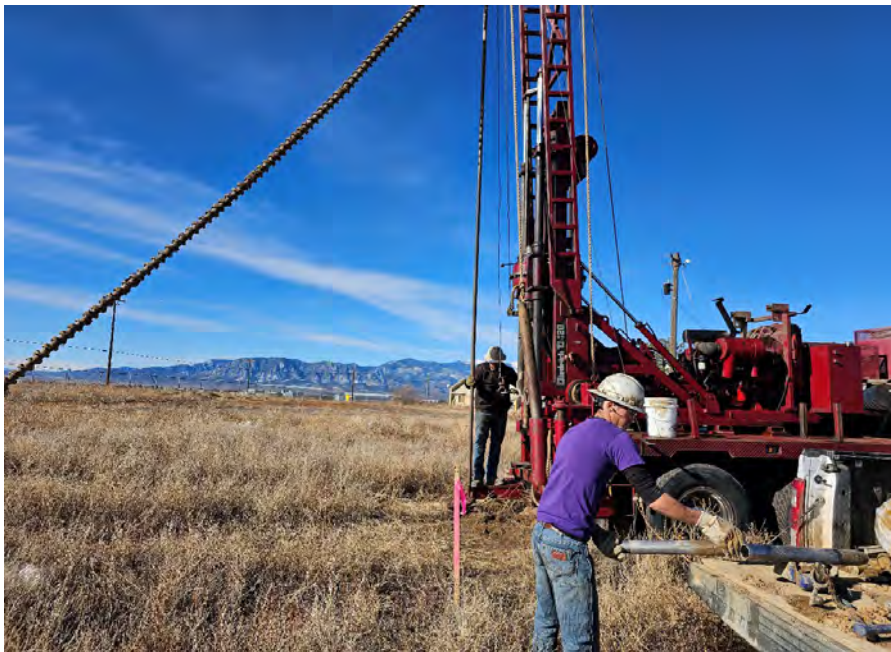
Photo No. 6 Location: Boring B-1 Date: 02/14/2024
Two truck mounted drill rigs equipped with solid stem augers were used for drilling. Samples were collected utilizing California barrel samplers.
