**ENTECH**  
ENGINEERING, INC.

Re: Soils and Geology Study  
Settlers Ranch Filing No. 3  
Parcel Nos. 61230-04-048, 61240-05-001, 61240-05-003, & 61230-07-024  
El Paso County, Colorado  
Entech Job No. 230662

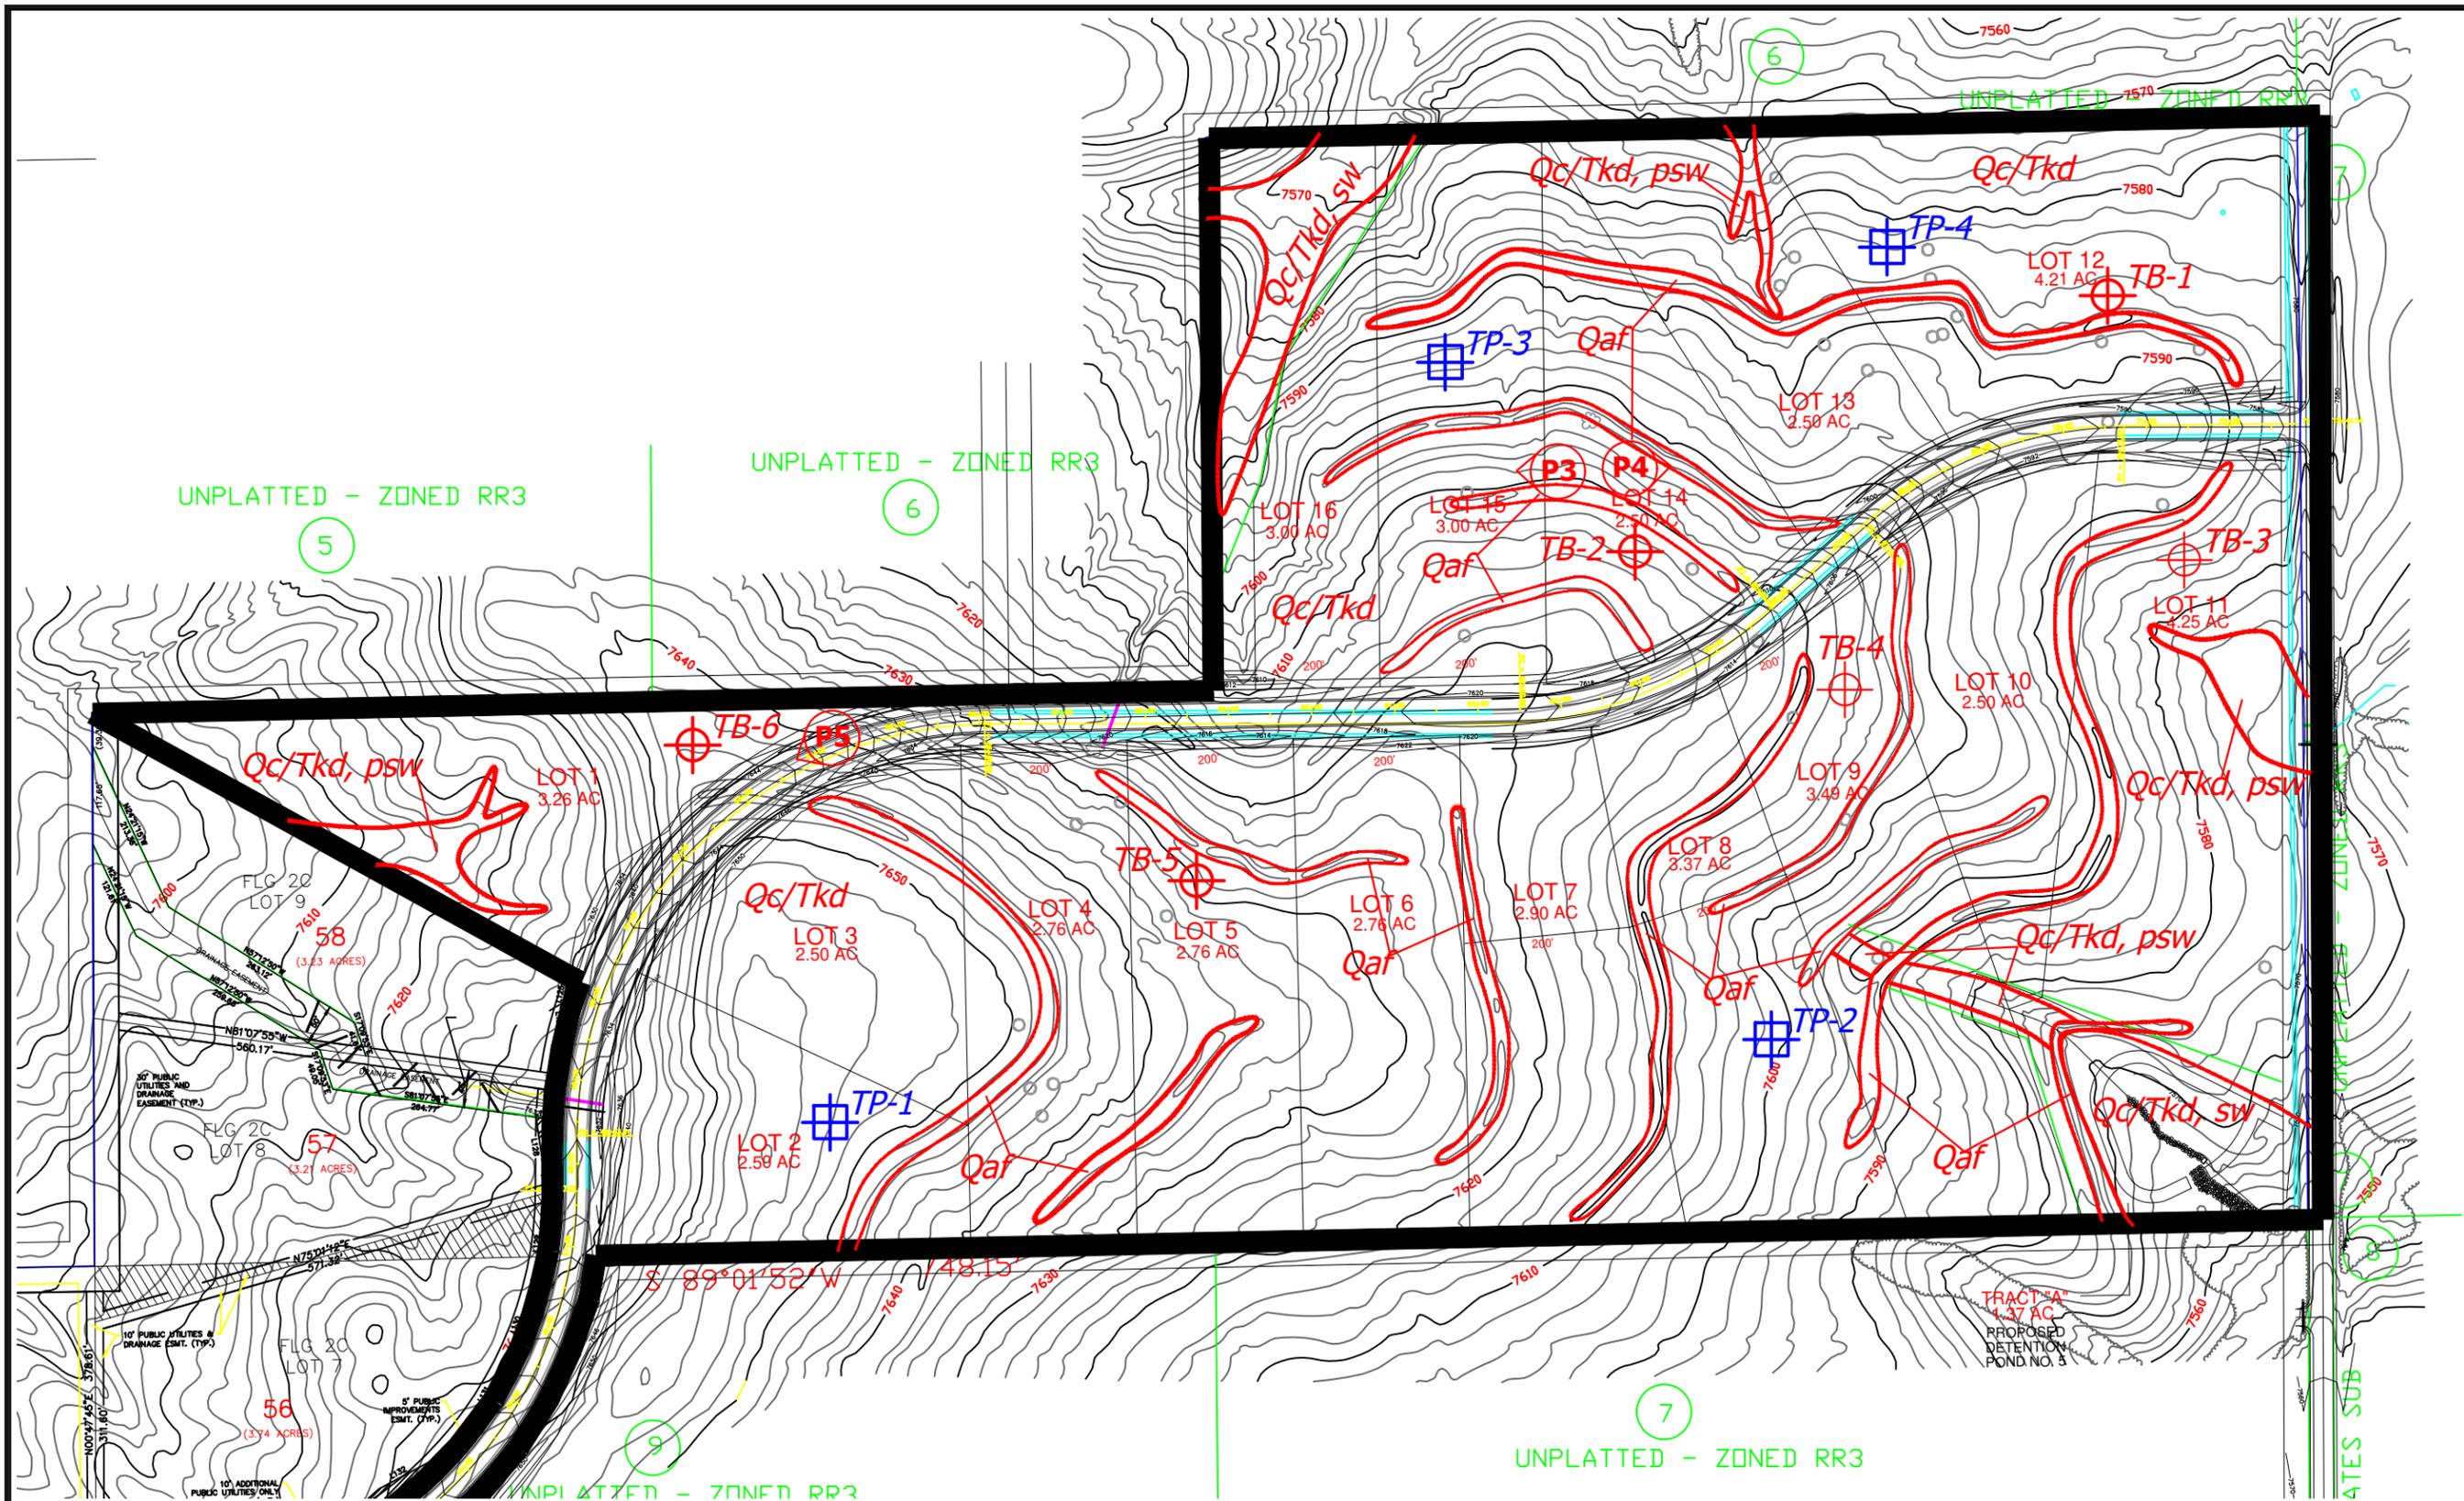
FIG. 6

Several minor drainage swales are located in the northwestern, northeastern, and southern portions of the site that have been mapped as potentially seasonal shallow groundwater and seasonal shallow groundwater. Water was not observed in the drainages at the time of this investigation. This area is indicated in the Geology/Engineering Geology Map (Figure 6) and are discussed below. Due to the size of the proposed lots these areas can be avoided. The site does not lie within any floodplain zones according to the FEMA Map No. 08041CO305G dated December 7, 2018 (Figure 7, Reference 8). Exact locations of floodplain and specific drainage studies are beyond the scope of this report.

Portions of the minor drainage swales on the site have been identified as a potentially seasonal shallow groundwater area. In these areas we would anticipate the potential for periodically high subsurface moisture conditions, frost heave potential and highly organic soils. The upslope sides of the erosion berms also have the potential to become saturated after periods of increased precipitation. These area lies within defined minor drainages or and will be avoided by the proposed development. Construction in any portions of these areas, if required, or immediately adjacent to these areas should follow these precautions.

These are areas located within the heads of drainage in the northern portions of the site within drainage easements, which be avoided by development. Water was not observed in the drainages at the time of this investigation. The same mitigation techniques for seasonally high groundwater areas are recommended for these seasonally ponded areas as well.

Mitigation: Foundations must have a minimum 30-inch depth for frost protection. In areas where high subsurface moisture conditions are anticipated periodically, subsurface perimeter drains are recommended to help prevent the intrusion of water into areas below grade. Typical drain details are presented in Figure 8. Any grading in these areas should be done to direct surface flow around structures to avoid areas of ponded water. All organic material would be completely removed prior to any fill placement. **Specific drainage studies are beyond the scope of this report.**

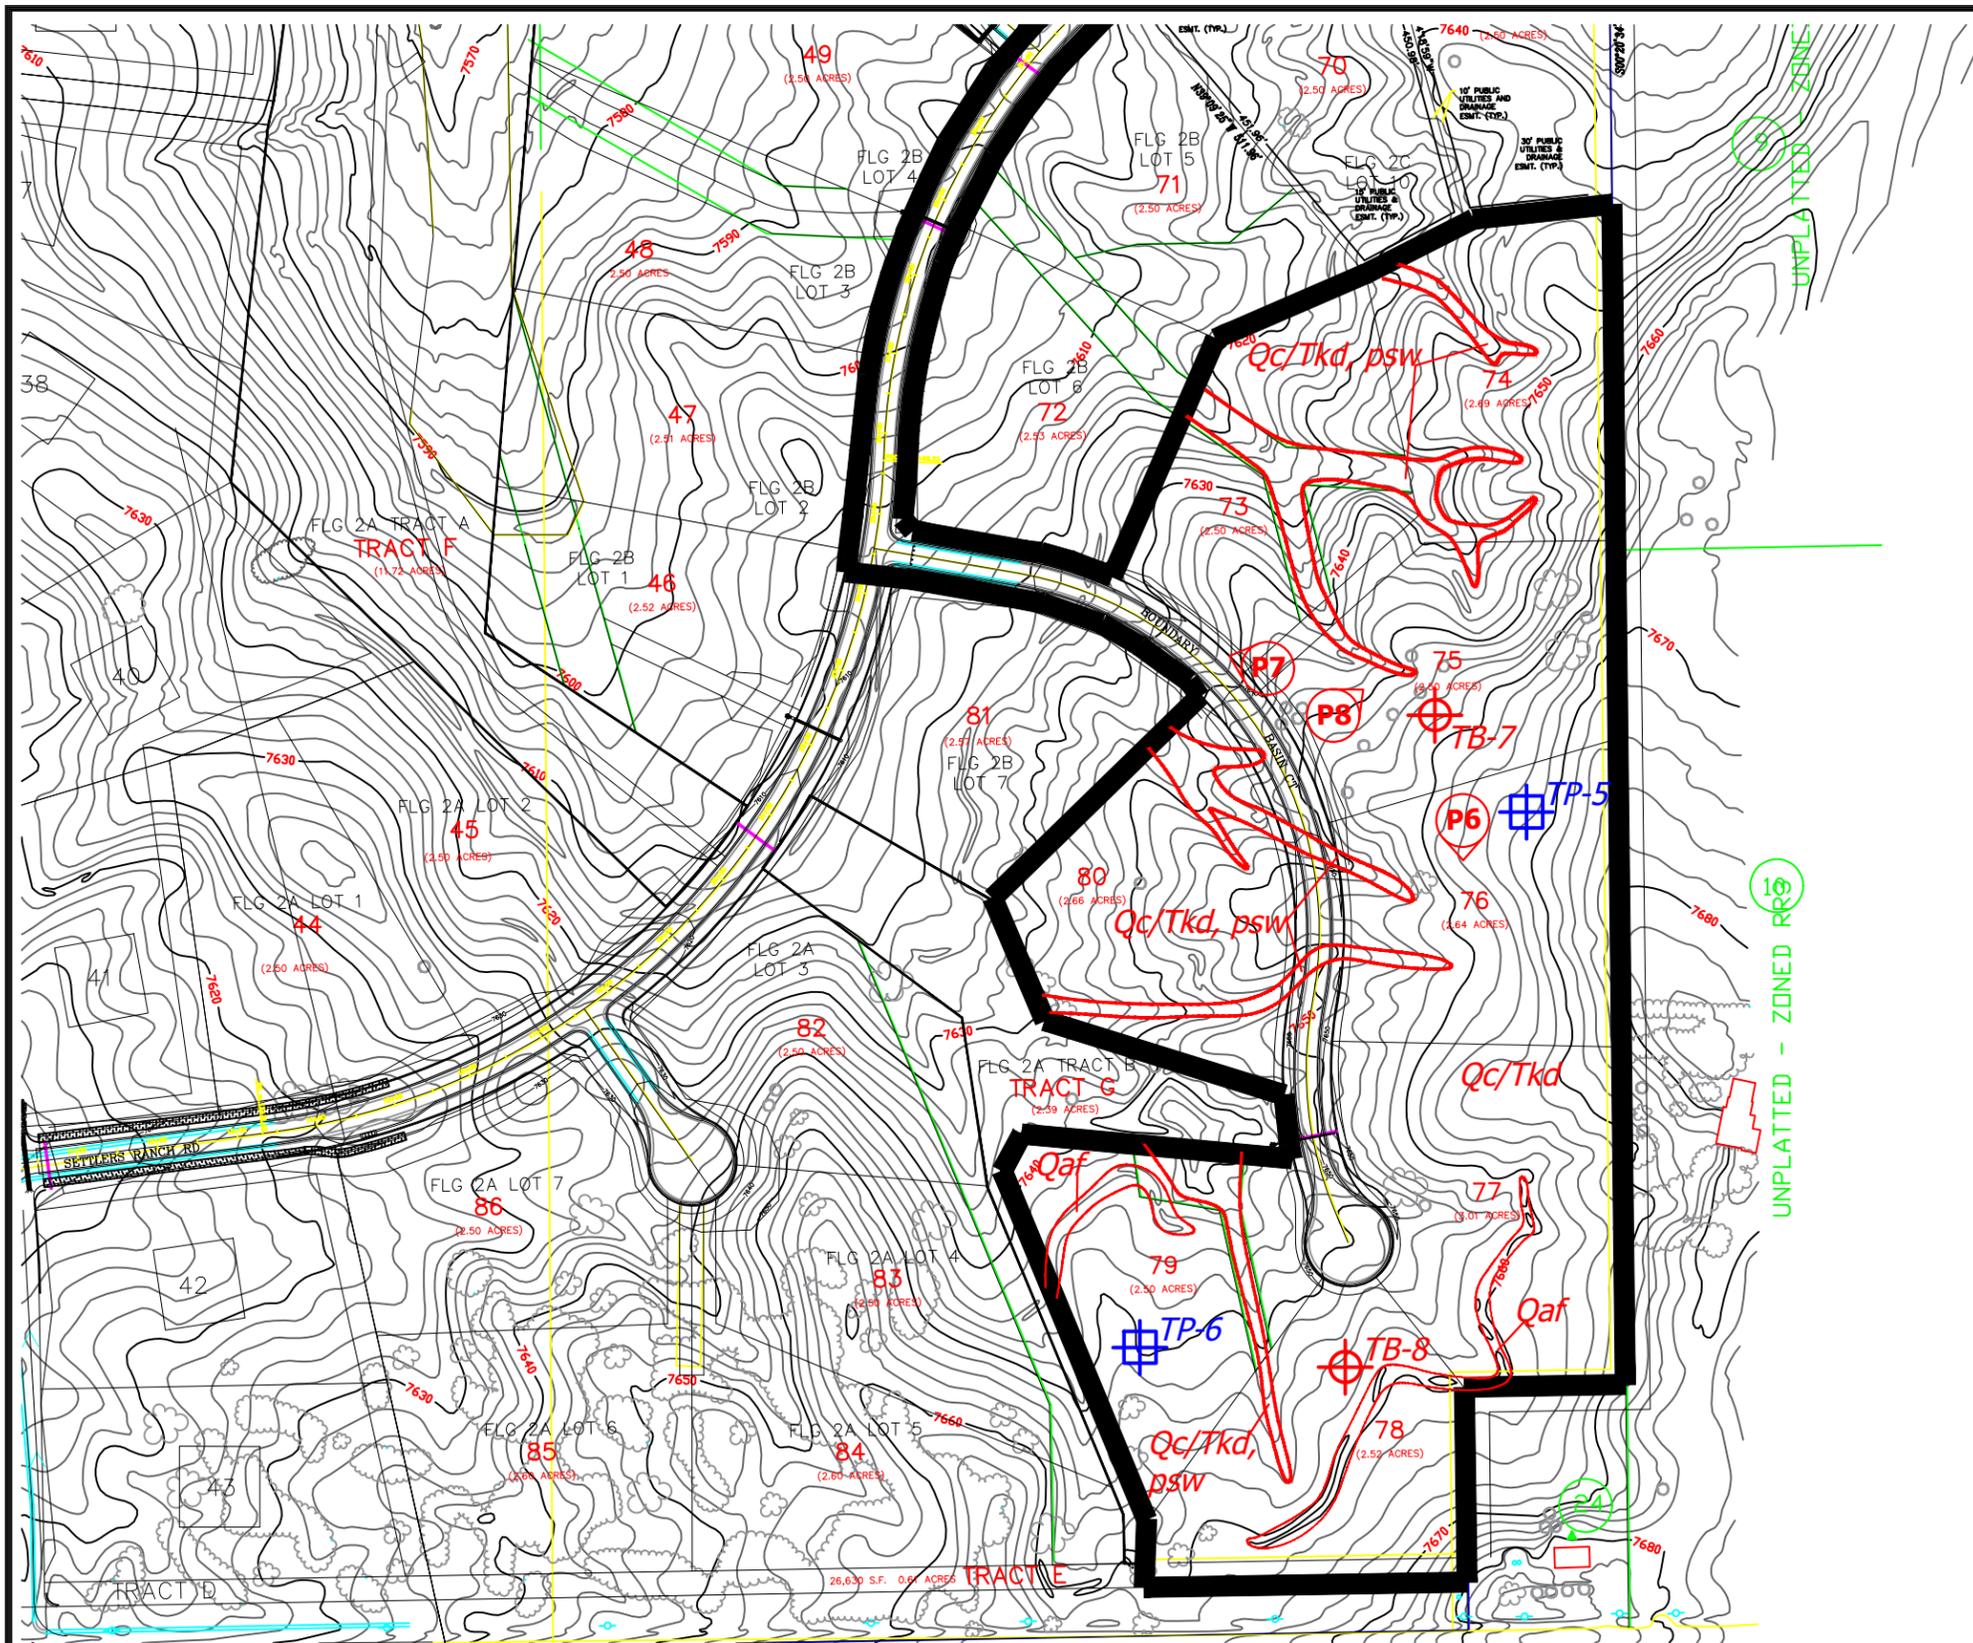
FIG. 6A

Areas of potential seasonally shallow groundwater were observed on the site (Figures 6 and 6A). In these areas, we would anticipate the potential for periodically high subsurface moisture conditions and frost heave potential. In these areas, we would anticipate the potential for periodically high subsurface moisture conditions and frost heave potential. These areas lie along minor drainage swales across the site. Water was not observed in any of the drainages at the time of our site investigation. Subsurface perimeter drains are recommended should structures encroach on this area. Typical drain details are presented in Figure 8. Septic systems are not recommended in in these areas due to the potential for shallow groundwater. Any grading in these areas should be done to direct surface flow around construction to avoid areas of ponded water. All organic material should be completely removed prior to any fill placement. Specific drainage studies are beyond the scope of this report. The site is not mapped within any floodplains according to the FEMA Map No. 08041C0305G (Figure 7, Reference 7).

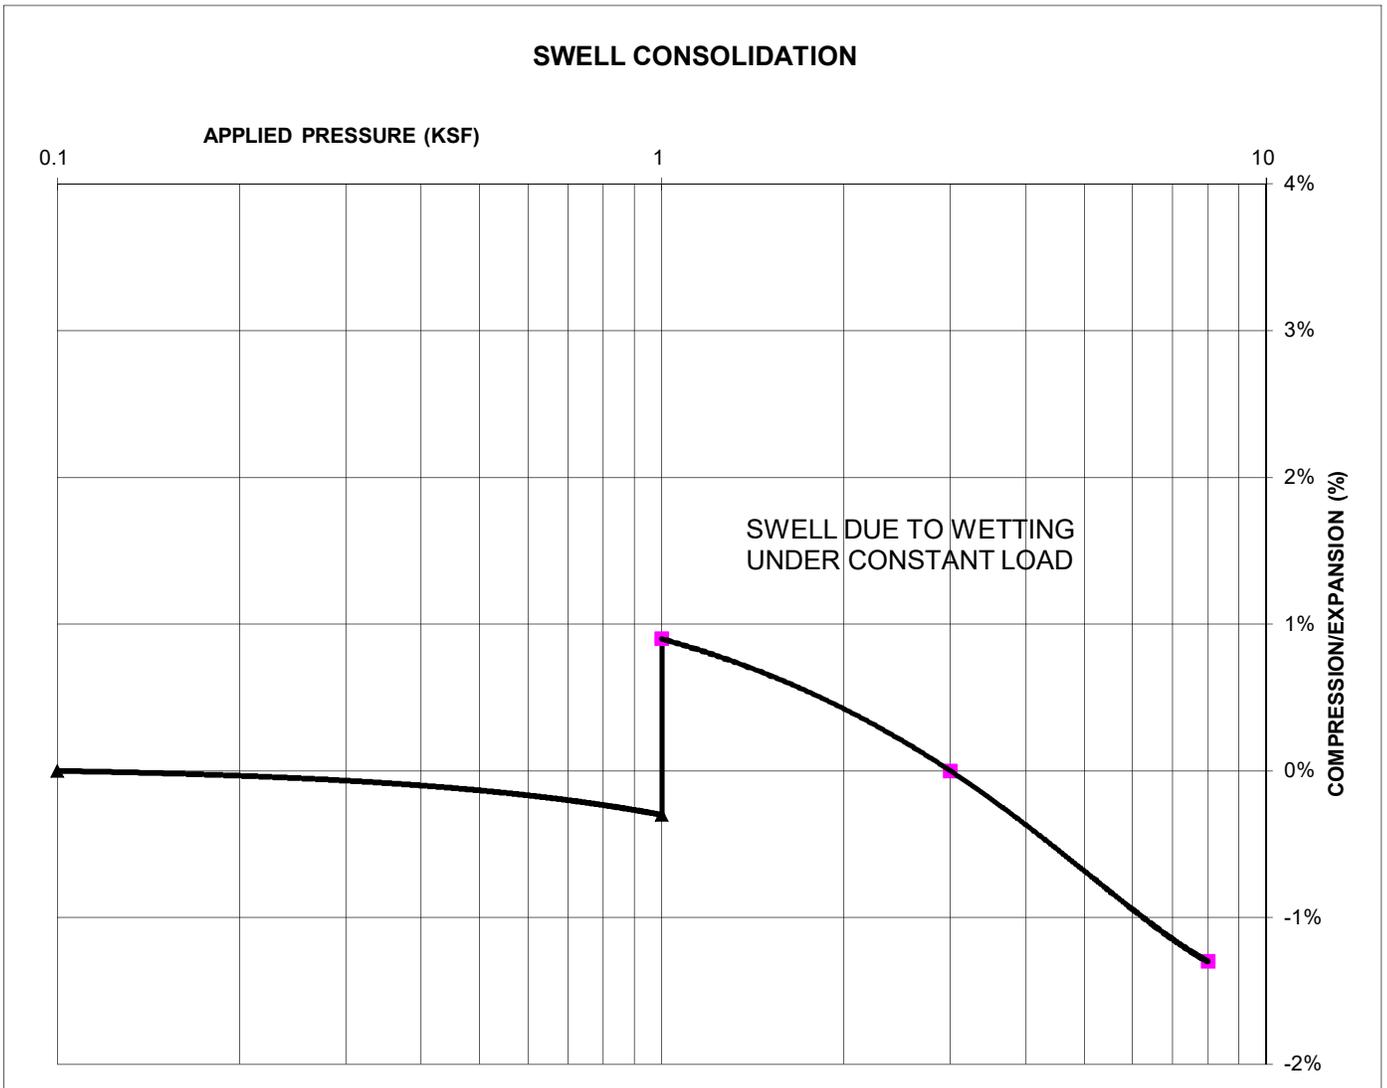
TEST BORING 6  
DEPTH (FT) 5

NATURAL UNIT DRY WEIGHT (PCF): 114  
NATURAL MOISTURE CONTENT: 11.2%  
SWELL/CONSOLIDATION (%): 1.2%
