## EL PASO COUNTY CONSTRUCTION STORMWATER SITE INSPECTION REPORT

Facility Name: Pine View Estates	Permittee: Jolene Owens
Date of Inspection: 02/23/2022	Weather Conditions: Cloudy
Permit Number: ESQ2136	Disturbed Acreage: 1/38.8 acres
Phase of Construction: Active	Site Qualified Stormwater Manager: Please provide information
Inspector Name: Molly Galloway	Site Contact Info: Alice Jolene Owens

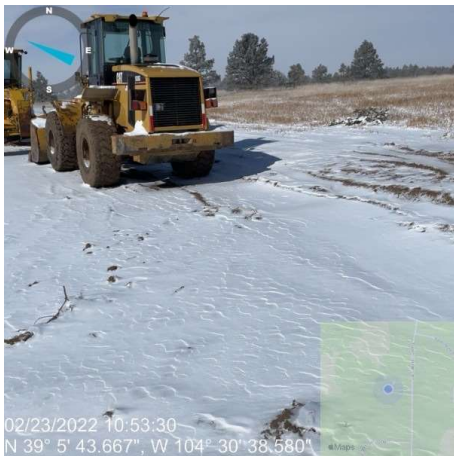
Construction equipment will be contained onsite for project.

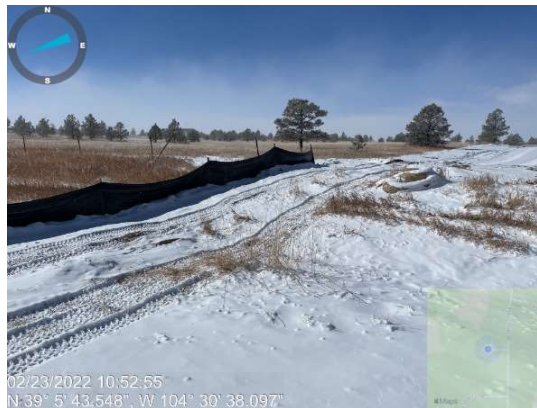
Silt fence control measure installed along site perimeter.

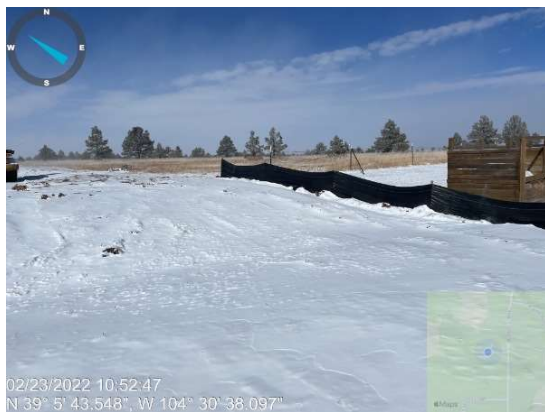
Silt fence control measure installed along site perimeter as per plans.
