Project Name:	Saddlehorn Ranch Filing 1
EDARP Filing Number(s):	ESQ2131
ESQCP Number:	SF1912
Attendees:	DPW SW: Natasha Grimaldo, Ben Jones, Christina Prete, and Mikayla Hartford DPW Development Services: N/A Developer: ROI Property, LLC
Date of Walk-Thru:	06/19/2023
Walk-Thru Number:	1 st

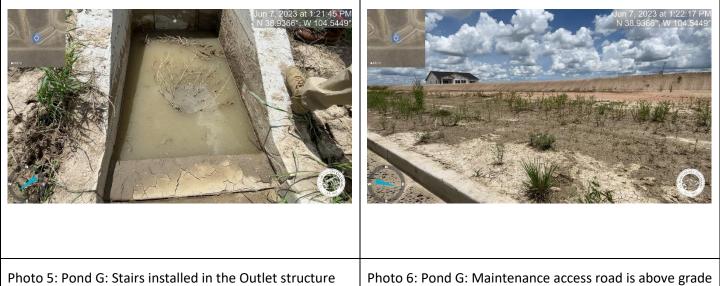
Photo 5: Pond G: Stairs installed in the Outlet structure for Pond G are not called for on the approved plans. Change structure to meet detail specs or show change on the as-builts. Reference Sheet 48 on the Construction Drawings. Photo 6: Pond G: Maintenance access road is above grade and holding water. Cut in road to be flush with the bottom of the pond per specification (12' wide with 8" of class 6). Reference Sheet 47 of the Construction Drawings.
