ENTECH
ENGINEERING, INC.

September 22, 2021

Re: Soil, Geology and Geologic Hazard Evaluation
Joyful View Subdivision
Joyful View & Peyton Highway
Schedule Nos. 33000-00-466 & 33000-00-467
El Paso County, Colorado

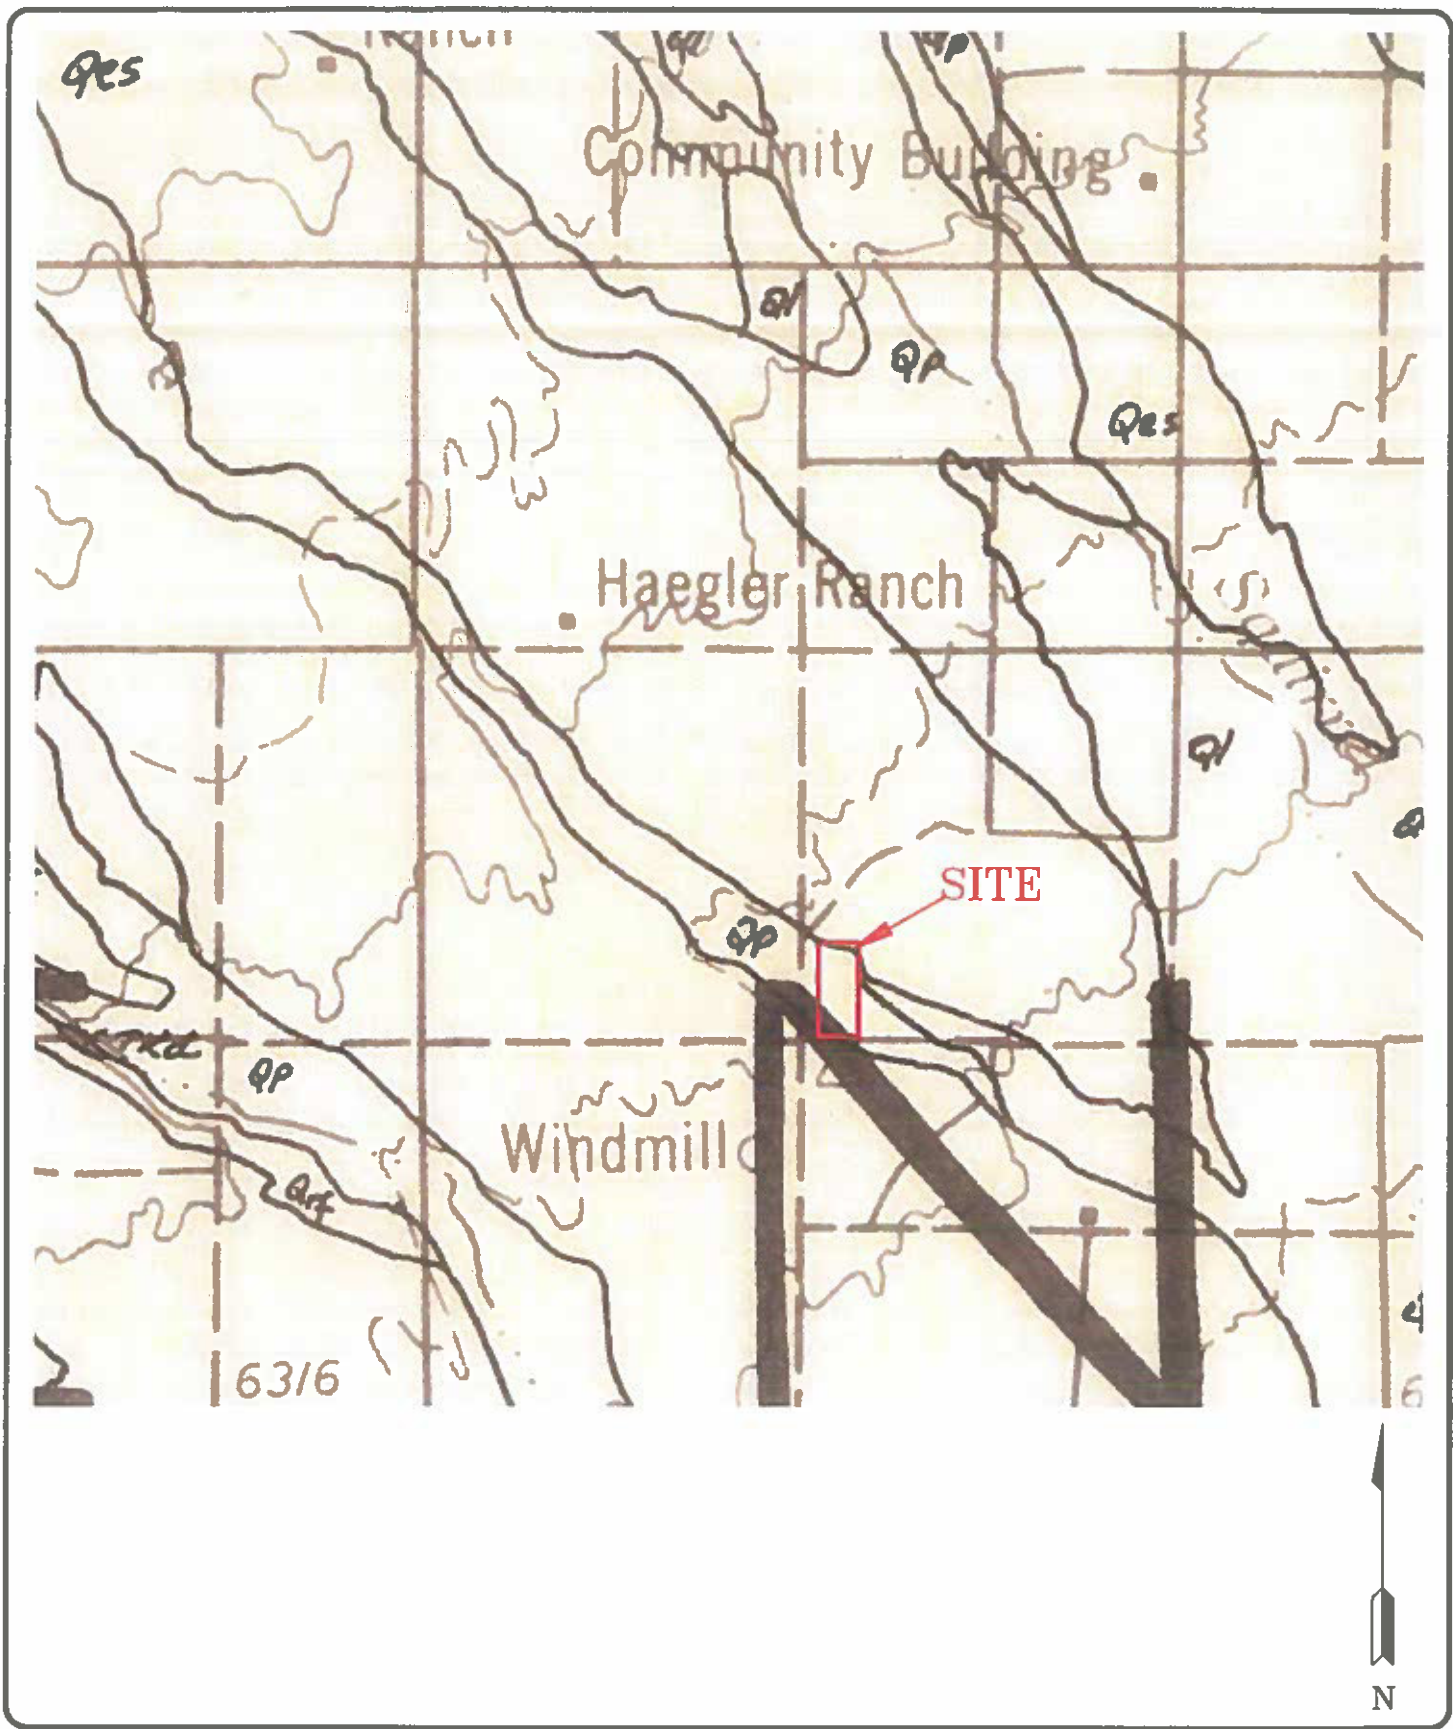
FIG NO.:
 5

Fill associated with an existing fill stockpile and erosion berms were observed in the southeast portion of the site (Figure 5).

Mitigation: The berm on site does not add to the geologic concerns of this site. Areas of fill other than those encountered may be encountered. The fill piles are considered uncontrolled. Any uncontrolled fill encountered beneath foundations should be removed and recompacted at a minimum of 95% of its maximum Modified Proctor Dry Density, ASTM D-1557.

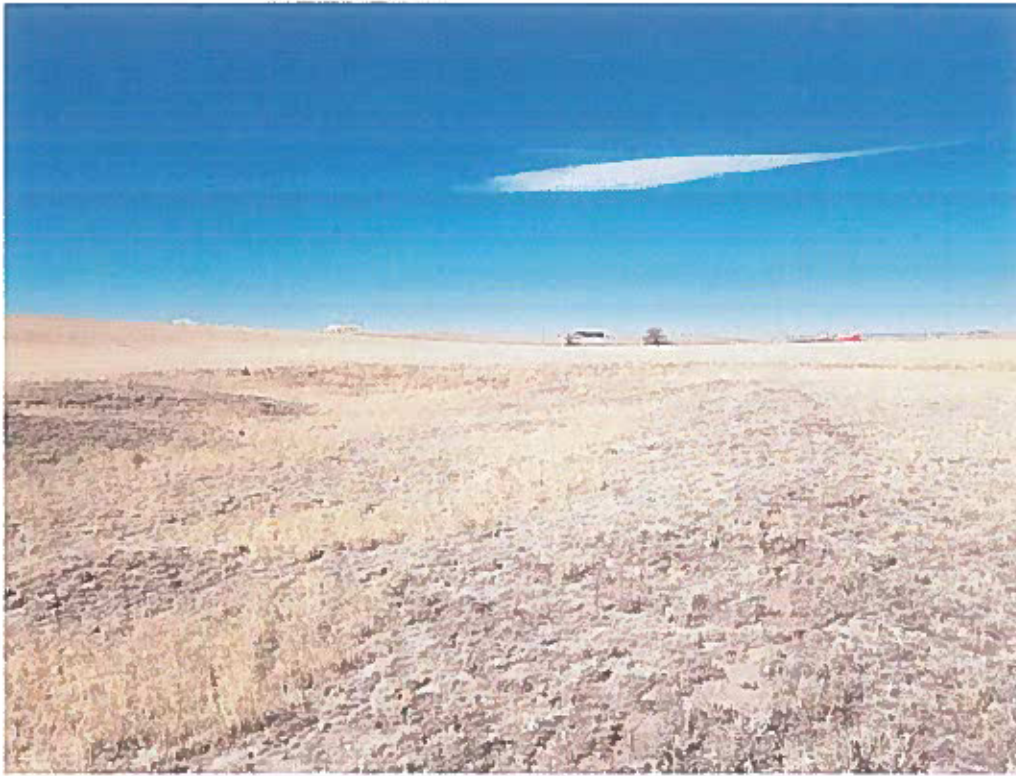
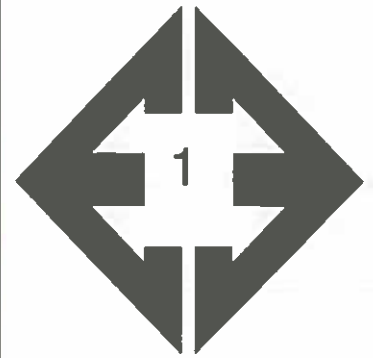
**Looking northwest
along drainage in the
southeastern portion
of the site.**

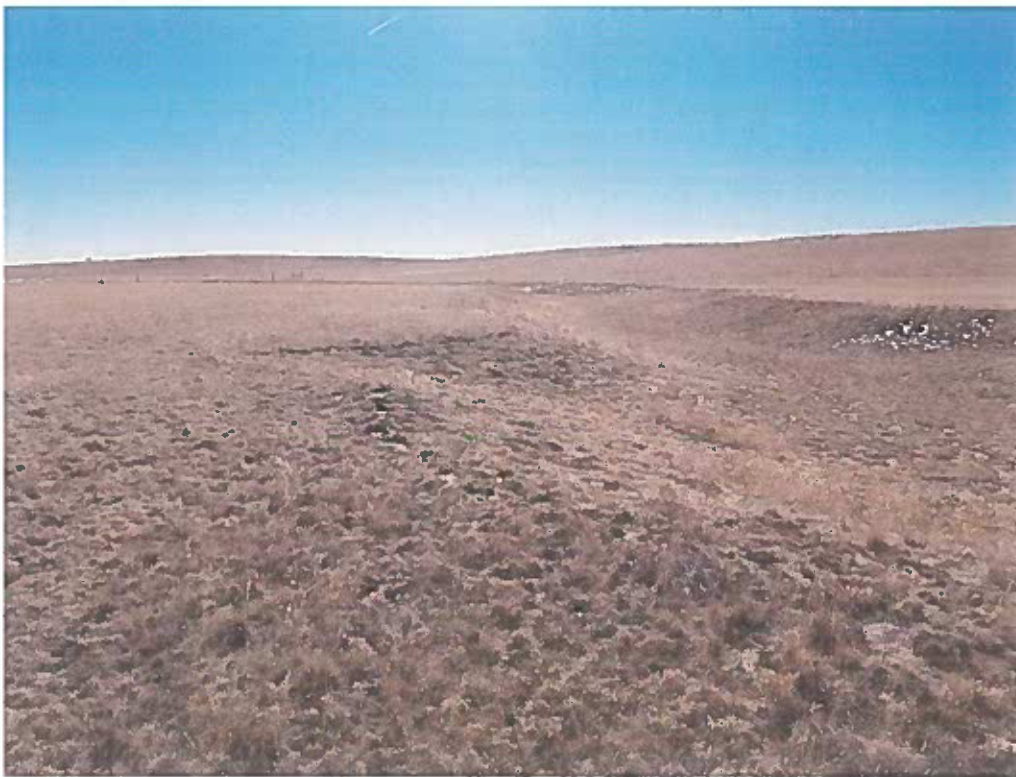
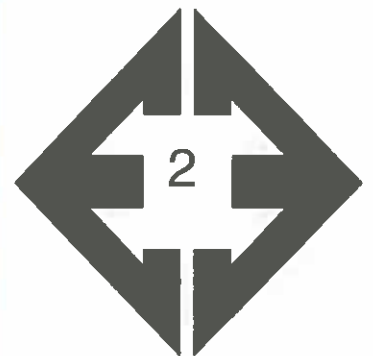
**Looking southeast
along drainage in the
southeastern portion
of the site.**

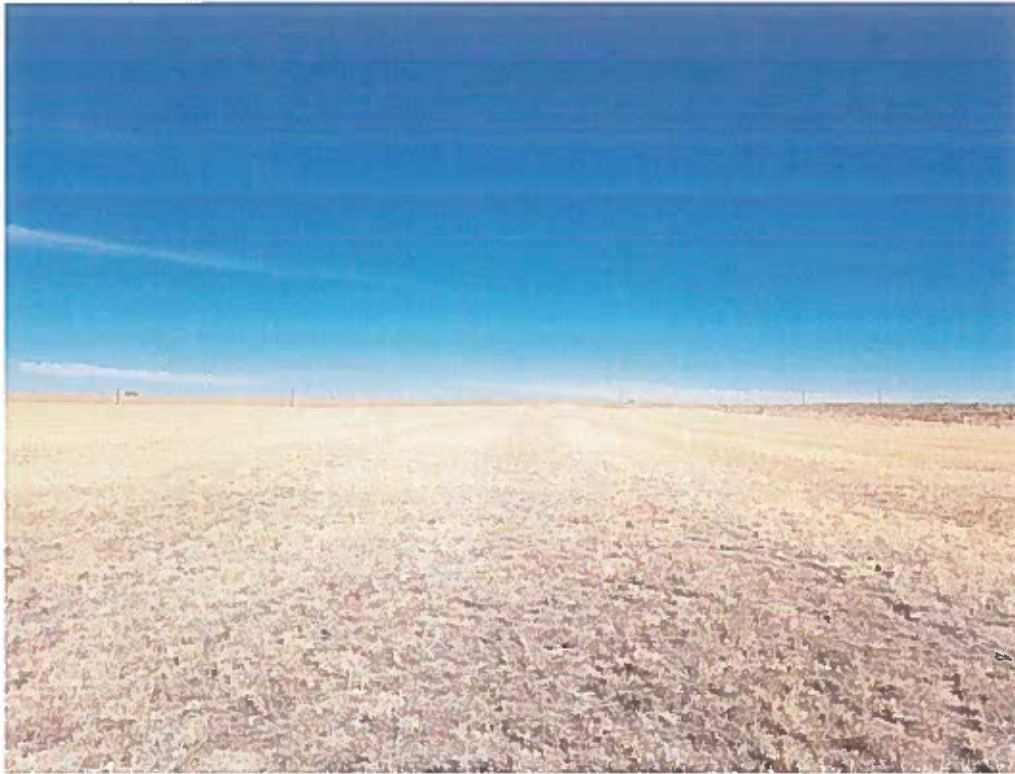
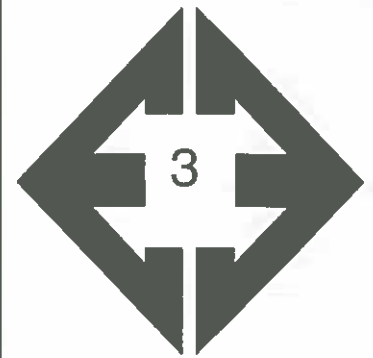
Looking north from the eastern side of the site.

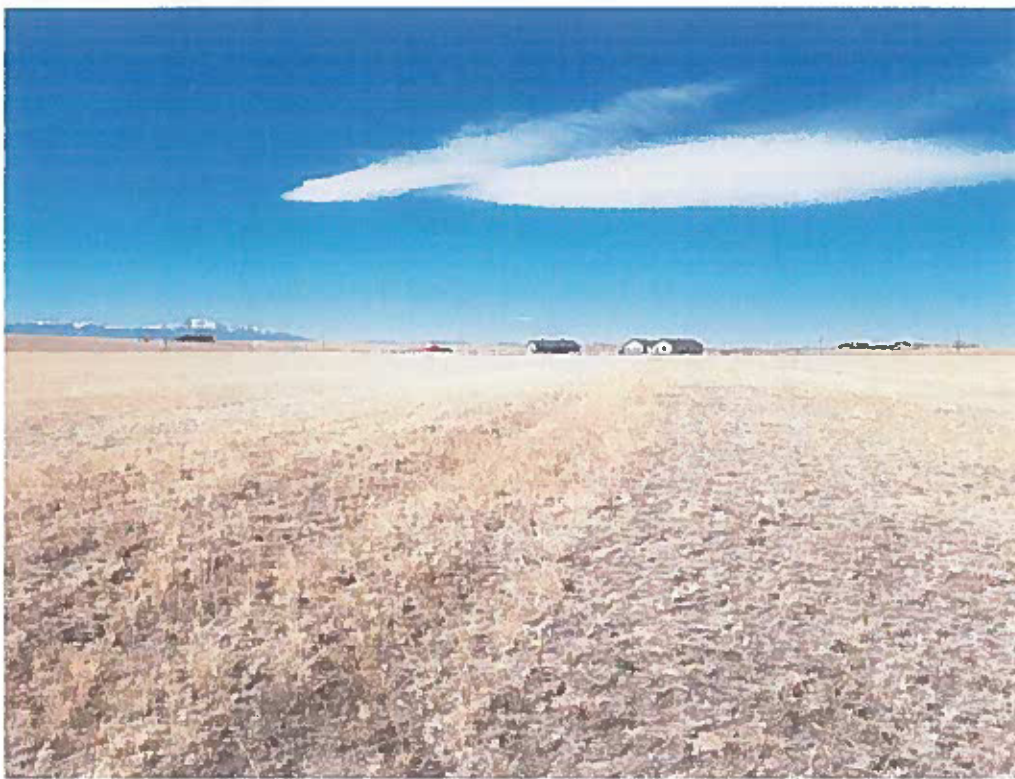
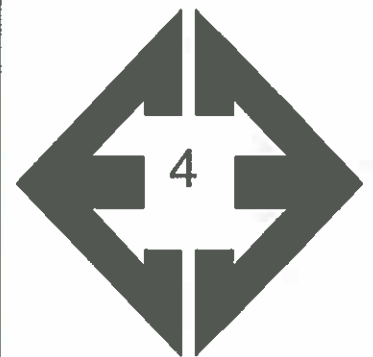
Looking west from the central portion of the site.
