Date: January 10, 2018
To: Jenna and Matthew Arvidson
2310 Wakonda Way
Monument, Colorado 80132
From: Logan L. Langford - Geologist *LLL*
Project: Entech Job # 171248
Soil, Geology, Geologic Hazard, and Wastewater Study
2310 Wakonda Way
Monument, Colorado
Re: EPC Report Redlines

**SOIL, GEOLOGY, GEOLOGIC HAZARD,
AND WASTEWATER STUDY
ARVIDSON SUBDIVISION
2310 WAKONDA WAY
MONUMENT, COLORADO**

Entech Job No. 171248

Project No.
MS-17-006

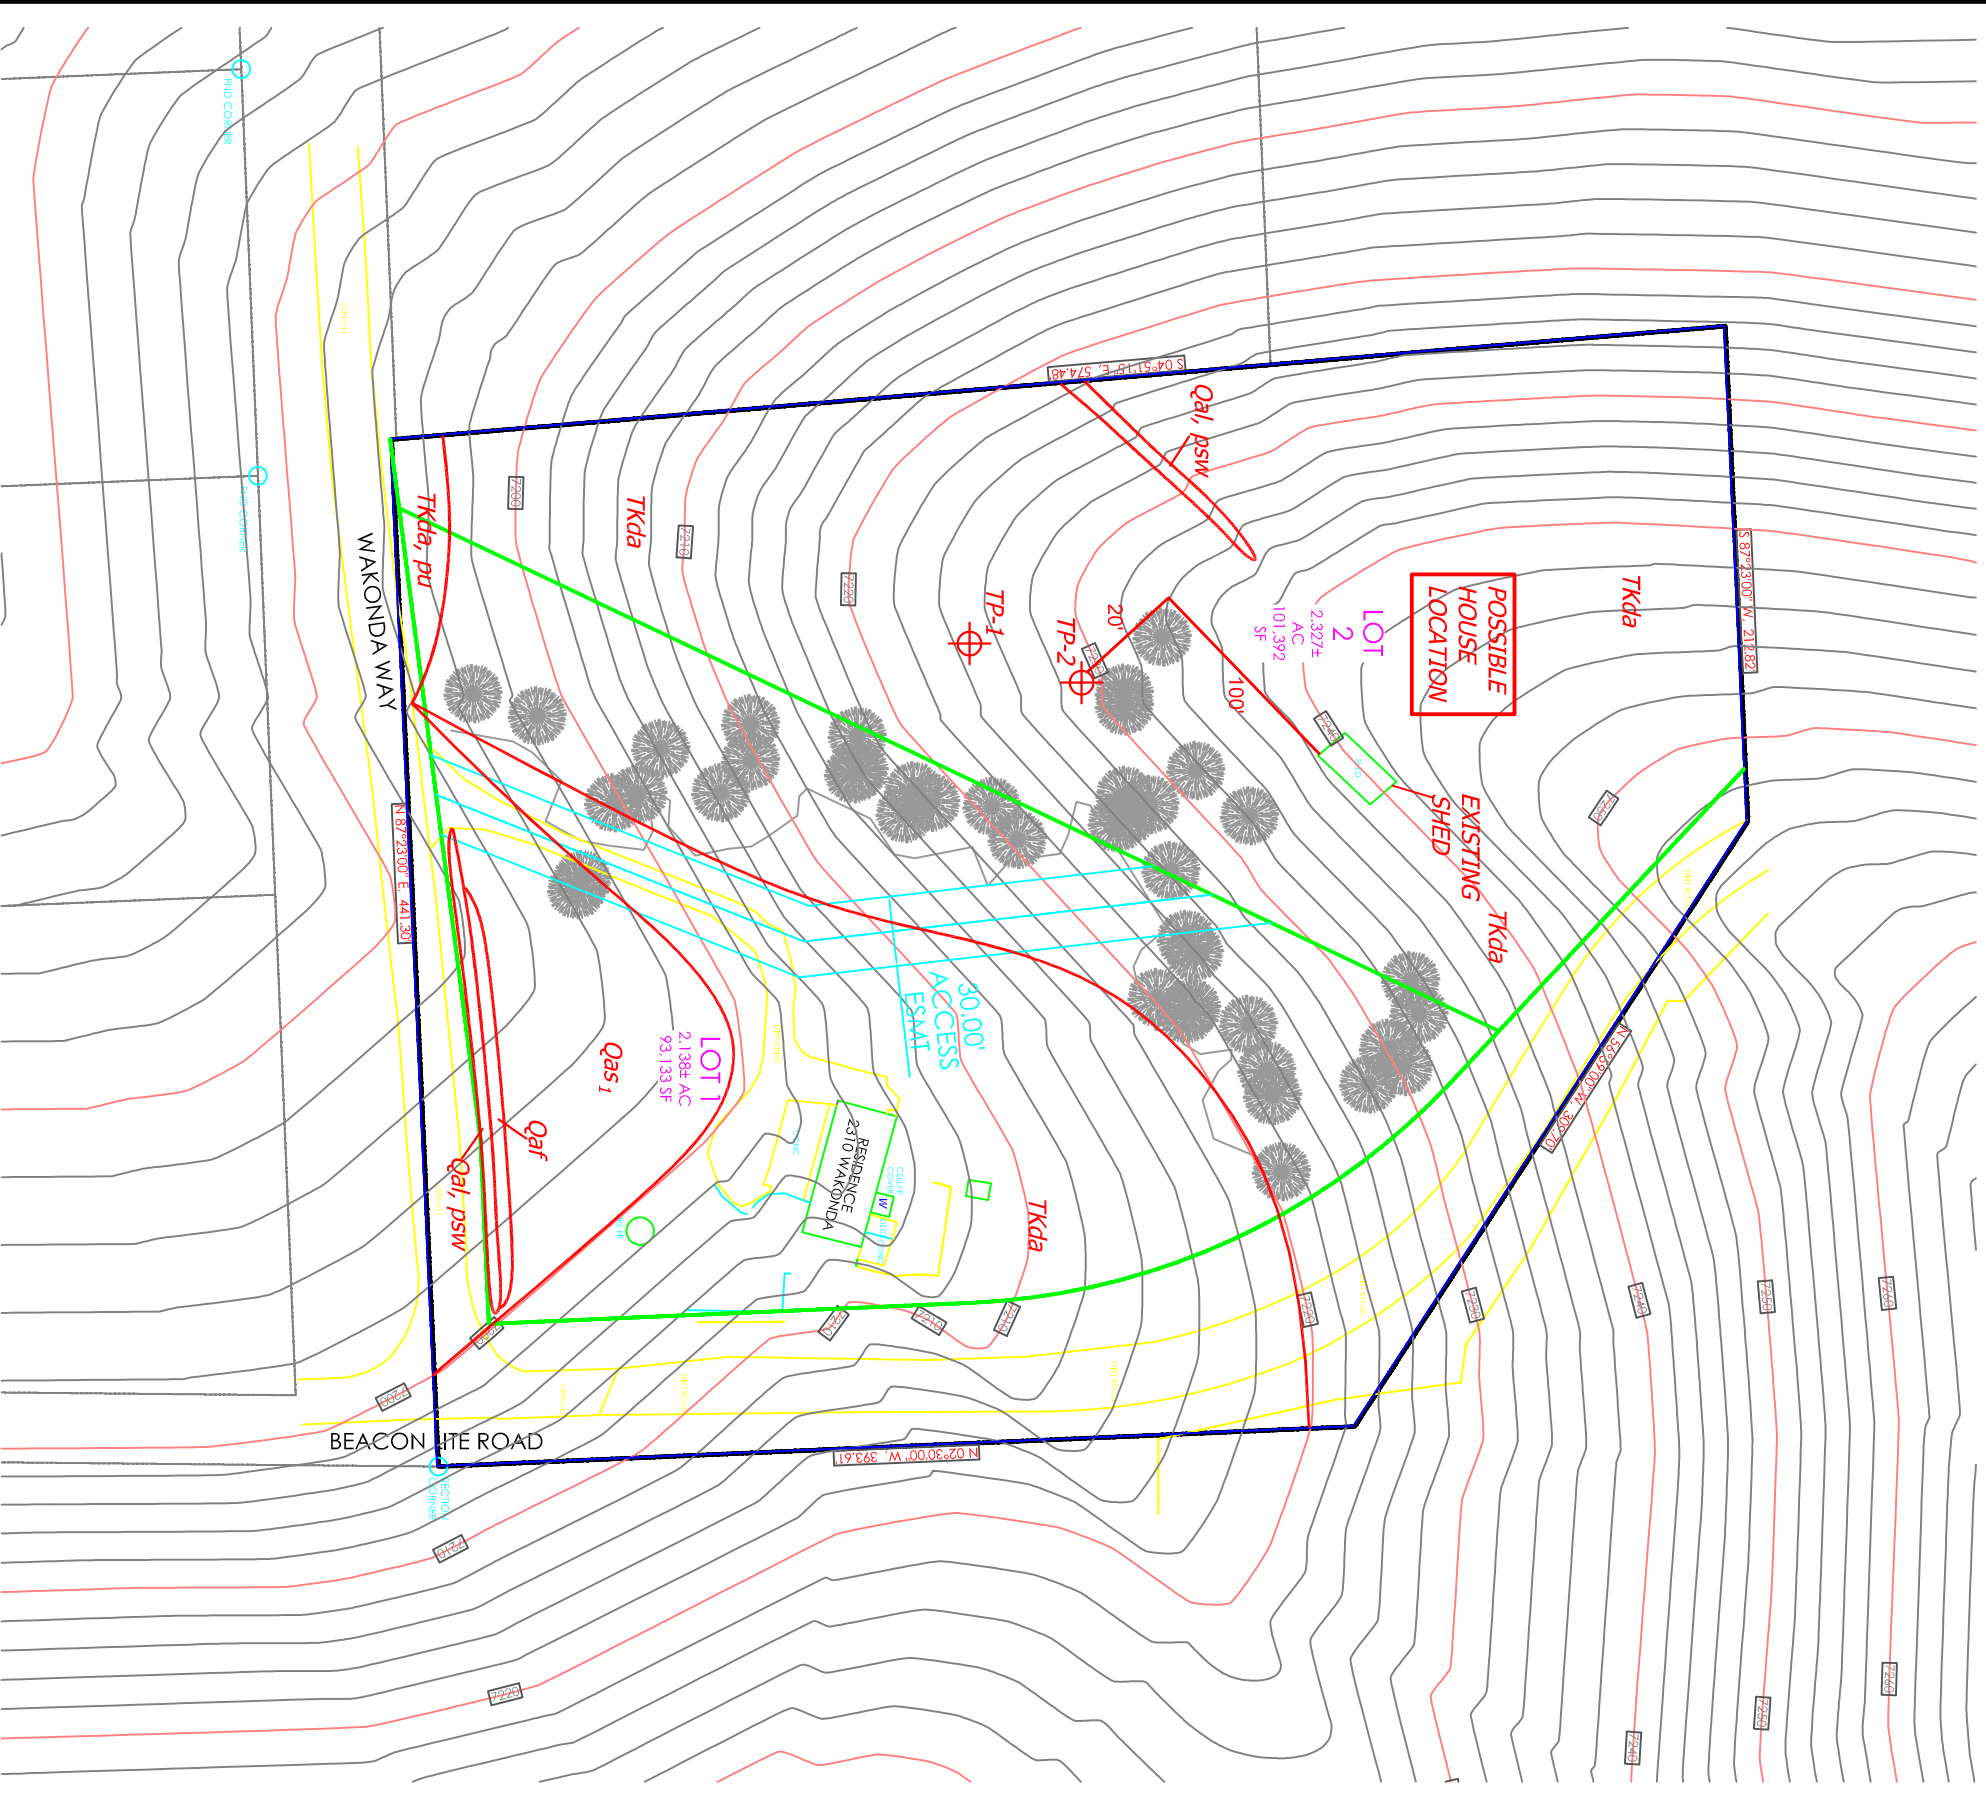
As mentioned previously, detailed mapping has been performed on this site to produce an Geology/Engineering Geology Map (Figure 6). This map shows the location of various geologic conditions of which the developers should be cognizant during the planning, design and construction stages of the project. These hazards and the recommended mitigation techniques are as follows:

The slopes identified with this hazard exist along the road cut on the north side of Wakonda Way in the southern portion of the site, and are indicated on Figure 6. These slopes are stable in their present condition; however, considerable care must be exercised in these areas not to create a condition which would tend to activate instability.

Areas of potentially seasonal shallow groundwater were encountered on site. These areas exist along a drainage swale located on the western side of Lot 2 and in the southeast side of Lot 1 along Wakonda Way. Water was not observed in the drainages on-site. Due to the size of the lots and the proposed development, these areas can be avoided by construction. Structures should not block drainages. Leach fields should not be located in these areas due to the potential for periodic high groundwater conditions.

Mitigation: Foundations must have a minimum 30-inch depth for frost protection. In areas where high subsurface moisture conditions are anticipated periodically, subsurface perimeter drains are recommended to help prevent the intrusion of water into areas below grade. Typical drain details are presented in Figure 8. Any grading in these areas should be done to direct surface flow around construction to avoid areas of ponded water. All organic material would be completely removed prior to any fill placement. Specific drainage studies are beyond the scope of this report.

Mitigation: These slopes lie along the southern property boundary, therefore, building from this project is not proposed on these slopes. The best mitigation for potentially unstable slopes is avoidance. The potential house location on Lot 2 is a sufficient distance away that potentially unstable slopes should not affect the proposed development.

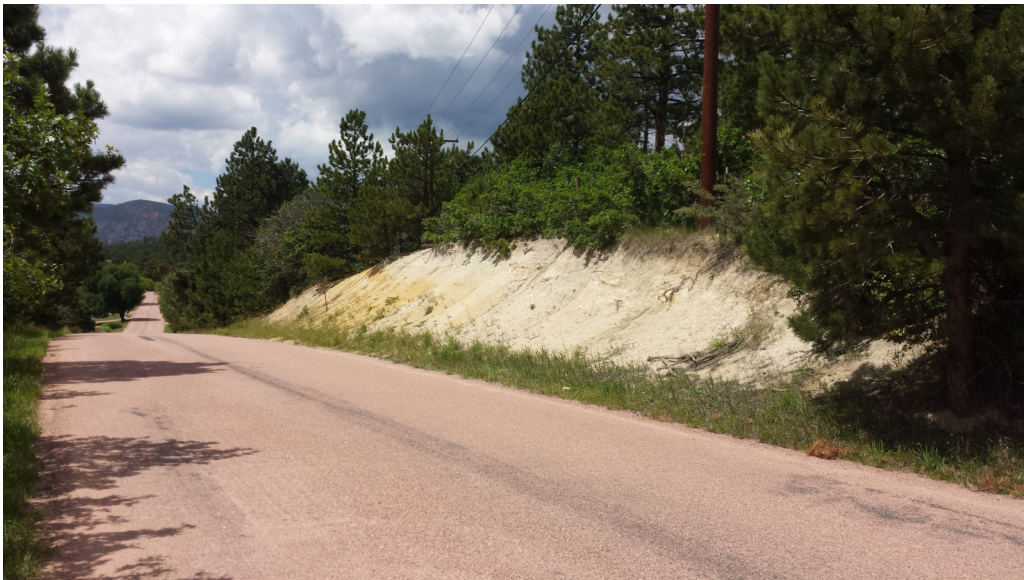
**Looking northwest at
road cut along
Wakonda Way.**
