**GEOLOGIC HAZARD STUDY
AND PRELIMINARY
SUBSURFACE SOIL INVESTIGATION
THE RANCH
EL PASO COUNTY, COLORADO**

PRI IV, LLC
6385 Corporate Drive, Suite 200
Colorado Springs, Colorado 80919

July 12, 2018

Entech Job No. 180549
AAPProjects/2018/180549ghs-pssi

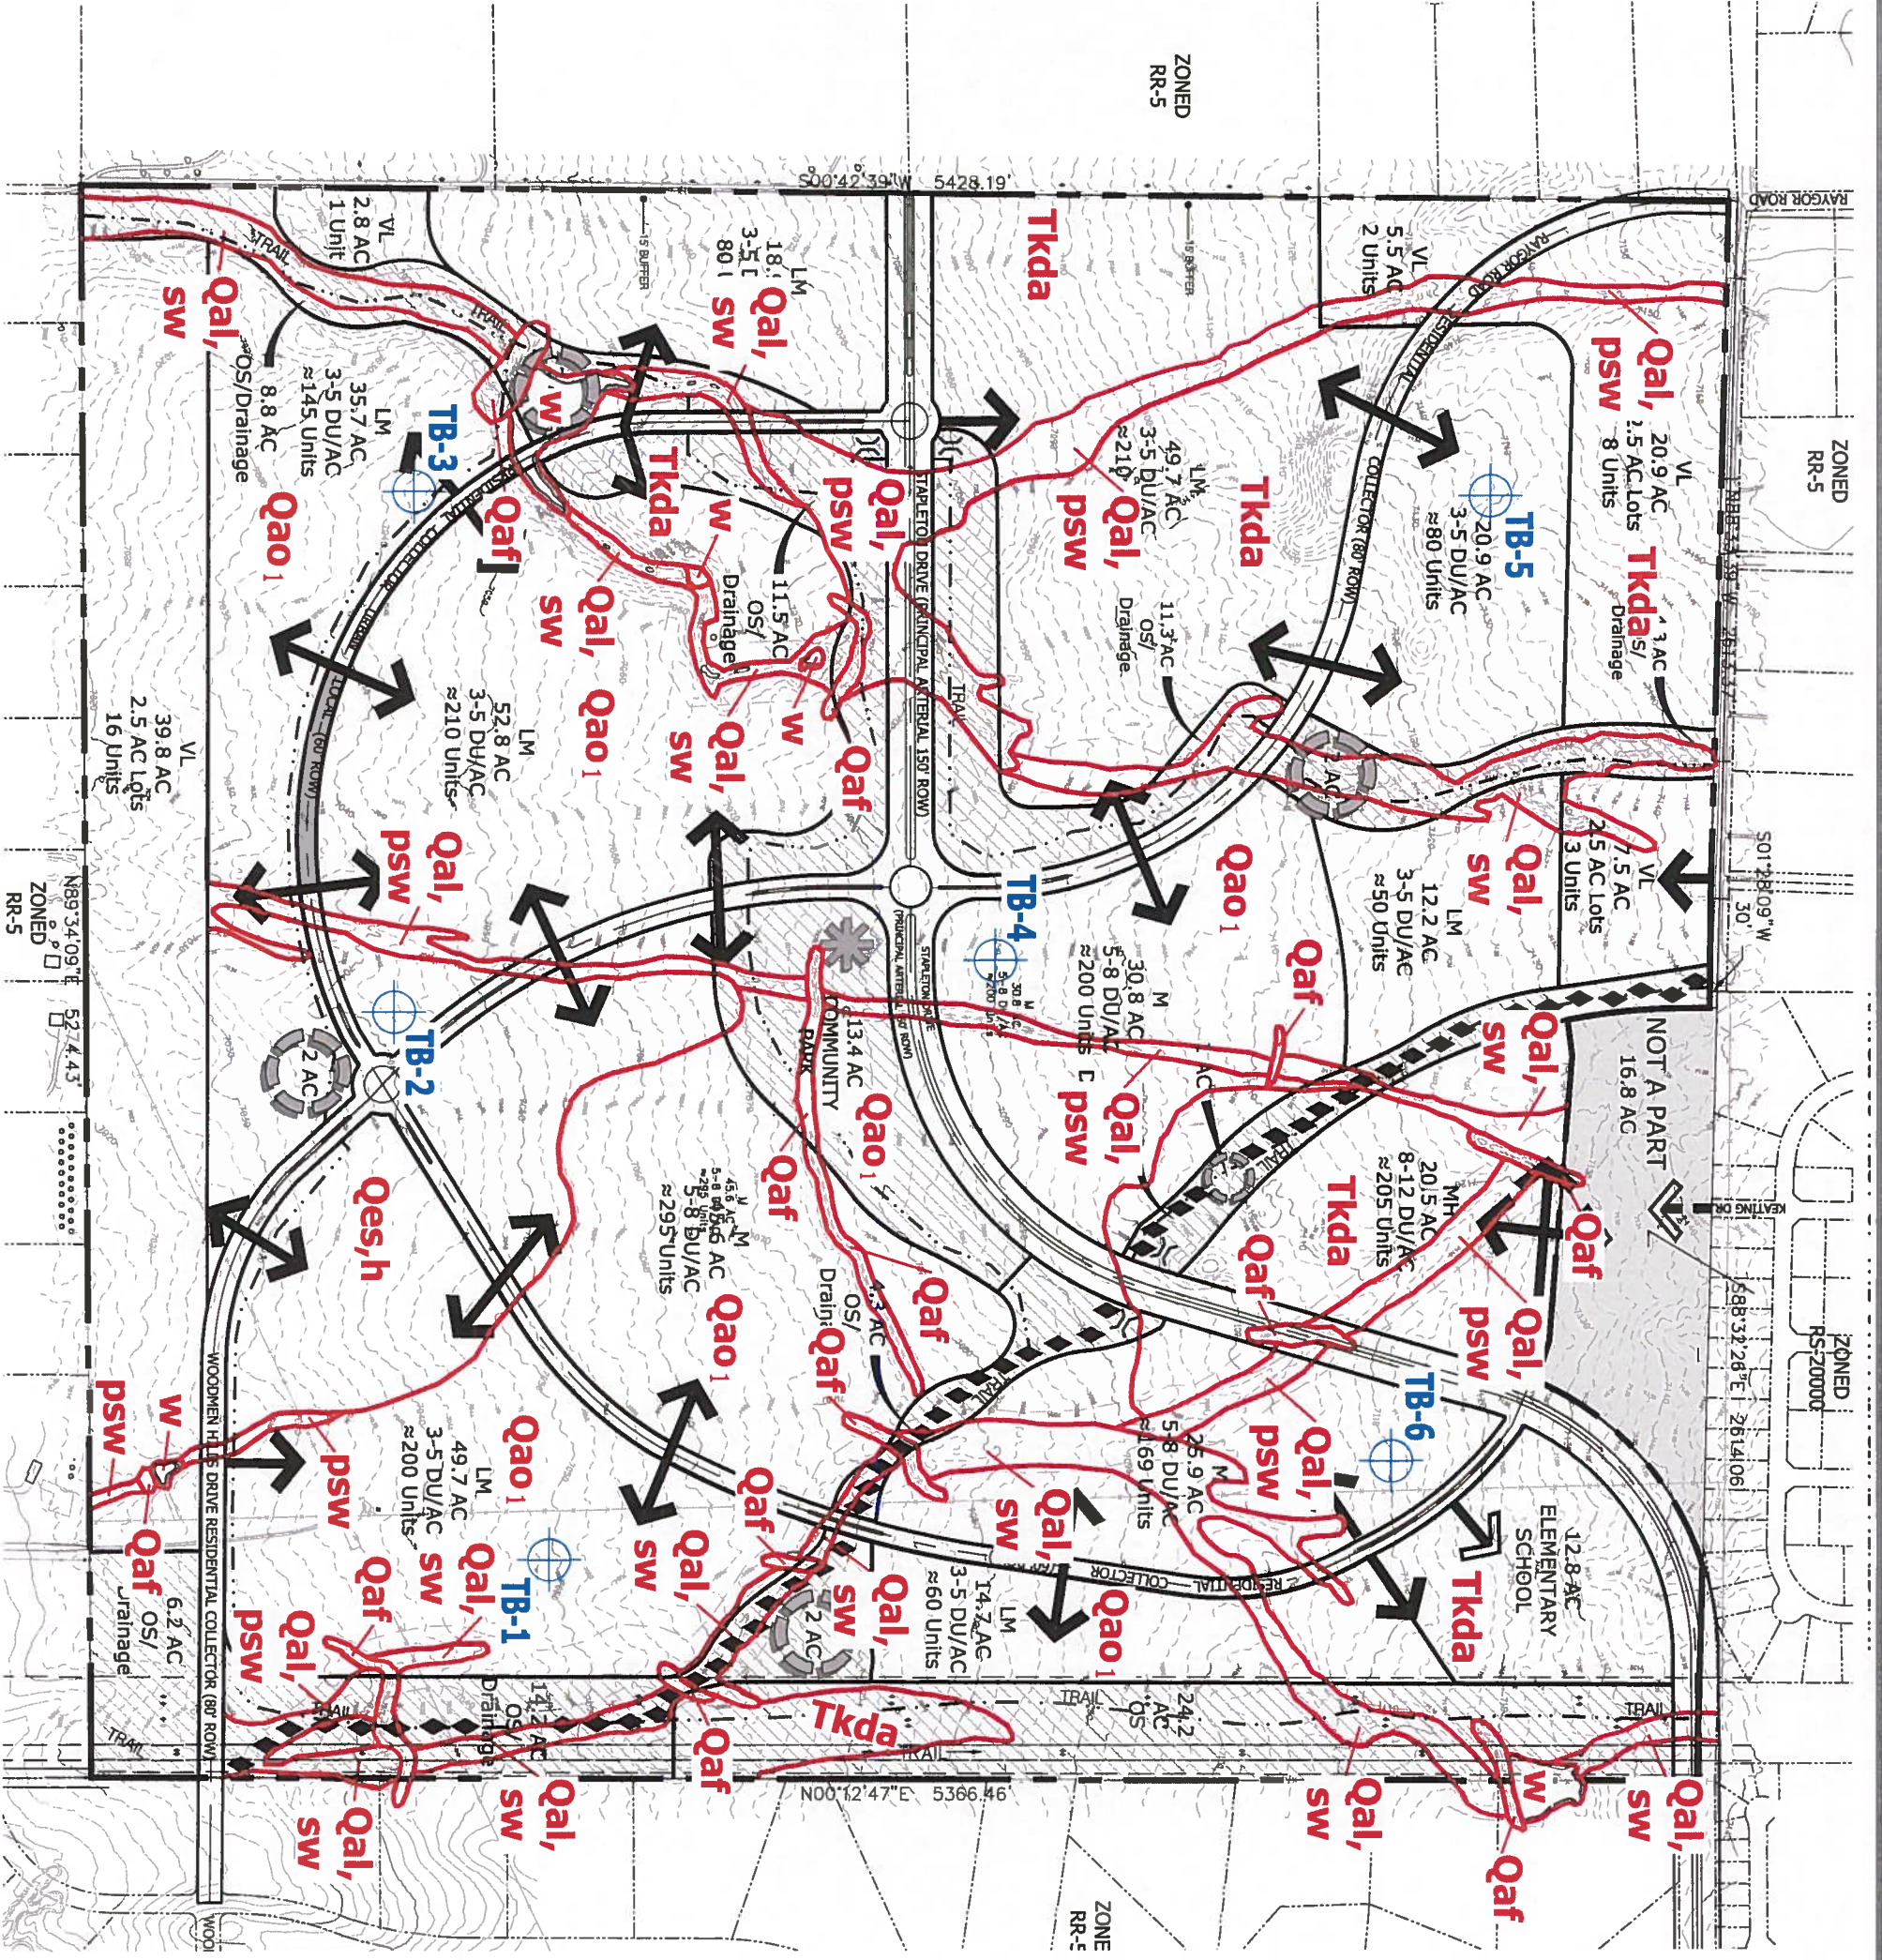
As mentioned previously, detailed mapping has been performed on this site to produce an Engineering Geology Map (Figure 6). This map shows the location of various geologic conditions of which the developers and planners should be cognizant during the planning, design and construction stages of the project. The hazards identified on this site include hydrocompaction, loose soils, artificial fill, potentially expansive soils, seasonal and potentially seasonal shallow groundwater areas and areas of ponded water. The following hazards have been addressed as a part of this investigation:

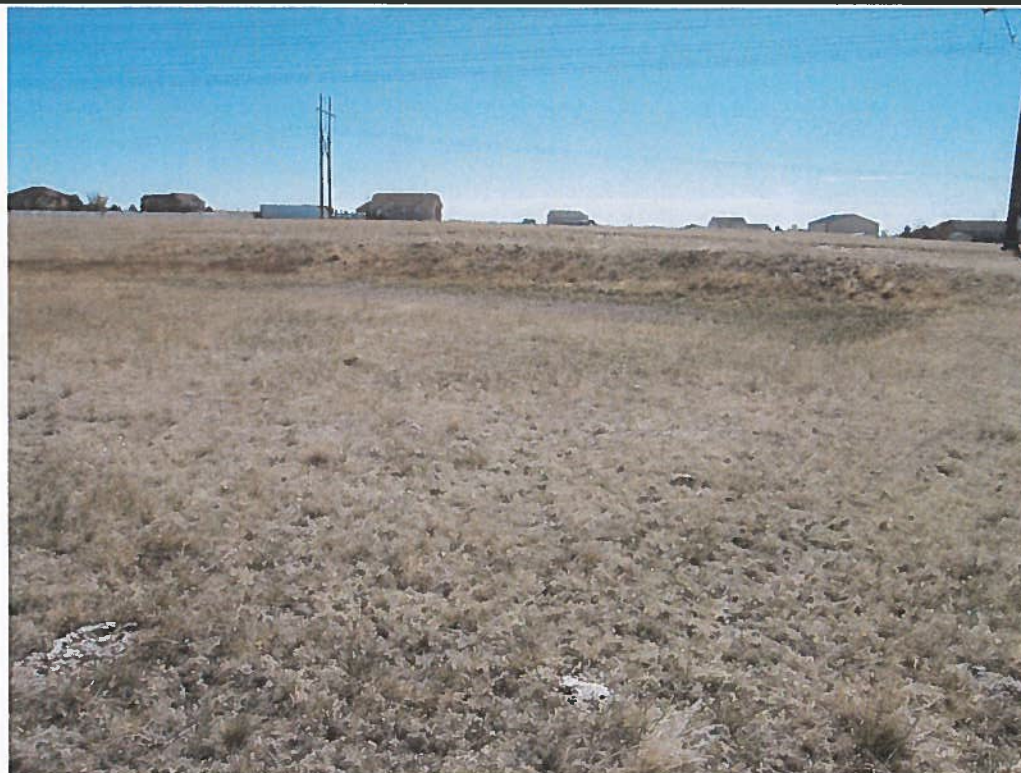
**Looking southeast at
dam in east-central
portion of the site.**

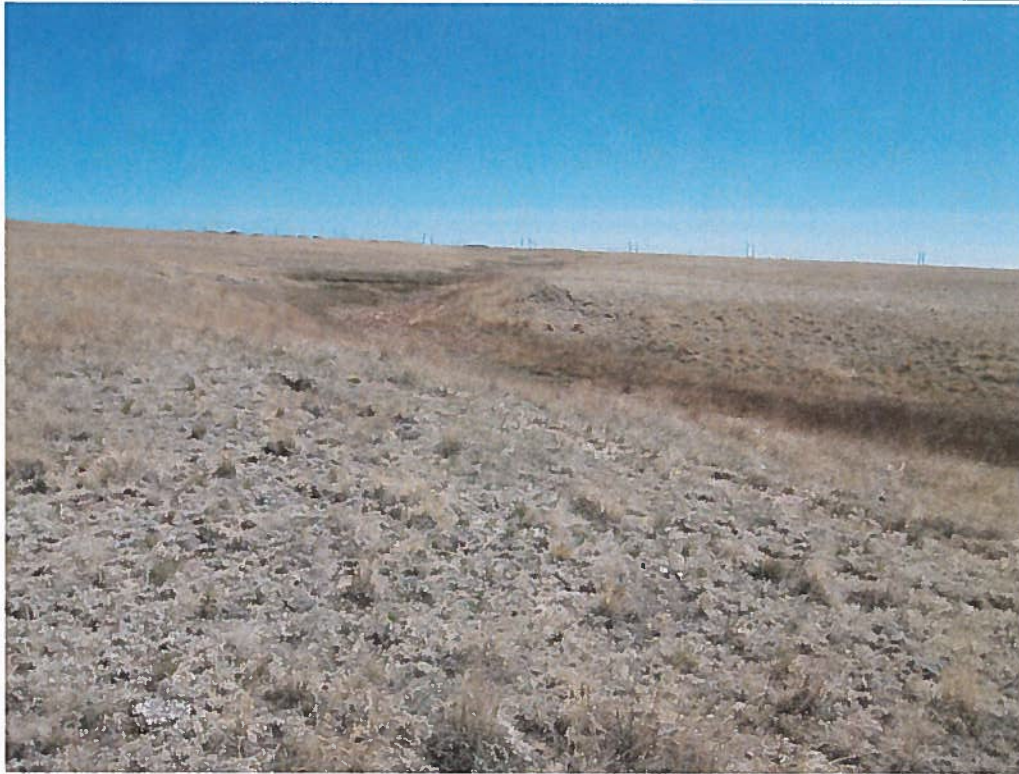
**Looking northeast at
drainage in the
southwest portion of
the site.**

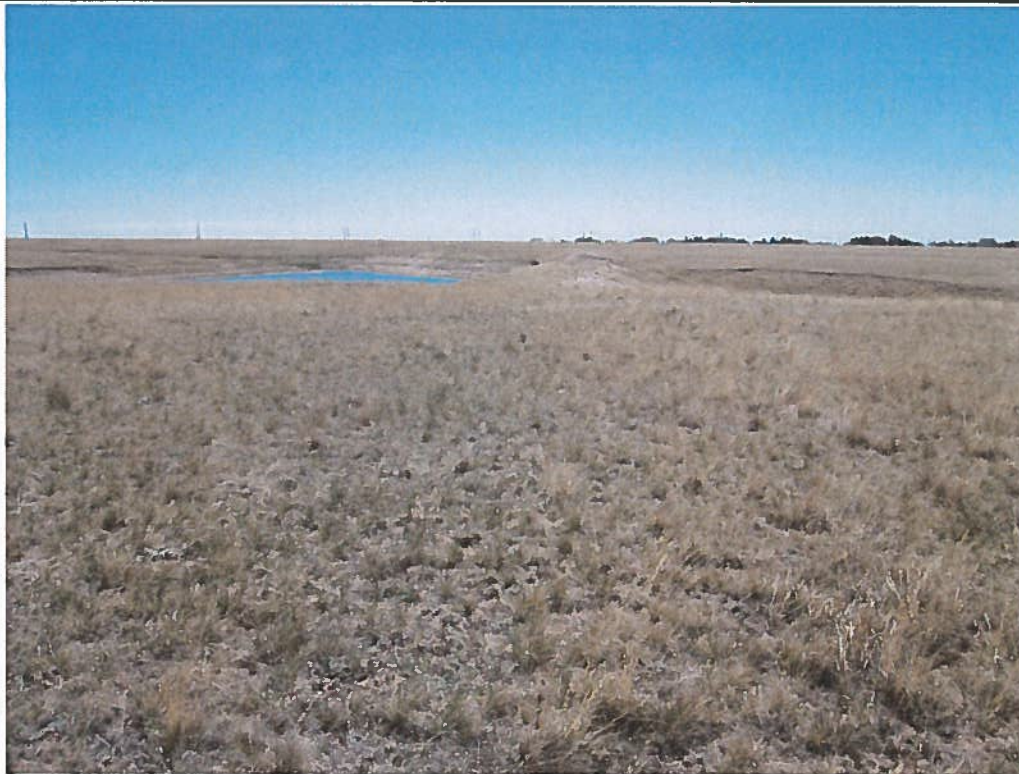
**Looking east towards
pond in the southwest
portion of the site.**

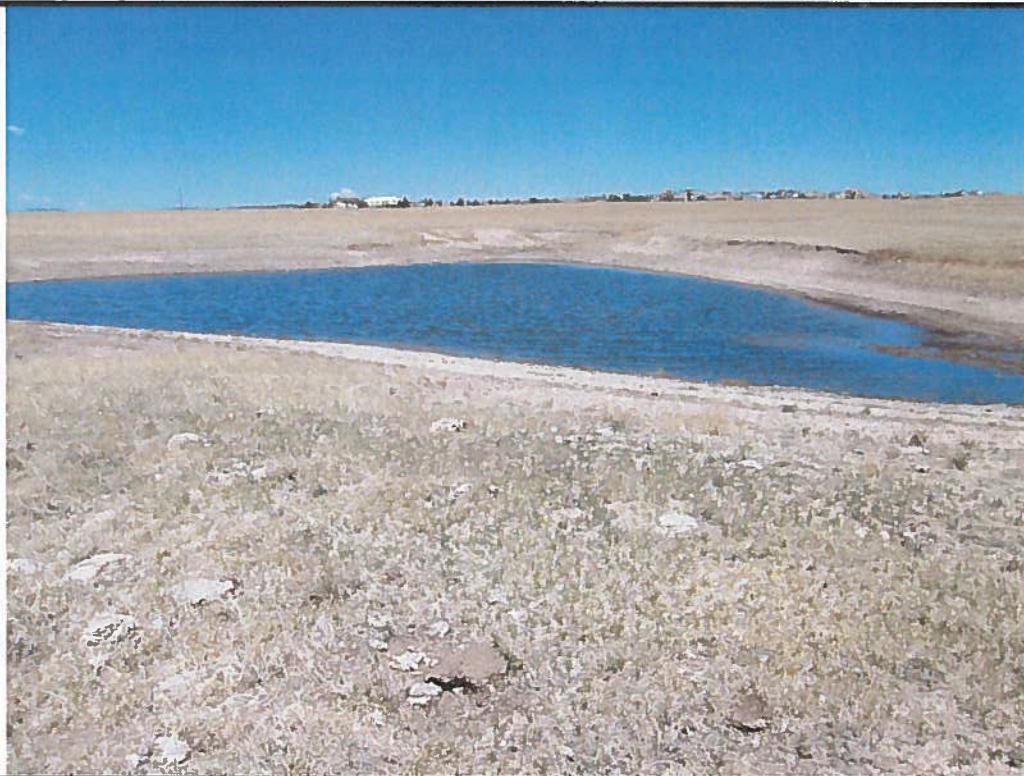
**Looking northwest at
pond in the southwest
portion of the site.**

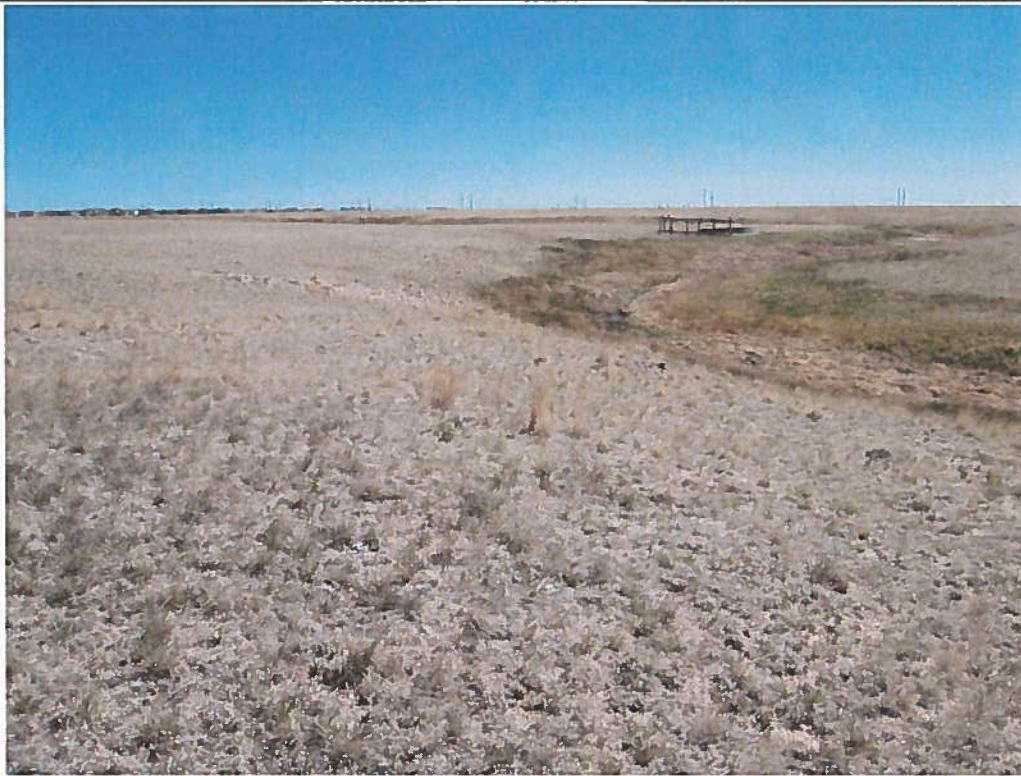
**Looking east at
drainage in the
southwest portion of
the site.**

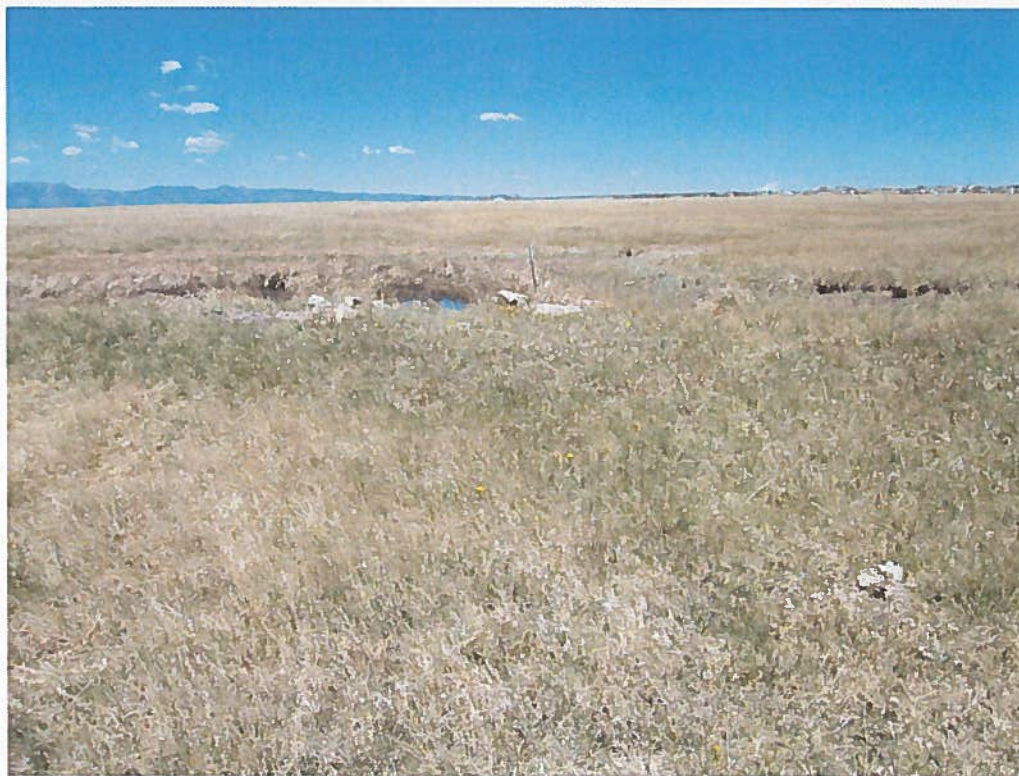
**Looking north at
ponded water in the
southeast portion of
the site.**

Mitigation: The larger of the ponds lie behind earthen dams: one in the southwestern portion of the site within an area designated as open space and another immediately northeast of the site in a dedicated easement. Other areas where ponded water were observed are minor and can be regraded. All soft and organic soils should be removed prior to fill placement. Any drainage into these areas should be rerouted in a non-erosive manner where it does not create areas of ponded water around proposed structures. The same mitigation techniques for the seasonal shallow groundwater areas are recommended for these areas as well.
