ENTECH
ENGINEERING, INC.

**GEOLOGIC HAZARD STUDY
AND PRELIMINARY
SUBSURFACE SOIL INVESTIGATION
THE RANCH
EL PASO COUNTY, COLORADO**

July 12, 2018
Revised May 8, 2019

Entech Job No. 180549
AAPProjects/2018/180549ghs-psi

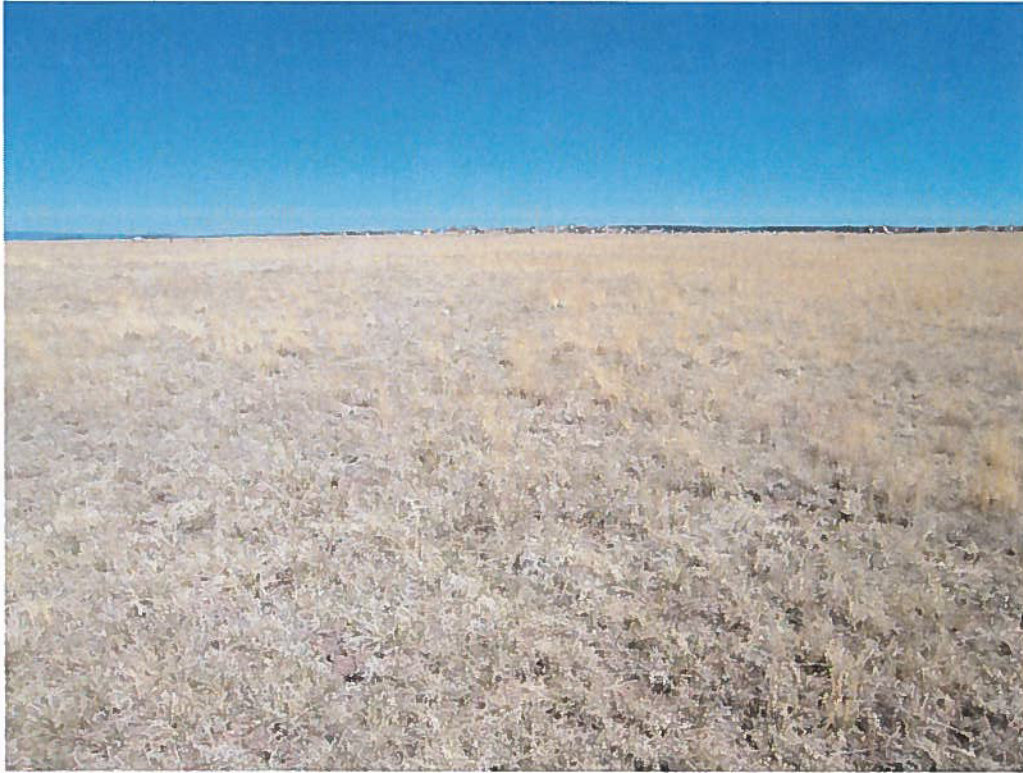
**Looking northwest
from southeast portion
of the site.**

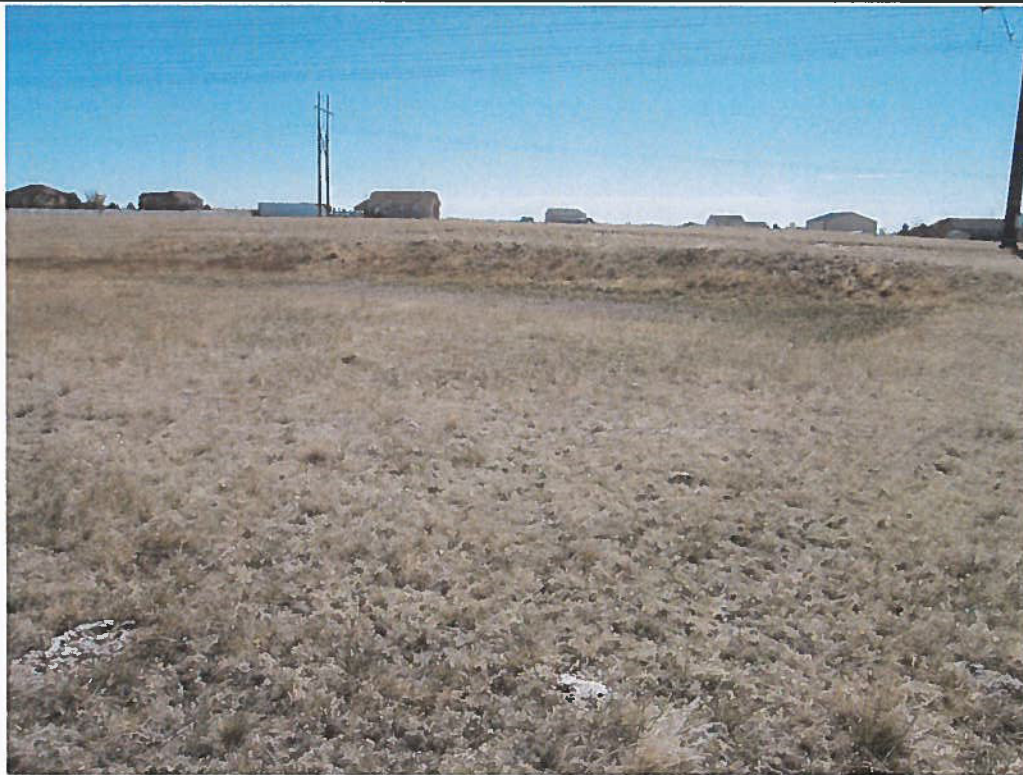
**Looking southeast at
dam in east-central
portion of the site.**

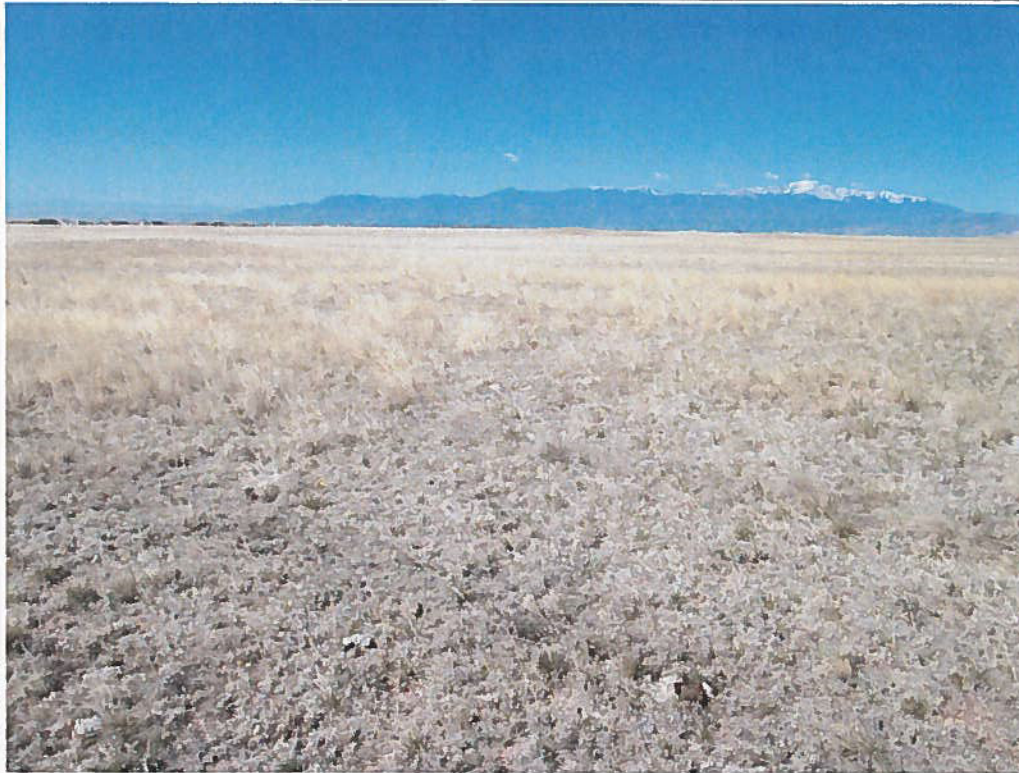
**Looking southwest
from northeast portion
of the site.**

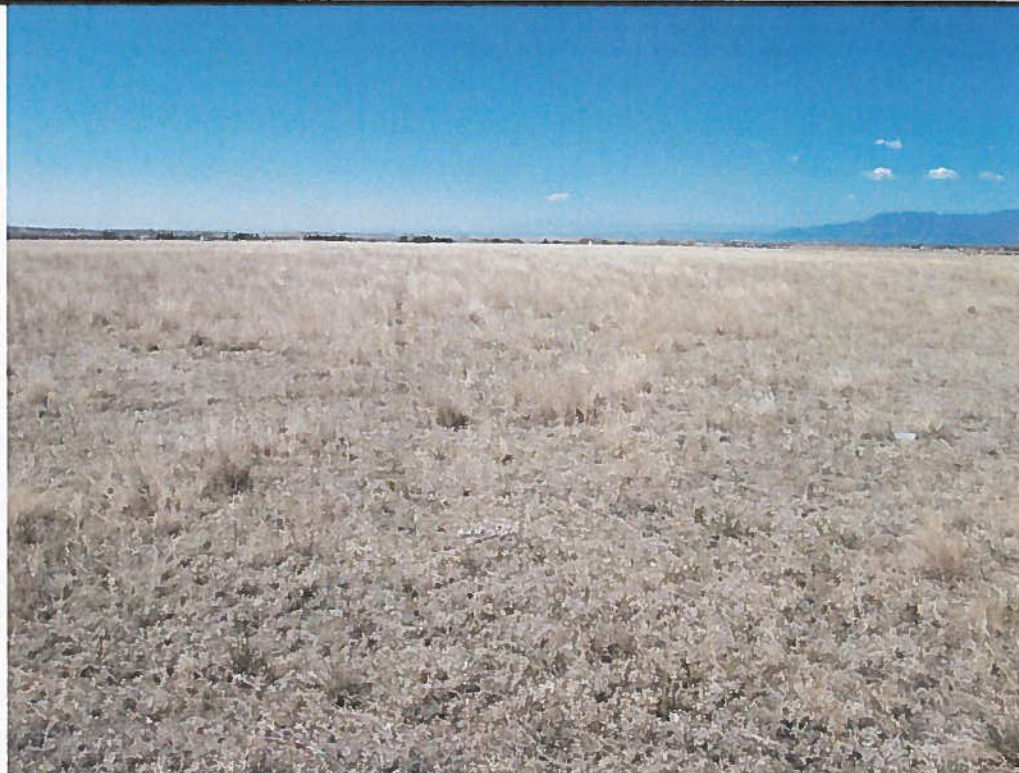
**Looking south from
the north-central
portion of the site.**

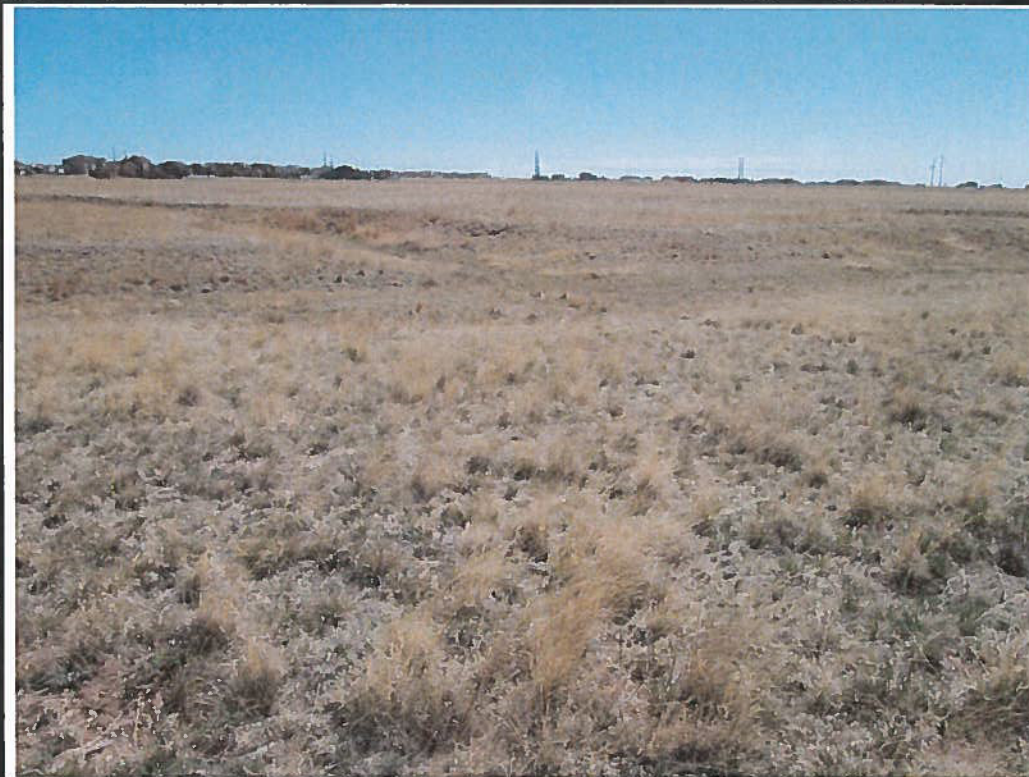
Looking east from the northwest portion of the site.

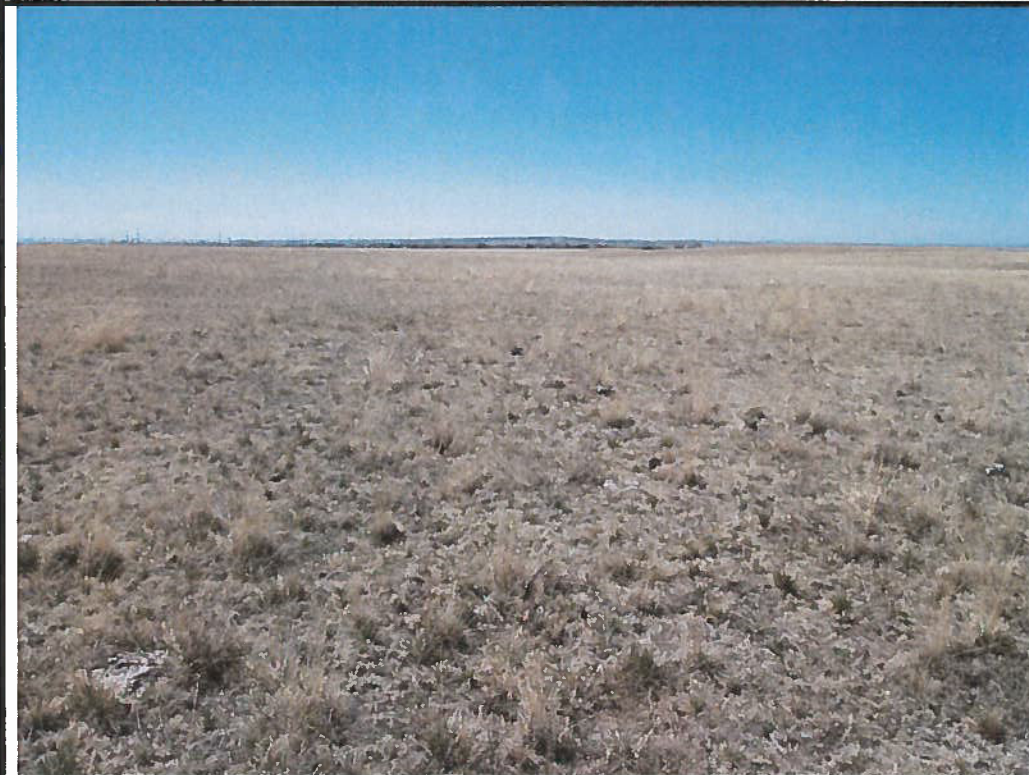
Looking southeast from the northwest portion of the site.

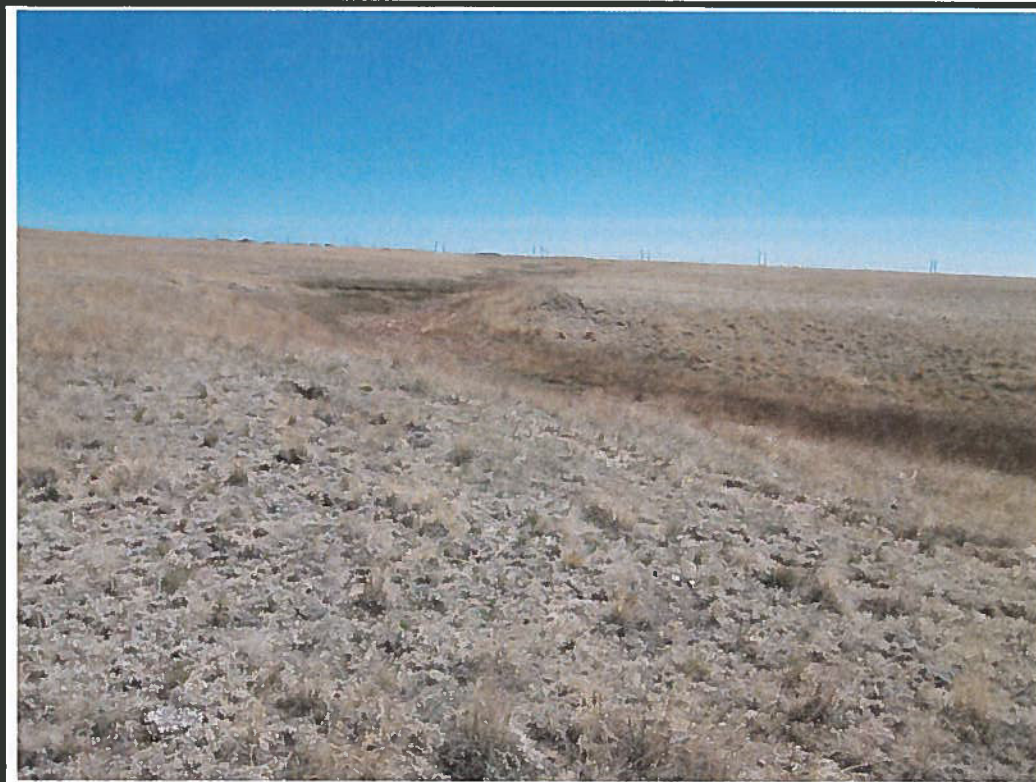
**Looking northeast at
drainage in the
southwest portion of
the site.**

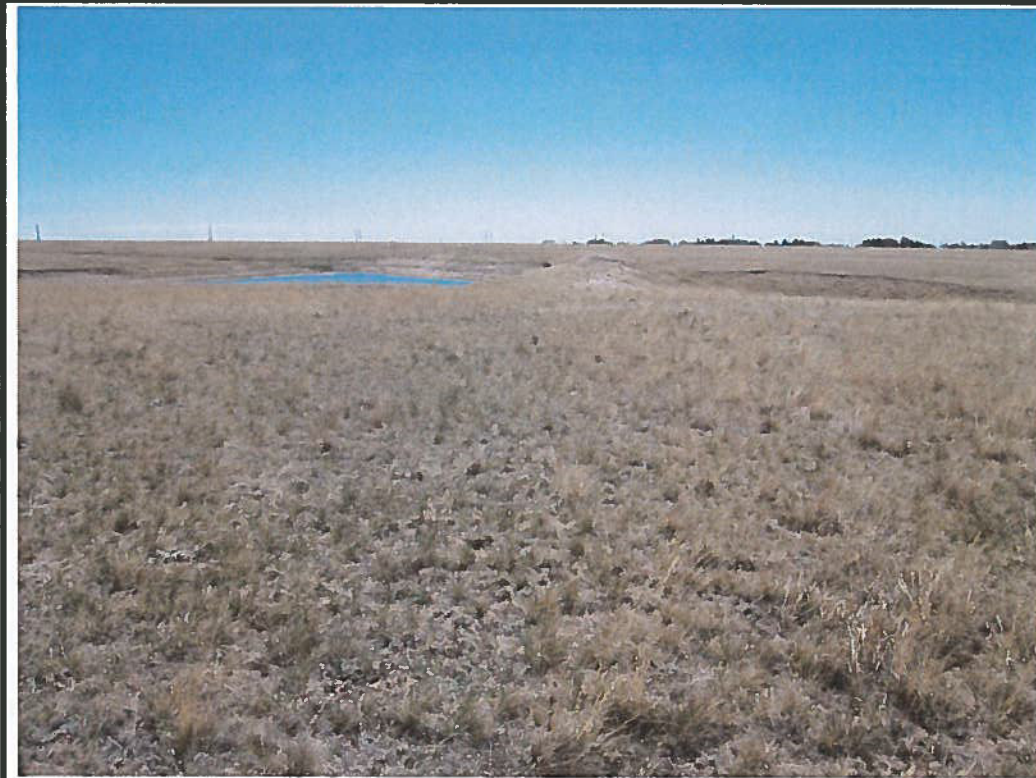
**Looking east towards
pond in the southwest
portion of the site.**

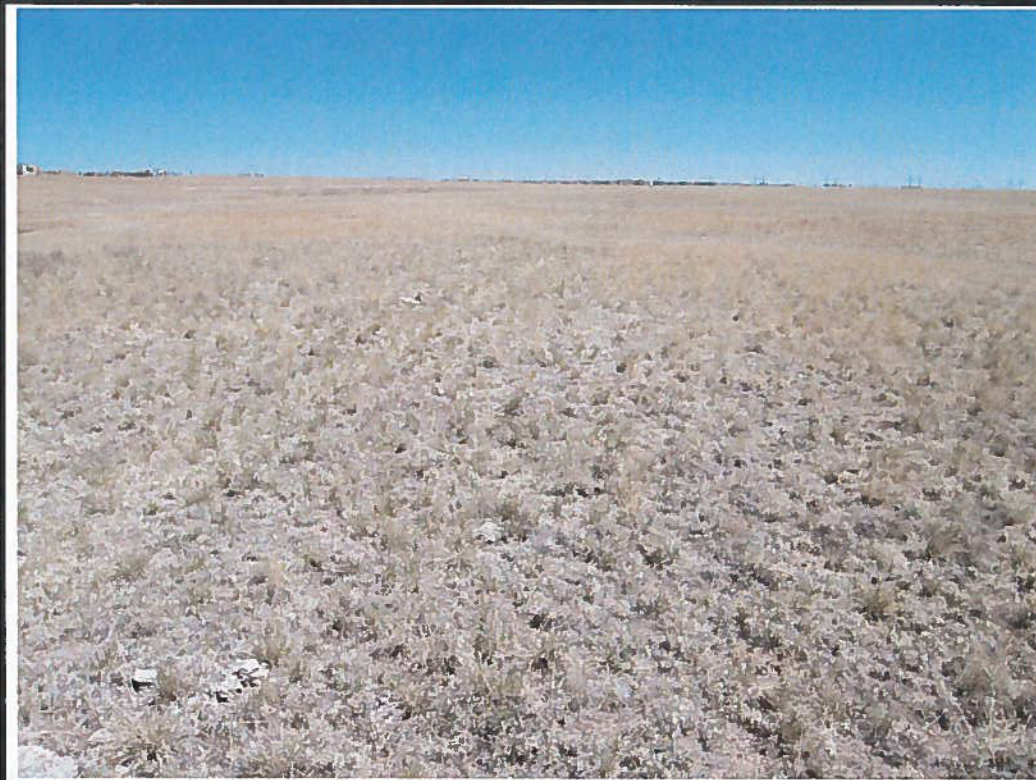
**Looking northeast
from the southwest
portion of the site.**

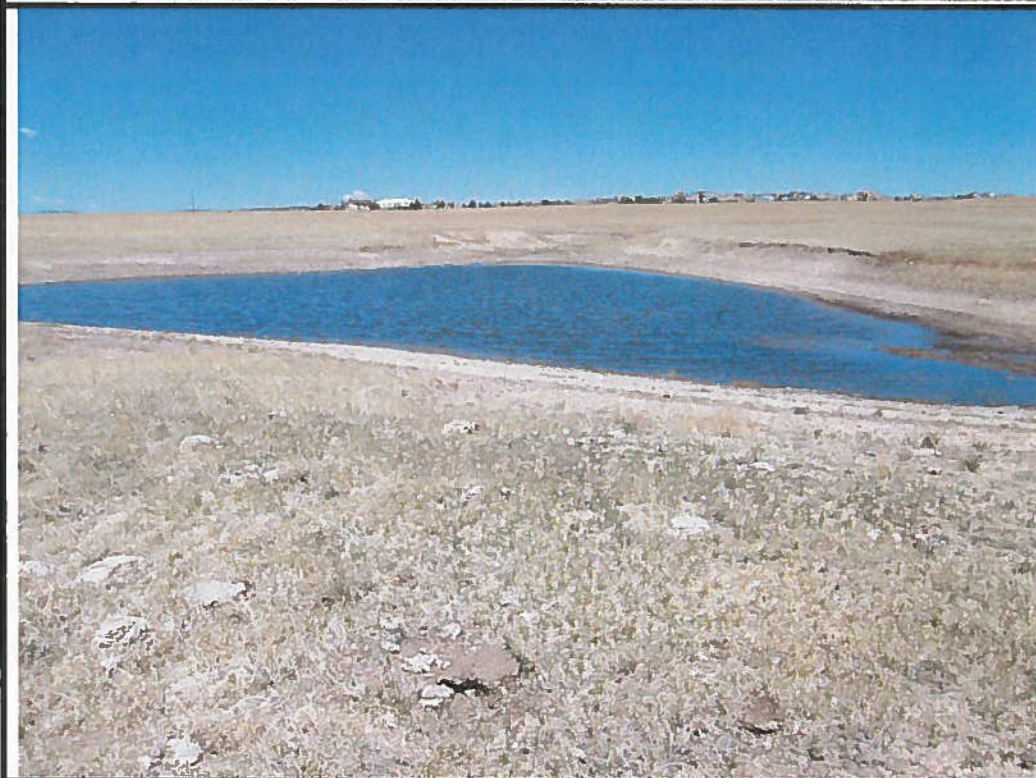
**Looking northwest at
pond in the southwest
portion of the site.**

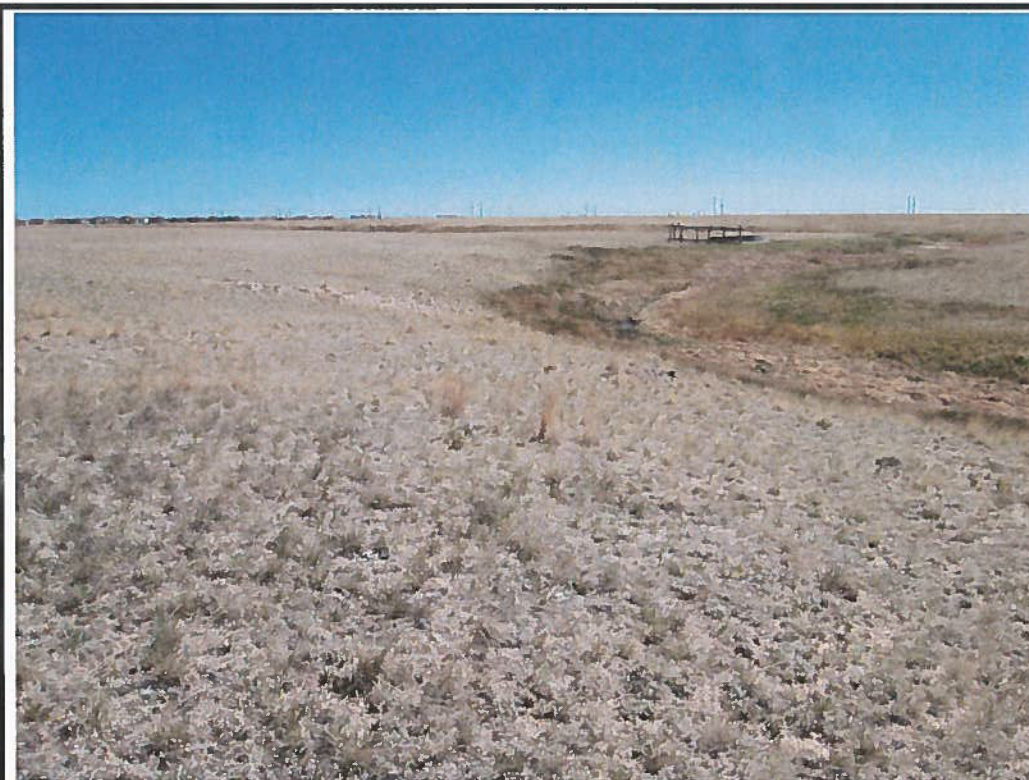
**Looking east at
drainage in the
southwest portion of
the site.**

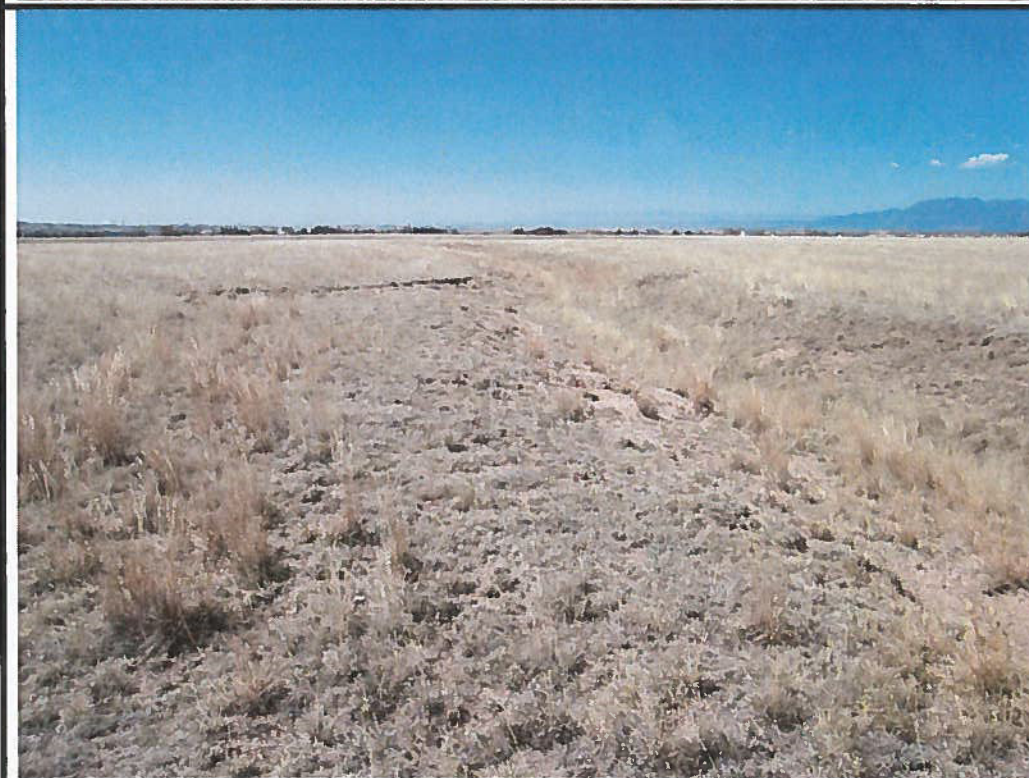
**Looking south from
the central portion of
the site.**

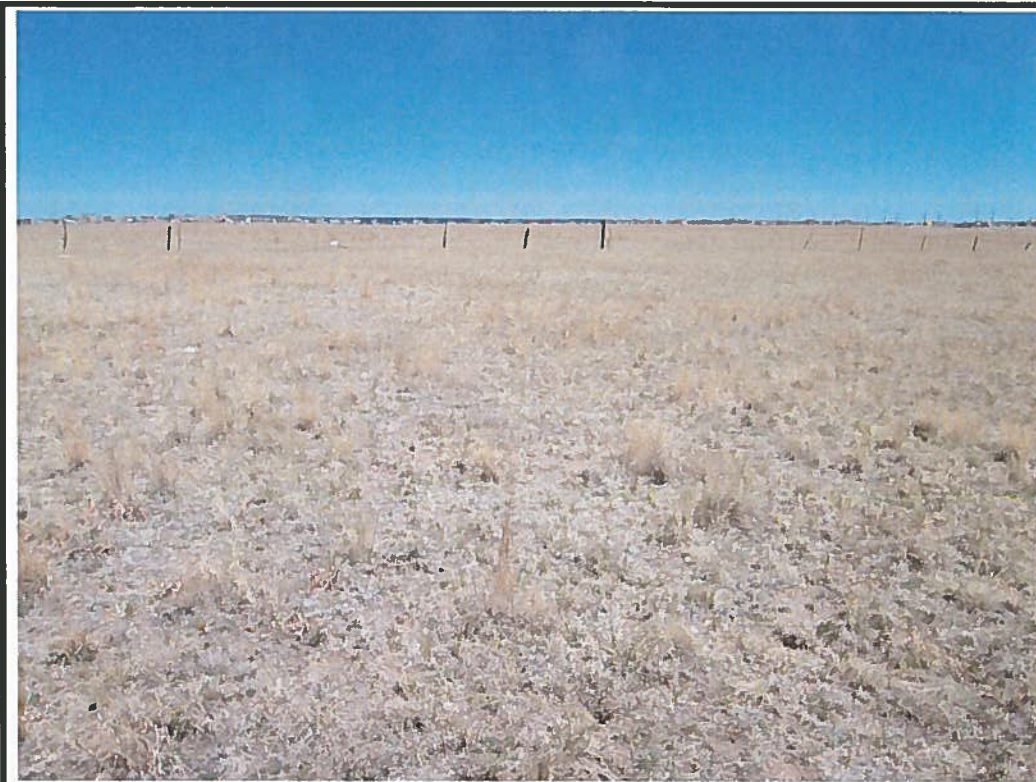
Looking north from the central portion of the site.

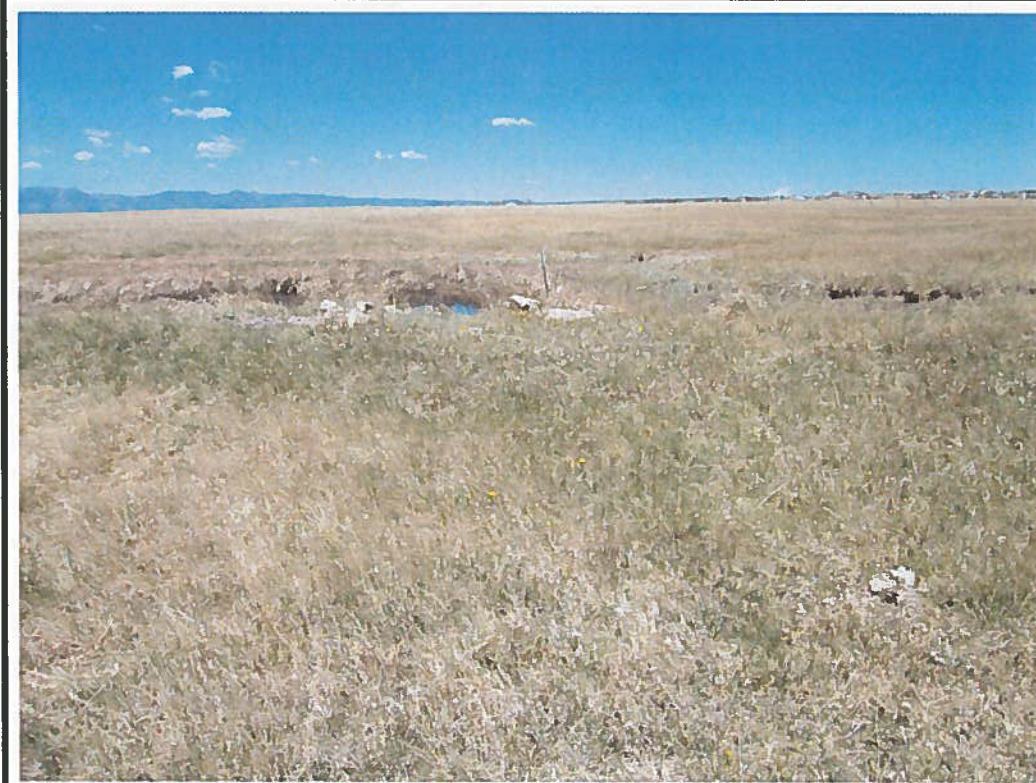
Looking north at ponded water in the southeast portion of the site.

Mitigation: The larger of the ponds lie behind earthen dams: one in the southwestern portion of the site within an area designated as open space and another immediately northeast of the site in a dedicated easement. Other areas where ponded water were observed are minor and can be regraded. All soft and organic soils should be removed prior to fill placement. Any drainage into these areas should be rerouted in a non-erosive manner where it does not create areas of ponded water around proposed structures. The same mitigation techniques for the seasonal shallow groundwater areas are recommended for these areas as well.
