**GEOLOGIC HAZARD STUDY
AND PRELIMINARY
SUBSURFACE SOIL INVESTIGATION
THE RANCH
EL PASO COUNTY, COLORADO**

PRI IV, LLC

July 12, 2018

Entech Job No. 180549
AAPProjects/2018/180549ghs-pssi

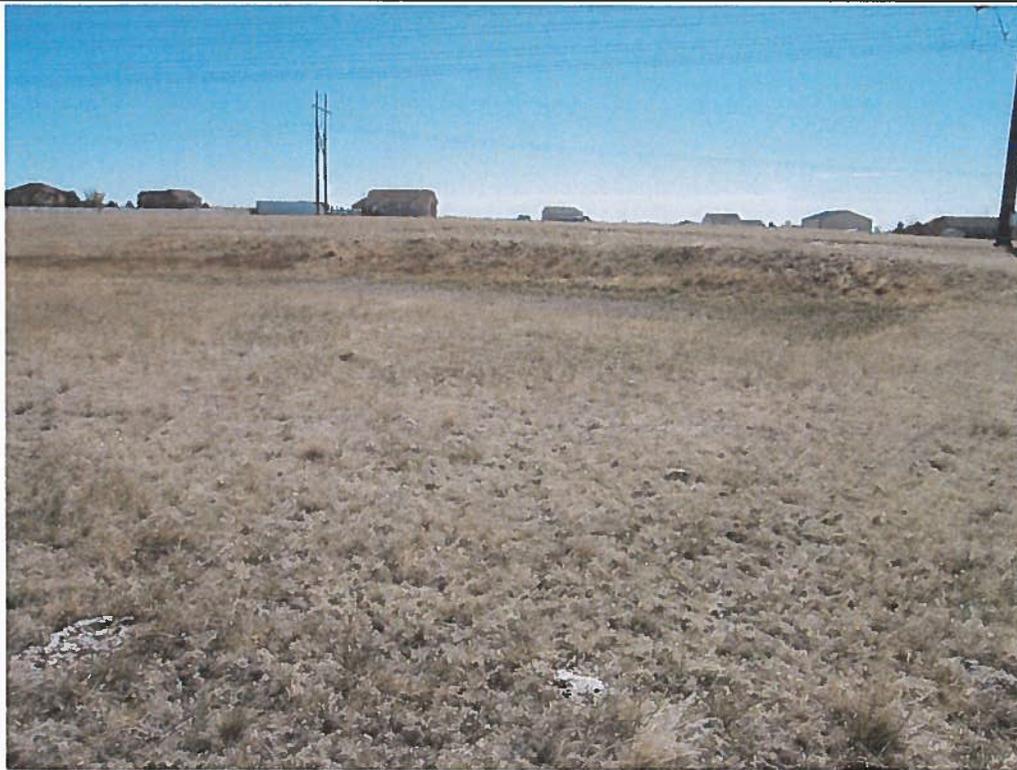
**Looking southeast at
dam in east-central
portion of the site.**

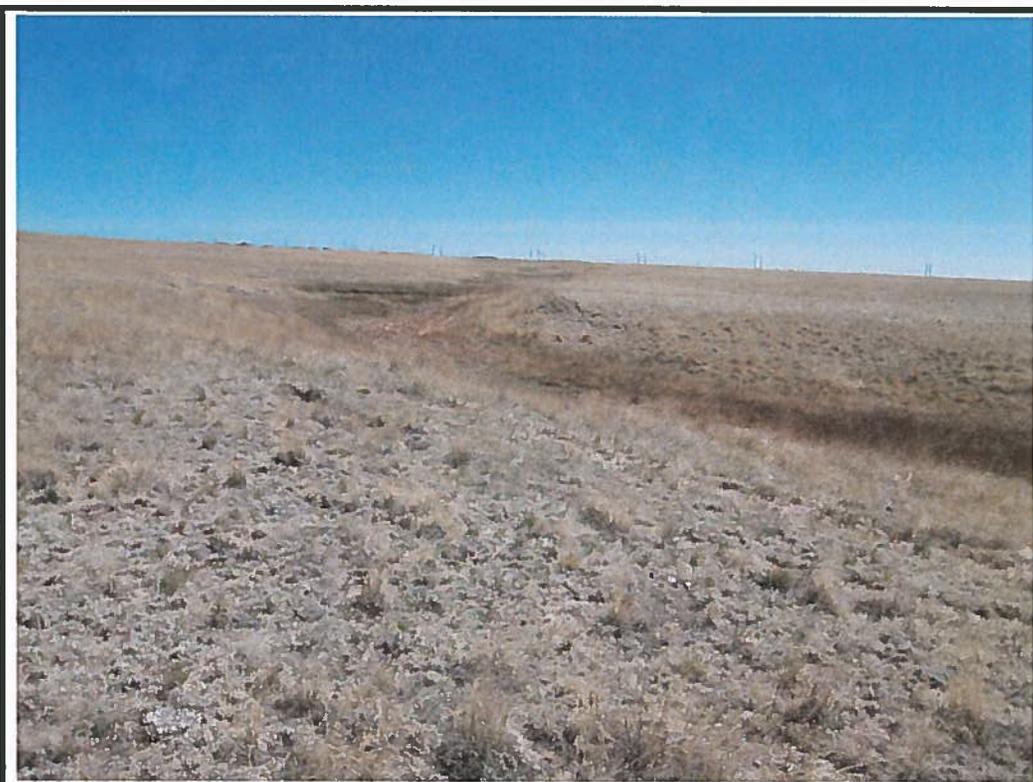
Looking northeast at drainage in the southwest portion of the site.

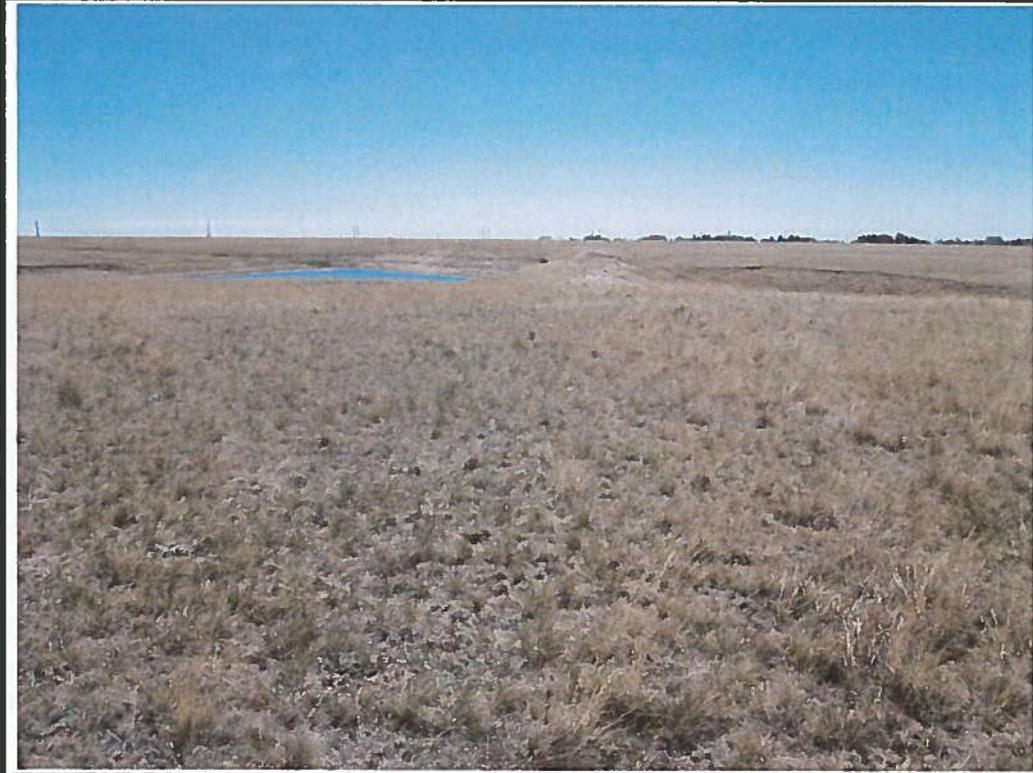
Looking east towards pond in the southwest portion of the site.

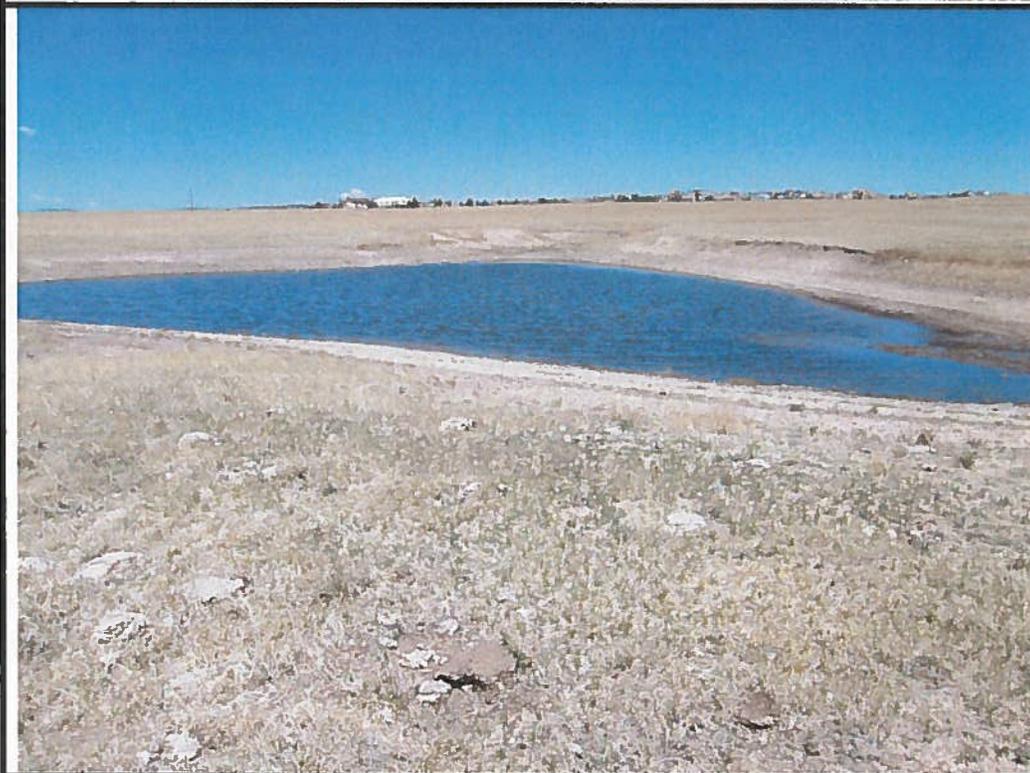
**Looking northwest at
pond in the southwest
portion of the site.**

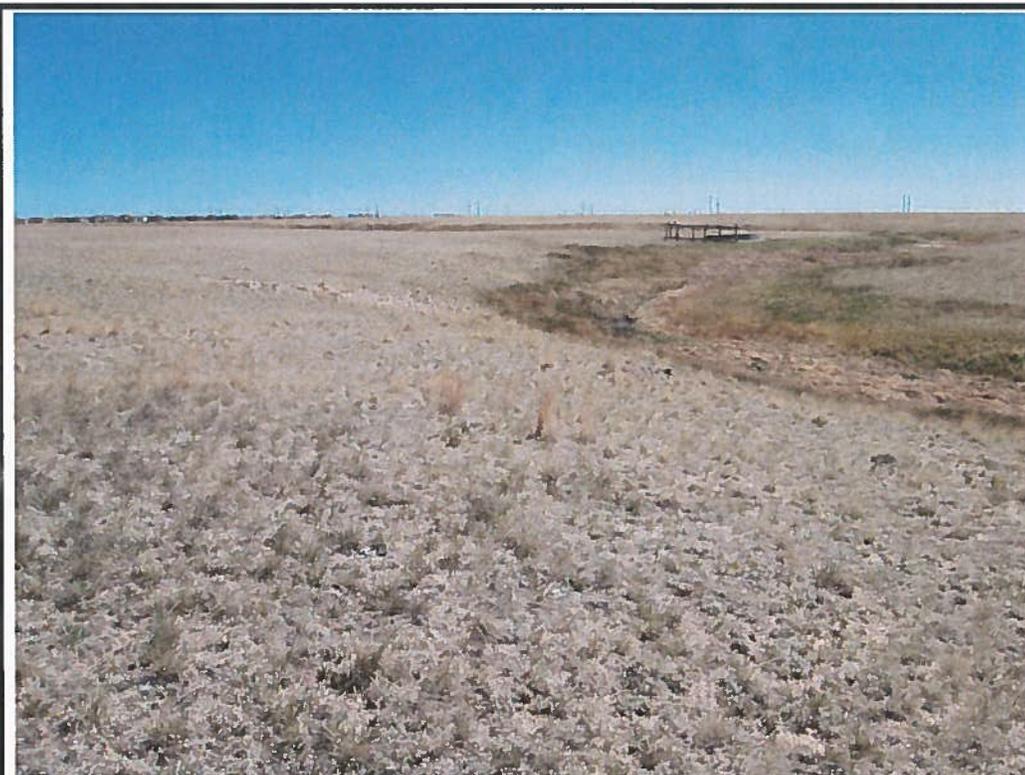
**Looking east at
drainage in the
southwest portion of
the site.**

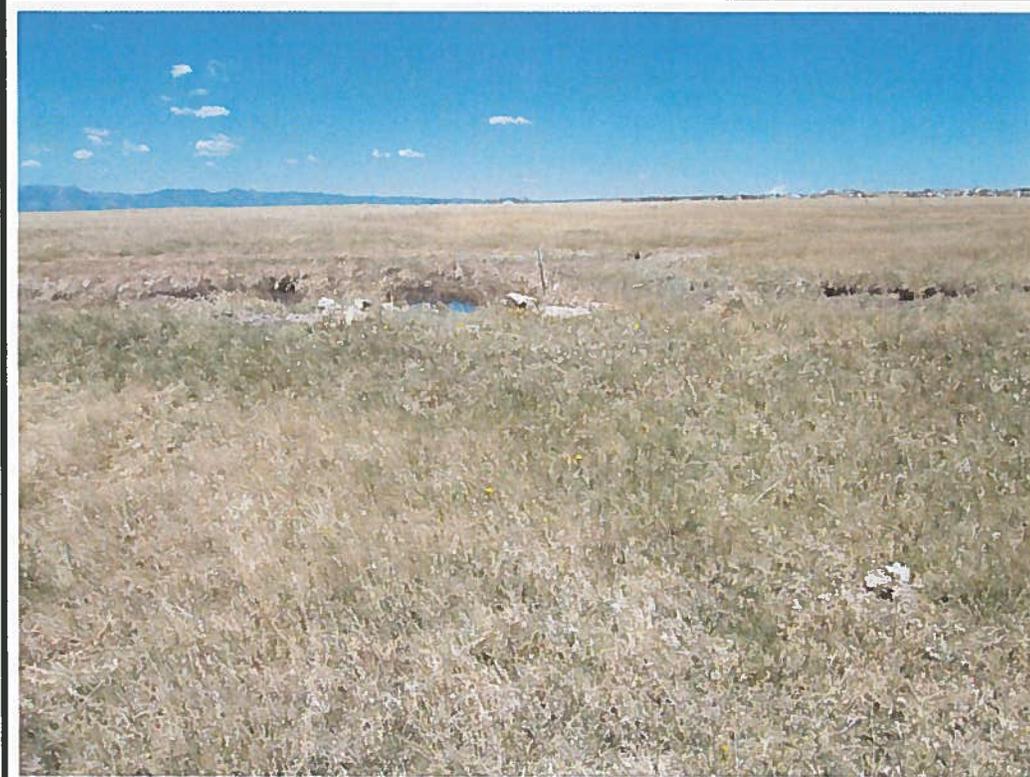
Looking north at ponded water in the southeast portion of the site.
