ENTECH
ENGINEERING, INC.

March 10, 2020
Revised March 17, 2022

Re: Soil, Geology, and Geologic Hazard Study
Didleau Subdivison
Herring Road & Forest Heights Circle
Parcel Nos. 52090-00-050 & 52090-00-120
El Paso County, Colorado

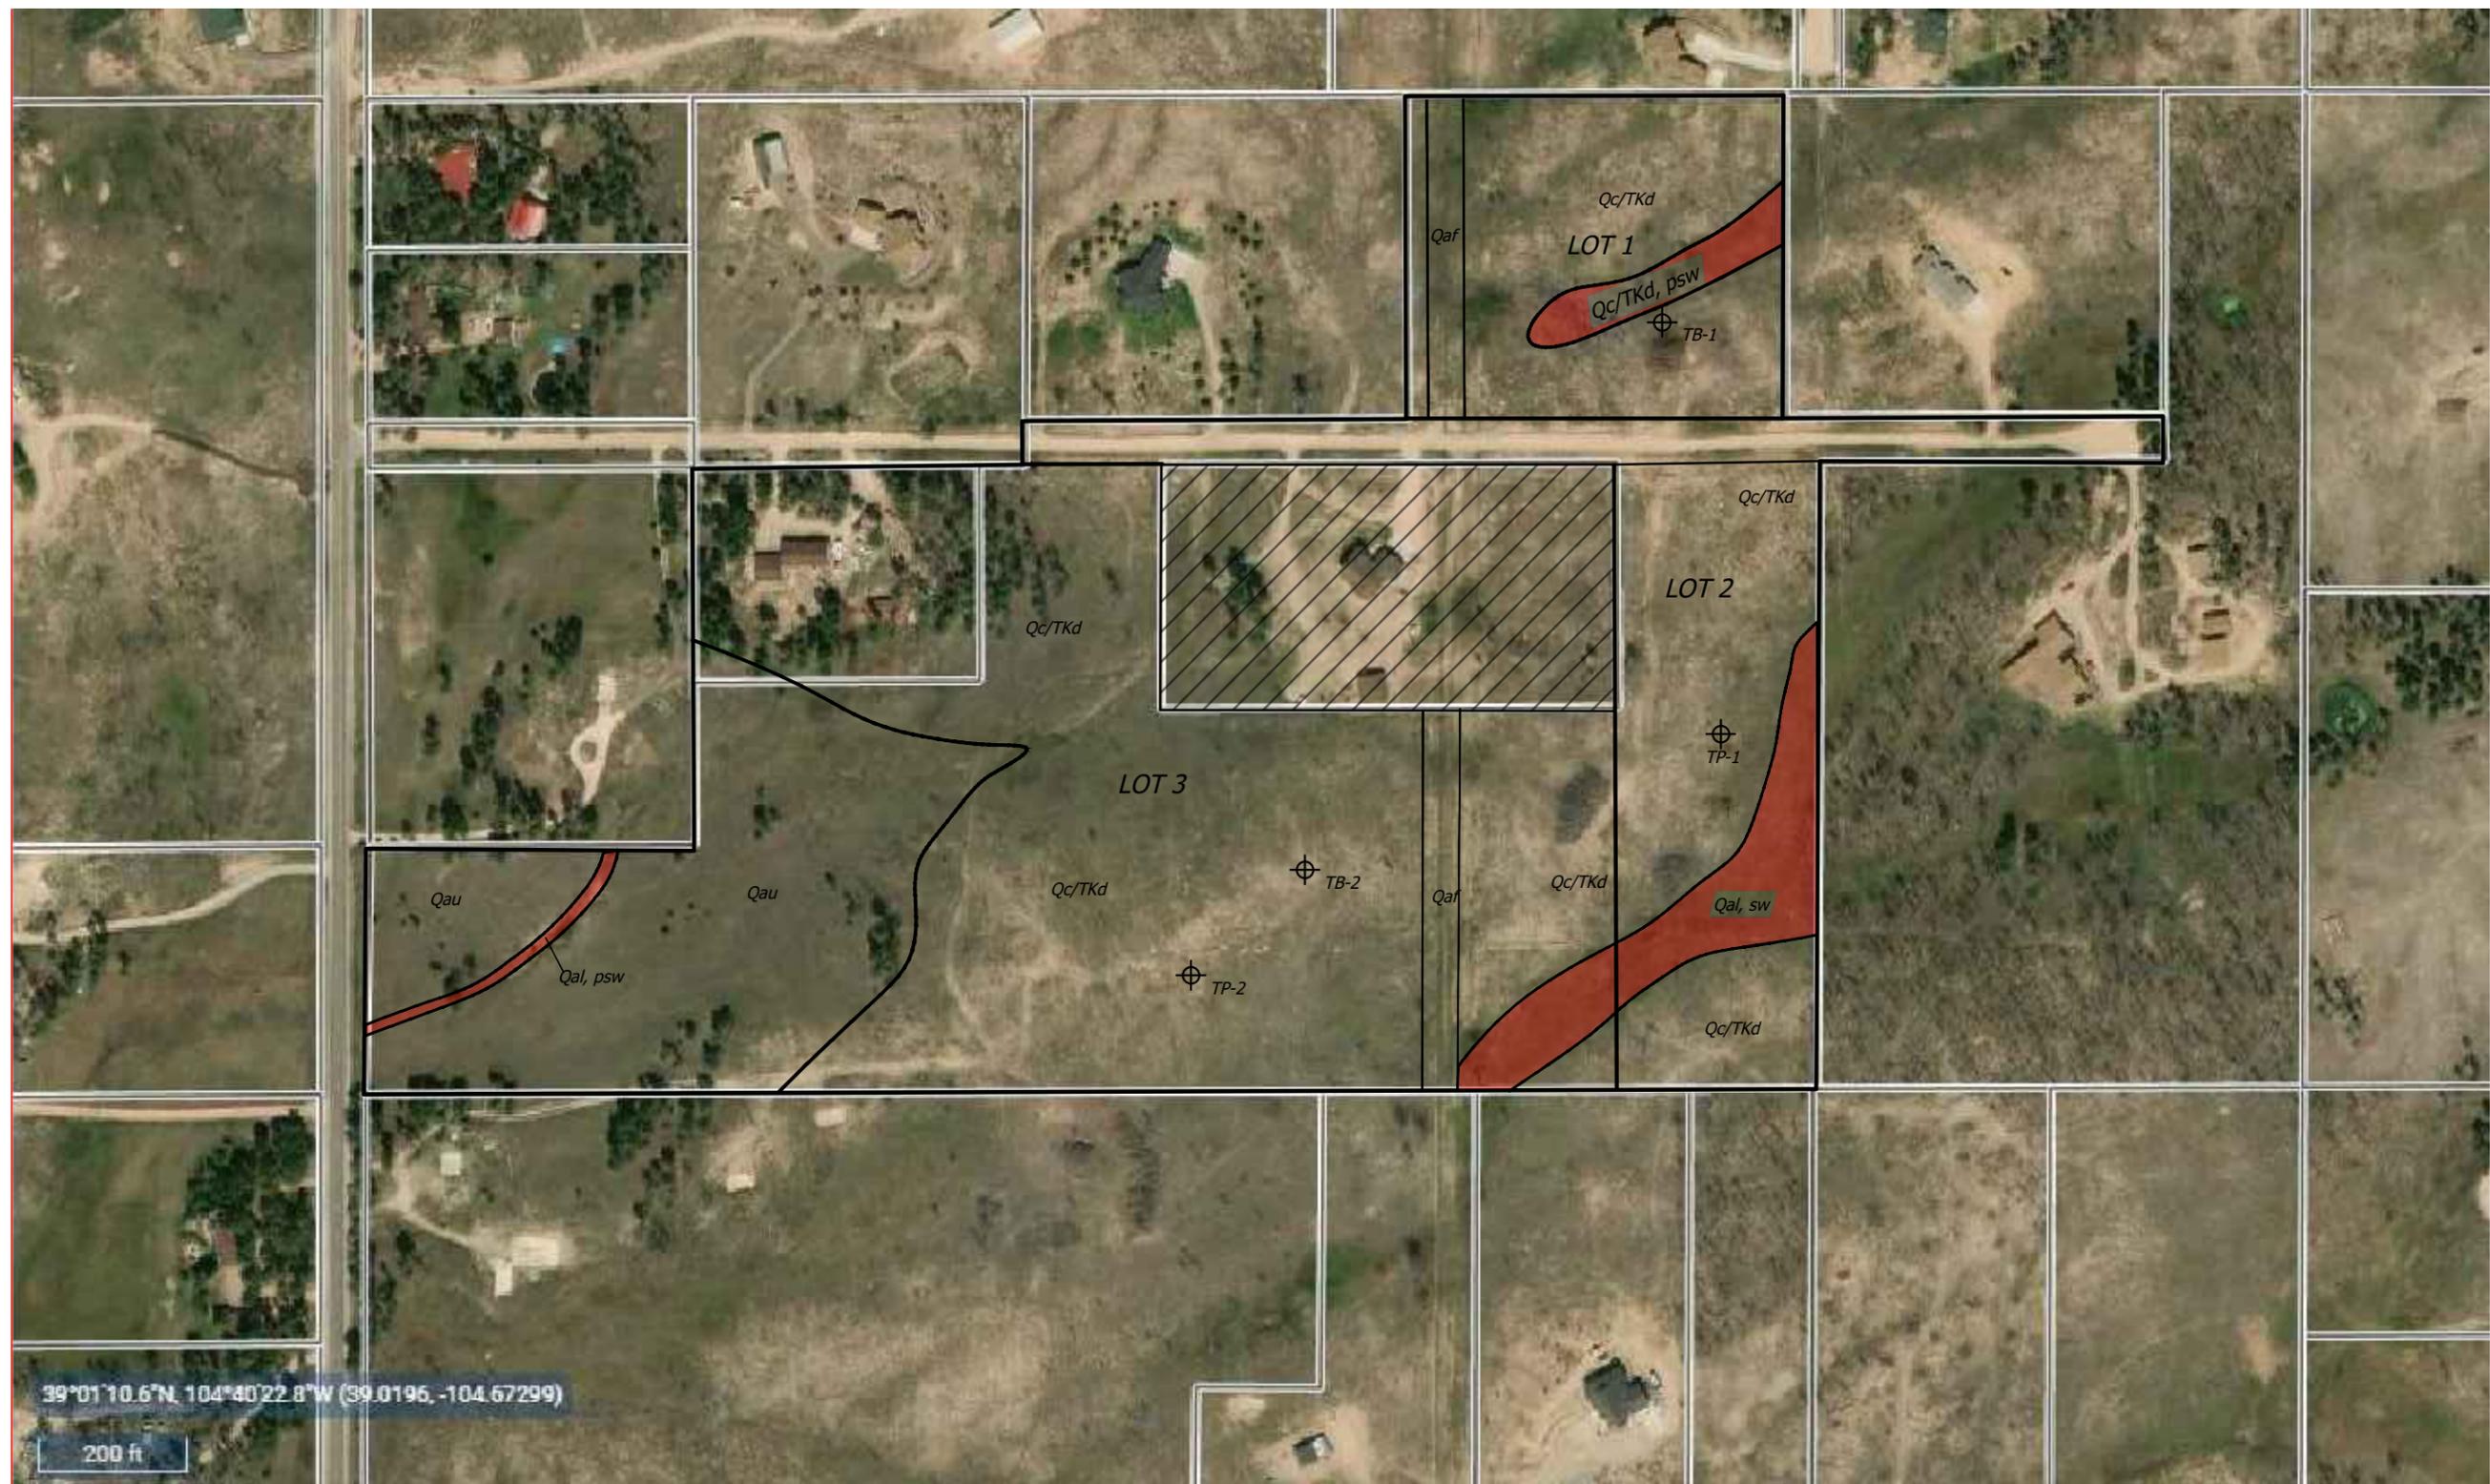
DRAWN L.L.
CHECKED
DATE 3/17/22
SCALE AS SHOWN
JOB NO. 192115
FIGURE No. 6

The soils listed above were mapped from site-specific mapping, the *Geologic Map of the Black Forest Quadrangle* distributed by the Colorado Geologic Survey in 2003 (Reference 4, Figure 5), the *Geologic Map of the Colorado Springs-Castle Rock Area*, distributed by the US Geological Survey in 1979 (Reference 5), and the *Geologic Map of the Pueblo 1° x 2° Quadrangle*, distributed by the US Geological Survey in 1978 (Reference 6). The test borings and test pits were used in evaluating the site and is included in Appendix B. The Geology Map prepared for the site is presented in Figure 6.

The site is not mapped within any floodplains according to the FEMA Map No. 08041CO320G, dated December 7, 2018 (Figure 7, Reference 7). Areas of potentially seasonal shallow and seasonal shallow groundwater were observed on the site (Figure 6). In these areas, we would anticipate the potential for periodically high subsurface moisture conditions and frost heave potential. These areas lie within low-lying areas and along the drainages in the eastern and western portions of the site. The seasonal shallow groundwater area is located along Burgess Creek located along the eastern portion of the site on Lot 2. The potentially seasonal shallow groundwater area is located in the western portion of the site on Lot 3. Water was not observed in any of the drainages at the time of our site investigation. These areas can likely be avoided or properly mitigated by development. The potential exists for high groundwater levels during high moisture periods and should structures encroach on these areas the following precautions should be followed.

Areas of potentially seasonal shallow and seasonal shallow groundwater were observed on the site (Figure 6). In these areas, we would anticipate the potential for periodically high subsurface moisture conditions and frost heave potential. These areas lie within low-lying areas and along the minor drainage in the western portion of the site, and Burgess Creek in the eastern portion of the site. These areas can likely be avoided or properly mitigated by development. The potential exists for high groundwater levels during high moisture periods and should structures encroach on these areas. Subsurface perimeter drains are recommended should structures encroach on this area. Typical drain details are presented in Figure 8. Septic systems are not recommended in these areas due to the potential for shallow groundwater. Any grading in these areas should be done to direct surface flow around construction to avoid areas of ponded water. All organic material should be completely removed prior to any fill placement. Specific drainage studies are beyond the scope of this report. The site is not mapped within any floodplains according to the FEMA Map No. 80841C0320G (Figure 7, Reference 7).

Mitigation: Foundations must have a minimum 30-inch depth for frost protection. In areas where high subsurface moisture conditions are anticipated periodically, subsurface perimeter drains are recommended to help prevent the intrusion of water into areas below grade. Typical drain details are presented in Figure 8. Any grading in these areas should be done to direct surface flow around construction to avoid areas of ponded water. All organic material would be completely removed prior to any fill placement. **Specific drainage studies are beyond the scope of this report.**

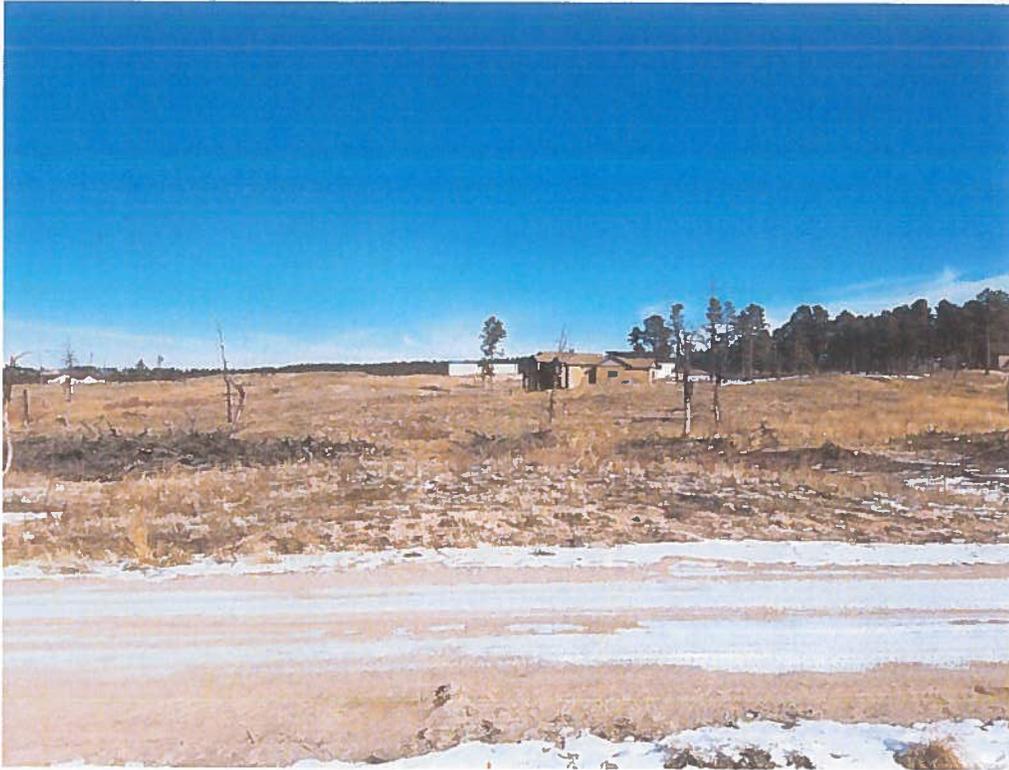
**Looking north towards
Lot 1 in the eastern
portion of the site.**

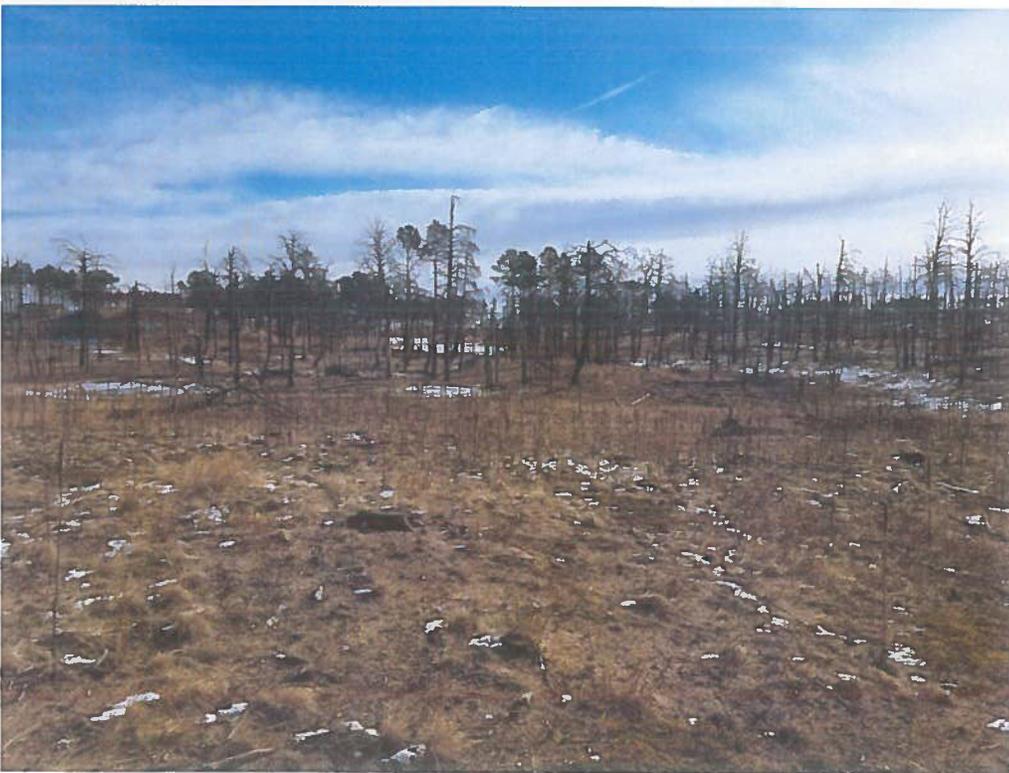
**Looking north from the
central portion of Lot
2.**

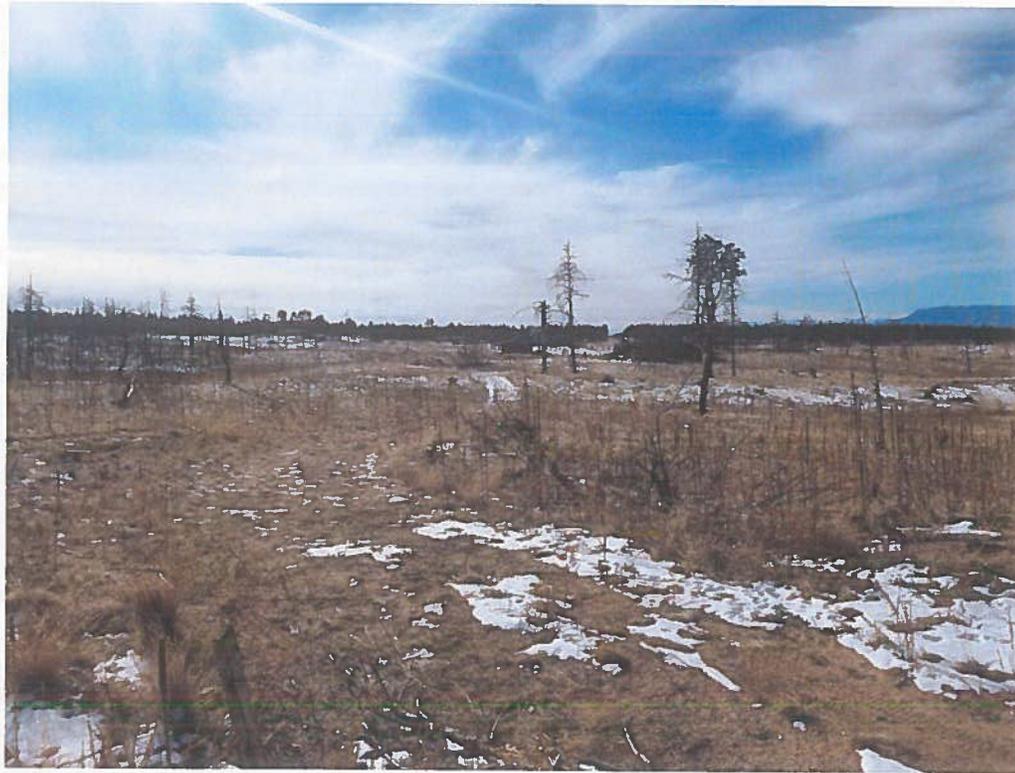
**Looking south from
the northern portion of
Lot 4.**

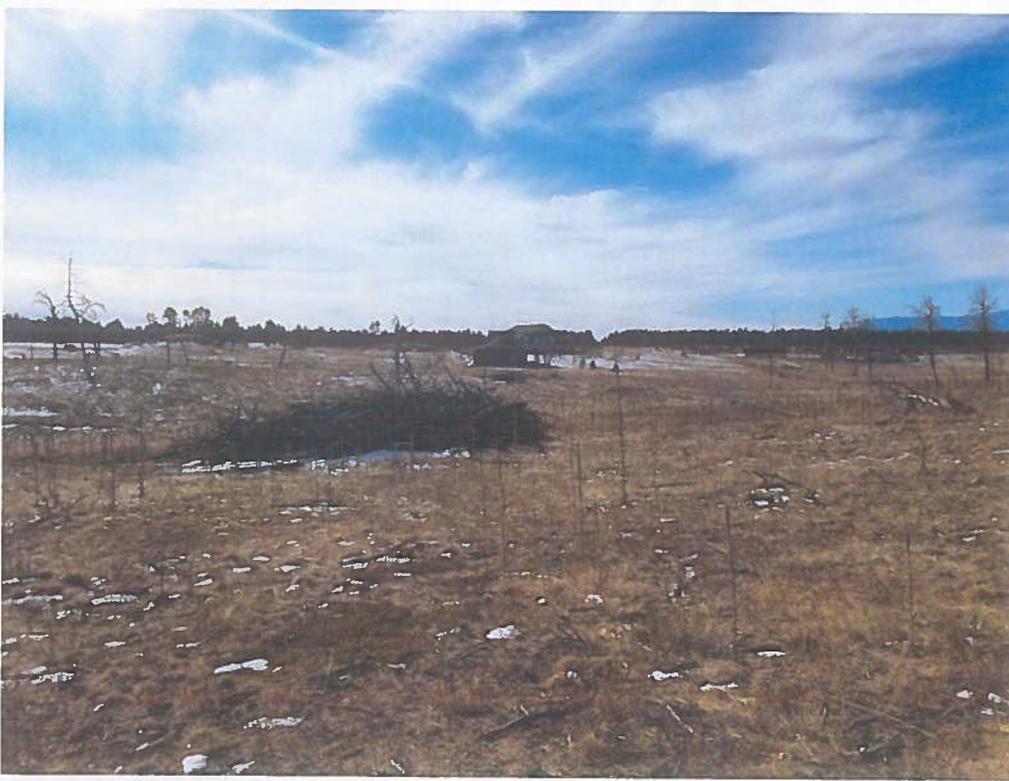
**Looking south towards
one of the stockpiles
of cut trees.**

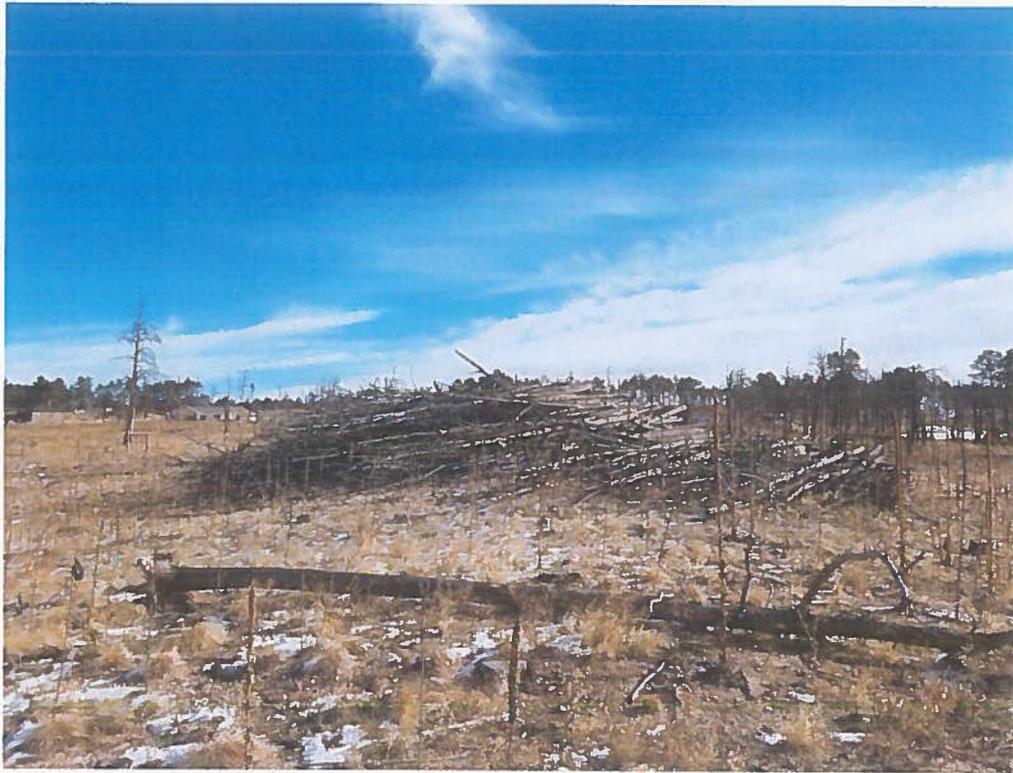
**Looking northeast
towards stockpile of
trees on Lot 3.**

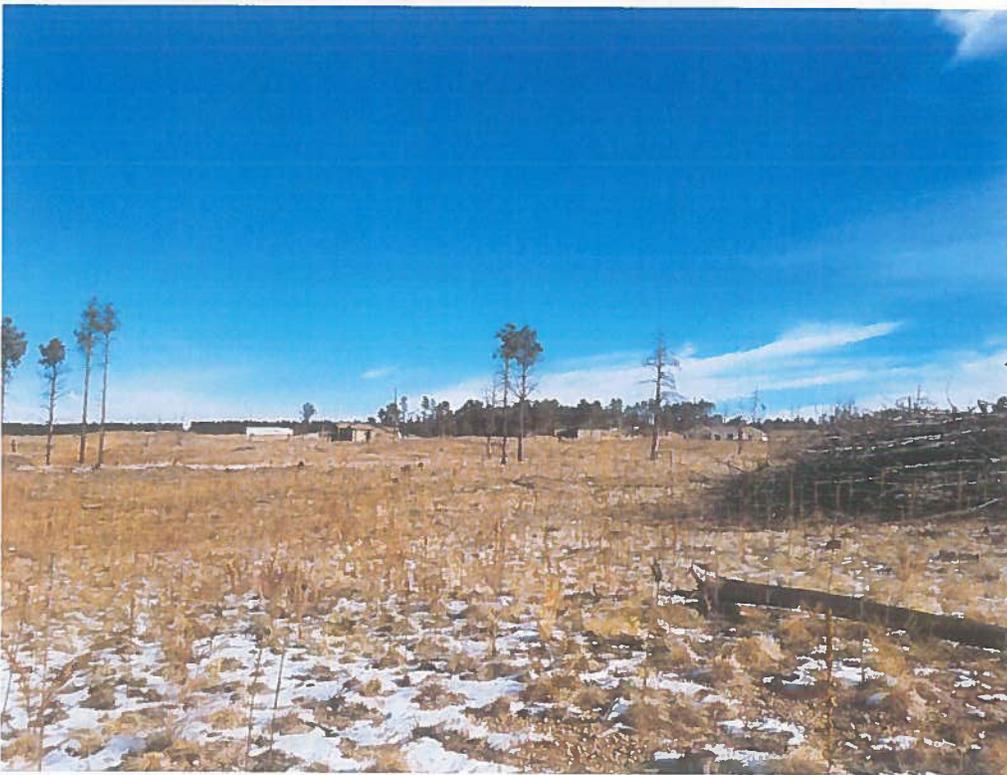
**Looking north from the
eastern portion of Lot
3.**
