Final Drainage Report

For:
Didleau Subdivision Filing 1

Project No. 2019.012

April 2020

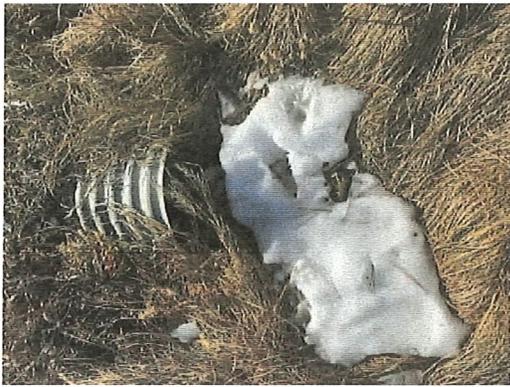
A total of three (3) corrugate metal pipe (CMP) culverts pass the water under Forest Heights Circle. The condition of each these culverts are discussed under the applicable Design Point number. The culverts contain a significant amount of silt. The culverts cross under Forest Heights Circle at 150 feet, 1,250 feet, and 2,250 feet east of the Herring Road intersection. Once under Forest Heights Circle the water continues in a southwesterly direction in natural drainage ways which are stable with only negligible signs of erosion. The majority of the culverts are 75% to 95% full of sediment and ash.

Figure 1: Upstream End of Culvert #1

It has been demonstrated that the existing 18" culverts do not have sufficient capacity due to the sedimentation and vegetative growth around the ends of each culvert. It is recommended that these culverts be replaced with 24" CMP culverts and the inverts be set so that the culvert can develop self-cleansing velocities. It has been pointed out that grading of the existing swales upstream and downstream of the culverts is not recommended because doing so would destabilize the existing wetland areas that have developed at either end of the culverts.

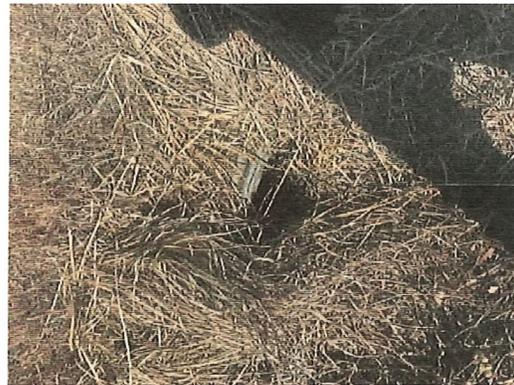
The existing culvert has minimal capacity due to sedimentation and the poor end conditions. Overtopping of the roadway is anticipated even with minor storm events. The downstream end (photo 5) controls the amount of water that the culvert can accommodate. The end is buried approximately 75% in the sediment where wetlands have been established. Sediment removal in the bottom of the existing swale is not recommended since this would require excavating the existing channel for a significant distance downstream.

Figure 5: Downstream End of Culvert 1

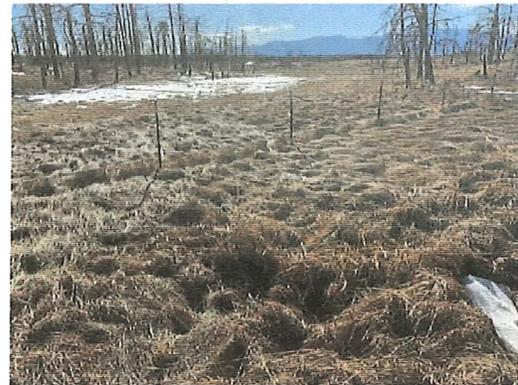
Swale 2 is a broad grass lined swale in a stable condition with only negligible indications of erosion. Swale 2 carries the water offsite at DP15. Wetlands are located immediately downstream of culvert 1 with approximate boundaries indicated on the drainage plan (Photo 6).

Figure 6: Facing downstream of Culvert 1

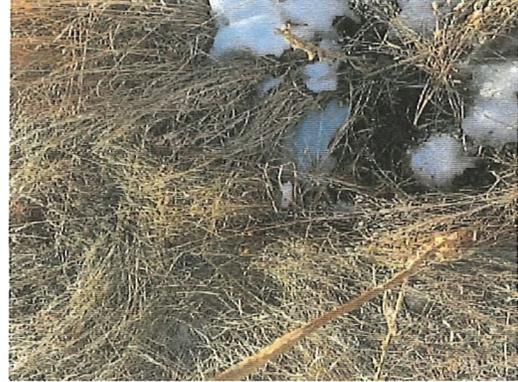
- Size: 18"
- Material: Corrugated Metal
- Slope: Undetermined
- Condition: ends are crushed, heavy sediment, dense grass and weed growth at both the upstream and downstream ends.
- End Sections: no end sections are present

Figure 21: Upstream end of Culvert 2

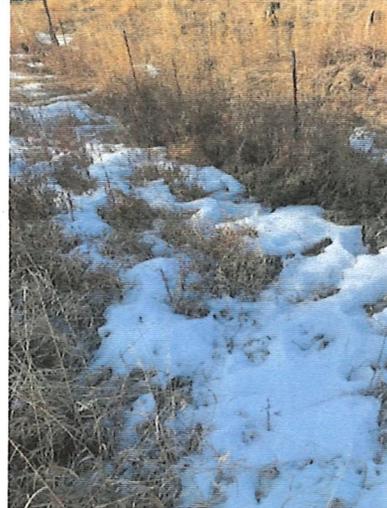
Figure 32: Water routed in northern borrow ditch

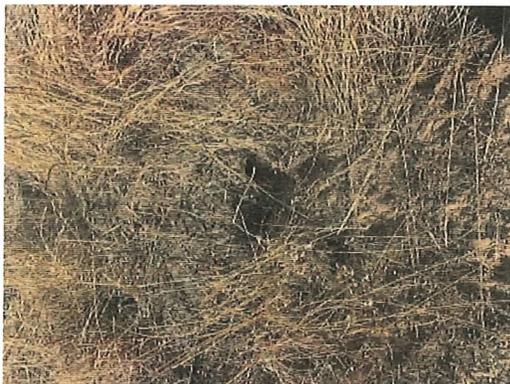
- Size: 18"
- Material: Corrugated Metal Pipe
- Slope: Undetermined
- Condition: silted to about 80%.
- End Sections: none

Figure 43: Downstream end of Culvert 3
