March 10, 2020

ENTECH
ENGINEERING, INC.

Re: Soil, Geology, and Geologic Hazard Study
Didleau Subdivision
Herring Road & Forest Heights Circle
Parcel Nos. 52090-00-050 & 52090-00-120
El Paso County, Colorado

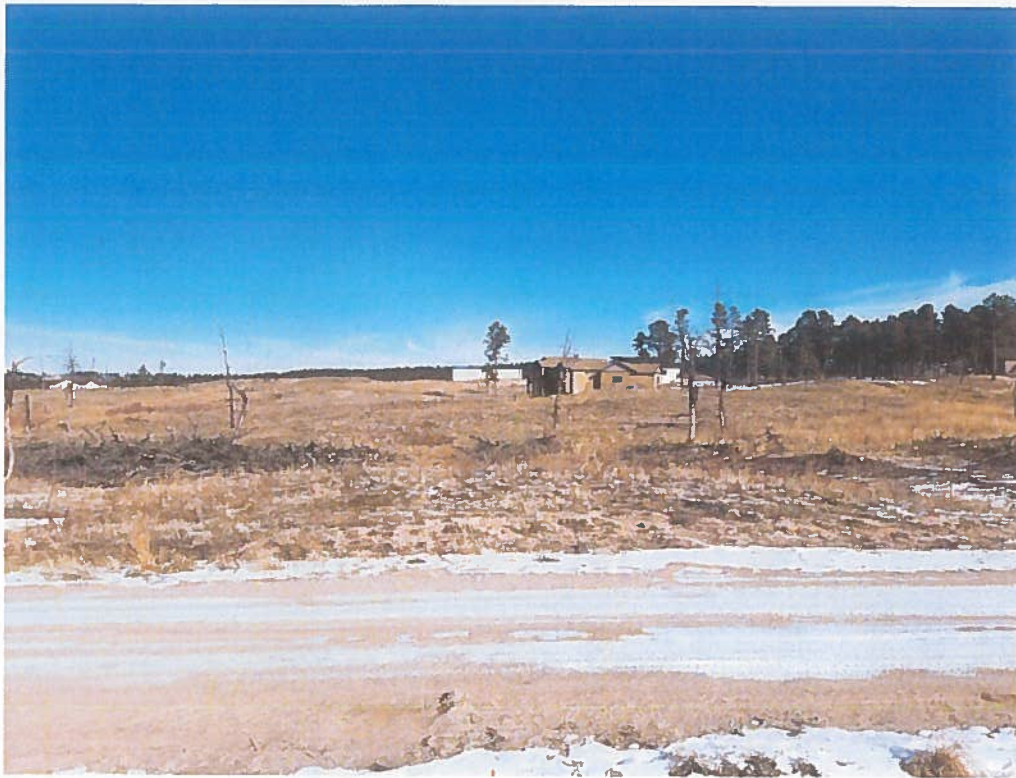
**Looking north towards
Lot 1 in the eastern
portion of the site.**

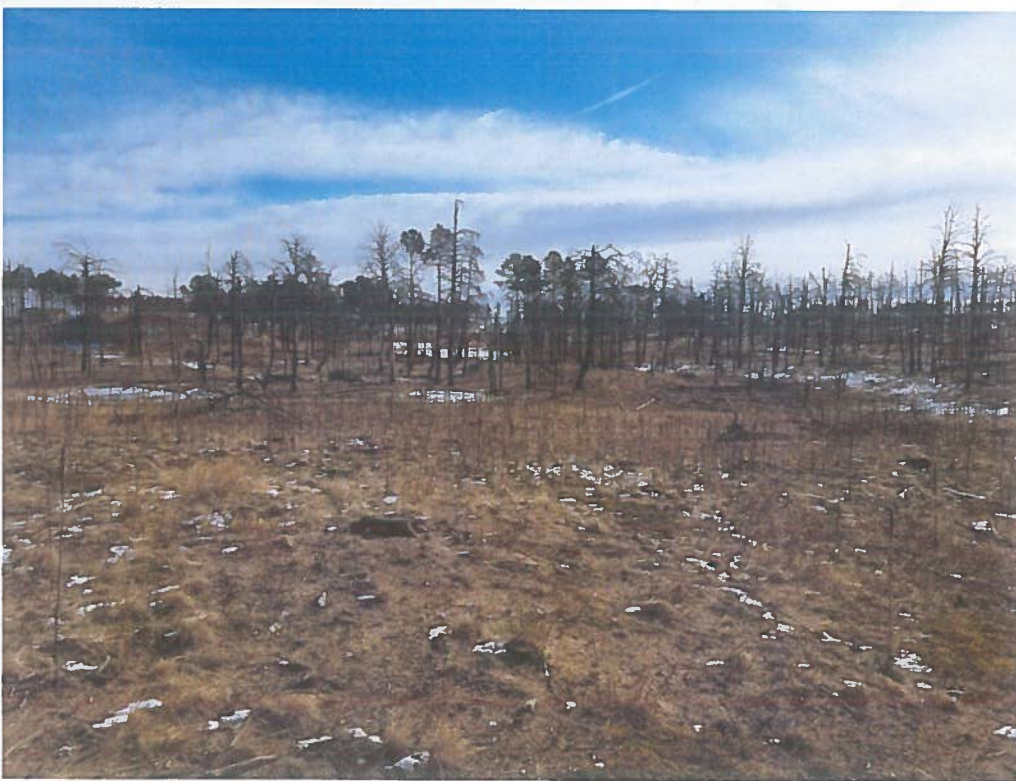
**Looking north from the
central portion of Lot
2.**

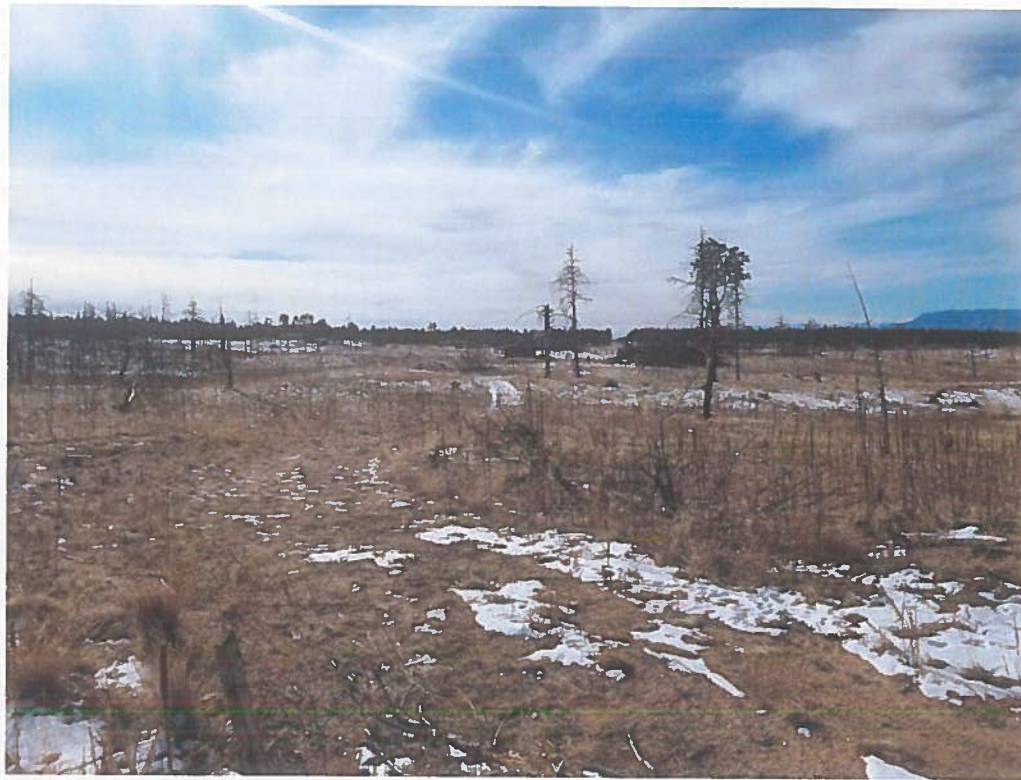
**Looking south from
the northern portion of
Lot 4.**

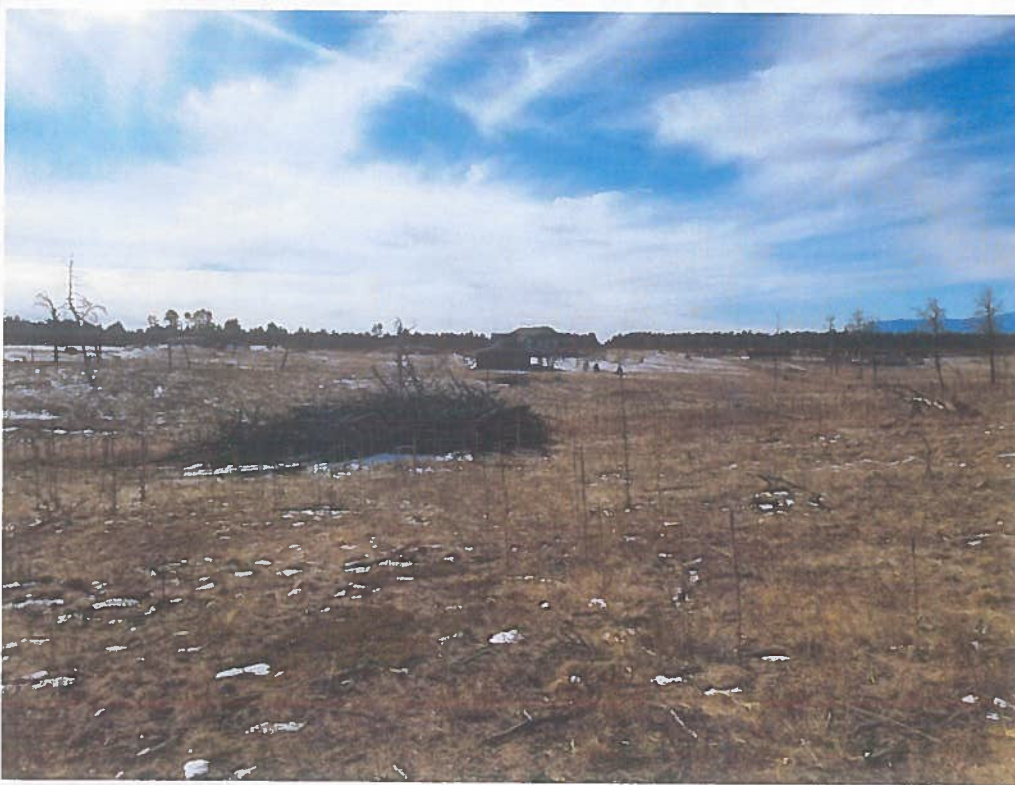
**Looking south towards
one of the stockpiles
of cut trees.**

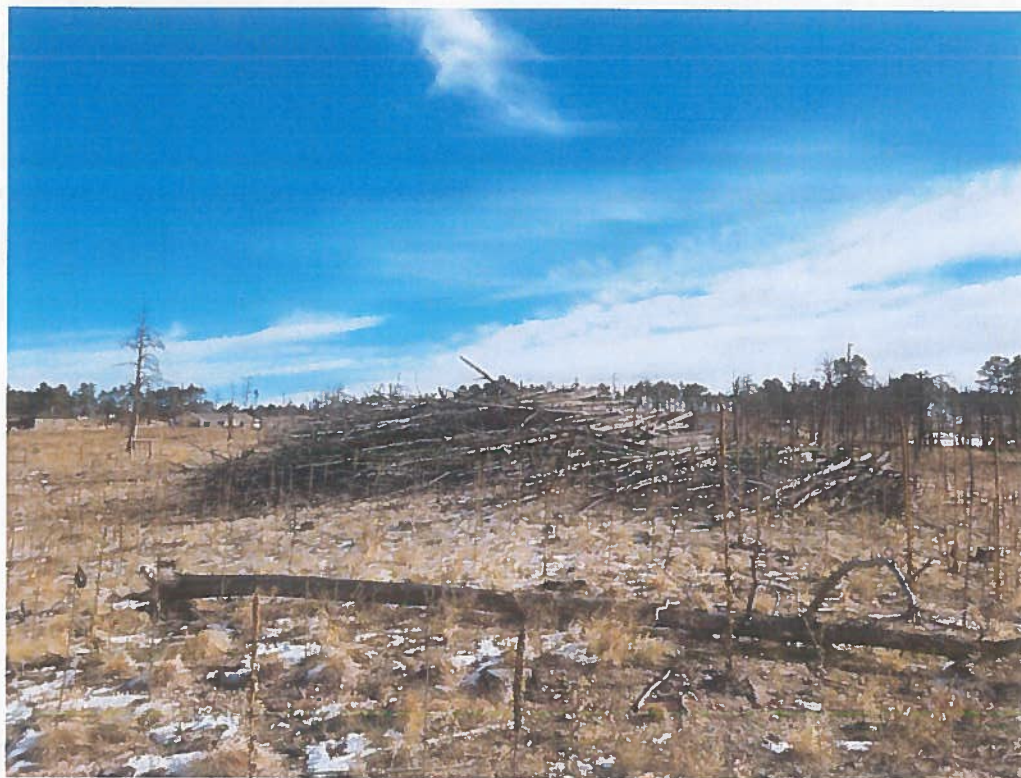
**Looking northeast
towards stockpile of
trees on Lot 3.**

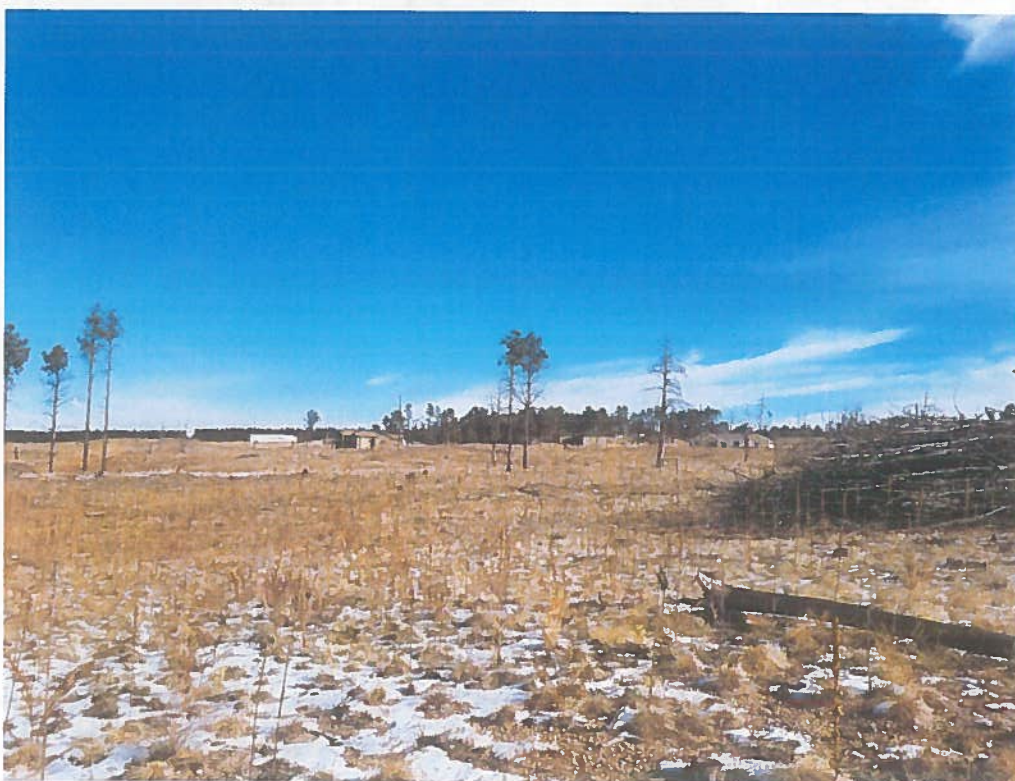
**Looking north from the
eastern portion of Lot
3.**
