**SOIL, GEOLOGY, GEOLOGIC HAZARD,  
AND WASTEWATER STUDY,  
FLYING HORSE NORTH  
PUD SUBMITTAL  
EL PASO COUNTY, COLORADO**

February 22, 2016

Entech Job No. 160118  
AAprojects/2016/160118 county soil geo ww

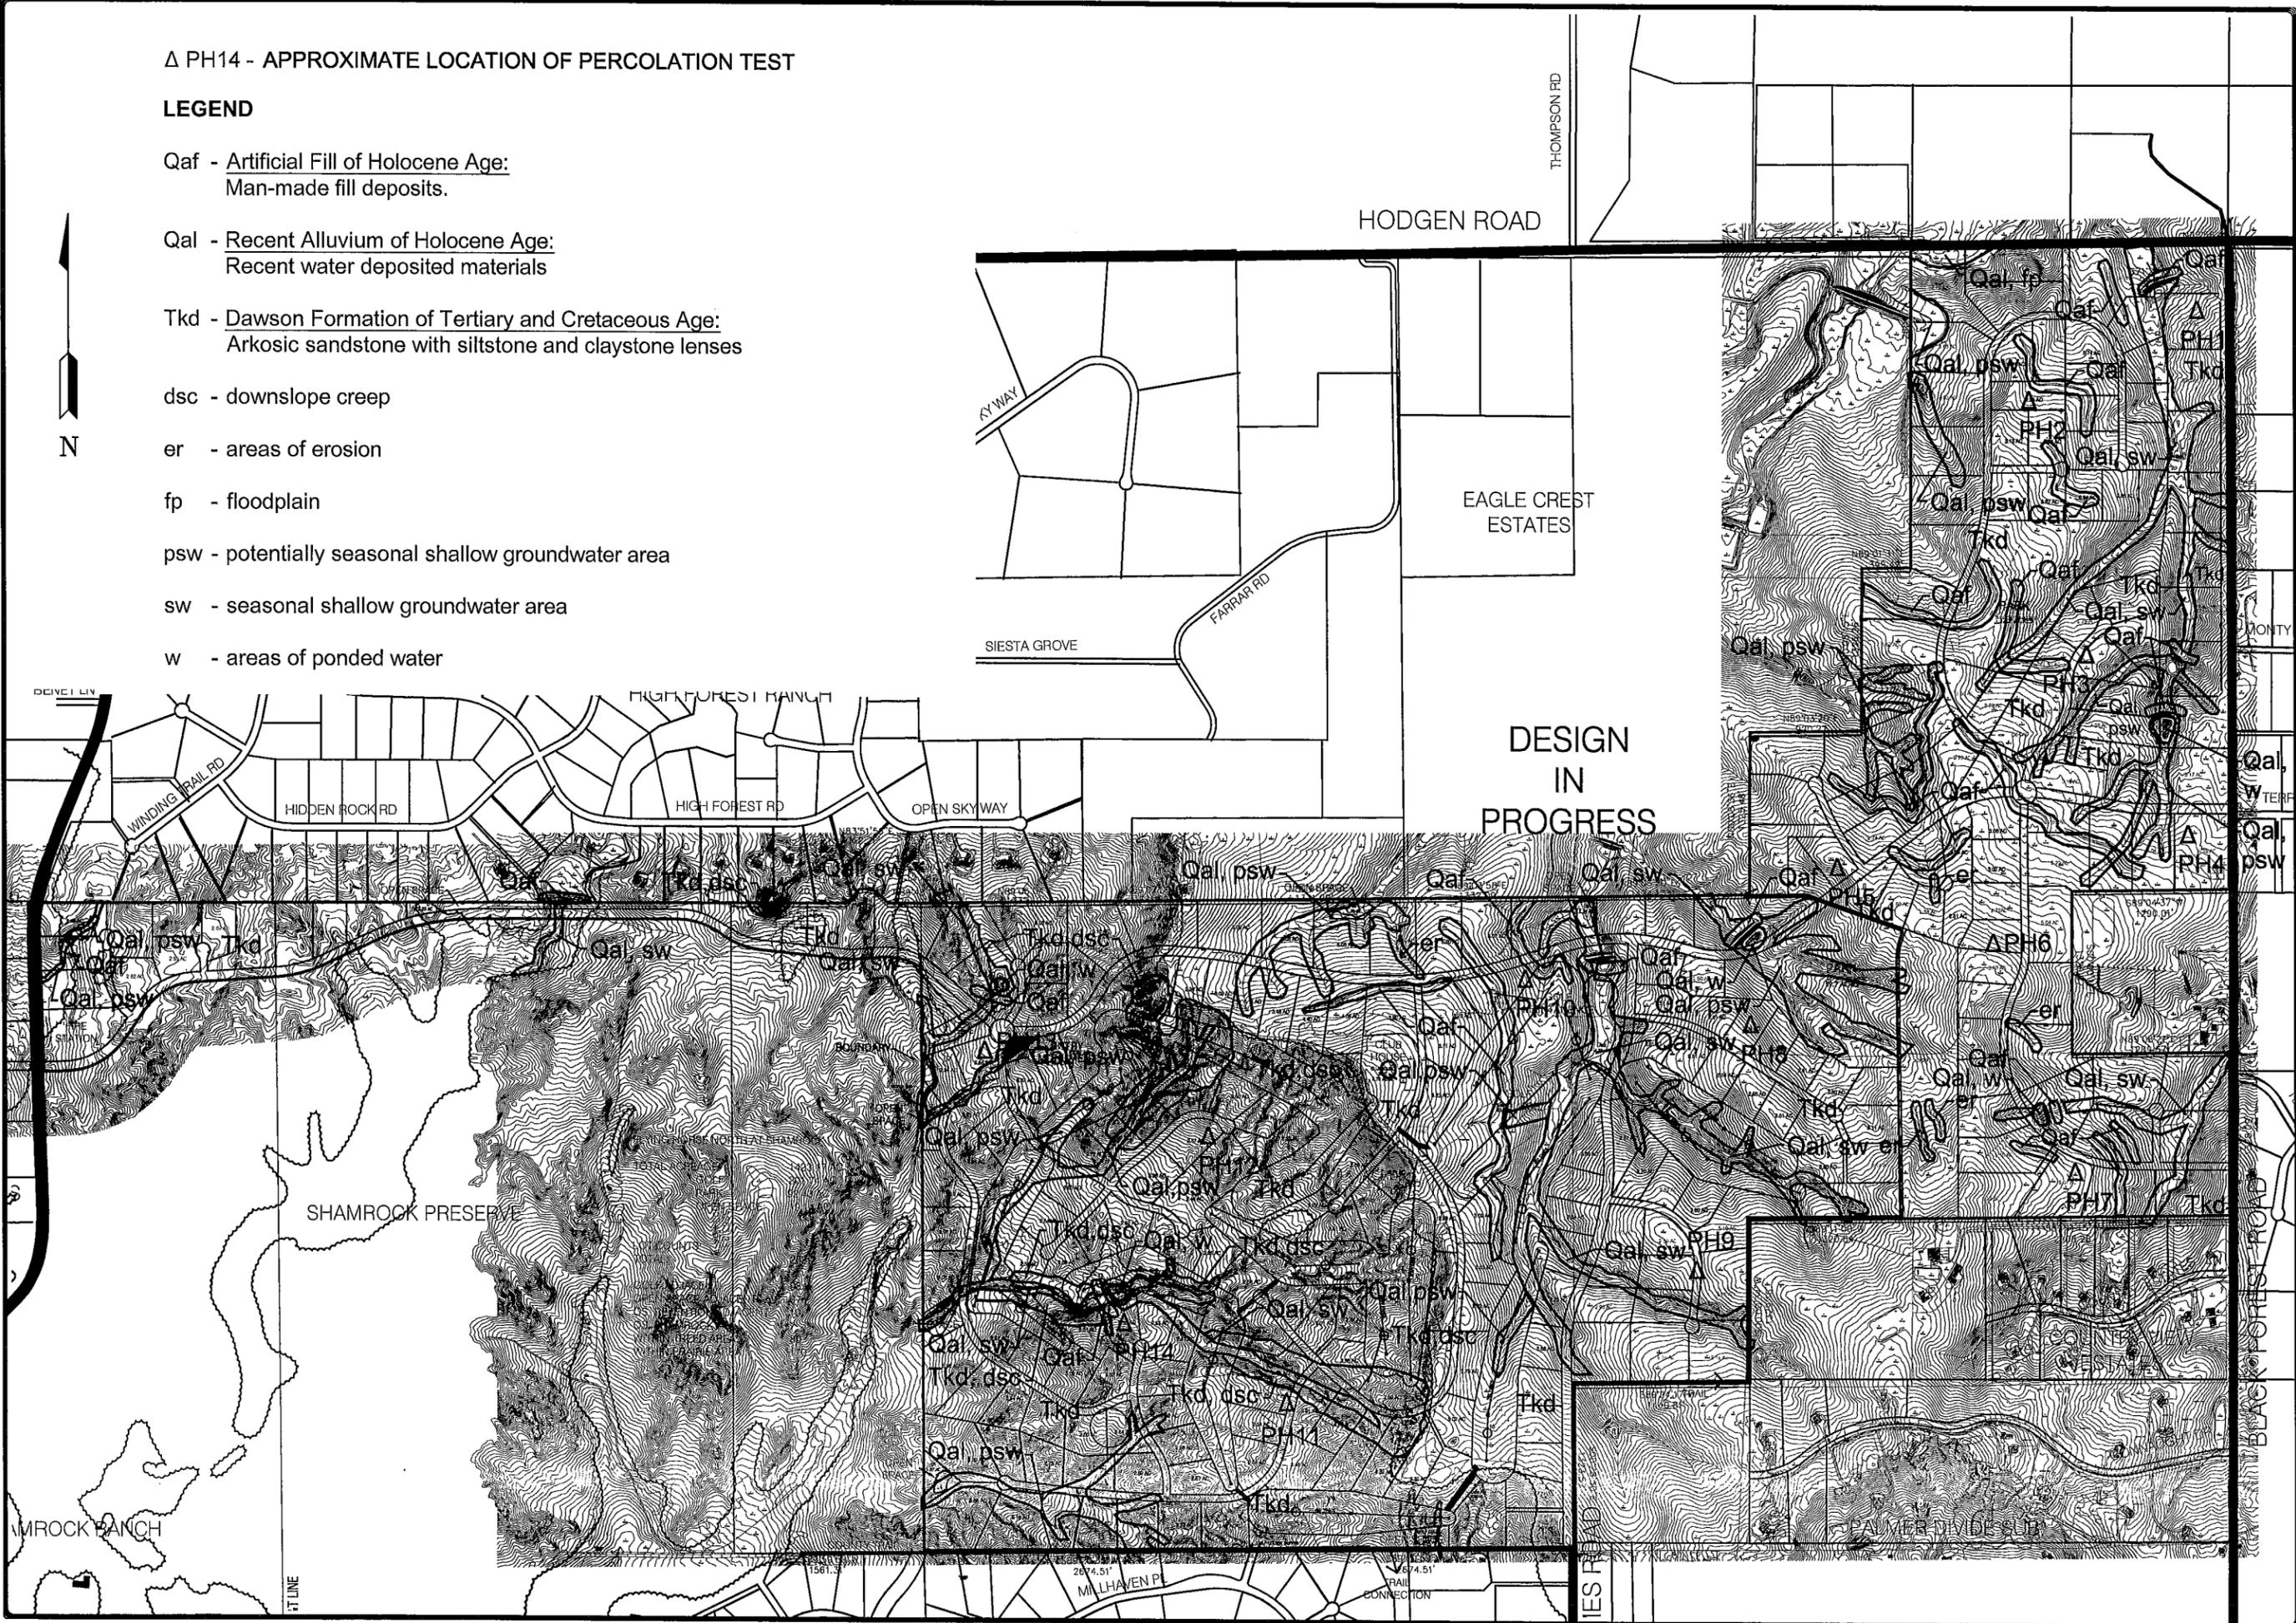
GEOLOGY/ENGINEERING GEOLOGY MAP  
FLYING HORSE NORTH  
EL PASO COUNTY, CO.

As mentioned previously, detailed mapping has been performed on this site to produce an Engineering Geology Map (Figure 6). This map shows the location of various geologic conditions of which the developers should be cognizant during the planning, design and construction stages of the project. These hazards and the recommended mitigation techniques are as follows:

In these areas, we would anticipate periodic high subsurface moisture conditions and frost heave potential on a seasonal basis. Additional, highly organic soils could be encountered in these areas. These areas lie within defined drainages and it is anticipated they will be avoided by development. Any structures in or adjacent to these areas should follow the mitigation discussed below.

In these areas, we would anticipate the potential for periodically high subsurface moisture conditions, frost heave potential and highly organic soils. The majority of these areas lie within defined drainages which can likely be avoided by the proposed development. The same mitigation recommendations for the seasonal shallow groundwater areas apply to the potentially seasonal shallow groundwater areas.

These areas are acceptable as building sites, however, in areas identified with this hazard classification, we would anticipate accelerated lateral and vertical movement of the near surface soils in the downslope direction.

Mitigation: Foundations must have a minimum 30-inch depth for frost protection. In areas where high subsurface moisture conditions are anticipated periodically, subsurface perimeter drains are recommended to help prevent the intrusion of water into areas below grade. Typical drain details are presented in Figure 7. Any grading in these areas should be done to direct surface flow around construction to avoid areas of ponded water. Structures should not block drainages. All organic material should be completely removed prior to any fill placement. Septic fields should not be located in areas where there is the potential for shallow groundwater. The majority of the site does not lie within any floodplain zones according to the FEMA Map Nos. 08041CO295F, 08041CO315F, and 08041CO325F dated March 17, 1997 (Figure 8, Reference 10). A minor area in the extreme northern portion of the site is mapped on a floodplain. This area is designated as open space and will be avoided by development. Exact locations of floodplain and specific drainage studies are beyond the scope of this report. Finished floor levels must be located a minimum of one foot above floodplain levels.

Mitigation: The design of foundations in these areas should account for the additional pressure on the uphill side of the structure due to the creep potential. The lateral pressure distribution for sloping conditions in downslope creep area is presented in Figure 9. Tie-beams, buttresses and counterforts may be necessary in some areas. Where possible, in areas of downslope creep, structures should be designed to be as compact and rigid as possible. This will help them better tolerate the vertical and lateral movements to which the foundation system may be subjected with minimal damage. Long, rambling, irregular structures should be avoided, as they are associated with much greater potential for damaging differential movement. Additionally, structures should be designed to step up the slope. Deep cuts in these areas should be avoided. Any retaining walls proposed in these areas should also be properly designed for by a qualified professional engineer for the global slope stability. Proper control of drainage at both the surface and subsurface is important. Saturation of materials should be avoided that may create unstable conditions.

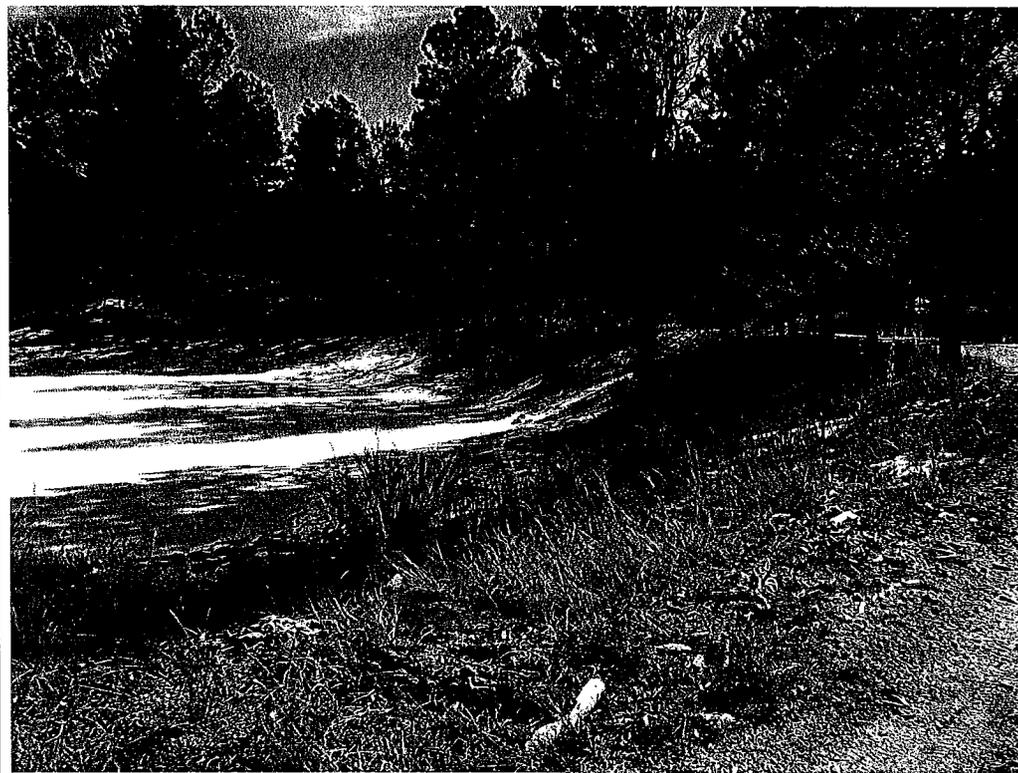
**Looking south at dam  
in southwest portion of  
the site.**

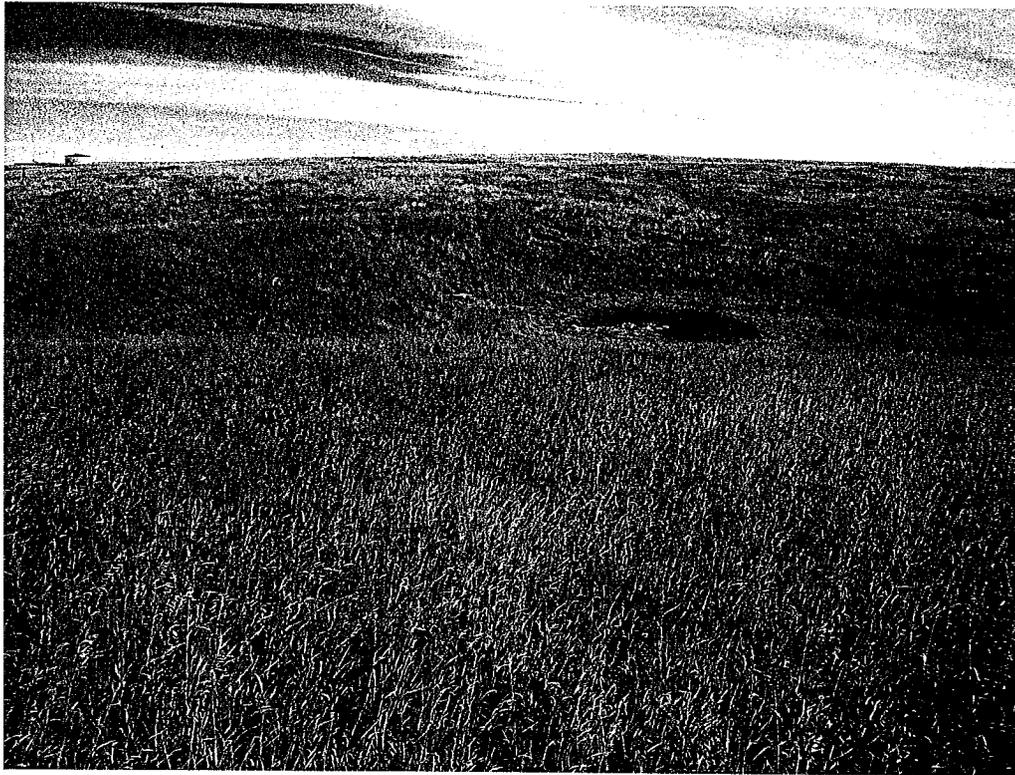
**Looking northeast at dam in north central portion of the site.**
