**SOIL, GEOLOGY, AND GEOLOGIC HAZARD STUDY
CATHEDRAL COMMONS
STRUTHERS ROAD AND SPANISH BIT DRIVE
EL PASO COUNTY, COLORADO**

December 23, 2021

Entech Job No. 210536
AAprojects/2021/210536 county soil/geo

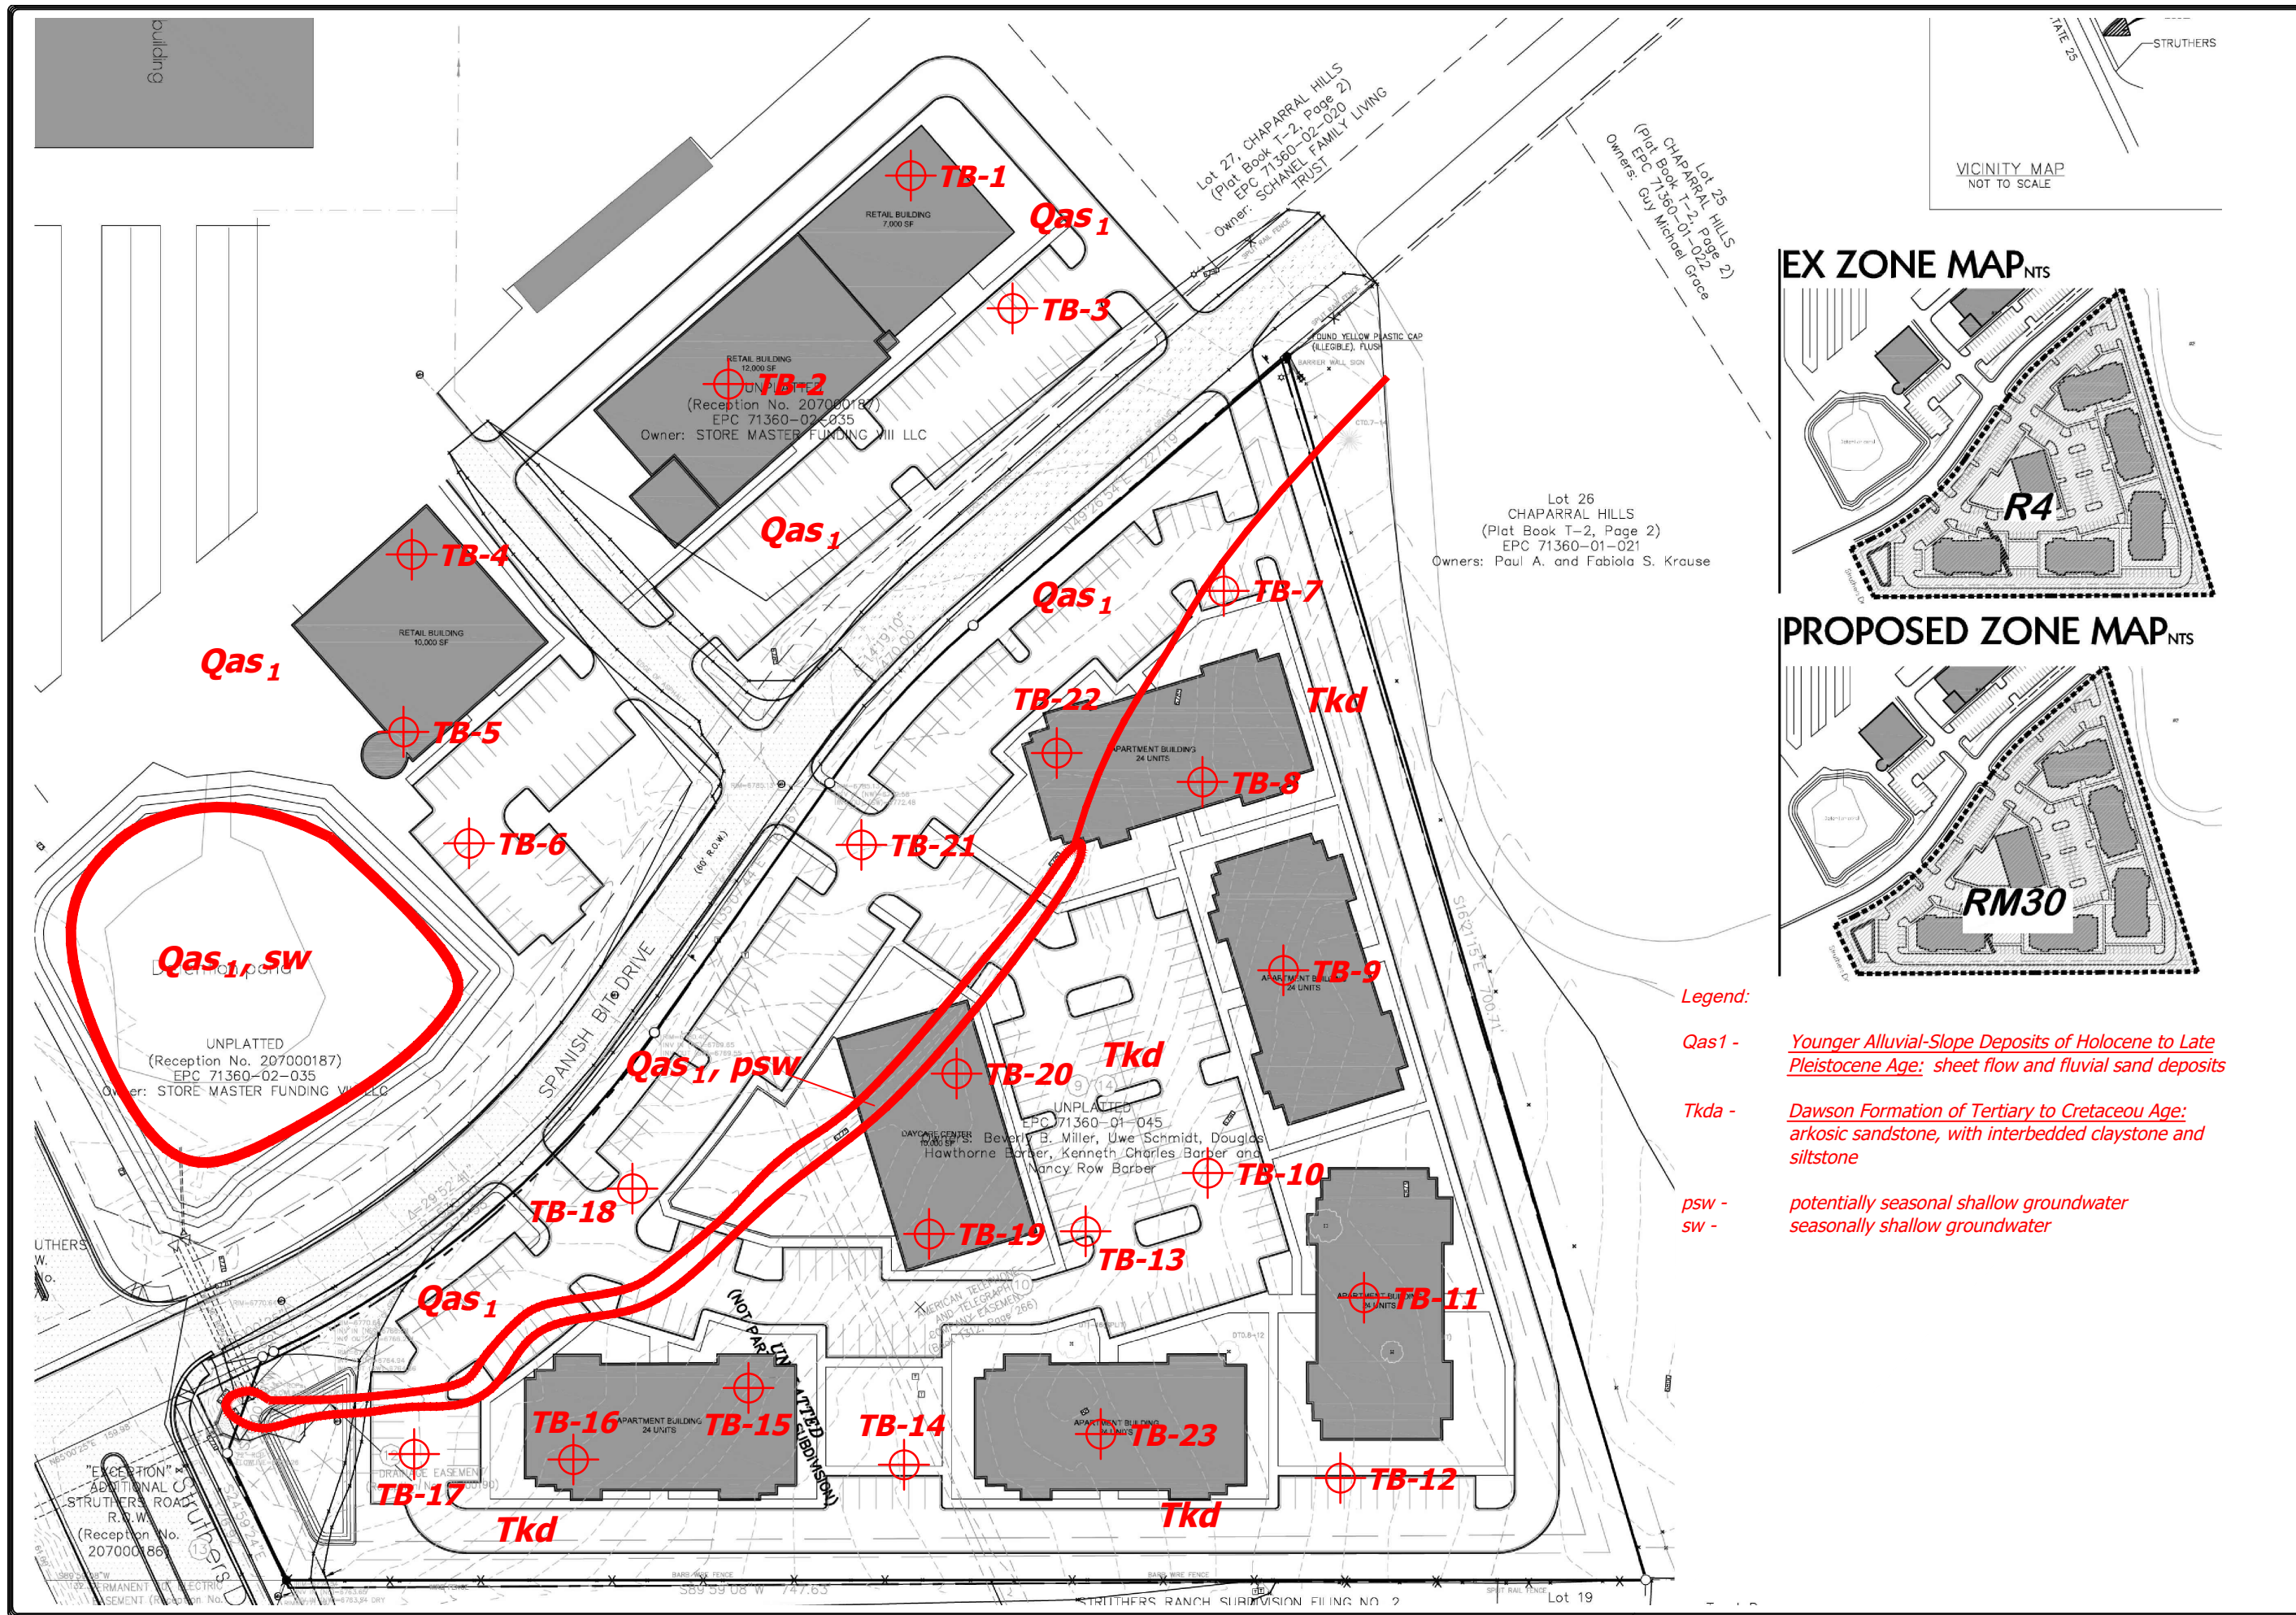
DRAWN	L.L.
CHECKED	
DATE	12/23/21
SCALE	AS SHOWN
JOB NO.	210536
FIGURE NO.	6

Detailed mapping has been performed on this site to produce a Geology Map/Engineering Geology Map Figure 6. This map shows the location of various geologic conditions of which the developers should be cognizant during the planning, design and construction stages of the project. Constraints/Hazards include potentially collapsible/expansive soils, potential seasonal shallow groundwater, and seasonal shallow groundwater areas. These constraints/hazards and the recommended mitigation techniques are as follows:

The area mapped with this hazard is the minor drainage swale located in the southwestern portion of the site. In this area, we would anticipate the potential for periodically high subsurface moisture conditions and possible frost heave potential, depending on the soil conditions. A new detention pond is located in the southwestern portion of the site, and it is anticipated that site grading will mitigate the hazard.

The area mapped with this hazard is the existing detention pond located in the northwestern portion of the site. In this area, we would anticipate the potential for high subsurface moisture conditions and possible frost heave potential, depending on the soil conditions. This area is will be avoided by the proposed development.

Areas of potential seasonally shallow were observed along the minor drainage swale in the southwestern portion of the site, and an area of seasonal shallow groundwater was observed in the northwestern portion of the site associated with the existing detention pond. These areas will likely be mitigated with the proposed site grading or avoided by the proposed development.

Mitigation Collapsible or expansive soils encountered beneath foundations will require mitigation. Mitigation of expansive soils may require special foundation design. Overexcavation and replacement with non-expansive soils at a minimum of 95 percent of its maximum Modified Proctor Dry Density, ASTM D-1557 is a suitable mitigation, which is common in the area. Floor slabs on expansive soils should be expected to experience movement. Overexcavation and replacement has been successful in minimizing slab movements. Overexcavation depths of 4 feet are anticipated for the site.

Mitigation In these locations, foundations in areas subject to severe frost heave potential should penetrate sufficient depth so as to discourage the formation of ice lenses beneath foundations. At this location and elevation, a foundation depth for frost protection of 2.5 feet is recommended. In areas where high subsurface moisture conditions are anticipated periodically, a subsurface perimeter drain will be necessary to help prevent the intrusion of water into areas

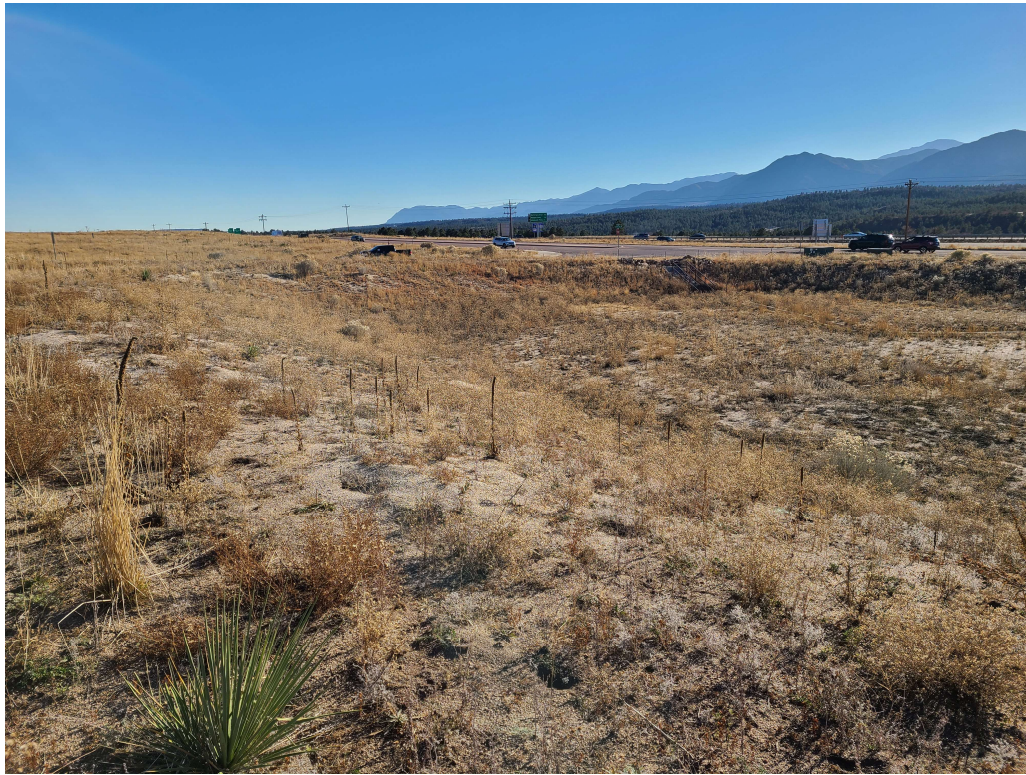
**Looking southwest
from northwestern
portion of the along
the existing detention
pond.**
