**SOIL, GEOLOGY, AND GEOLOGIC HAZARD STUDY  
PARCEL NOS. 43070-00-001 AND 430720-00-015  
WOODMEN ROAD AND HIGHWAY 24  
EL PASO COUNTY, COLORADO**

**Falcon Field, LLC**  
**c/o Springs Engineering, Inc.**  
31 North Tejon Street, Suite 500  
Colorado Springs, Colorado 80903

January 20, 2021

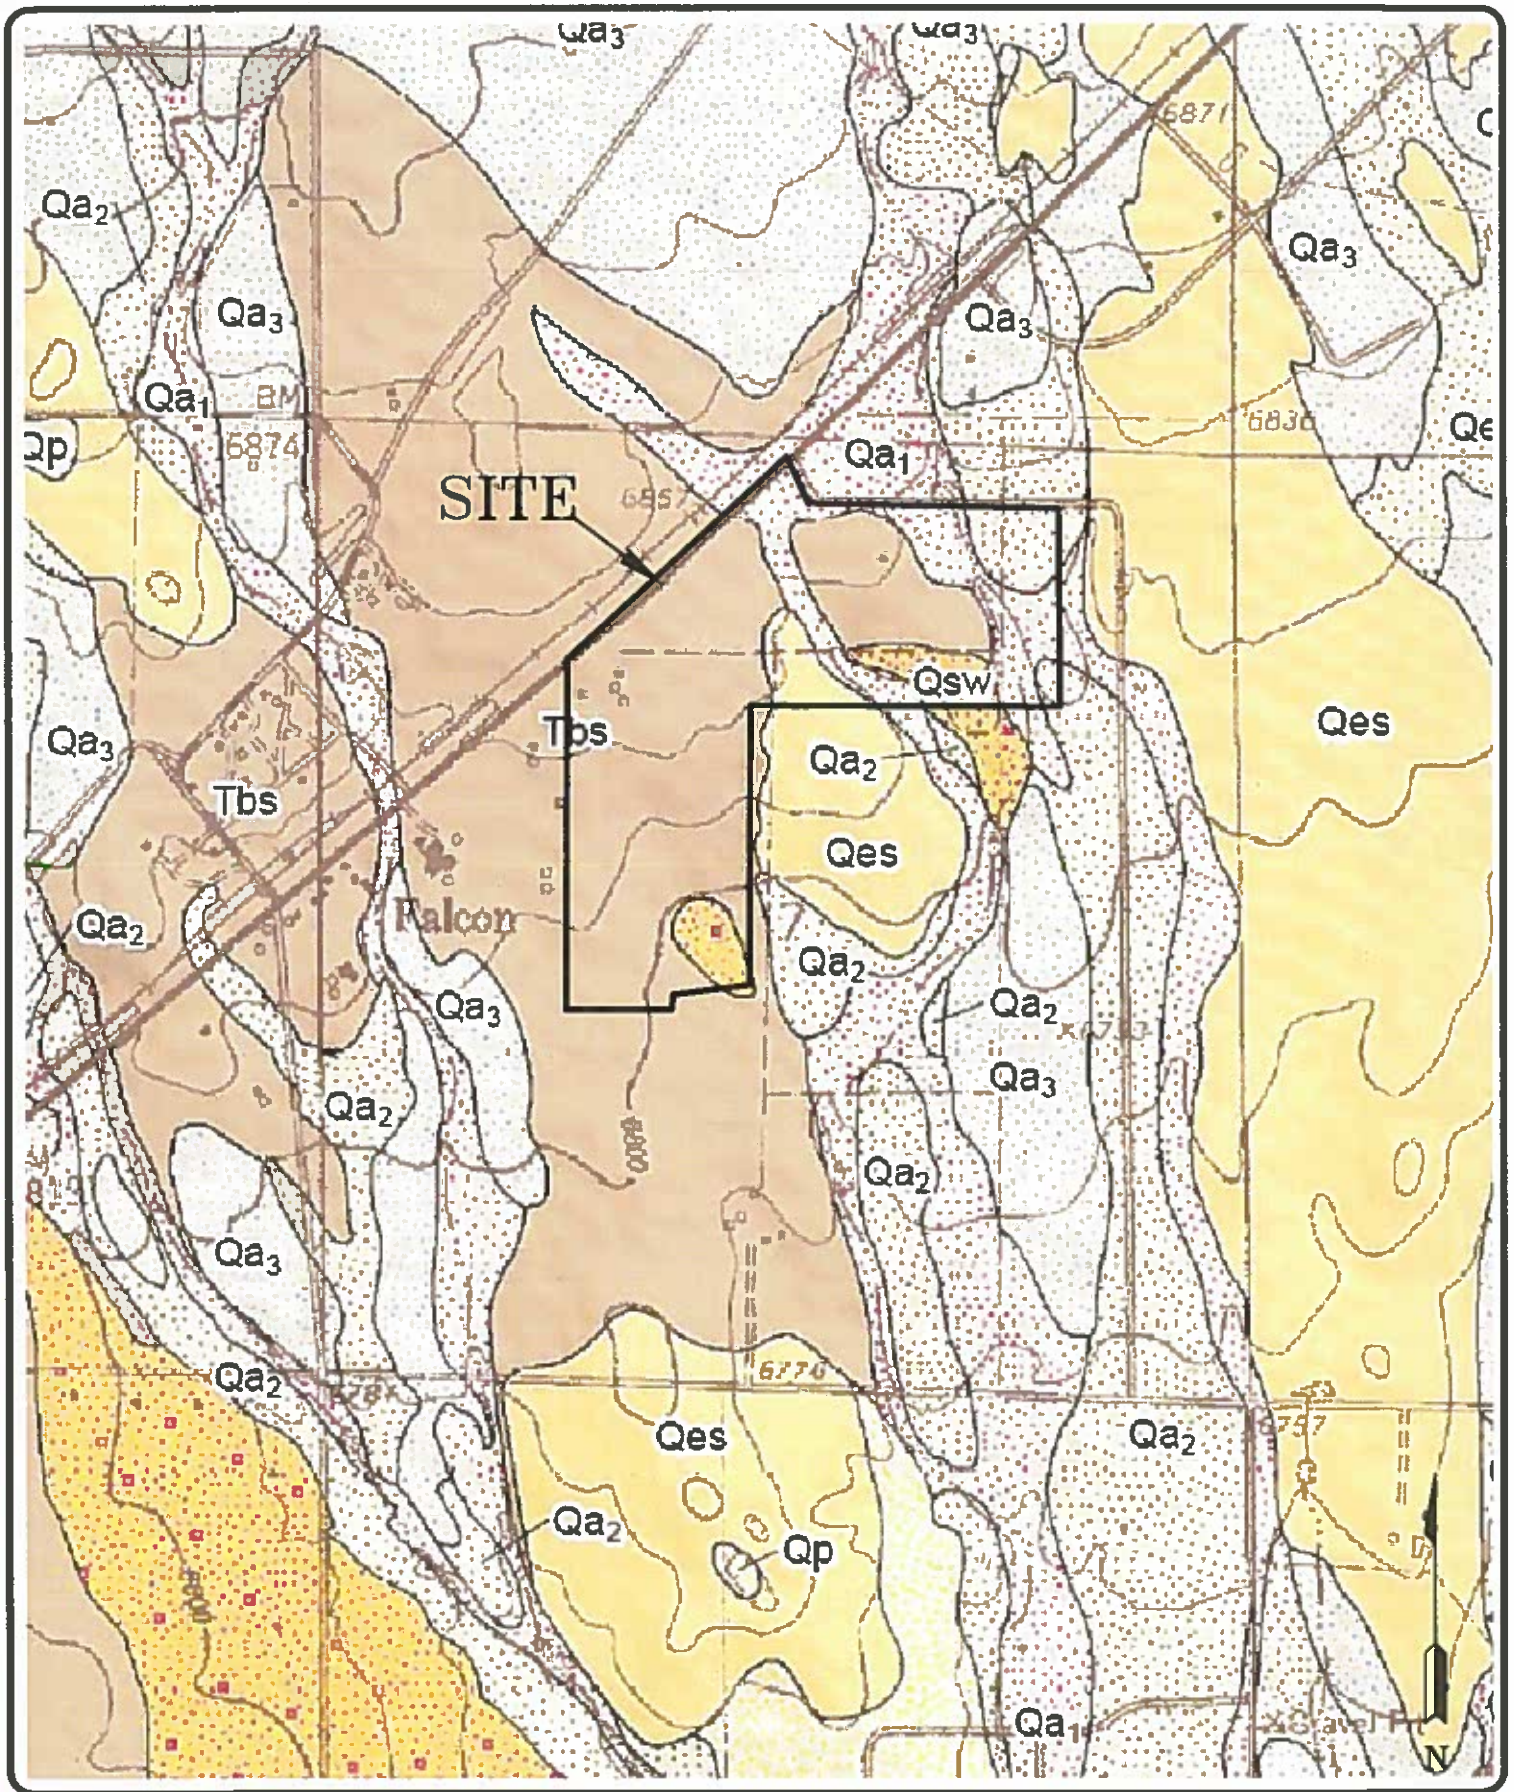
FIG NO.:  
**5**

This does not appear to be the correct location for the floodplain.

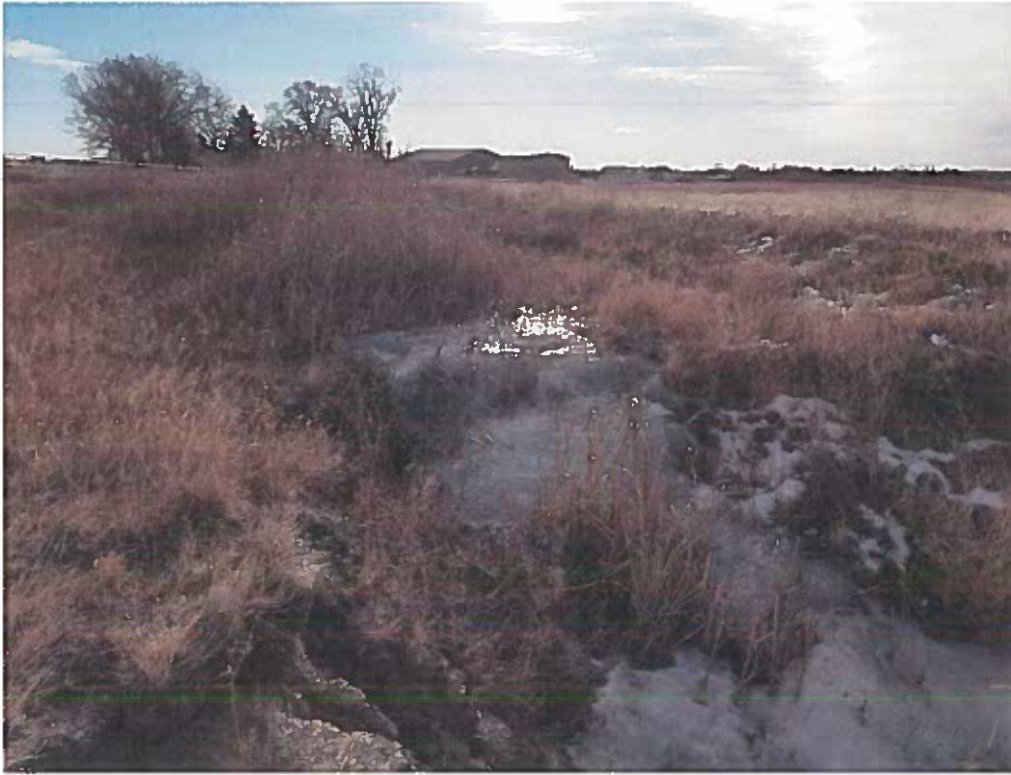
Spring: This area lies within the floodplain area on the eastern portion of the site, therefore, recommendations for the floodplain should be followed for the spring area. Additionally, should development be considered in this area, interceptor drains will be necessary to capture waters and transport them safely around structures. It is anticipated dewatering and drainage systems will be necessary for this site, particularly in the drainage area below the spring.

**Looking northeast  
towards spring in the  
northern portion of the  
site.**

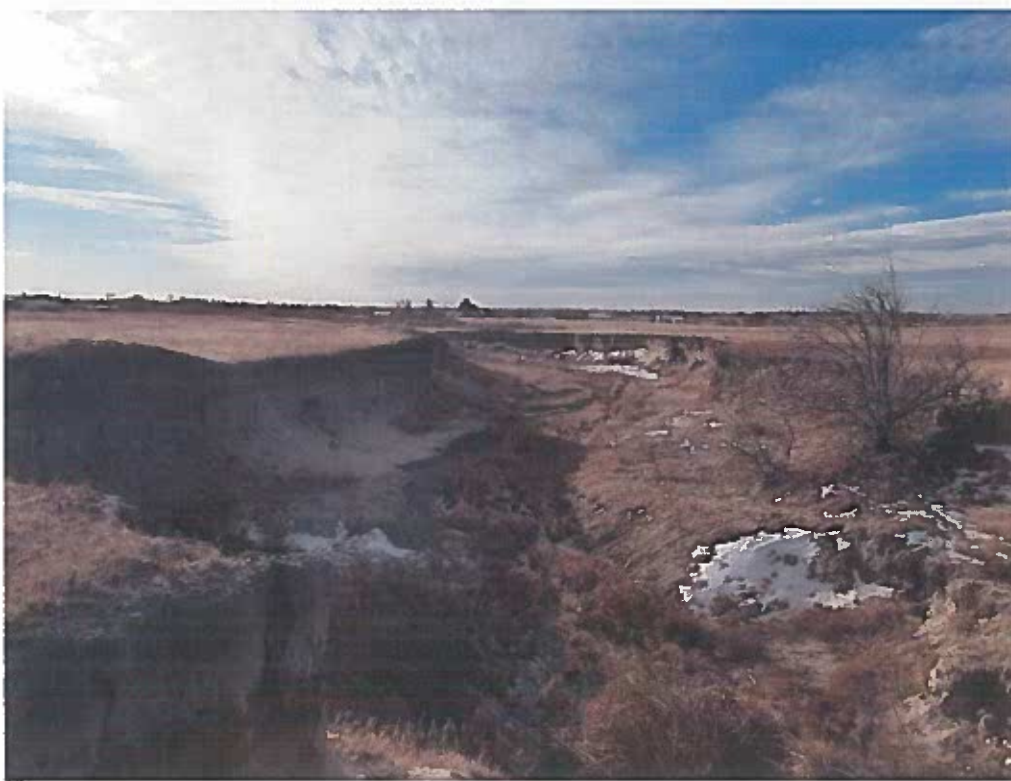
The majority of the slopes on-site are gently sloping and do not exhibit any past or potential unstable slopes or landslides. Some of the steeper slopes along a drainage in the central portion of the site have been identified as unstable slopes. The mitigation recommendation for these areas is as follows:

**Looking southeast  
along drainage in the  
central portion of the  
site.**

Mitigation: Based on the proposed development plan, the majority of the drainage is to be located in a drainage tract. It is anticipated these areas would be avoided or regraded. Building should be avoided on the unstable slopes unless stabilized. A setback of 20 feet from the crest of these slopes is recommended unless stabilized. Stabilization could involve regrading to slope angles no steeper than 3:1 or the use of engineer-designed retaining walls, tiebacks, or buttresses. Where retaining walls are not used, erosion protection may be necessary to prevent undercutting by the creek during periods of high water. Specific slope stabilization recommendations are beyond the scope of this report.
