Job No. 175674

October 1, 2020

Re: Wastewater Study  
Cleese Ct  
EPC Schedule No. 4100000075  
El Paso County, Colorado

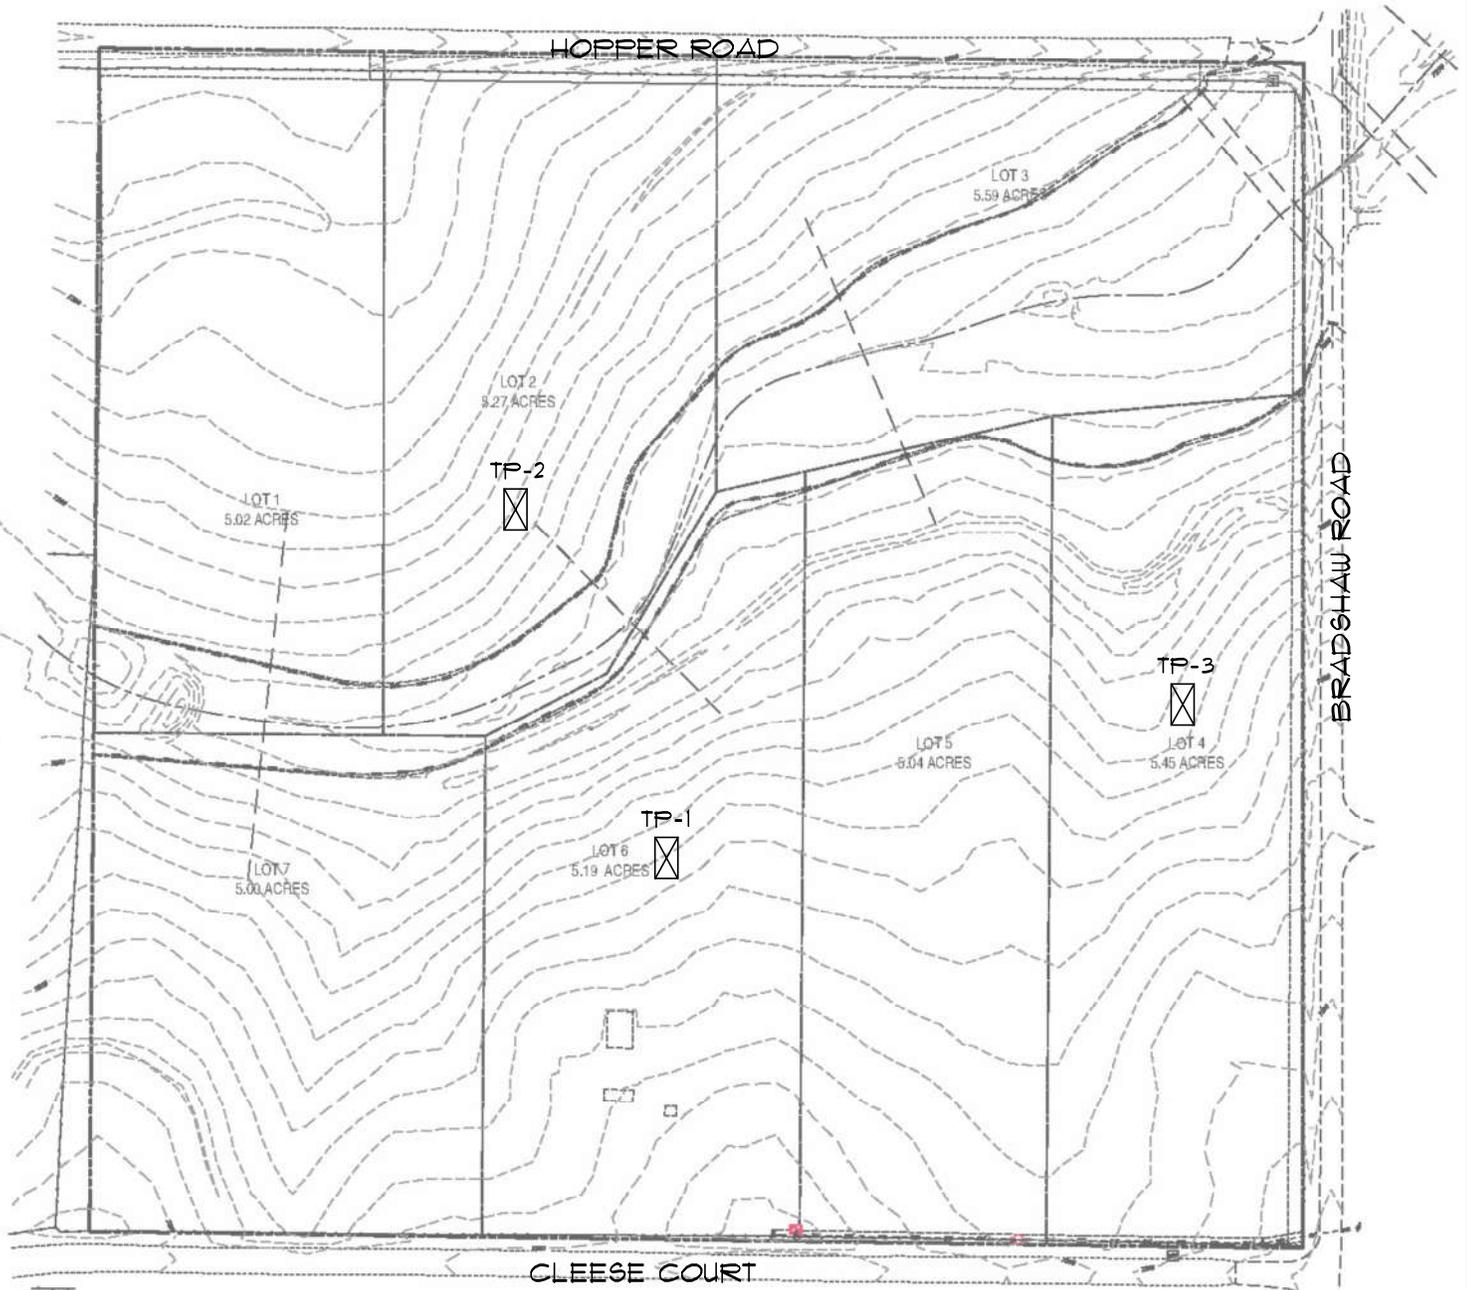
FIG No. 1

Personnel of RMG performed a reconnaissance visit on August 21, 2020. The purpose of the reconnaissance visit was to evaluate the site surface characteristics including landscape position, topography, vegetation, natural and cultural features, and current and historic land uses. Three 8-foot deep test pits were performed across the site, during our reconnaissance visit. A Test Pit Location Plan is presented in Fig 1.

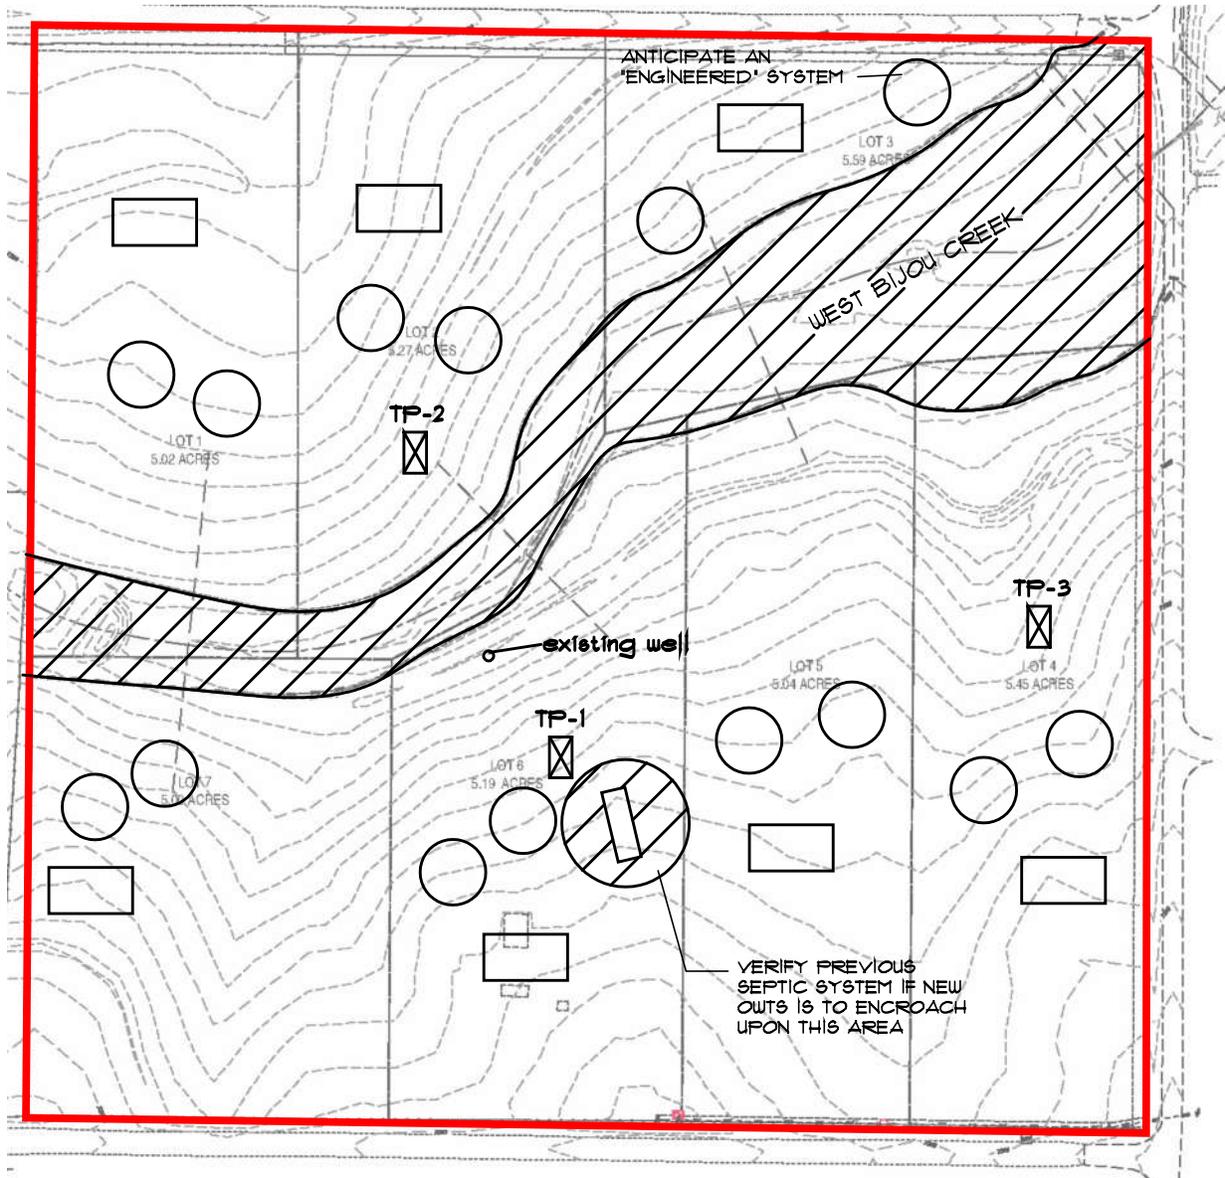
FIG No. 2

- Each new lot shall be laid out to insure that a minimum of 2 sites are appropriate for an OWTS and do not fall within any restricted areas, (e.g. utility easements, right of ways). Based on the test pit observations performed, each new lot has a minimum of two locations for the OWTS, as presented on the OWTS Suitability Map, Figure 2.

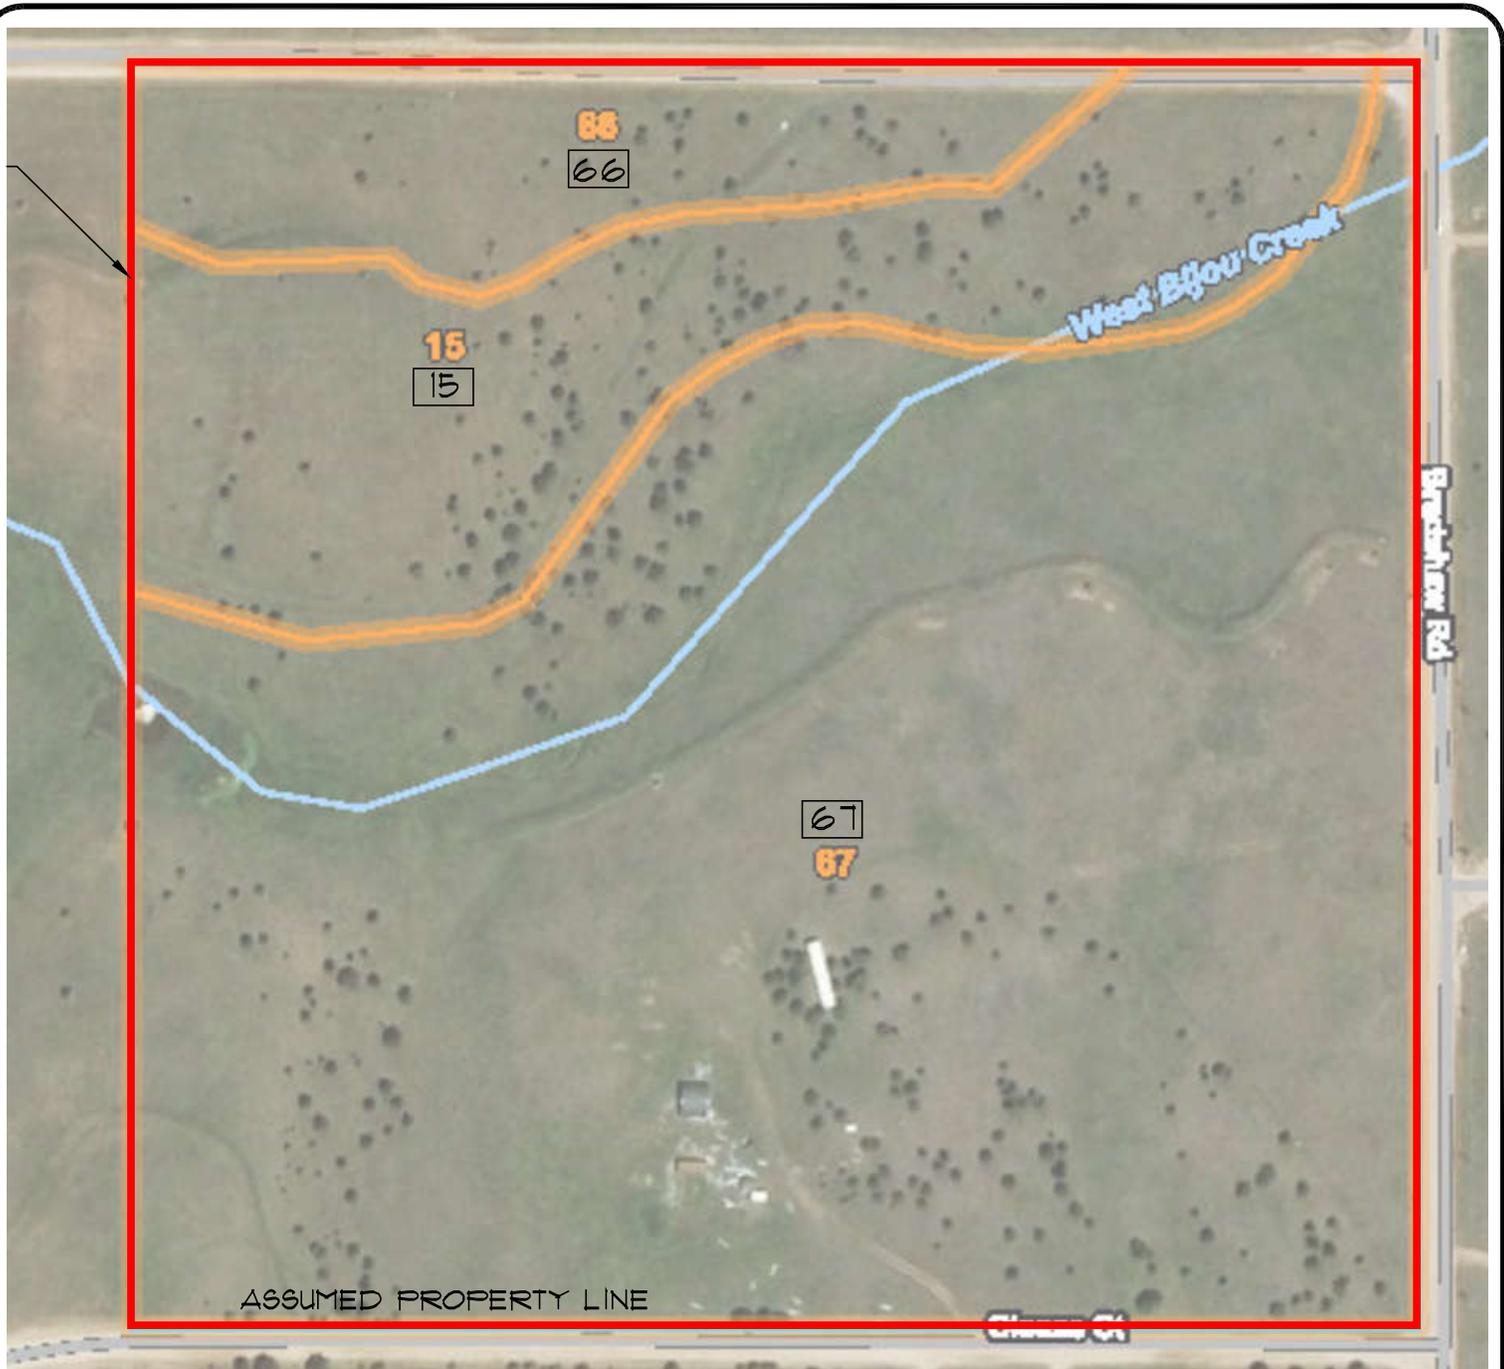
FIG No. 3

The soil conditions as indicated by the NRCS data are anticipated to consist of Peyton sandy loam and Brussett loam. The Peyton sandy loam was mapped by the USDA to encompass the majority of the southern of the property with slopes ranging from 1 to 9 percent. Properties of the Peyton sandy loam include somewhat well drained soils, depth of the water table is anticipated to be greater than 80 inches, runoff is anticipated to be medium, frequency of flooding and/or ponding is none, and landforms include hills and flats. Brussett loam was mapped to encompass a sliver of the northern property. The Brussett loam has slopes that range from 3 to 5 percent. Properties of the Peyton sandy loam include somewhat well drained soils, depth of the water table is anticipated to be greater than 80 inches, runoff is anticipated to be low, frequency of flooding and/or ponding is none, and landforms include hills. A USDA Soil Survey Map and USDA Full Map Unit Descriptions are attached in Figures 3 and 4.
