**SOIL, GEOLOGY AND
GEOLOGIC HAZARD STUDY
CLOVERLEAF DEVELOPMENT
MONUMENT, EL PASO COUNTY, COLORADO**

Proterra Properties, LLC
1864 Woodmoor Drive, Suite 100
Monument, Colorado 80132

April 7, 2020

Entech Job No. 200100
AAPProjects/2020/200100 soil ge

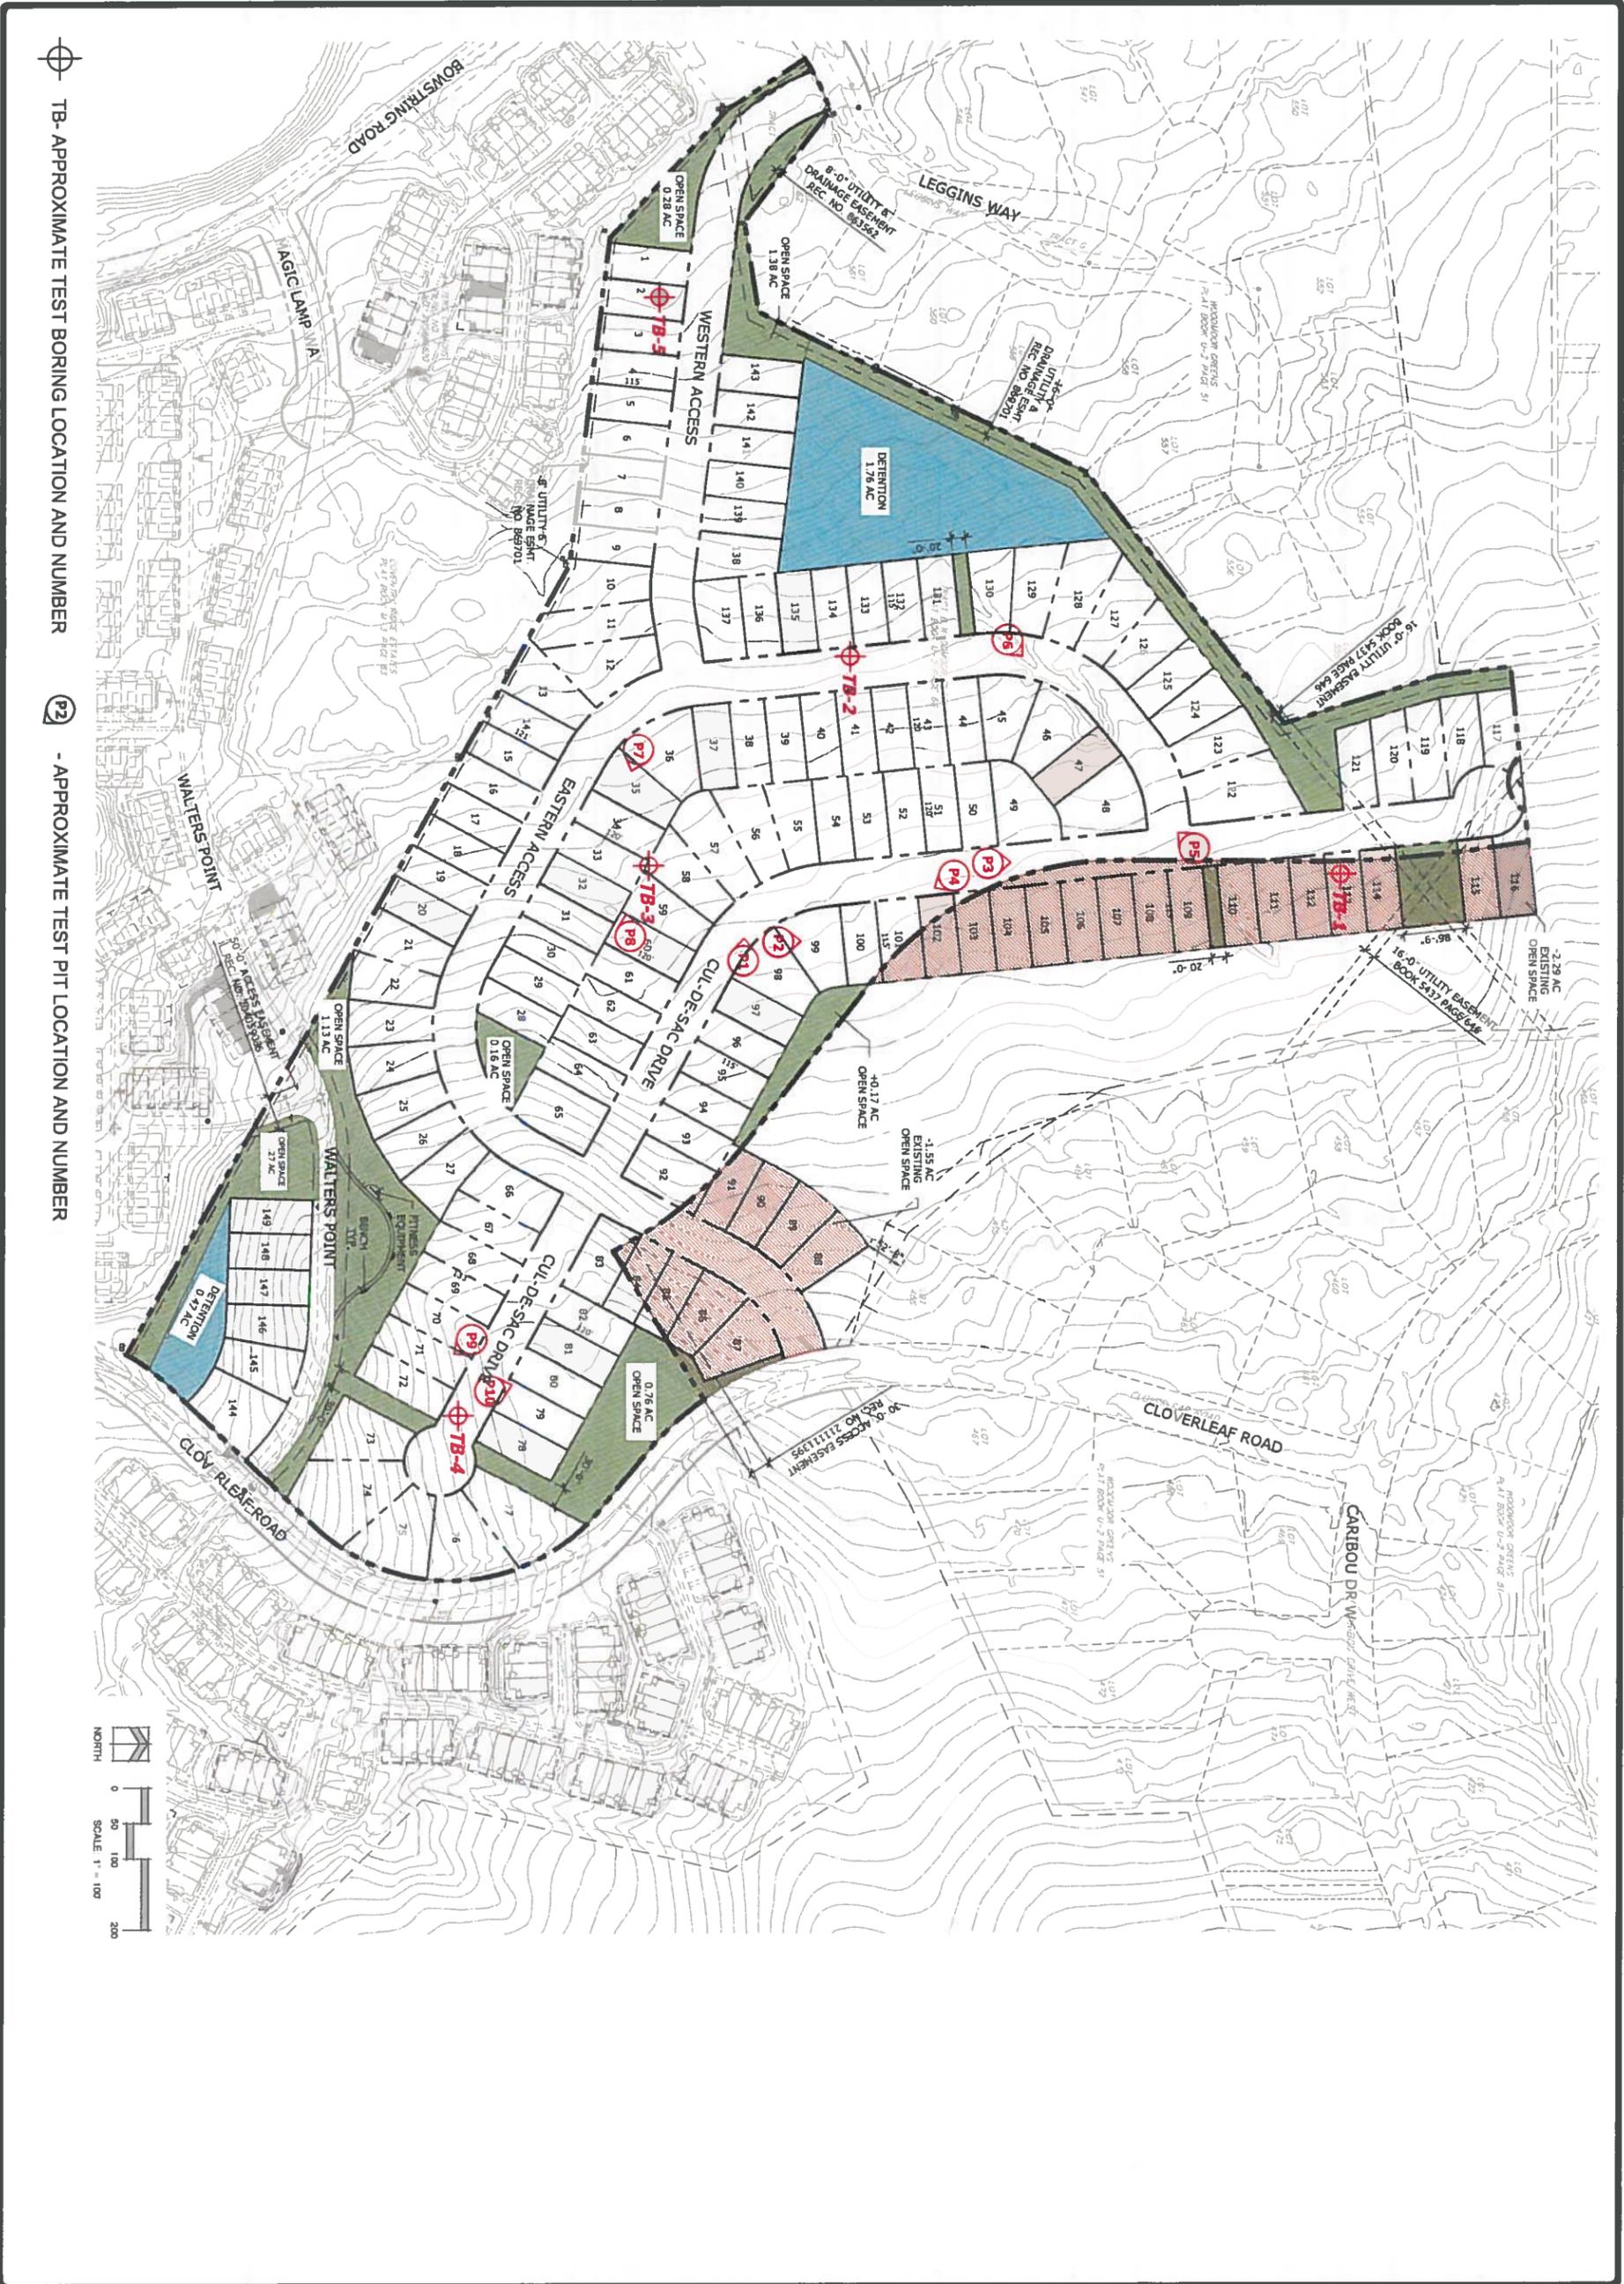
DATE	4/6/20
CHECKED	AS SBO/WH
SCALE	2000/100
FIGURE NO.	3

Additionally, five (5) test borings were drilled as a part of the preliminary subsurface soil investigation for the subdivision to determine general soil conditions. The borings were drilled with a power-driven continuous flight auger drill rig to depths of 20 to 35 feet. Samples were obtained during drilling using the Standard Penetration Test, ASTM D-1586, utilizing a 2-inch O.D. Split Barrel Sampler and a California Sampler. Results of the penetration tests are shown on the drilling logs to the right of the sampling point. The location of the test borings is shown on the Test Boring Location Map, Figure 3. The drilling logs are included in Appendix B.

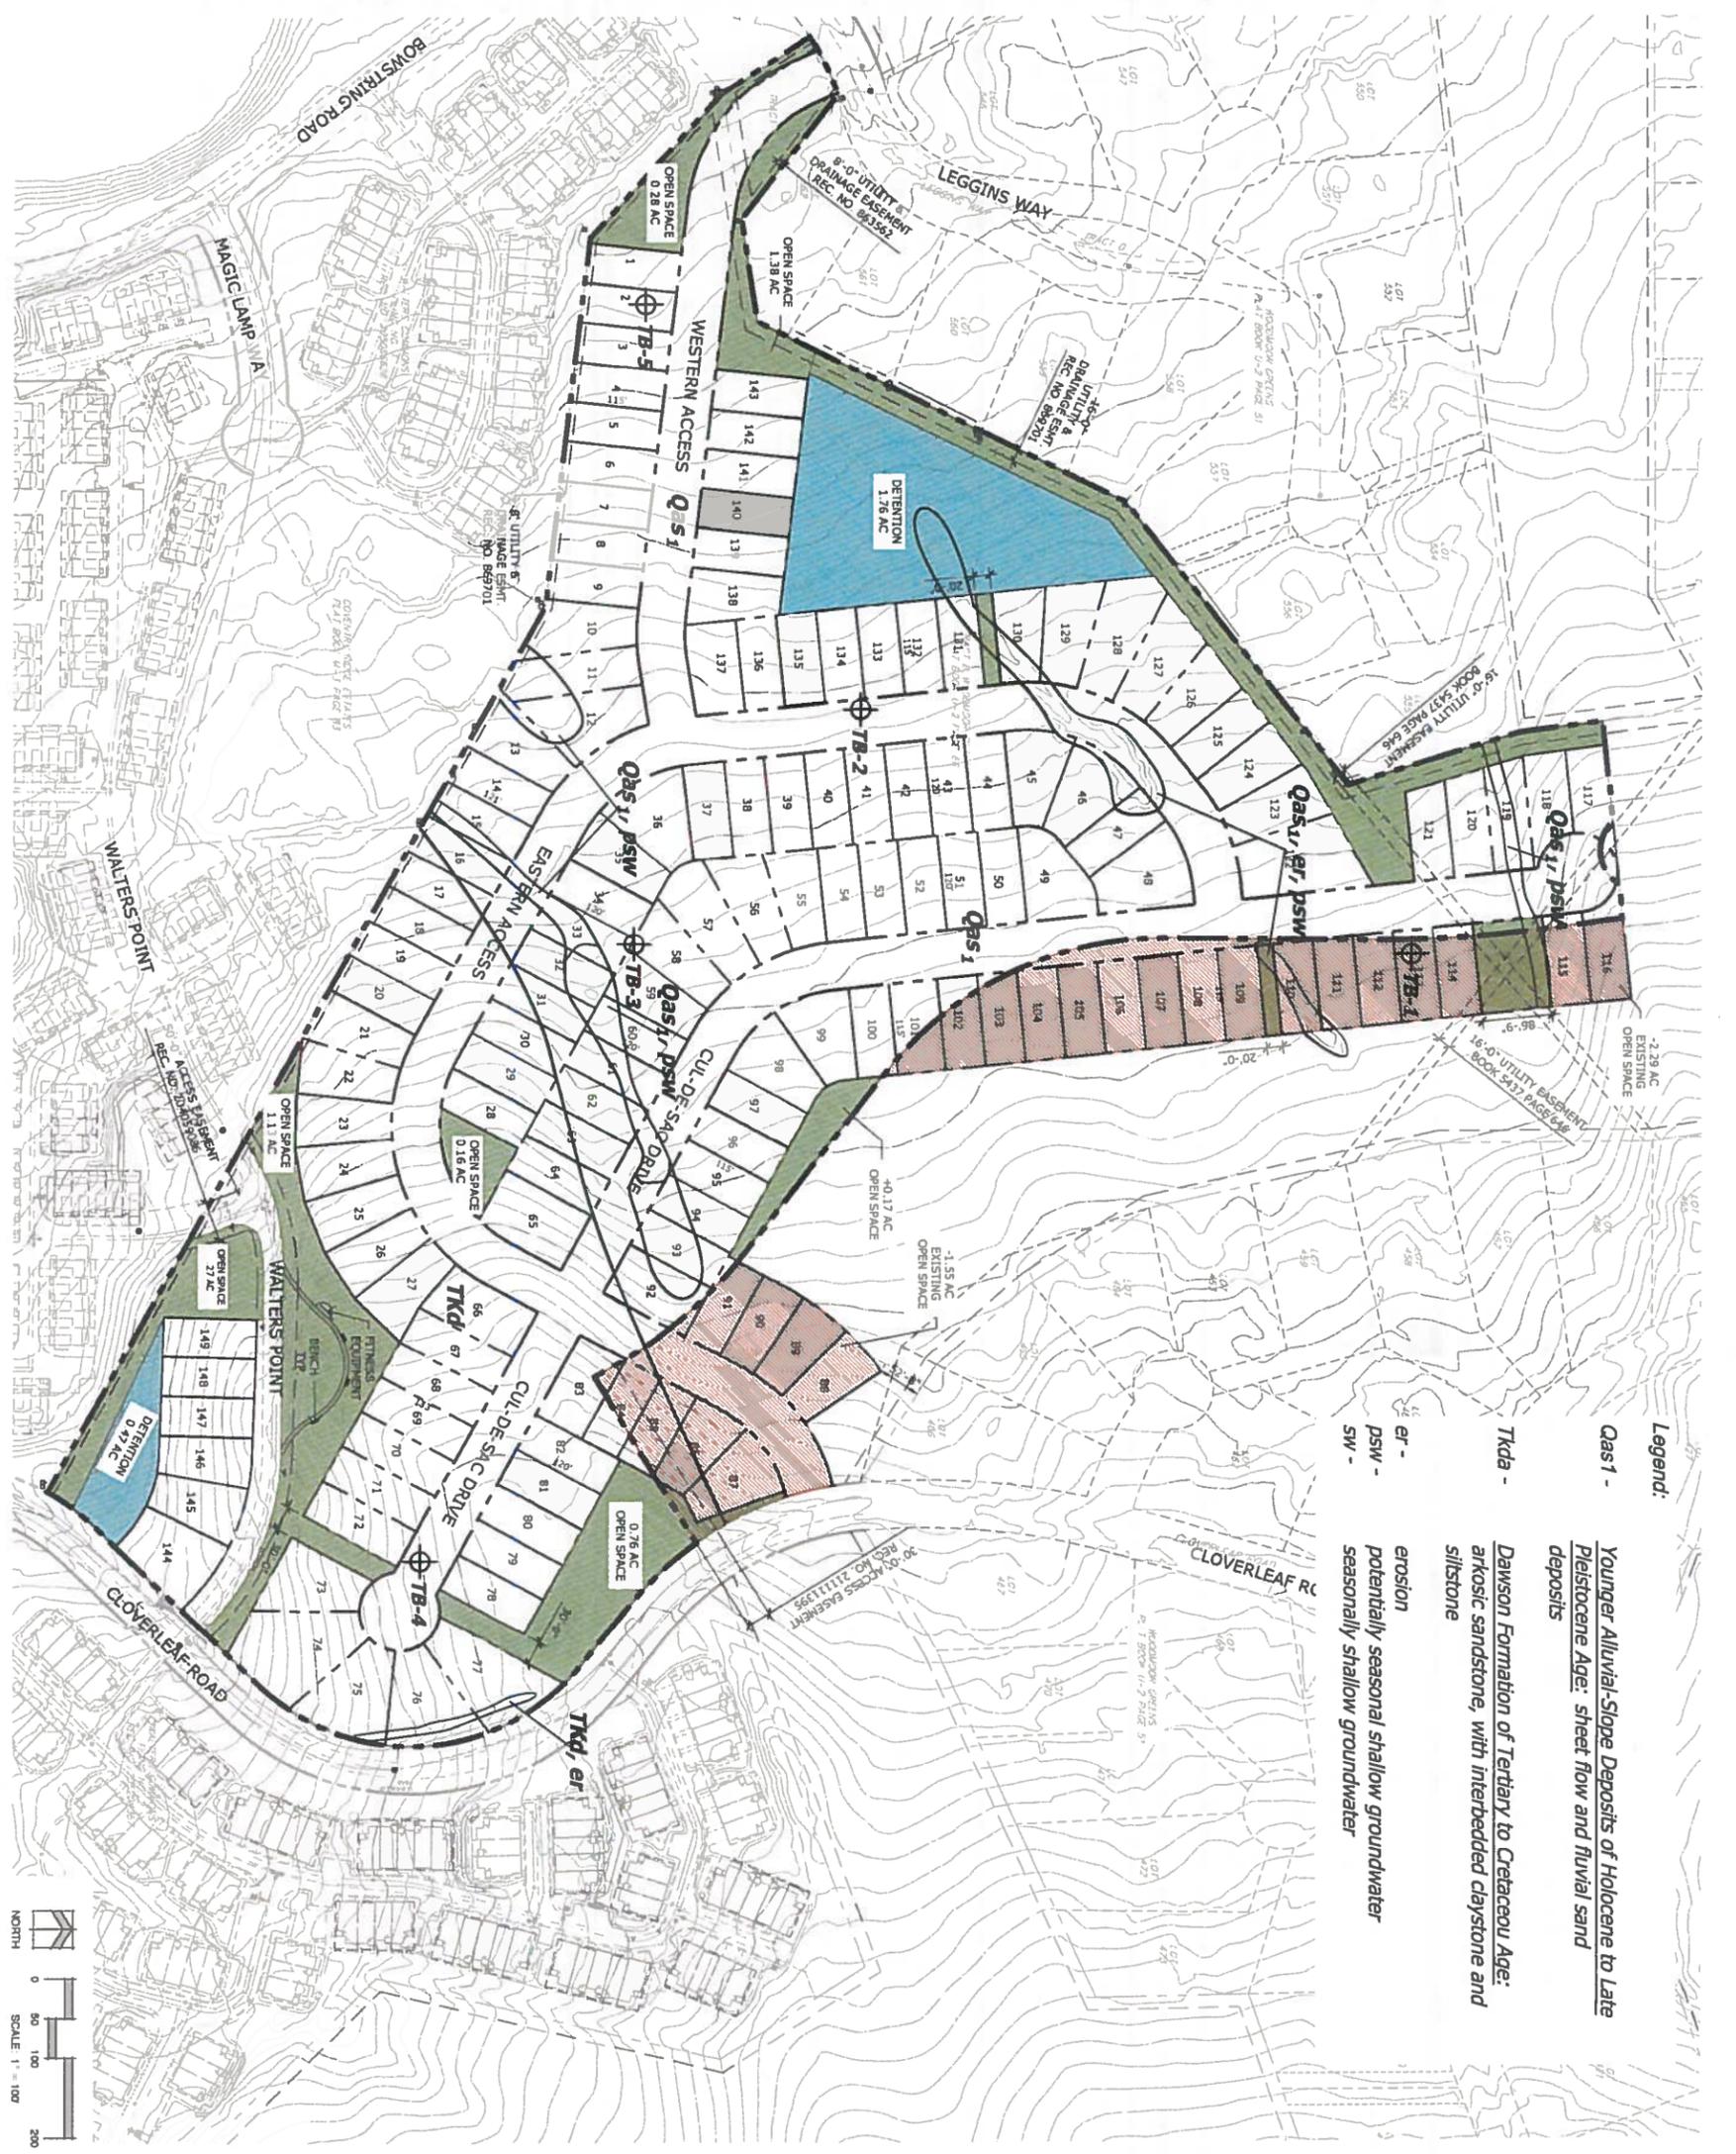
As mentioned previously, detailed mapping has been performed on this site to produce an Engineering Geology Map (Figure 6). This map shows the location of various geologic conditions of which the developers and planners should be cognizant during the planning, design and construction stages of the project. The hazards identified on this site include loose soils, erosion, potentially seasonal shallow groundwater, and seasonal shallow groundwater areas. The following hazards have been addressed as a part of this investigation:

These are areas that are undergoing erosion by water and sheetwash producing gullies and rill erosion. Areas of erosion were observed in the Teachout Creek drainage in the northern portion of the site, and an area along eastern side of the site along Cloverleaf Road.

Groundwater was encountered in four of the five test borings at depths ranging from 12.5 to 33 feet. Areas within the drainages on-site have been identified as potentially seasonal shallow groundwater, and the seasonal shallow groundwater area is located in a minor drainage area in the south-central portion of the site. In this area we would anticipate the potential for surface and near surface groundwater conditions depending on seasonal changes in precipitation and runoff. This area had saturated surface conditions and minor areas of standing water during our field mapping. This area is further discussed in the following section. No areas of the site have been mapped as floodplain zones according to the FEMA Map No. 08041CO278G, Figure 7 (Reference 9). Exact floodplain location and drainage studies are beyond the scope of this report. Groundwater areas are discussed as follows:

In these areas, we would anticipate the potential for periodically high subsurface moisture conditions and possible frost heave potential, depending on the soil conditions. Areas within the drainages on-site have been identified as potentially seasonal shallow groundwater, and the seasonal shallow groundwater area is located in a minor drainage area in the south-central portion of the site. In this area we would anticipate the potential for surface and near surface groundwater conditions depending on seasonal changes in precipitation and runoff. This area had saturated surface conditions and minor areas of standing water during our field mapping. The areas mapped with this designation lie within drainages that will be regraded

Mitigation: Due to the nature of the soils on this site, virtually all the soils are subject to erosion by wind and water. Other minor areas of erosion were observed on site other than those mapped, particularly where some rill erosion has occurred. Areas of erosion can occur across the entire site, particularly if the soils are disturbed during construction. Vegetation reduces the potential for erosion. The areas identified where erosion is actually taking place may require check dams, regrading and revegetation using channel lining mats to anchor vegetation. Further

Mitigation: In these locations, foundations in areas subject to severe frost heave potential should penetrate sufficient depth so as to discourage the formation of ice lenses beneath foundations. Preliminary grading plans indicate the seasonally wet area will be filled. At this location and elevation, a foundation depth for frost protection of 30 inches is recommended. In areas where high subsurface moisture conditions are anticipated periodically, a subsurface perimeter drain will be necessary to help prevent the intrusion of water into areas located below grade. A typical perimeter drain detail is presented in Figure 8. Where shallow groundwater is encountered, additional drains, such as capillary breaks and/or interceptor drains may be necessary typical drain details are presented in Figures 9 and 10. Unstable conditions should be expected where excavations approach the groundwater level. The use of rock, shotcrete, or geo-grids may be necessary to stabilize excavations. Additionally, swales should be created to intercept surface runoff and carry it safely around and away from structures. The drainages will be filled during site grading mitigating the seasonal shallow and potentially seasonally shallow groundwater hazards. The water table may be of sufficient depth to minimize the effects on buildings; however, groundwater may be encountered during utility trenches during site development. All soft and organic soils should be removed prior to fill placement. Stabilization of the subgrade with rock and fabric prior to placing fill may be necessary if saturated unstable conditions are encountered.

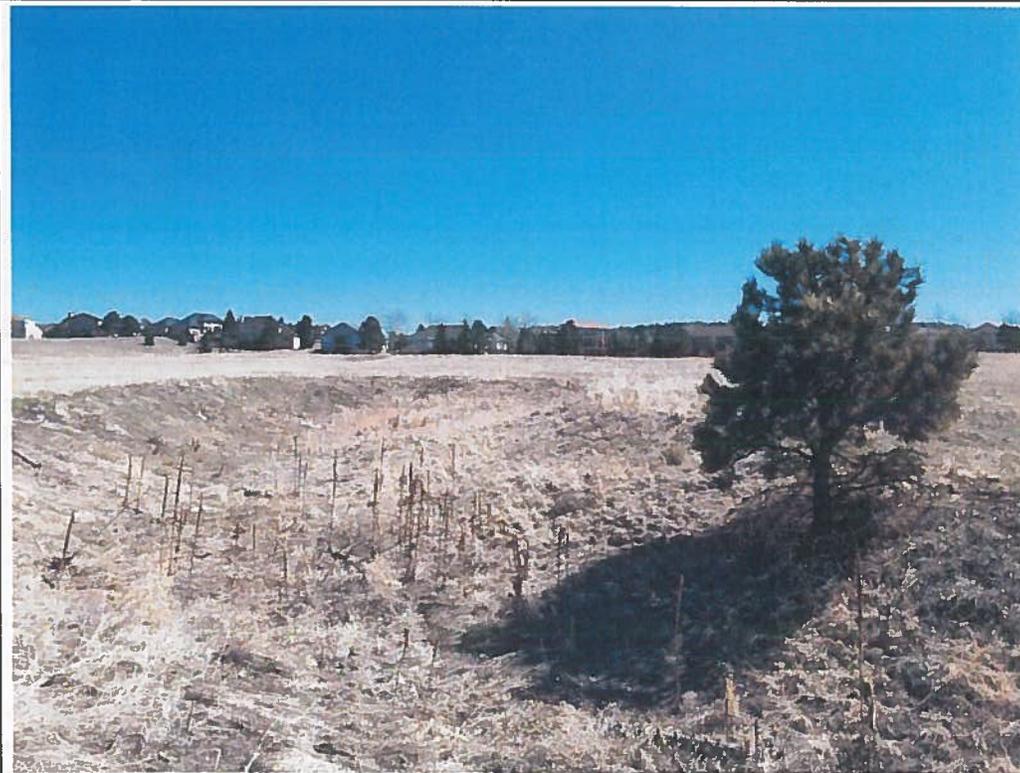
**Looking northeast
along Teachout Creek
in the northwestern
portion of the stie.**

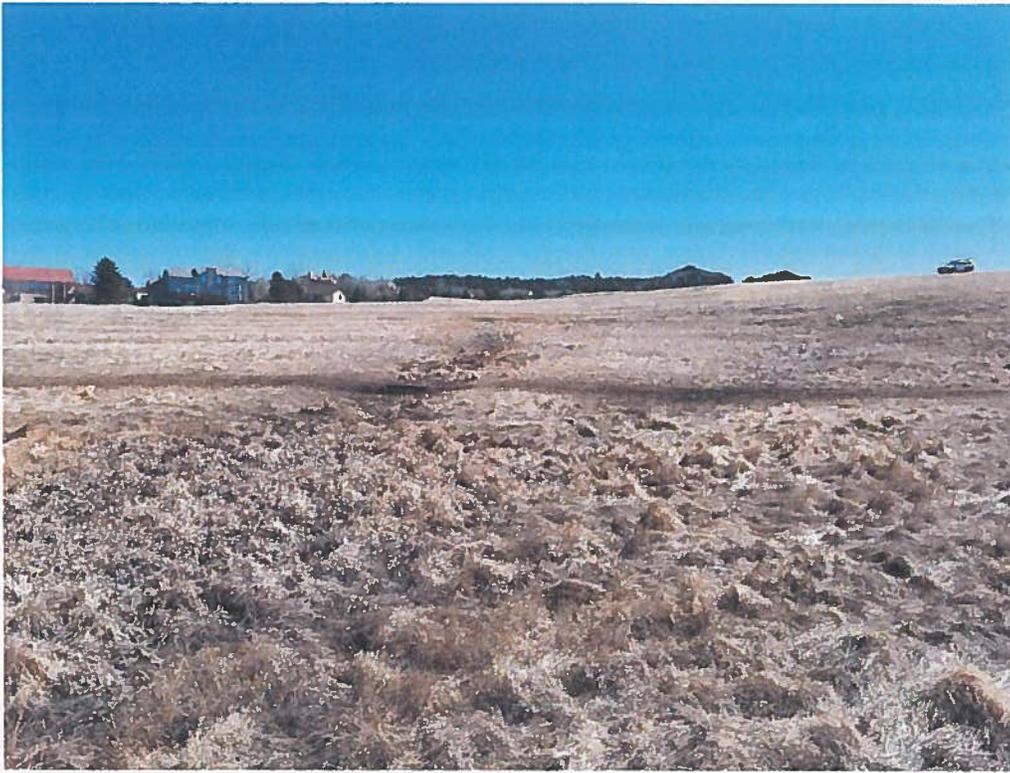
**Looking east along
seasonally wet area in
the central portion of
the site.**

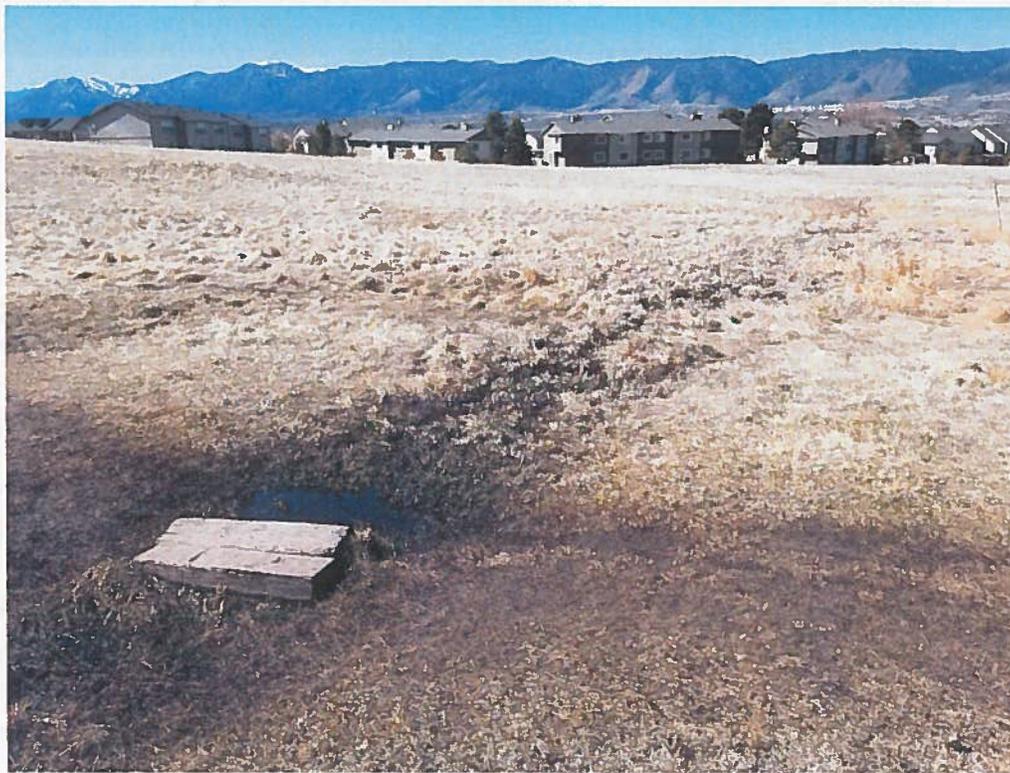
**Looking west along
seasonally wet area in
the central portion of
the site.**
