## SOIL AND GEOLOGY STUDY

**Esteban Subdivision  
3 parcels totaling 496.25 acres  
EL Paso County, Colorado**

**JOB NO. 190388**

**April 27, 2023**

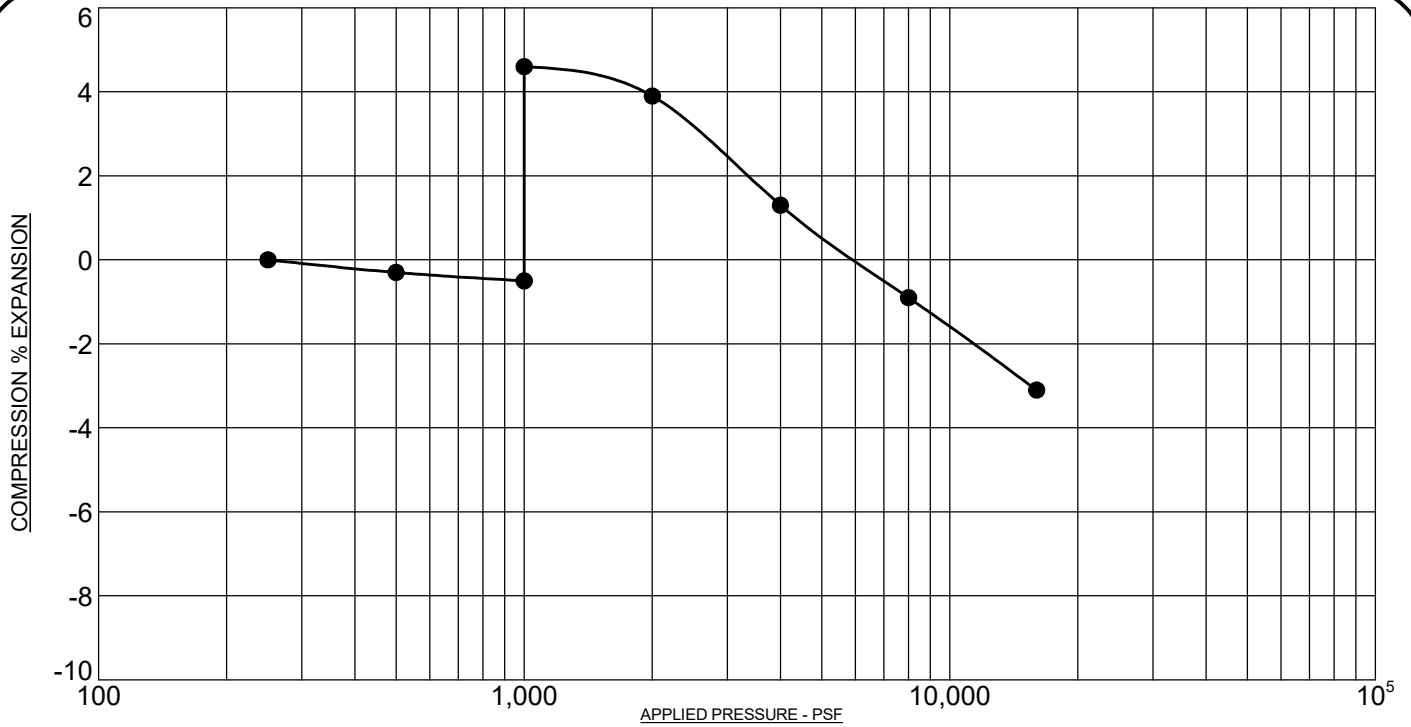
Based on the test borings performed for this investigation and our experience with similar soils in the area, the sandy clay and claystone bedrock generally possess low to high swell potential. It is anticipated expansive clay soils or claystone bedrock will be encountered at the time of the site-specific subsurface soil investigations, and that final mitigations and construction recommendations will be provided at that time. These materials are readily mitigated with typical construction practices common to this region of El Paso County, Colorado.

SAMPLE LOCATION: 3 @ 4 FT  
 NATURAL DRY UNIT WEIGHT: 112.8 PCF  
 NATURAL MOISTURE CONTENT: 14.9%  
 PERCENT SWELL/COMPRESSION: 5.1

Localized overexcavation below the proposed foundations and replacement with structural fill is anticipated to be the preferred mitigation. Overexcavation is anticipated for the majority of the lots. Overexcavation depths of 3 to 6 feet are anticipated. Moisture-conditioning and recompacting the on-site clays (if desired) may also be considered for mitigation of expansive materials, but may result in differing overexcavation depths and foundation design parameters. Floor slabs bearing directly on expansive material should be expected to experience a higher degree of movement. Overexcavation and replacement below the floor slabs has been successful in reducing slab movement.

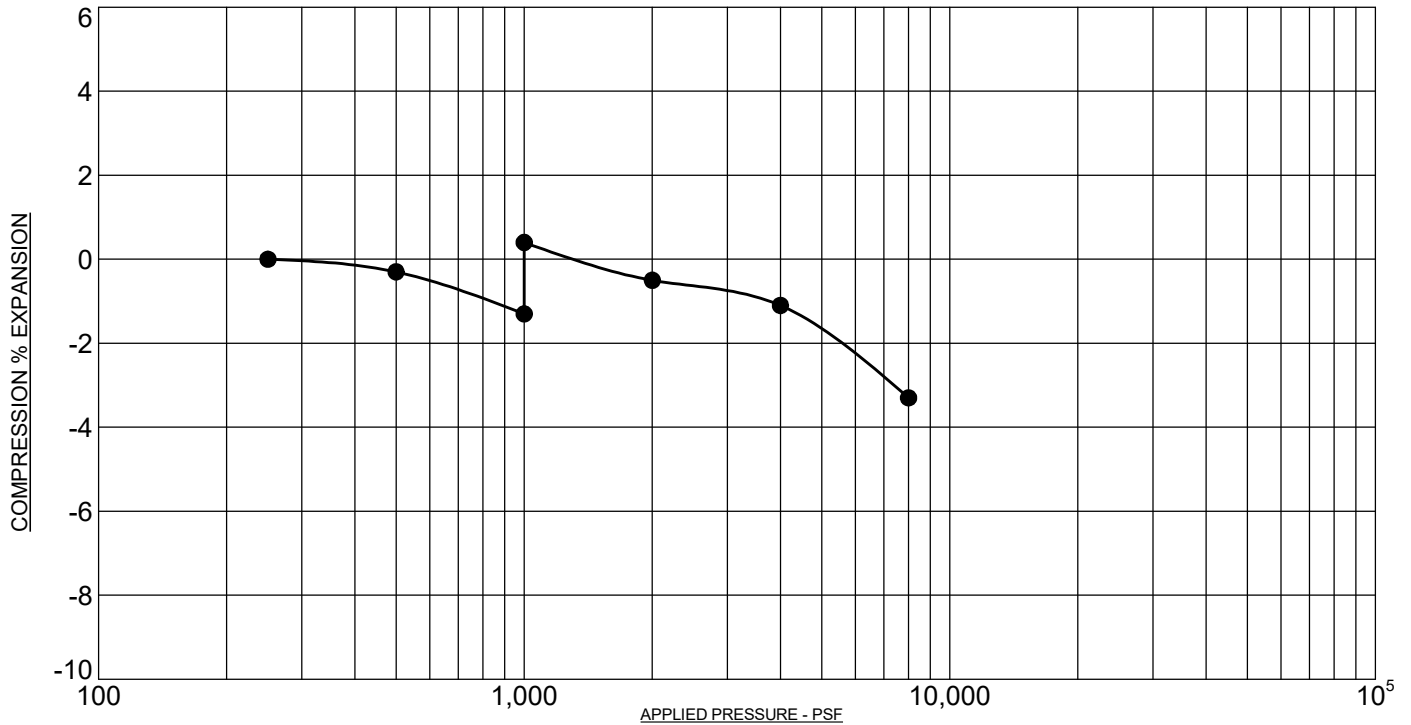
SAMPLE LOCATION: 14 @ 14 FT  
 NATURAL DRY UNIT WEIGHT: 102.5 PCF  
 NATURAL MOISTURE CONTENT: 23.7%  
 PERCENT SWELL/COMPRESSION: 1.7

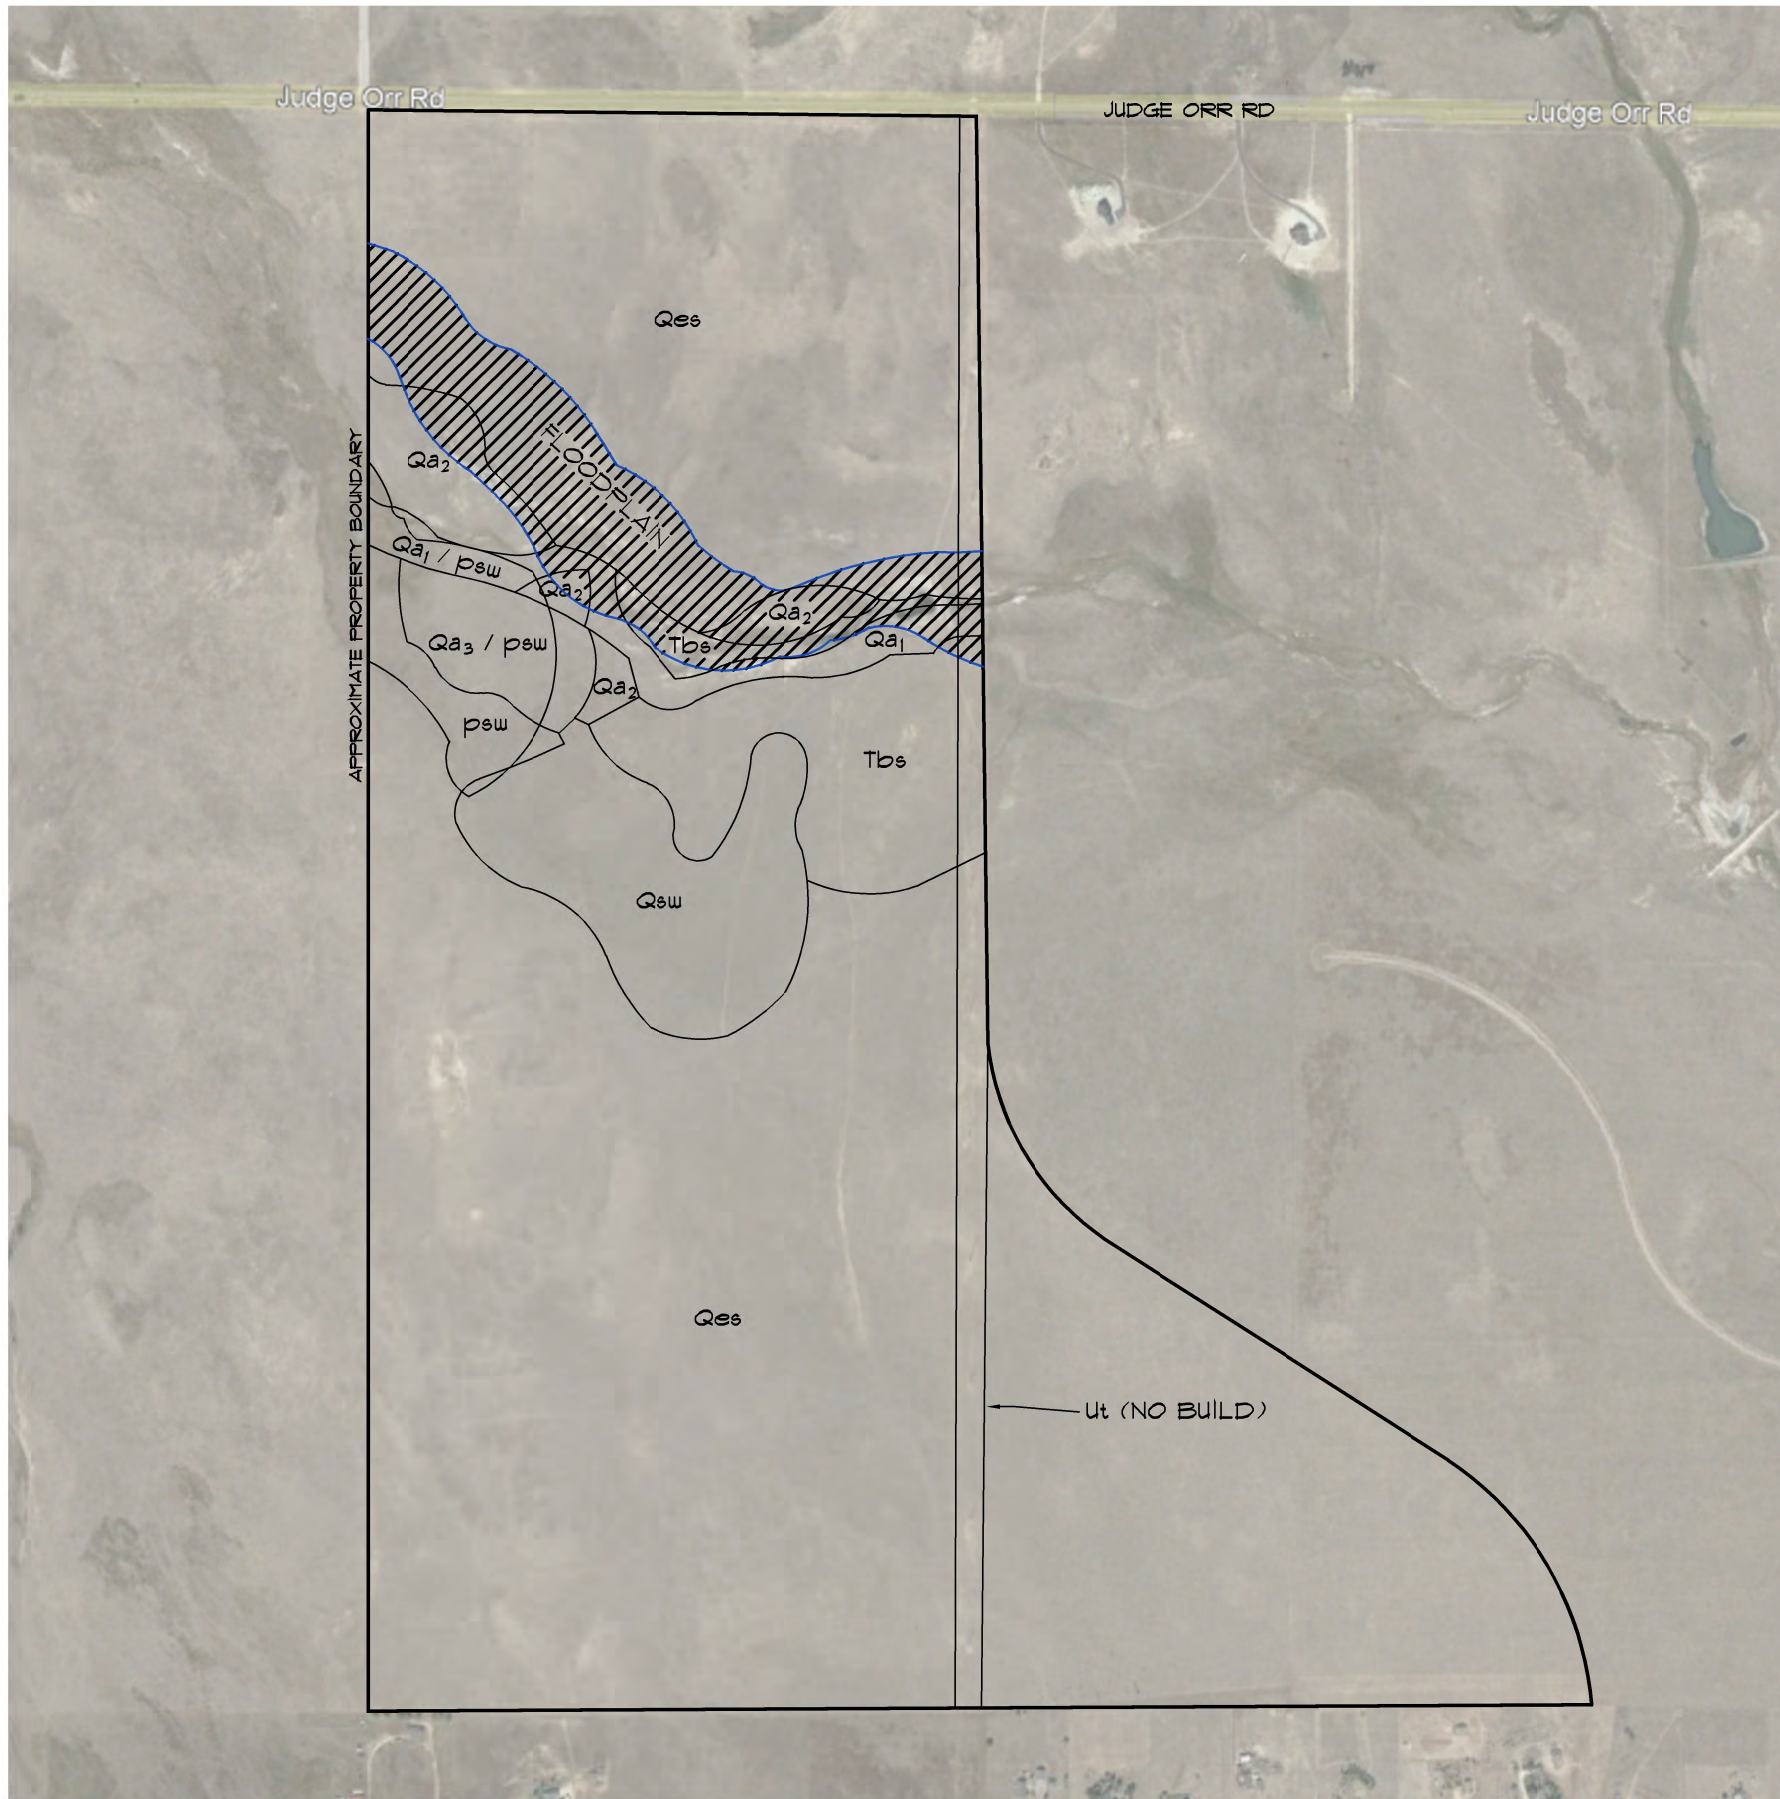
Based on our field observations and review of relevant geologic maps, we identified the geologic conditions (listed below) affecting the development, as shown on the Engineering and Geology Map, Figure 28.

- *psw* – *potential seasonally wet* - areas that may collect surface water during high moisture events.

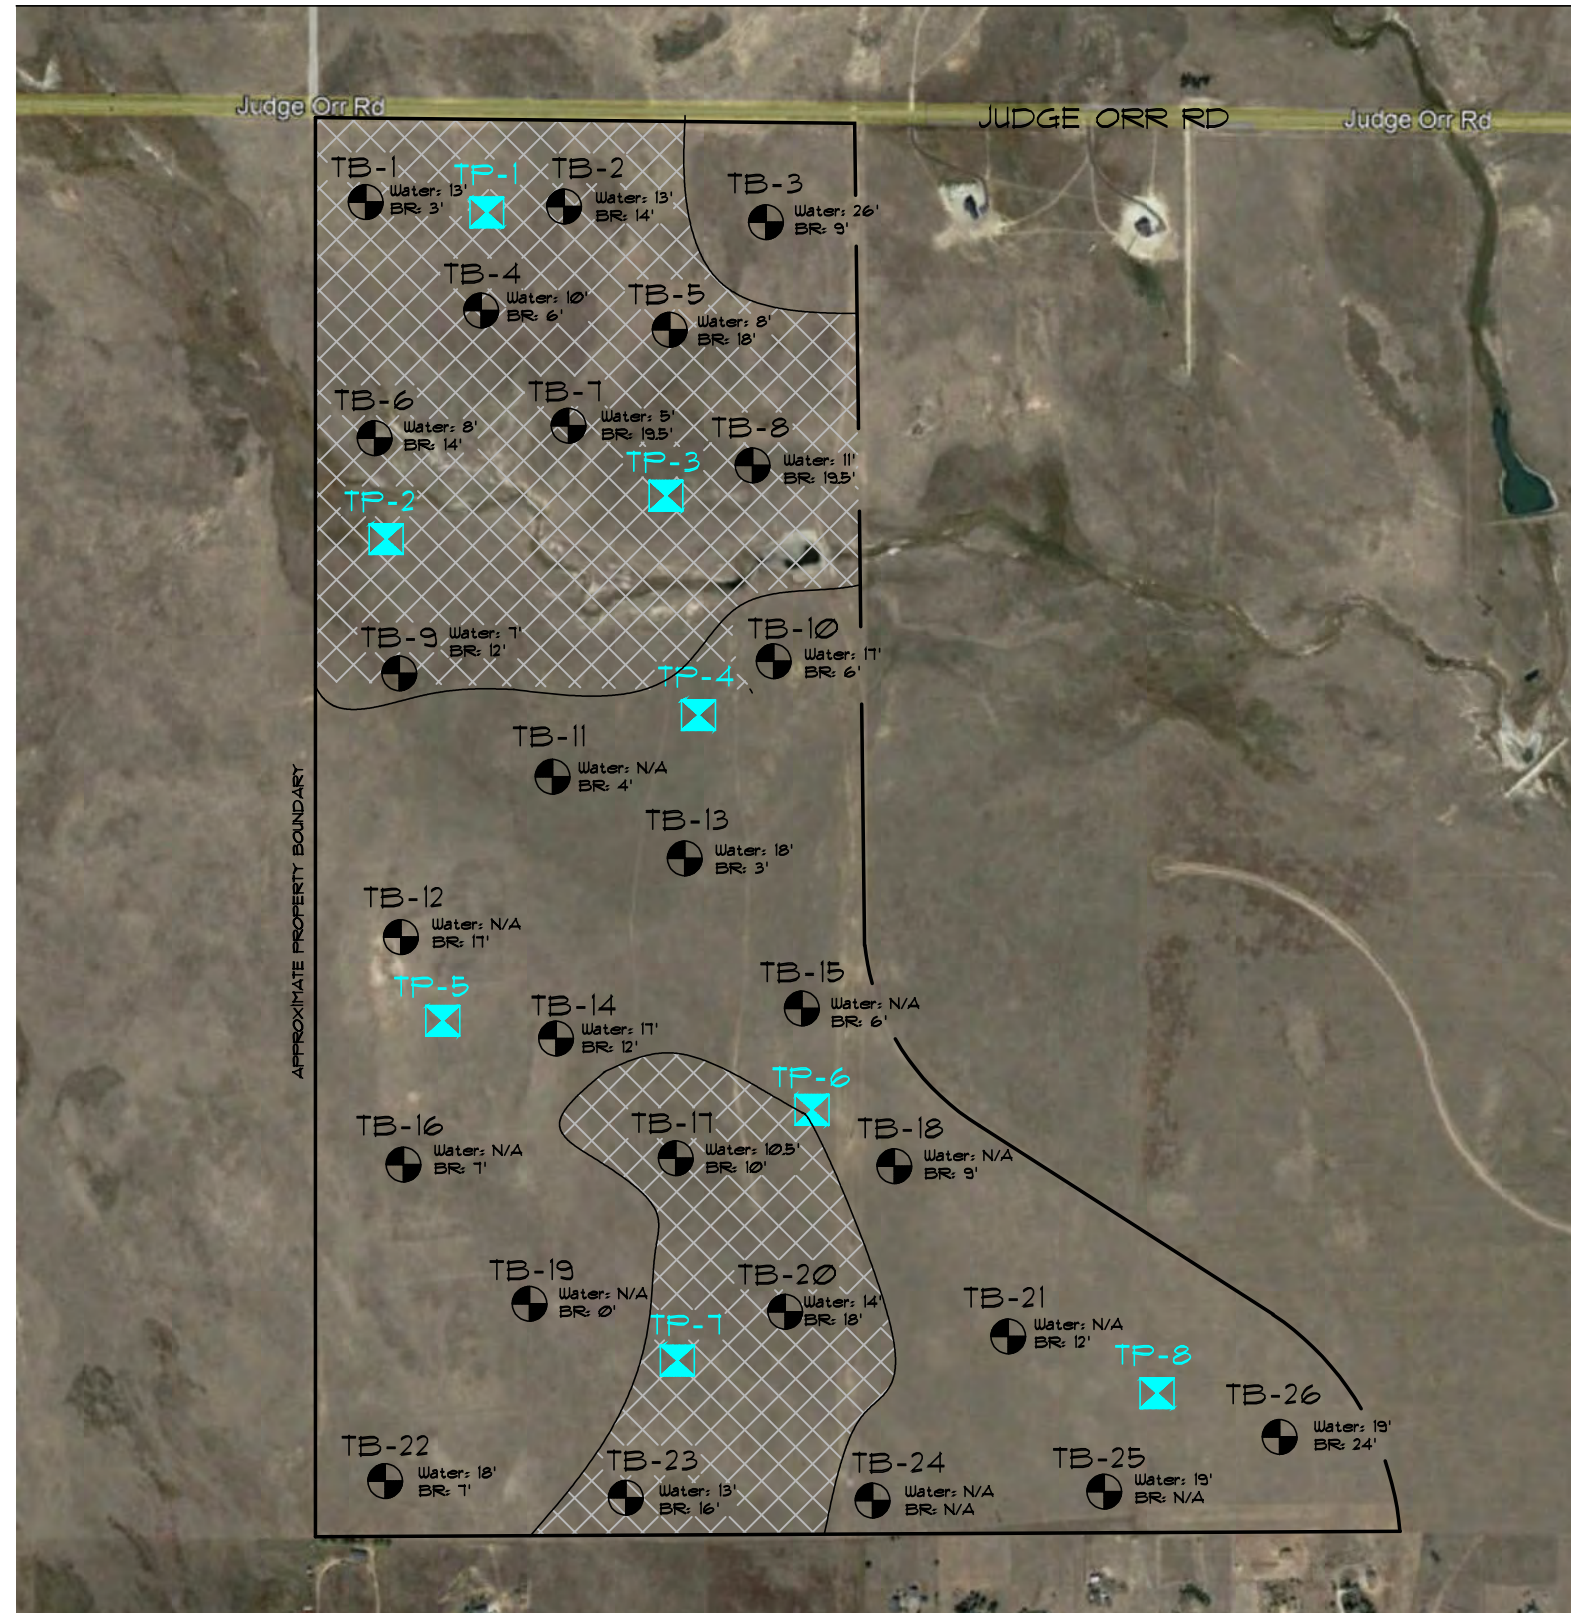
SHEET No.  
**FIG-31**

Based on our knowledge of the area and engineering design and construction techniques commonly employed in the El Paso County area at this time, it is our opinion that basements should be restricted in areas where groundwater was encountered at 15 feet or shallower. Additional recommendations are presented in **Section 8.4**. Shallow groundwater conditions are anticipated to be found at the time of the site-specific subsurface soil investigations.

BASEMENT  
FEASIBILITY MAP

The feasibility of basement construction should be evaluated through a site-specific subsurface soil investigation for each lot. Seasonal variations in groundwater levels are expected due to the unnamed drainageway. It is assumed underground water beneath the subject site predominates in fractured weathered consolidated sedimentary bedrock located at depth. If shallow underground water conditions are encountered during the site-specific subsurface soil investigations and/or open excavation observations, mitigations may include restricting basement construction, raising the grade of the residence and/or a combination of surface and subsurface drainage systems, vertical drainboard, etc.
