**ENTECH**  
ENGINEERING, INC.

**SOIL, GEOLOGY, GEOLOGIC HAZARD STUDY  
FLYING HORSE NORTH  
SKETCH PLAN  
EL PASO COUNTY, COLORADO**

**Flying Horse Development, LLC**  
2138 Flying Horse Club Drive  
Colorado Springs, Colorado 80921

March 8, 2022  
Revised May 2, 2022

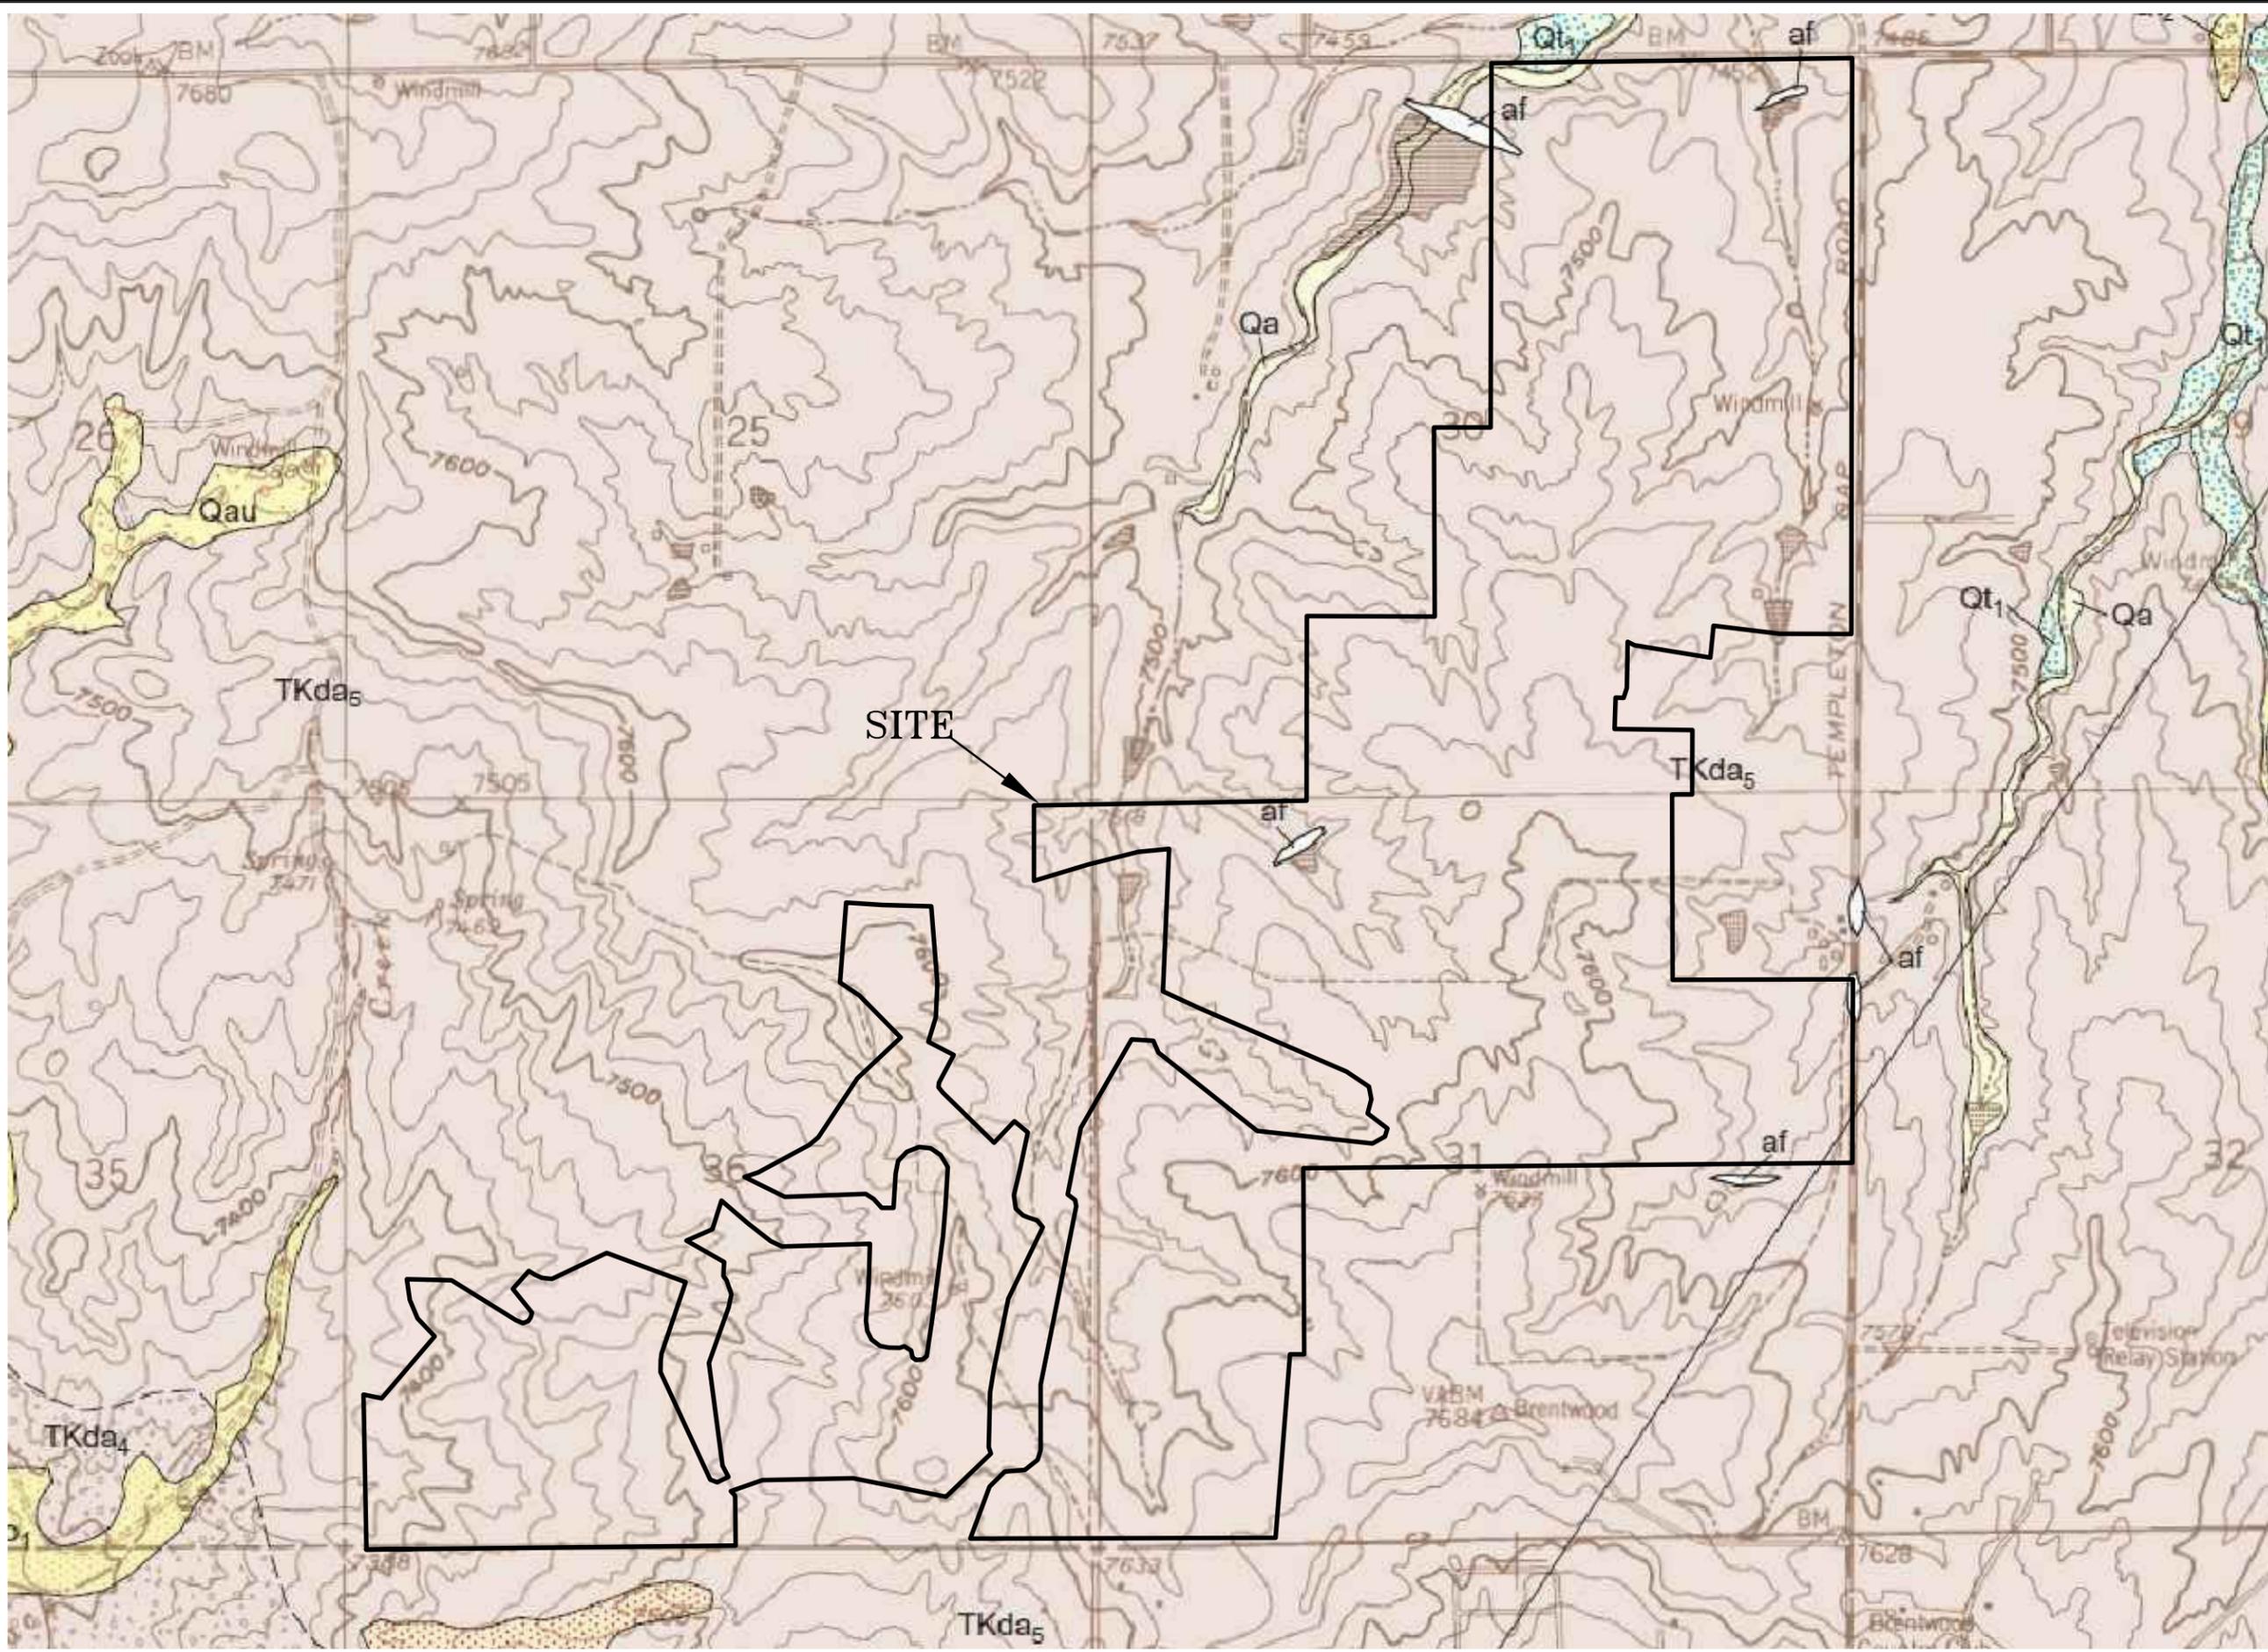
DRAWN	LLL
CHECKED	
DATE	3/7/22
SCALE	AS SHOWN
JOB NO.	220404
FIGURE No.	7

As mentioned previously, detailed mapping has been performed on this site to produce an Engineering Geology Map (Figure 7). This map shows the location of various geologic conditions of which the developers should be cognizant during the planning, design and construction stages of the project. These hazards and the recommended mitigation techniques are as follows:

These are areas of man-made fill associated with earthen dams and erosion berms on-site. Additionally, temporary stockpiles were observed on the site.

The site is classified in an area of low to moderate swell potential according to *the Map of Potentially Swelling Soil and Rock in the Front Range Urban Corridor, Colorado* by Hart, 1974 (Reference 10). Expansive soils were encountered in some of the profile holes drilled on the site as a part of the entire Flying Horse North Subdivision (References 1 and 2). These occurrences are typically sporadic; therefore, none have been indicated on the maps. These clays, if encountered beneath foundations, can cause differential movement in the structure foundation. These occurrences should be identified and dealt with on an individual basis.

In these areas, we would anticipate periodic high subsurface moisture conditions and frost heave potential on a seasonal basis. Additional, highly organic soils could be encountered in these areas. These areas lie within defined drainages and it is anticipated they will be avoided by development. Any structures in or adjacent to these areas should follow the mitigation discussed below.

In these areas, we would anticipate the potential for periodically high subsurface moisture conditions, frost heave potential and highly organic soils. The majority of these areas lie within defined drainages which can likely be avoided by the proposed development. The same mitigation recommendations for the seasonal shallow groundwater areas apply to the potentially seasonal shallow groundwater areas.

These areas are acceptable as building sites, however, in areas identified with this hazard classification, we would anticipate accelerated lateral and vertical movement of the near surface soils in the downslope direction.

**Mitigation:** The earthen dams lie within defined drainages and should be avoided as building sites. Some dams are to be removed or reconstructed as a part of detention ponds. The erosion berms can either be avoided or penetrated by foundations. It is anticipated the temporary stockpiles would be removed prior to construction. The fill on this site is considered uncontrolled for construction purposes. Any uncontrolled fill encountered beneath foundations will require removal and recompaction at a minimum of 95% of its maximum Modified Procter Dry Density, ASTM D-1557.

Mitigation: Due to the nature of the soils on this site, virtually all the soils are subject to erosion by wind and water. Other minor areas of erosion were observed on site other than those mapped, particularly where some rill erosion has occurred. Areas of erosion can occur across the entire site, particularly if the soils are disturbed during construction. Vegetation reduces the potential for erosion. The areas identified where erosion is actually taking place may require check dams, regrading and revegetation using channel lining mats to anchor vegetation. Further recommendations for erosion control are discussed under Section 9.0 "Erosion Control" of this report. Recommendations pertaining to revegetation may require input from a qualified landscape architect and/or the Natural Resource Conservation Service (previously Soil Conservation Service).

Mitigation: Should expansive soils be encountered beneath the foundation, mitigation will be necessary. Mitigation of expansive soils will require special foundation design. Overexcavation and replacement with non-expansive soils at a minimum of 95% of its maximum Modified Proctor Dry Density, ASTM D-1557 is a suitable mitigation, which is common in the area. Another alternative in areas of highly expansive soils is the use of drilled pier foundation systems. Typical minimum pier depths are on the order of 25 feet or more and require penetration into the bedrock material a minimum of 4 to 6 feet, depending upon building loads. Floor slabs on expansive soils should be expected to experience movement. Overexcavation and replacement has been successful in minimizing slab movements. The use of structural floors should be considered for

**Mitigation:** Foundations must have a minimum 30-inch depth for frost protection. In areas where high subsurface moisture conditions are anticipated periodically, subsurface perimeter drains are recommended to help prevent the intrusion of water into areas below grade. Typical drain details are presented in Figure 7. Any grading in these areas should be done to direct surface flow around construction to avoid areas of ponded water. Structures should not block drainages. All organic material should be completely removed prior to any fill placement. Septic fields should not be located in areas where there is the potential for shallow groundwater. The area of the site located in Filing No. 1 does not lie within any floodplain zones according to the FEMA Map Nos. 08041CO305G, and 08041CO315G, dated December 7, 2018 (Figure 9, Reference 11). A floodplain is mapped in the extreme northwestern portion of the site. A detention pond is proposed in this area which will be located in an open space. Exact locations of floodplain and specific drainage studies are beyond the scope of this report. Finished floor levels must be located a minimum of one foot above floodplain levels.

Mitigation: The design of foundations in these areas should account for the additional pressure on the uphill side of the structure due to the creep potential. The lateral pressure distribution for sloping conditions in downslope creep area is presented in Figure 9. Tie-beams, buttresses and counterforts may be necessary in some areas. Where possible, in areas of downslope creep, structures should be designed to be as compact and rigid as possible. This will help them better tolerate the vertical and lateral movements to which the foundation system may be subjected with minimal damage. Long, rambling, irregular structures should be avoided, as they are associated with much greater potential for damaging differential movement. Additionally, structures should be designed to step up the slope. Deep cuts in these areas should be avoided. Any retaining walls proposed in these areas should also be properly designed for by a qualified professional engineer for the global slope stability. Proper control of drainage at both the surface and subsurface is important. Saturation of materials should be avoided that may create unstable conditions.

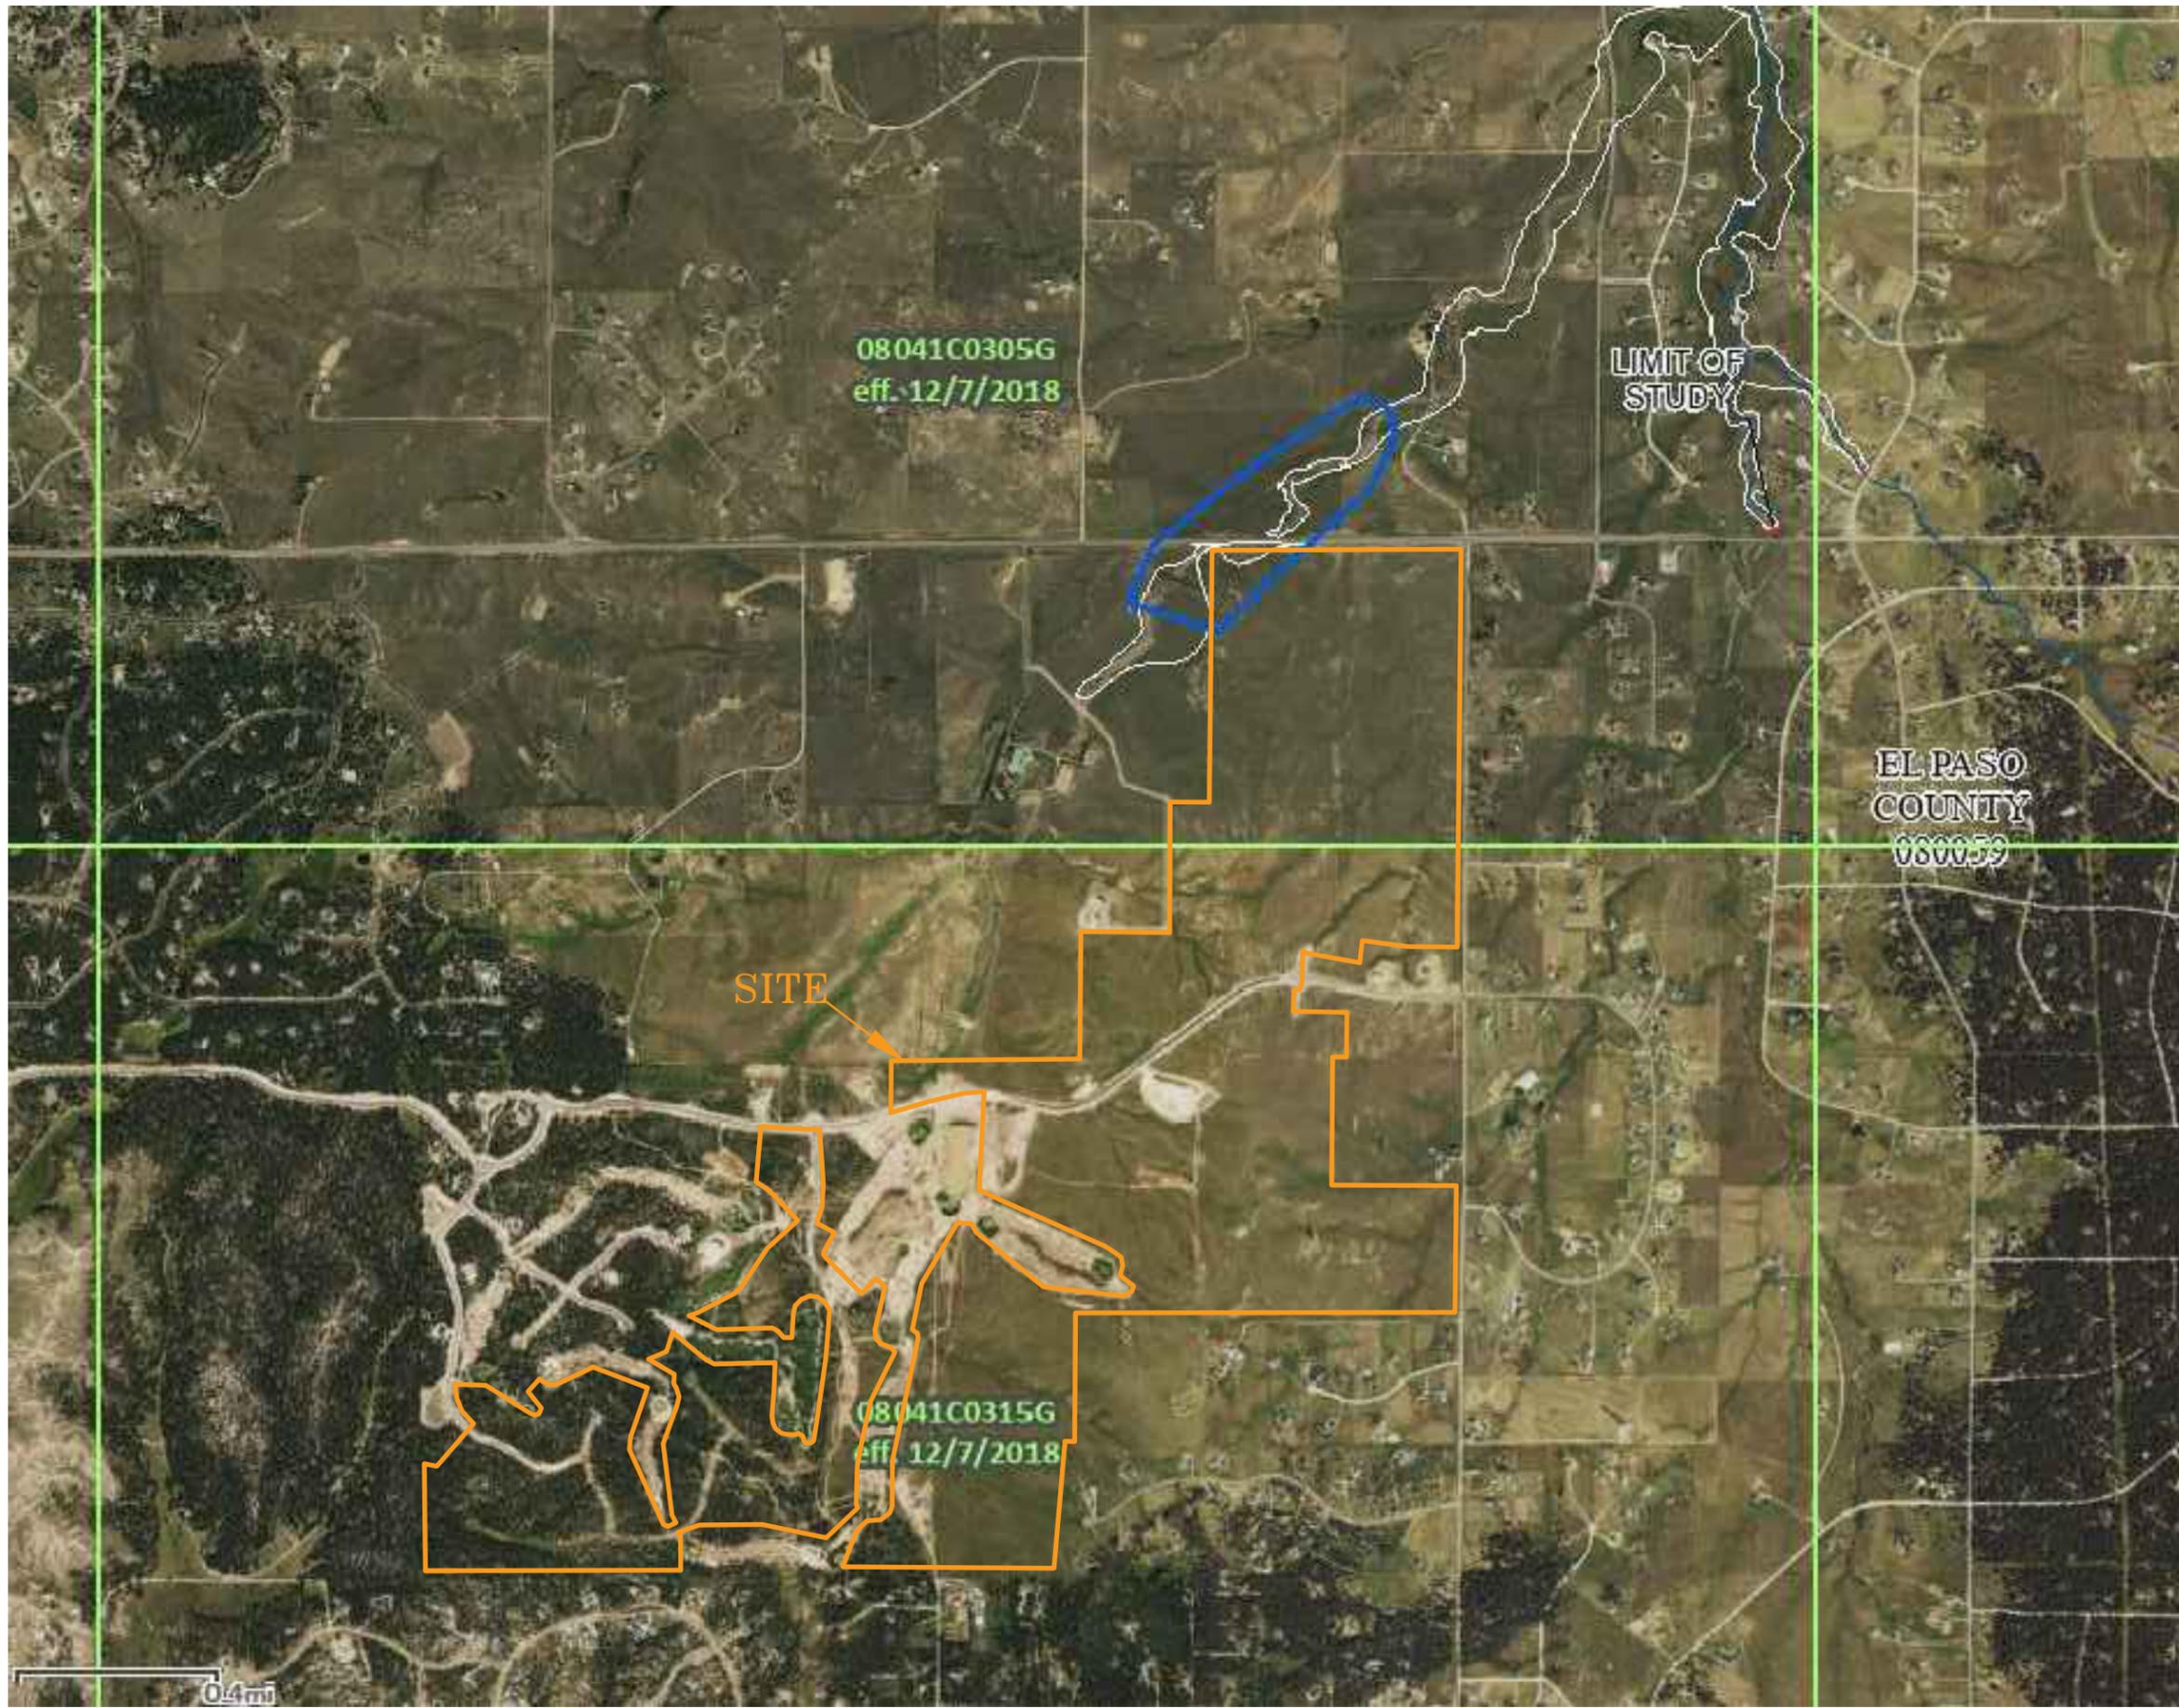
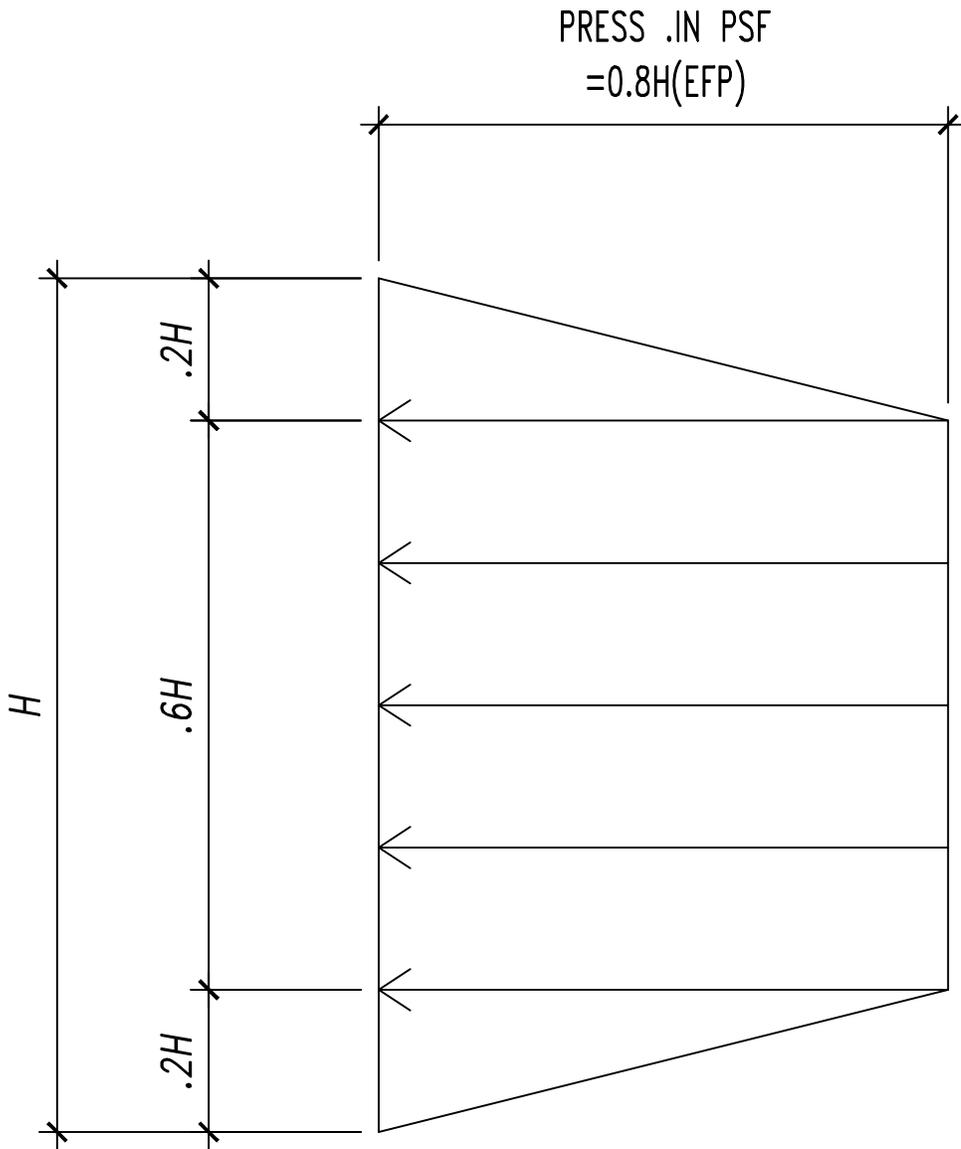
*FIG. NO.:*  
10

*LATERAL PRESSURE DISTRIBUTION  
AREA WITH CREEP*
