October 30, 2020

**ENTECH**  
ENGINEERING, INC.

Re: Soil, Geology, and Geologic Hazard Study  
16860 Thompson Road – 2 Lot Subdivision  
Parcel No. 51190-04-002  
El Paso County, Colorado

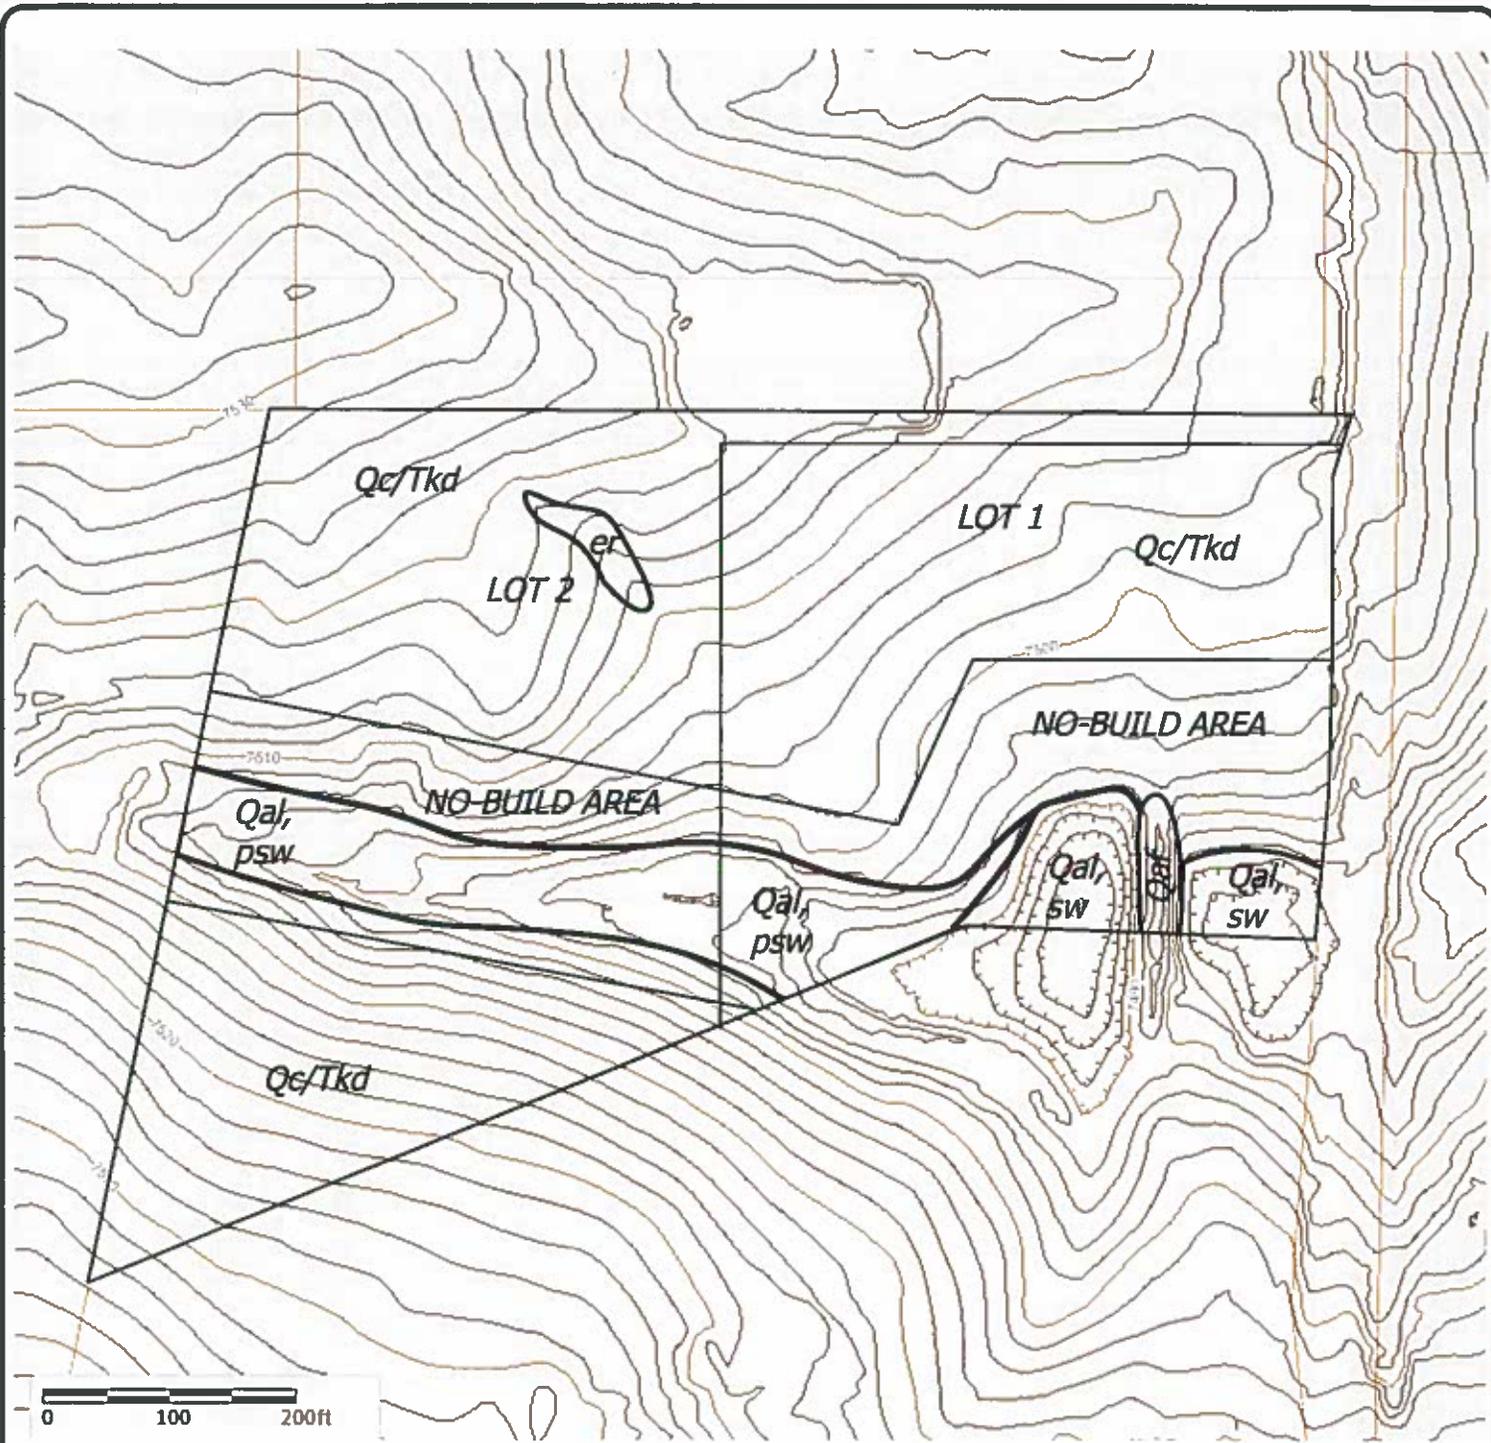
The site is not mapped within any floodplains according to the FEMA Map No. 08041CO305G, dated December 7, 2018 (Figure 7, Reference 9). Areas of seasonal and potentially seasonal shallow groundwater were observed on the site (Figure 6). In these areas, we would anticipate the potential for periodically high subsurface moisture conditions and frost heave potential. These areas lie within the drainage in the southern portion of the site. Water was not observed in the area at the time of this investigation, however, the potential for ponding of water does exist to the west of the earthen dam. These areas can likely be avoided or properly mitigated by development and are discussed below.

These are areas along east and west sides of the earthen dam in the southeastern portion of the site. Water was not observed in this area at the time of this investigation, however, the potential for ponding of water does exist to the west of the earthen dam. These areas also contain frost heave potential and highly organic soils.

**Mitigation:** Because areas mapped as seasonally shallow groundwater lie within a defined drainage where water can pond, we do not recommend structures be built within this area. Septic fields should be located a minimum of 25 feet away from the drainage or pond areas. Any construction in these areas should be done in a manner that does not create areas of ponded water near structures or the septic field. Structures adjacent to this area should follow the precautions for potentially seasonal shallow groundwater areas. No areas of the site are mapped within any floodplain zones according to the FEMA Map No. 08041CO305G, Figure 11 (Reference 10). Specific floodplain locations and drainage studies are beyond the scope of this report.

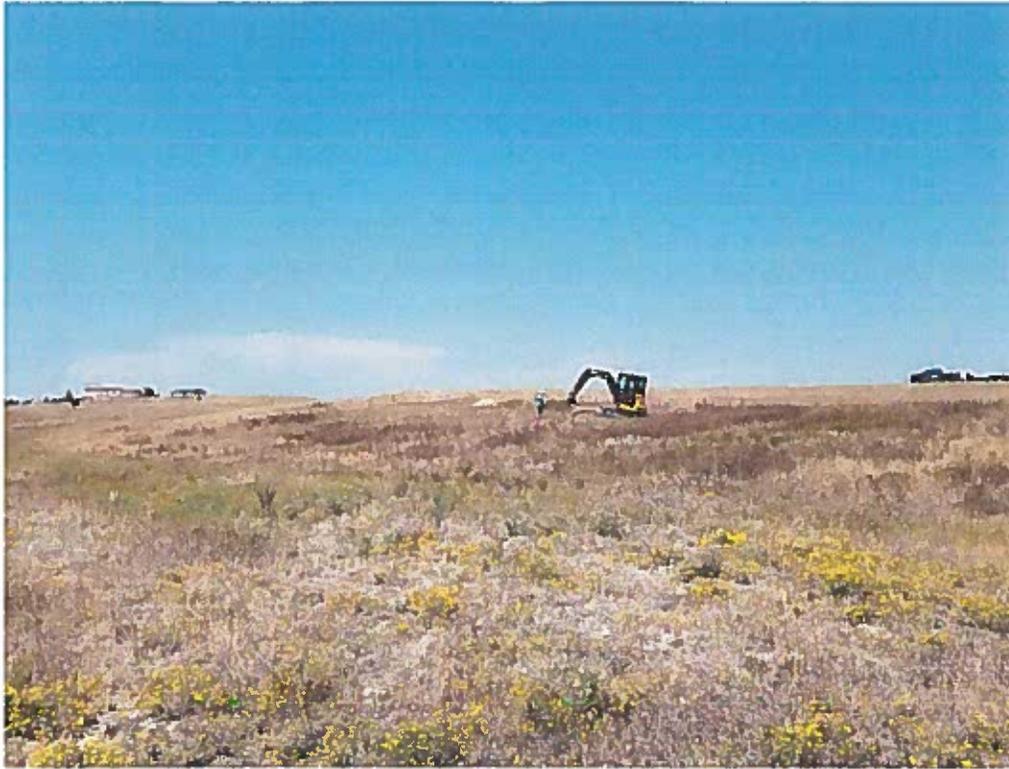
**Looking west from the drainage in the central portion of the site.**

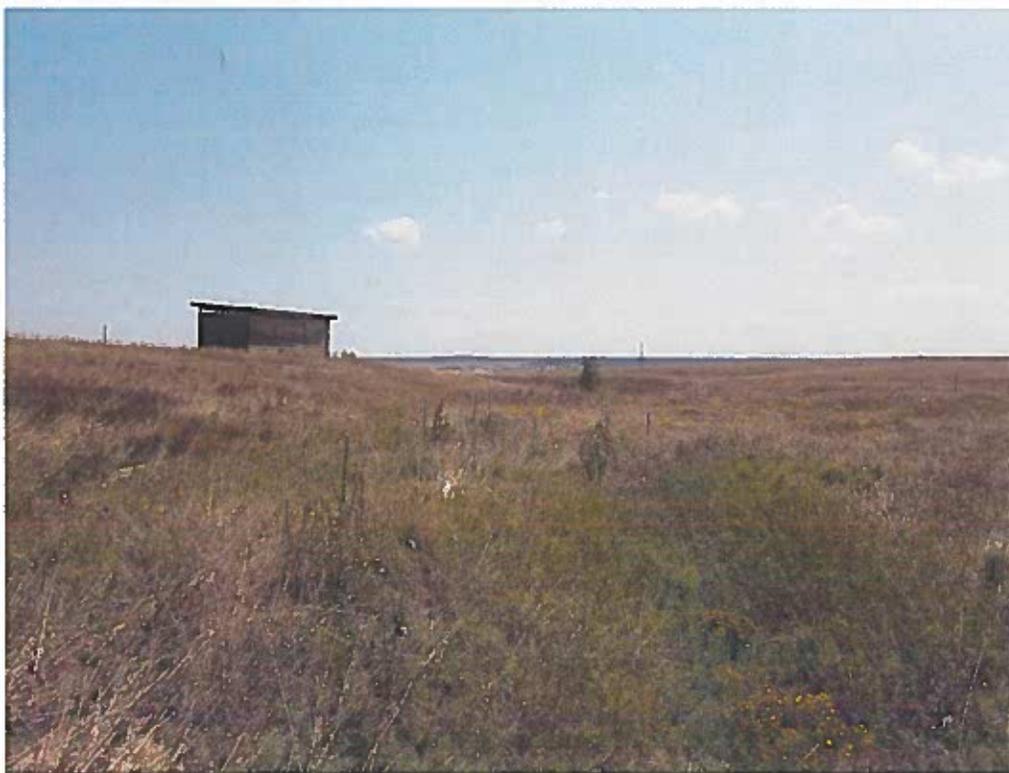
**Looking east along the drainage in the central portion of the site.**

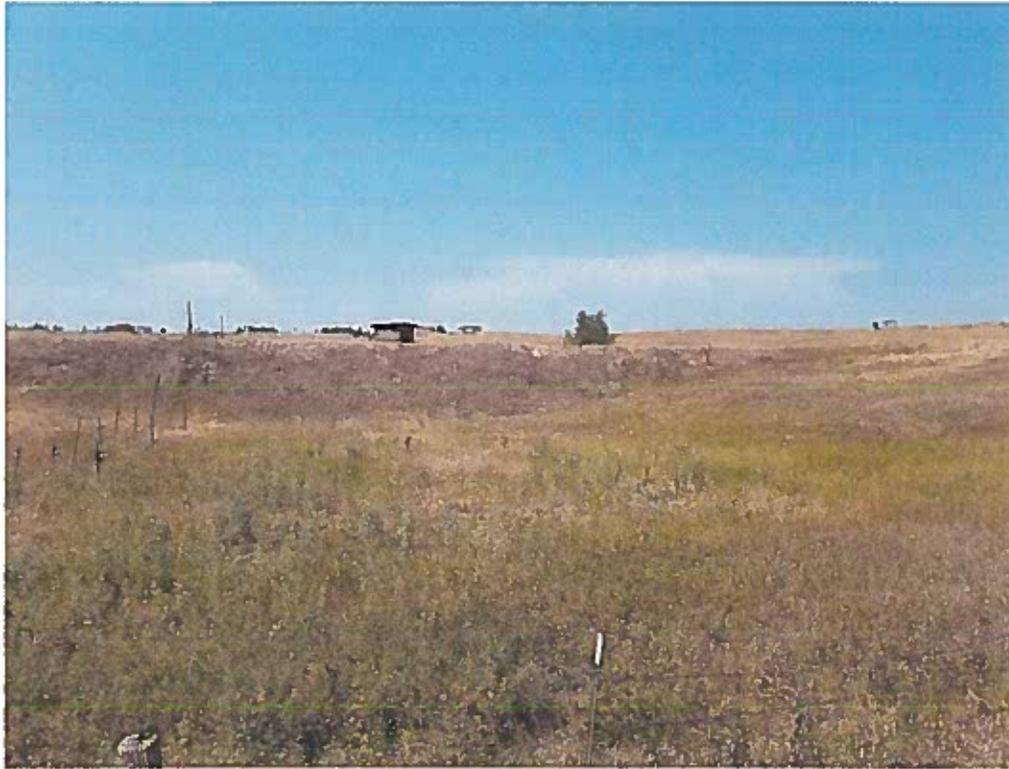
**Looking west along  
the drainage toward  
earthen dam in the  
southeastern side of  
the site.**
