**SOIL, GEOLOGY, & GEOLOGIC HAZARD STUDY  
STERLING RANCH EAST – PRELIMINARY PLAN NO. 1  
PARCEL NOS. 17, 18, 22, 23, 24, 26, 37, & 38  
EL PASO COUNTY, COLORADO**

April 19, 2022

Entech Job No. 220571

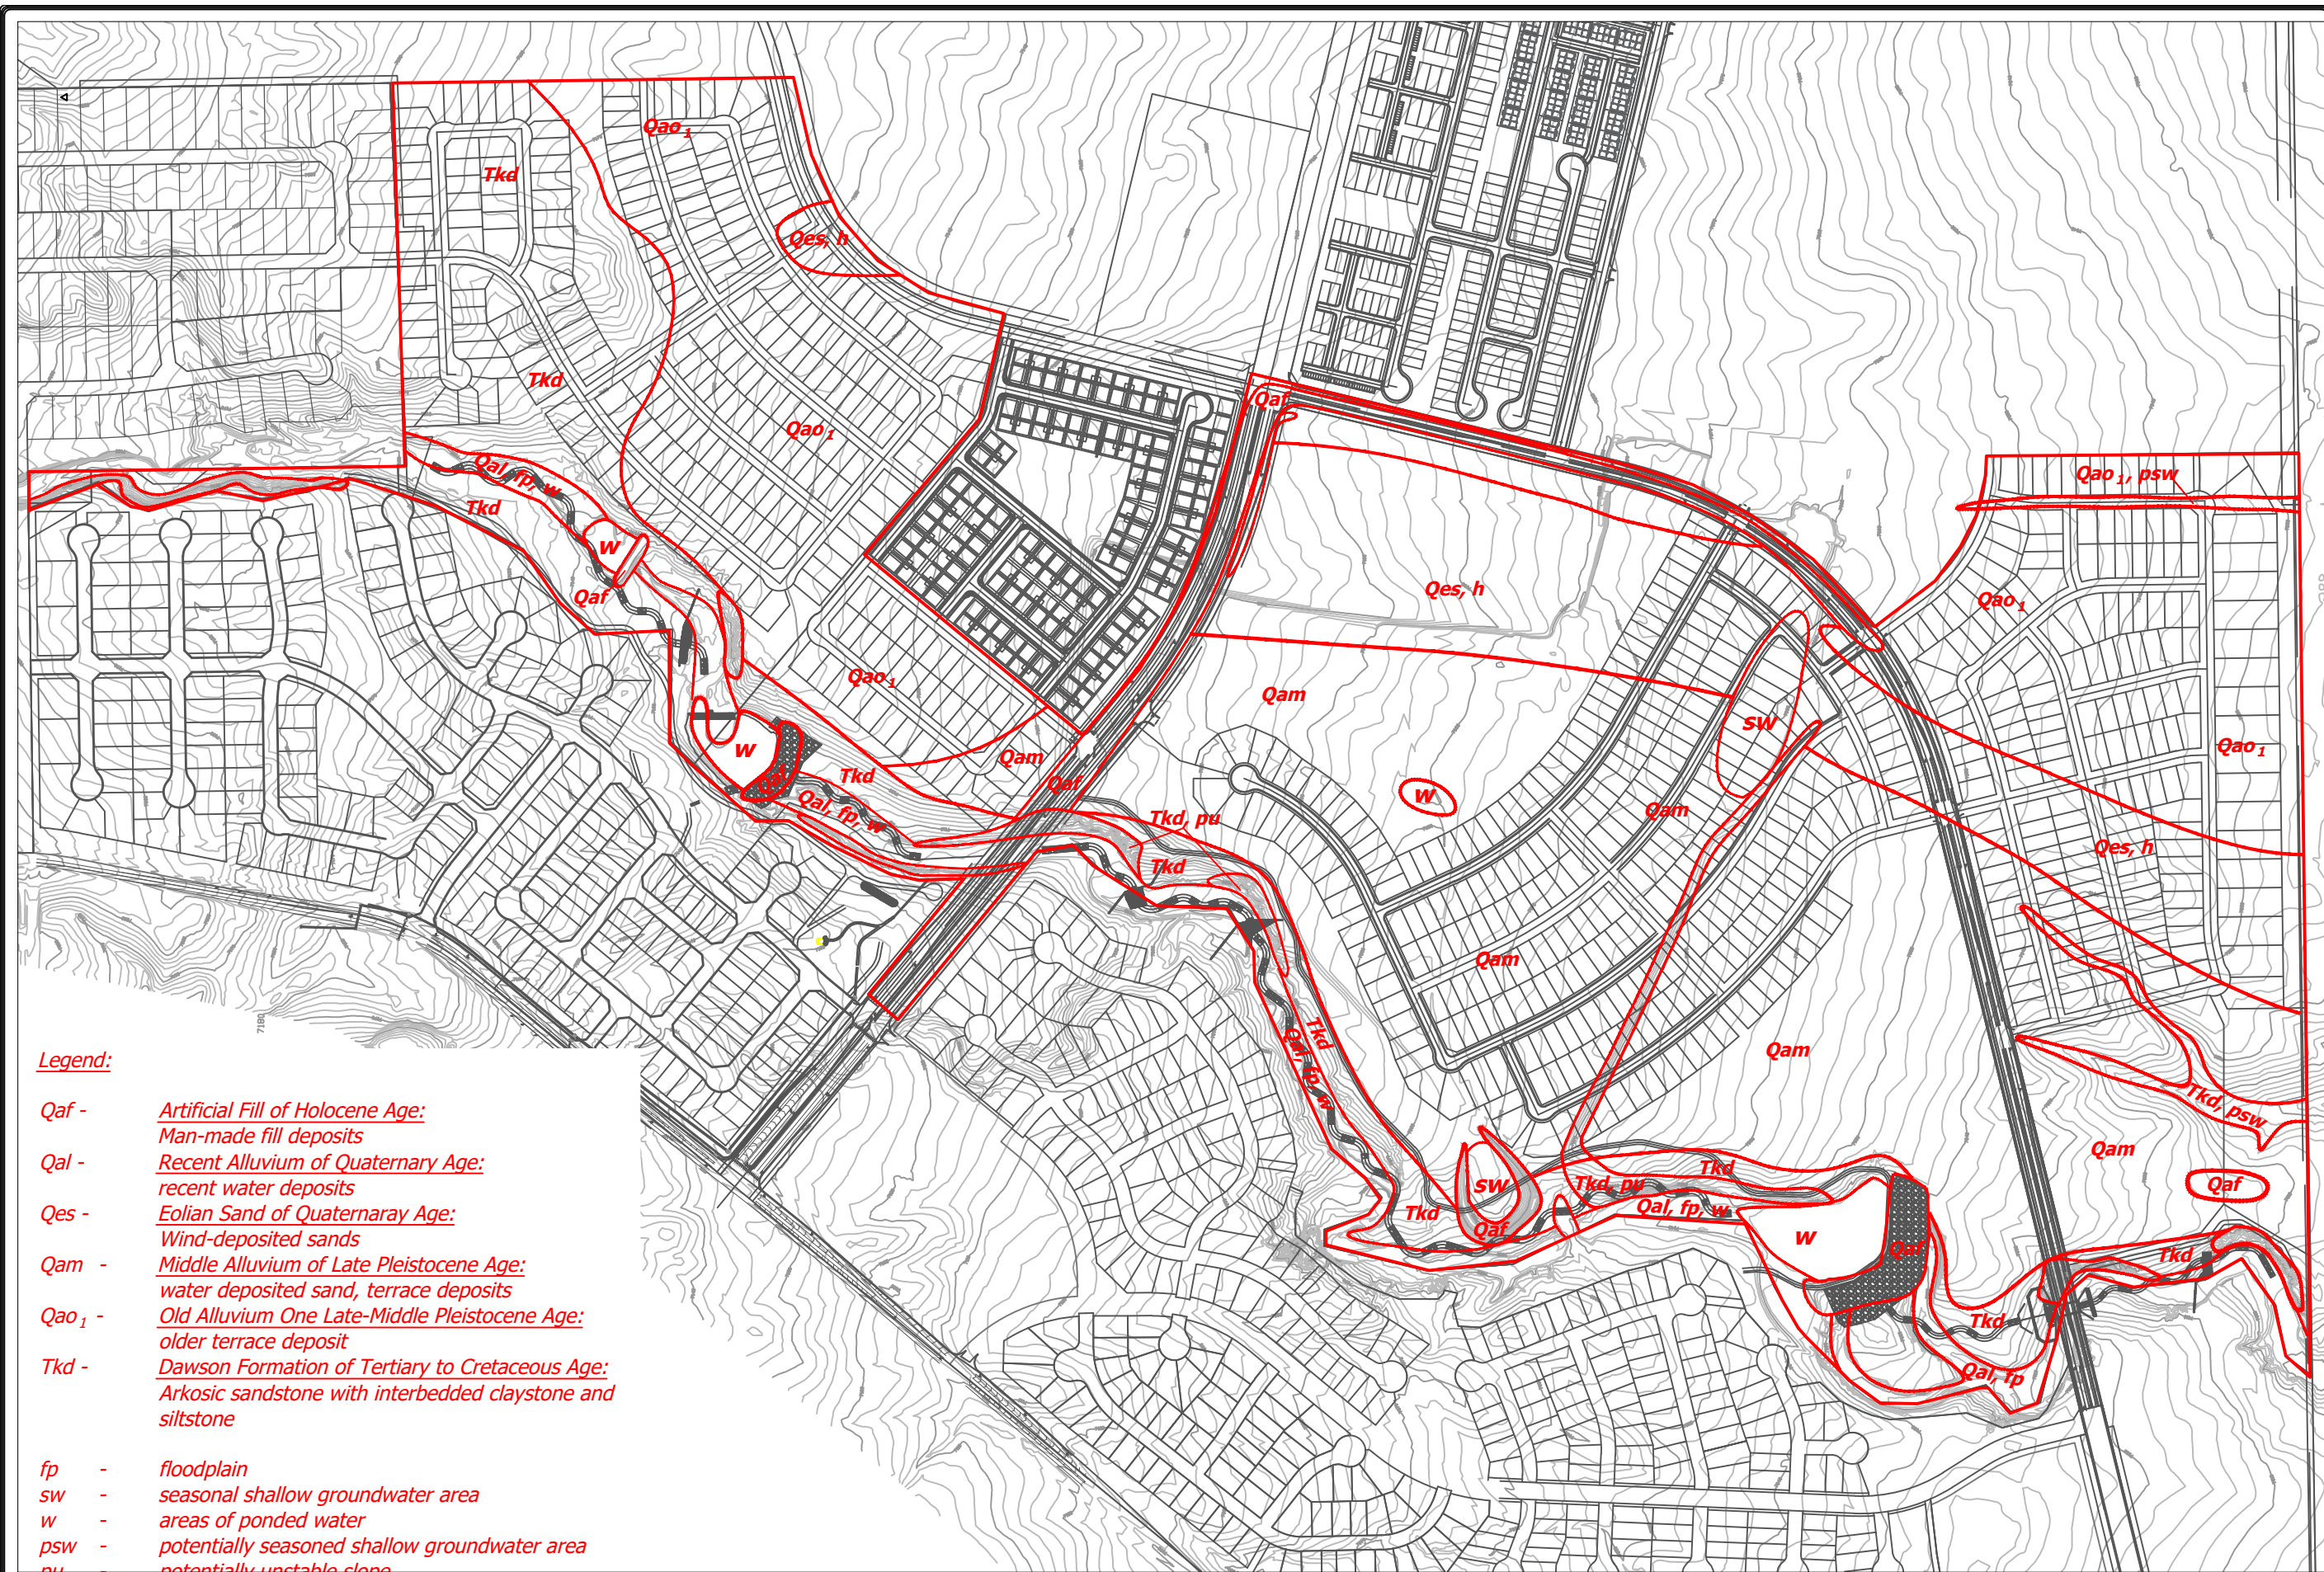
DRAWN	L.L.
CHECKED	
DATE	4/19/22
SCALE	AS SHOWN
JOB NO.	220571
FIGURE No.	7

As mentioned previously, detailed mapping has been performed on this site to produce an Engineering Geology Map Figure 7. This map shows the location of various geologic conditions of which the developers should be cognizant during the planning, design and construction stages of the project. These hazards and the recommended mitigation techniques are as follows:

Areas of artificial fill were observed in areas of the site. The majority of these areas are associated with recent grading and fill stockpiling.

These are areas that are undergoing erosion by water and sheetwash producing gullies and rill erosion. The areas significant erosion observed on the site are located in the former borrow areas where most of the vegetation had been removed.

The majority of the slopes on-site are gently sloping and do not exhibit any past or potential unstable slopes or landslides. Some of the steeper slopes along Sand Creek west of the site, and the cut slopes from fill borrow areas in the central portion of the site have been identified as potentially unstable slopes. The mitigation recommendation for these areas is as follows:

These slopes are considered stable in their present condition; however, considerable care must be exercised in these areas not to create a condition which would tend to activate instability. The steeper slopes along portions of Sand Creek which are located within open-space or park areas and will be avoided by the planned development. Other areas of potentially unstable slopes are associated with cut slopes in the fill borrow areas in the central portion of the site will likely be regraded during the development of the site.

Mitigation: It is anticipated the fill piles will be removed prior to construction during site grading. In the areas of site grading, fill records should be obtained to determine if the fill was placed in a controlled manner. Where uncontrolled fill is encountered beneath foundations, mitigation will be necessary. Mitigation typically involves removal and recompaction at a minimum of 95 percent of its maximum Modified Proctor Dry Density, ASTM D-1557. Any new fill added to the site should be placed on native or controlled fill soils, compacted as recommended above.

Mitigation: Due to the nature of the soils on this site, virtually all the soils are subject to erosion by wind and water. Other minor areas of erosion were observed on site other than those mapped, particularly where some rill erosion has occurred. Areas of erosion can occur across the entire site, particularly if the soils are disturbed during construction. Vegetation reduces the potential for erosion. The areas identified where erosion is actually taking place may require check dams, regrading and revegetation using channel lining mats to anchor vegetation. Further recommendations for erosion control are discussed under Section 8.0 "Erosion Control" of this report. Recommendations pertaining to revegetation may require input from a qualified landscape architect and/or the Natural Resource Conservation Service (previously Soil Conservation Service).

Mitigation: According to the development plan shown on Figure 3, the majority of these areas are to be avoided. Building should be avoided on the potentially unstable slopes unless stabilized. A setback of 20 feet from the crest of these slopes is recommended unless stabilized. Stabilization could involve regrading to slope angles no steeper than 3:1 or the use of engineer-designed retaining walls, tiebacks, or buttresses. Where retaining walls are not used, erosion protection may be necessary to prevent undercutting by the creek during periods of high water. It is our understanding the project will include drainage improvements and the construction of a regional trail along the Sand Creek drainage and stabilization of the slopes will be a part of the improvements. Specific slope stabilization recommendations are beyond the scope of this report.

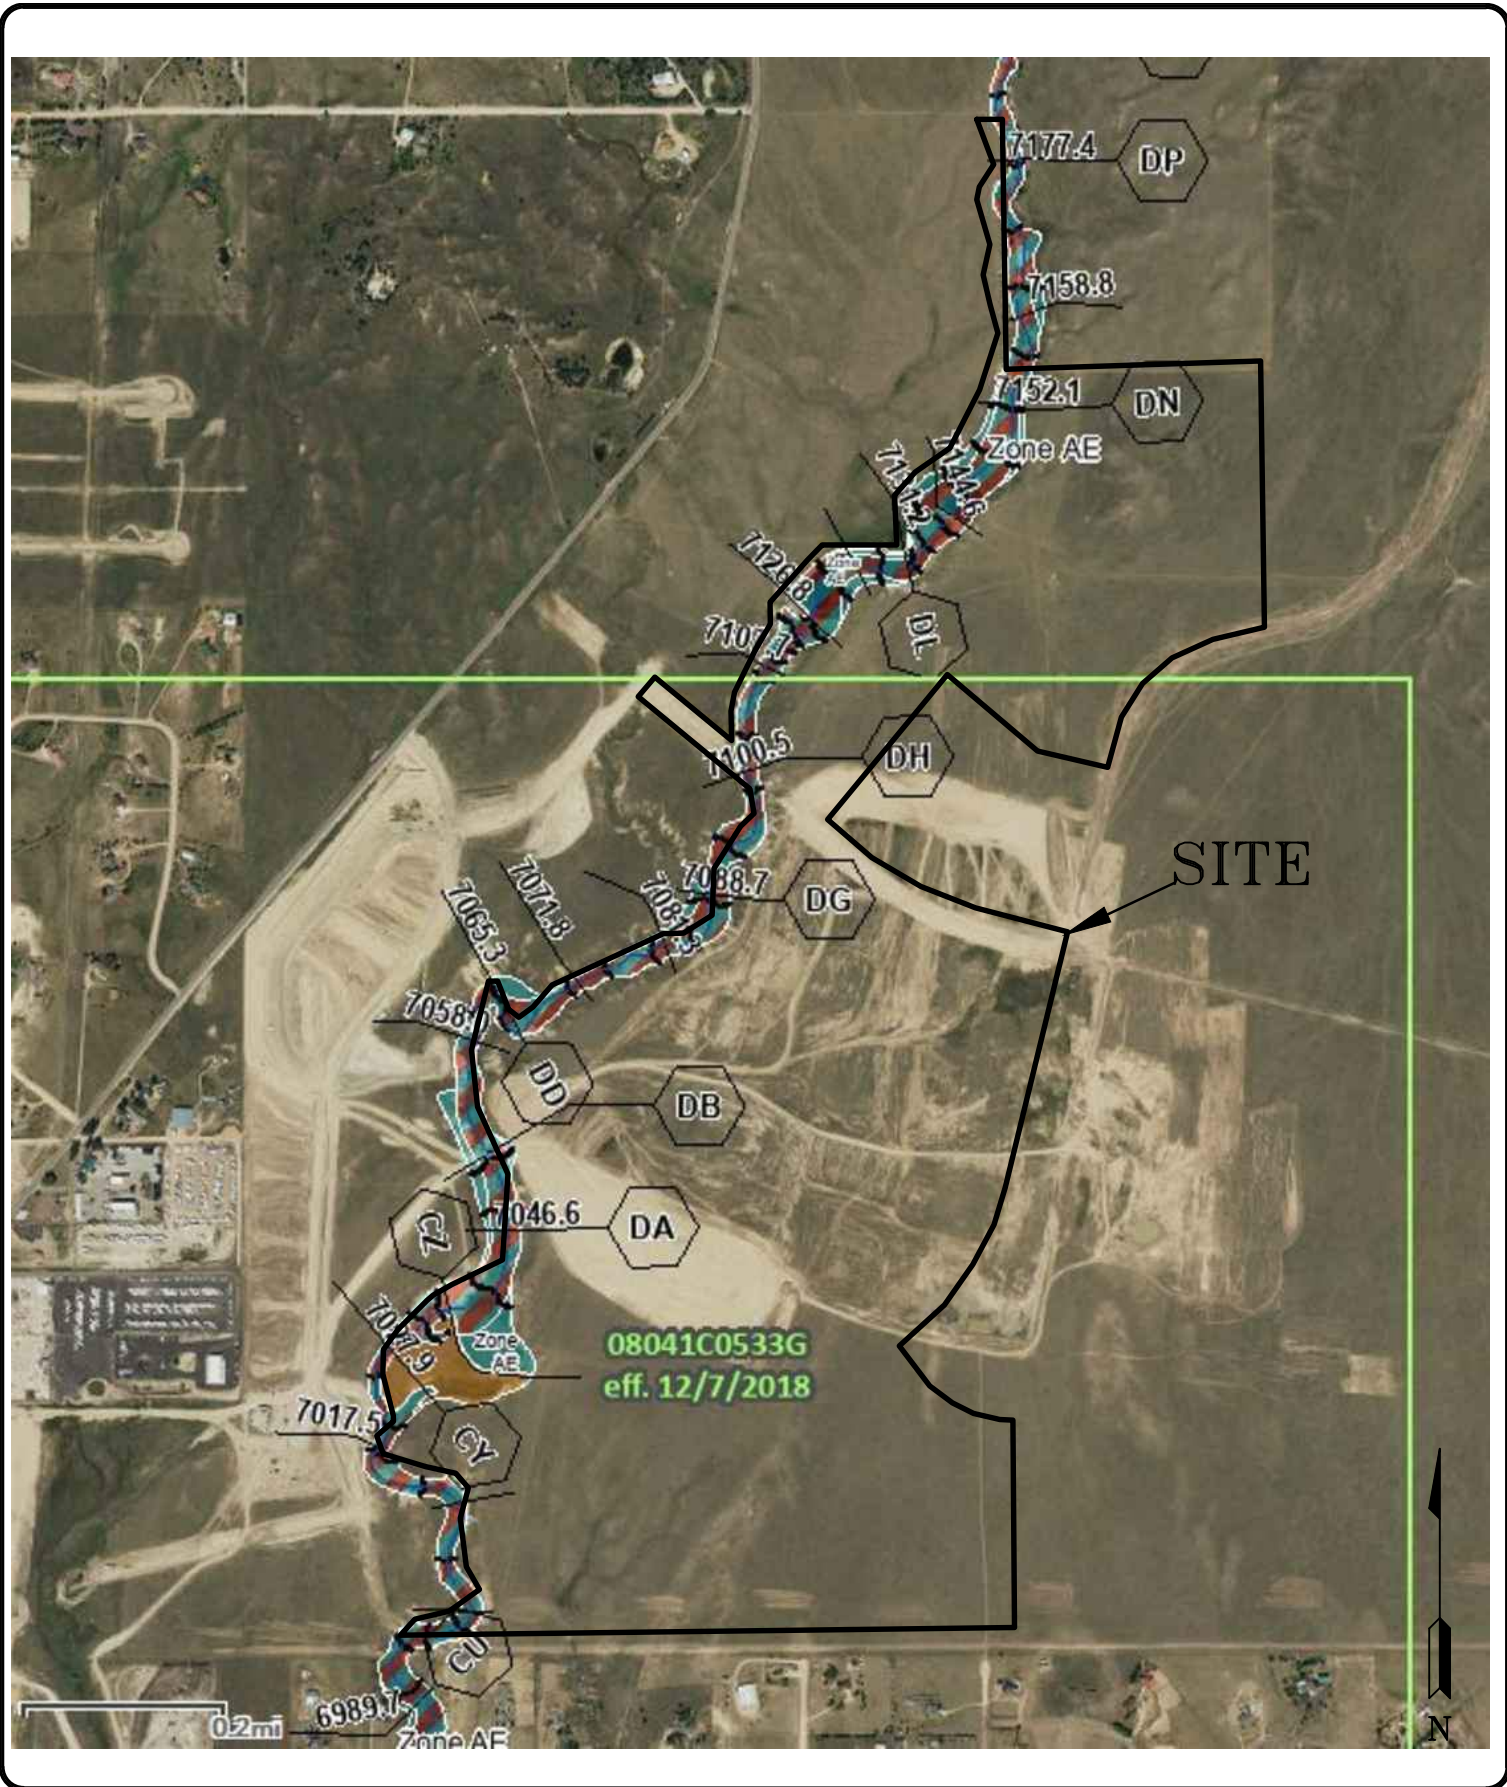
FIG NO.:  
8

The Sand Creek drainage lies west of the site and has been mapped as a floodplain zone according to the FEMA Map Nos. 08041CO533G and 08041CO535G, Figure 8 (Reference 12). Additionally, areas of ponded water exist along Sand Creek. Other areas of standing water were observed on the site to the south of the site at the northwest corner of future Briargate Parkway and Sterling Ranch Road, within the central portion of the site south west of the middle school site. Groundwater was encountered in nine of the test borings at depths of 3 to 19 feet, the remaining borings were dry. A minimum separation of 3 feet between foundation components and groundwater levels are recommended. These areas are discussed as follows:

The Sand Creek drainage lies west of the site and has been mapped as a floodplain zone according to the FEMA Map Nos. 08041CO533G and 08041CO535G, Figure 8 (Reference 12). The building areas of the site do not lie within the floodplain zone as indicated in Figure 8. Any construction considered in a floodplain area will require approval of the drainage plan. Lots immediately adjacent to the floodplain may experience higher groundwater levels during peak flows. Subsurface perimeter drains are recommended for structures adjacent to the floodplain to help prevent the intrusion of water into areas below grade. Typical drain details are presented in Figure 9. Finished floor levels must be a minimum of one floor above the floodplain level. Exact floodplain locations by drainage studies are beyond the scope of this report.

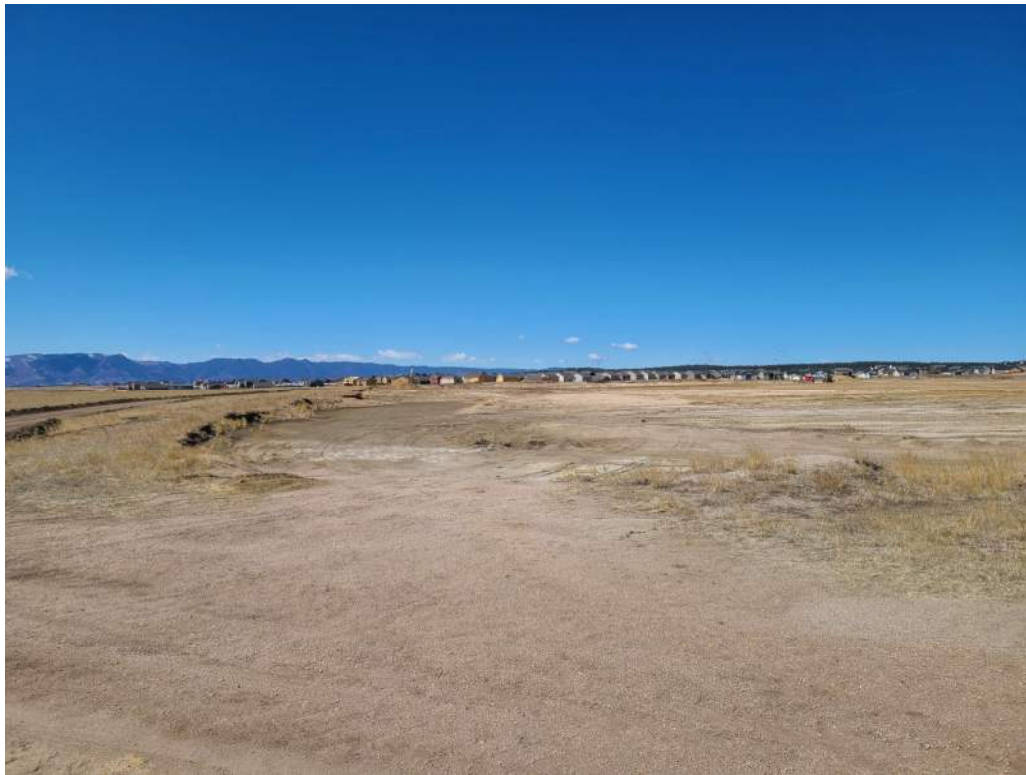
**Looking northwest  
from the southeastern  
portion of the site  
towards low-lying  
seasonal wet area.**

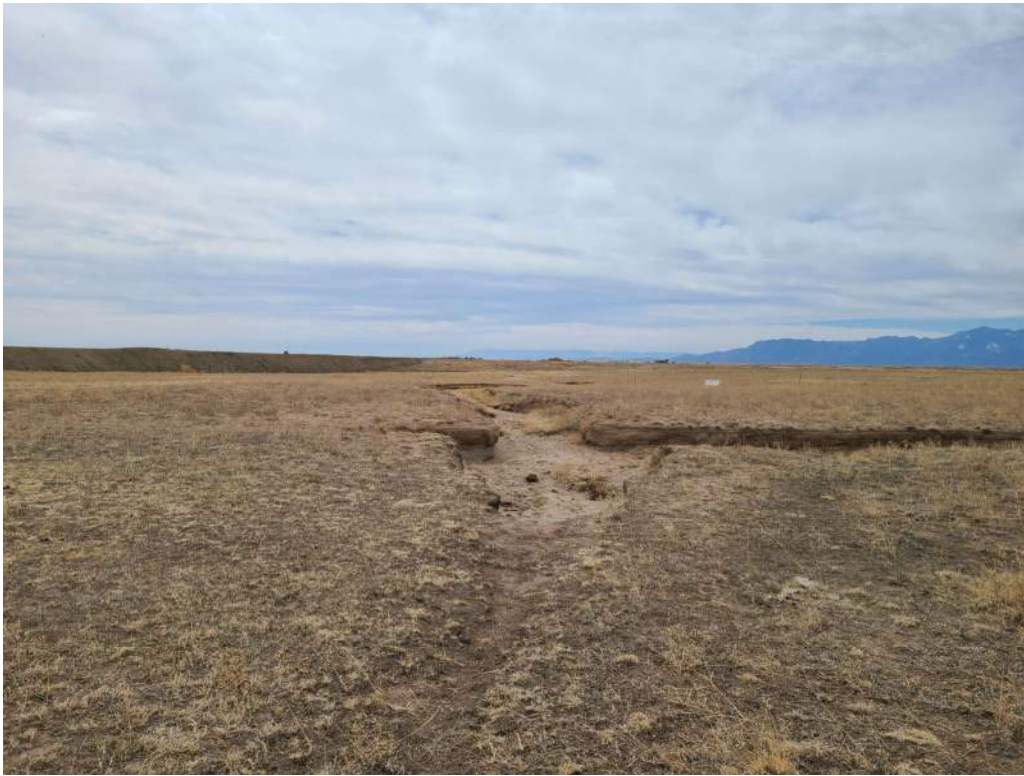
**Looking southwest  
towards erosion  
feature in the central  
portion of the site west  
of future Sterling  
Ranch Road.**

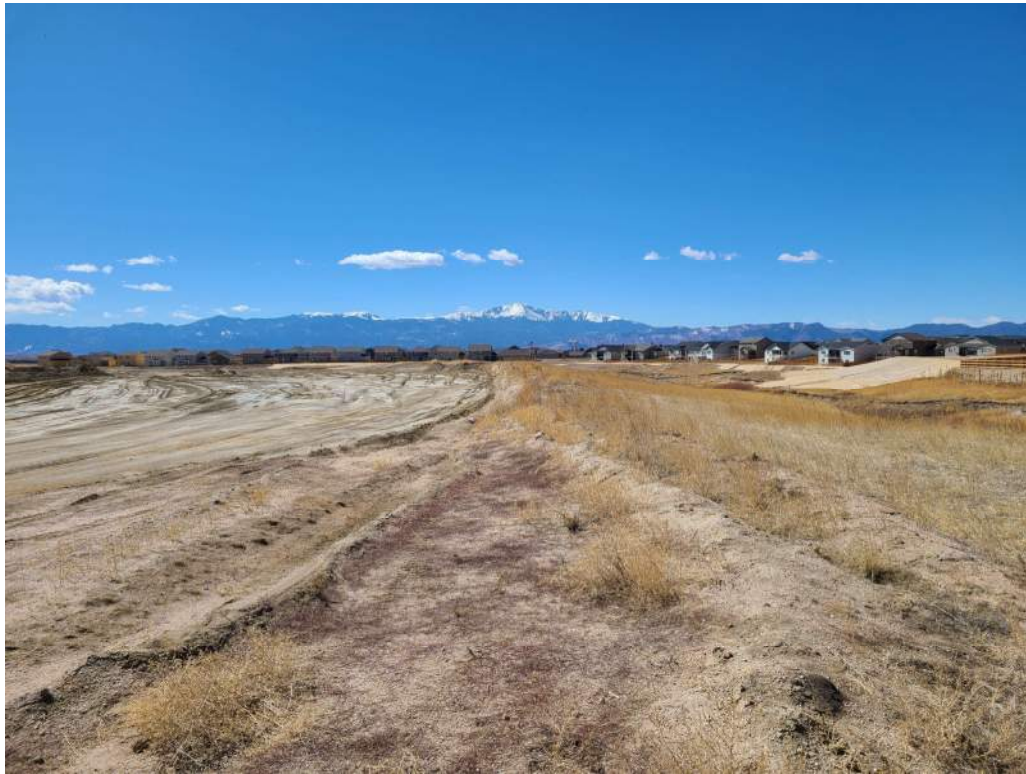
**Looking southwest  
along Sand Creek  
from  
the west central  
portion of the site.**

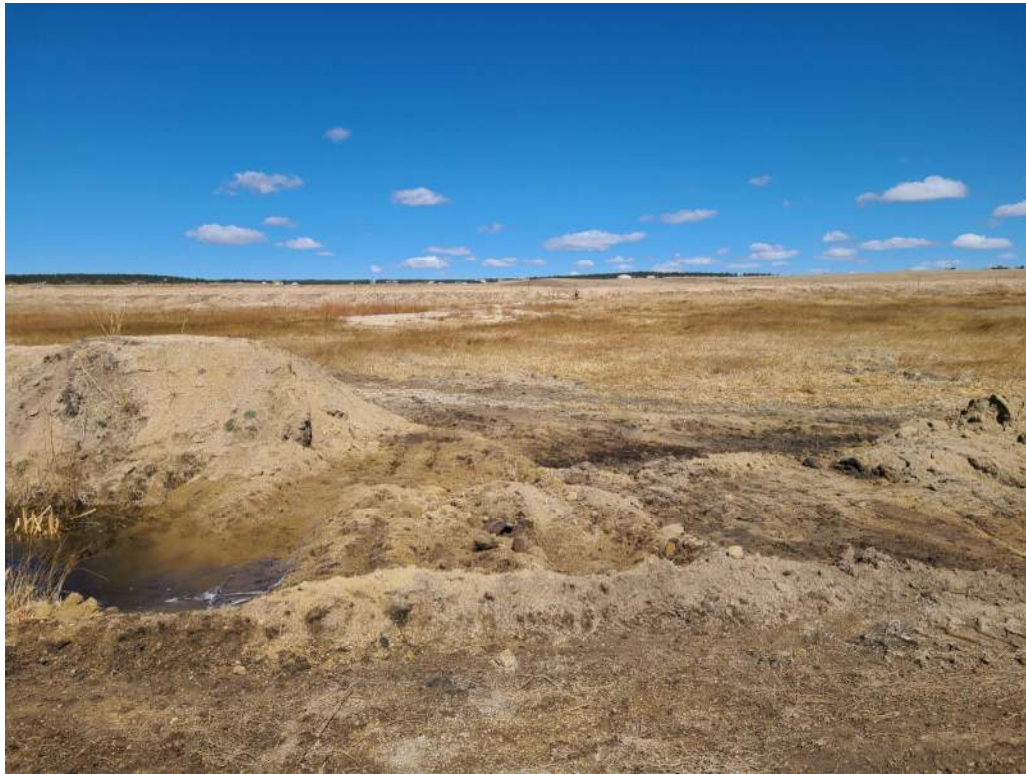
**Looking north at area  
of standing water on the  
south side of  
future Briargate  
Parkway.**
