**SOILS AND GEOLOGY STUDY
SILVERADO RANCH FILING NO. 2
EL PASO COUNTY, COLORADO**

September 27, 2024
Revised October 8, 2024

PCD No. SF246

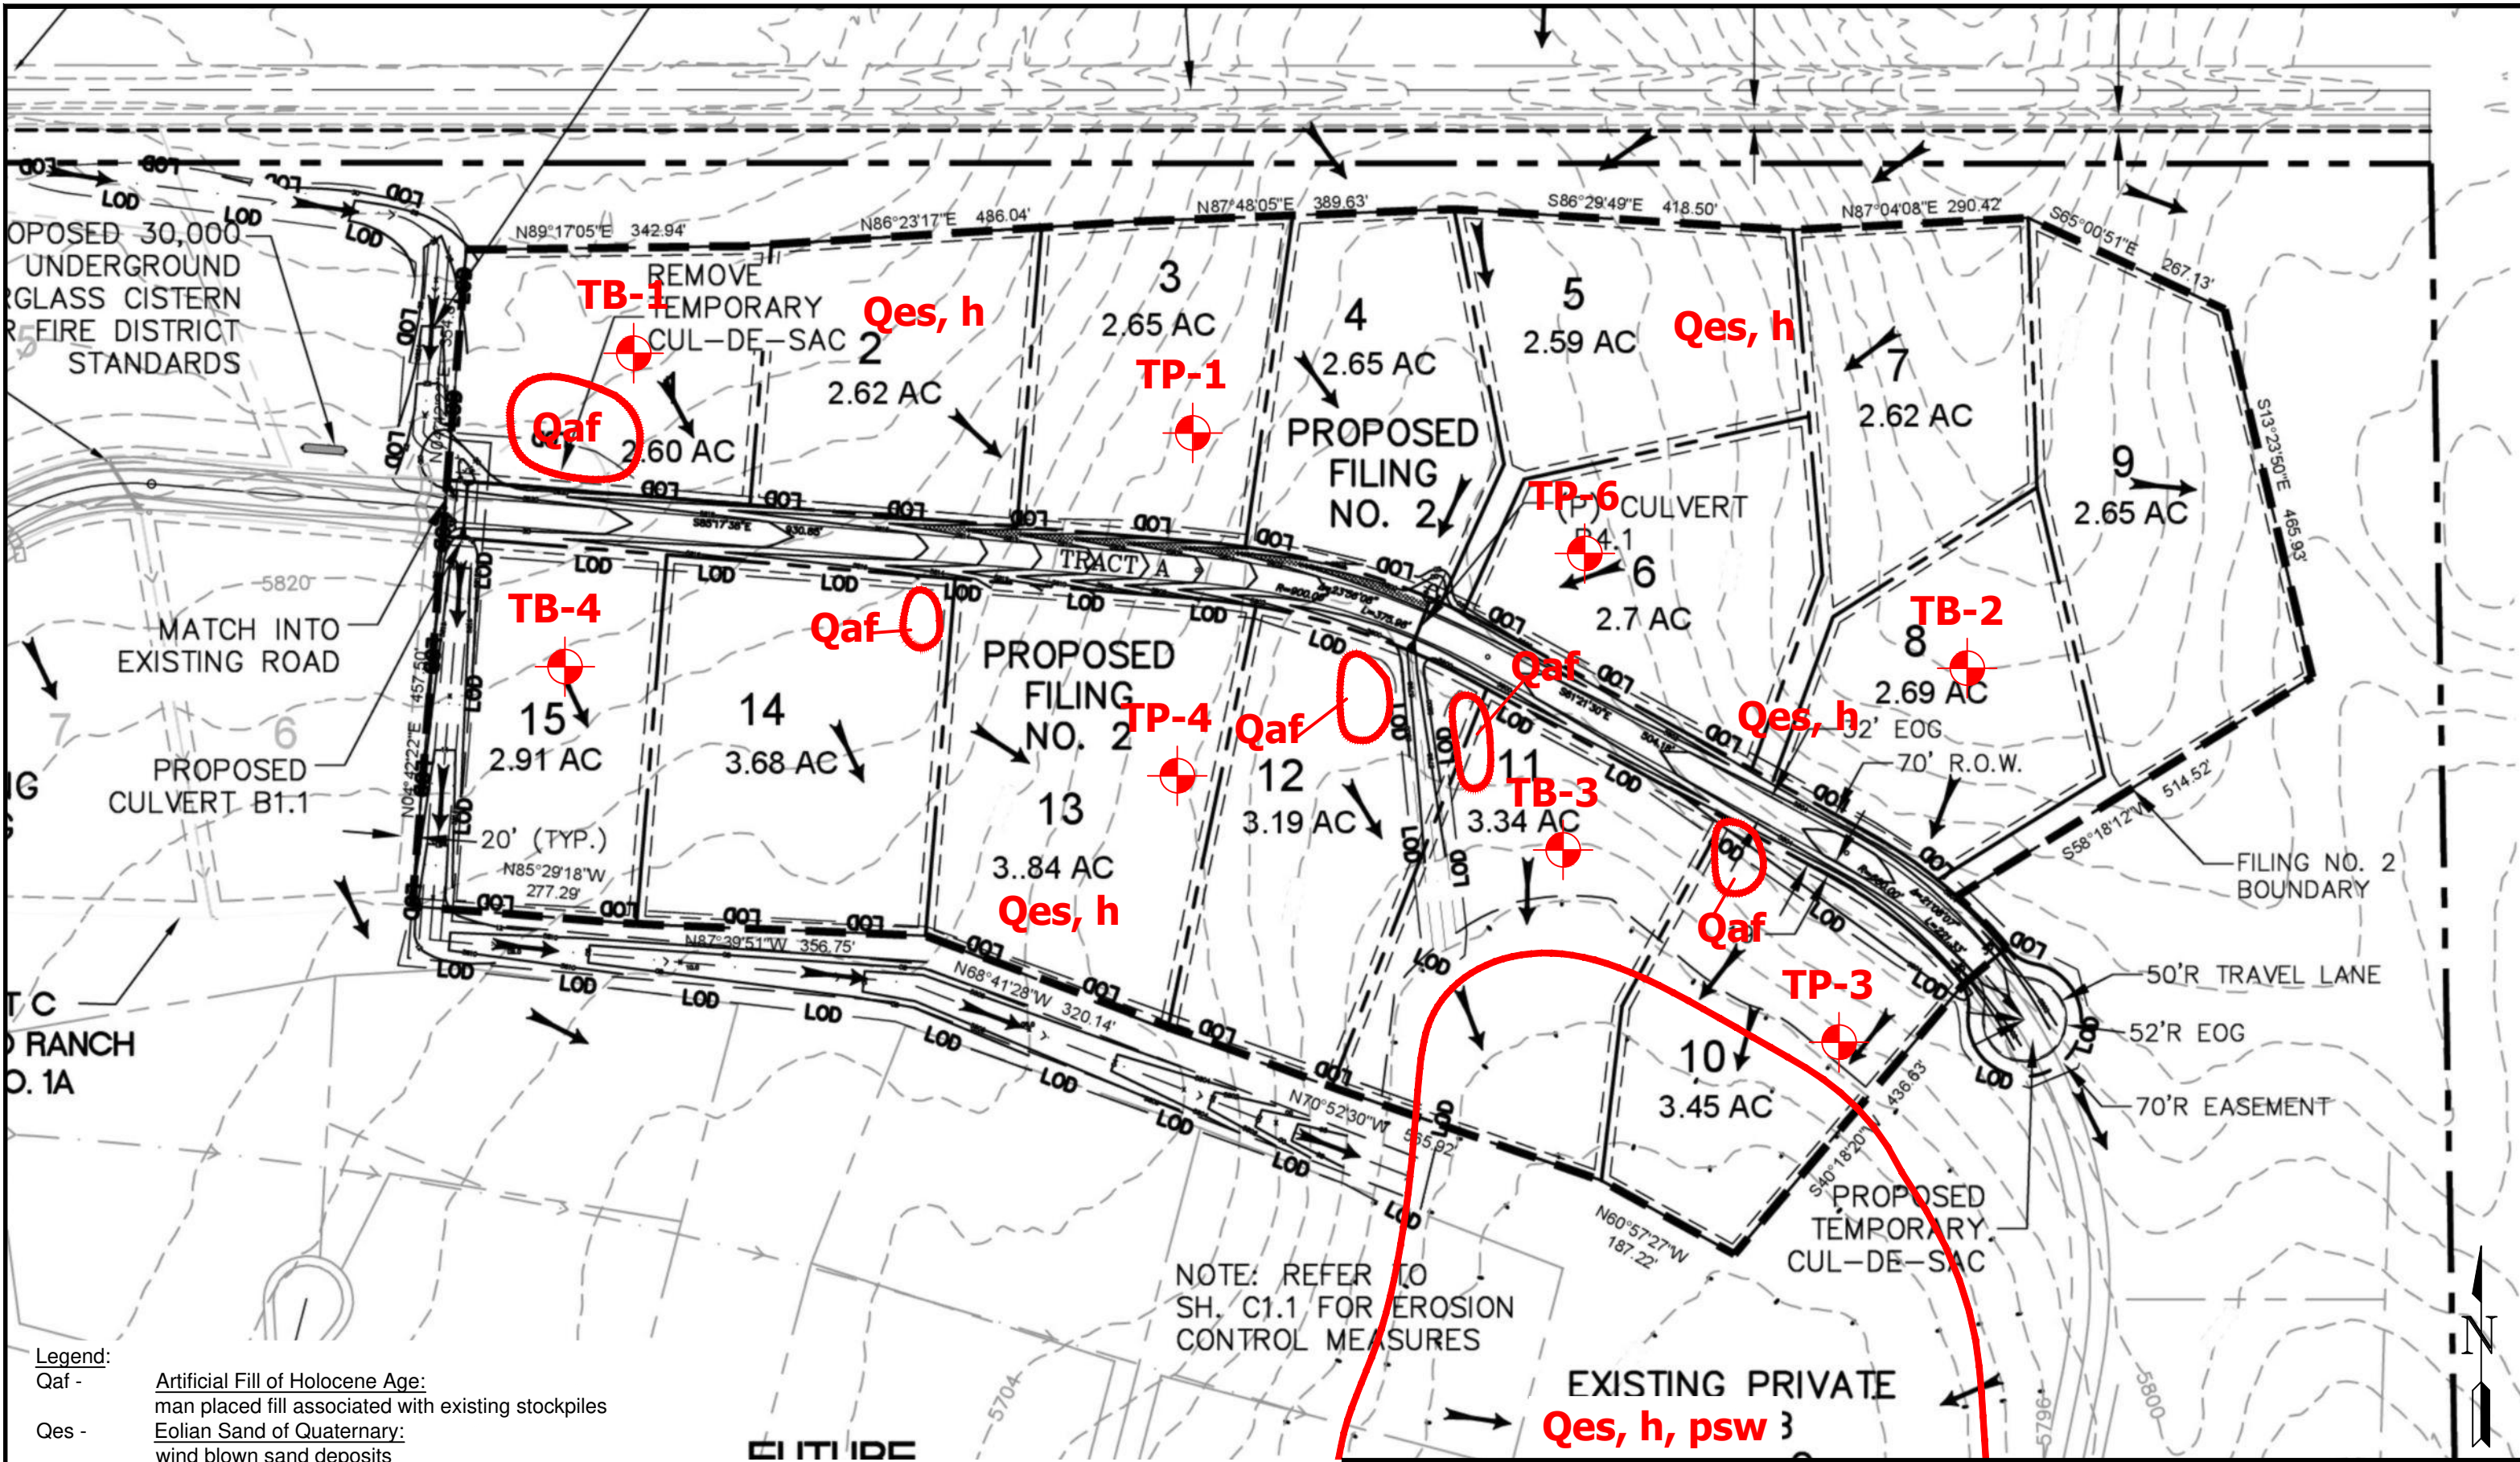
JOB NO. 241337
 FIG. 6

Detailed mapping has been performed on this site to produce an Engineering Geology Map Figure 6. This map shows the location of various geologic conditions of which the developers should be cognizant during the planning, design and construction stages of the project. These hazards and the recommended mitigation techniques are as follows:

These are areas of man-made fill associated with existing fill stockpiles located across the filing. The stockpiles are associated with ongoing drainage improvements currently under construction at the site. These stockpiles will be removed during the completion of the drainage improvements. Mitigation: Any uncontrolled fill encountered beneath foundations will require removal and recompaction at a minimum of 95% of its maximum Modified Proctor Dry Density, ASTM D-1557.

The majority of the soils encountered on-site do not exhibit collapsible characteristics, however, minor areas of loose soils were encountered in the test borings drilled on site. In areas identified for this hazard classification, we anticipate a potential for settlement movements upon saturation of these surficial soils. The low density, uniform grain sized, windblown sand deposits are particularly susceptible to this type of phenomenon and have been identified on Figure 6. Mitigation: Should loose or collapsible soils be encountered beneath foundations, recompaction and moisture conditioning of the upper 2 feet of soil at 95% of its maximum Modified Proctor Dry Density ASTM D-1557 will be required. Roadway areas may also experience movement. Proofrolling and recompaction of soft areas should be performed during site work.

In these areas, we would anticipate the potential for periodically high subsurface moisture conditions, frost heave potential and highly organic soils. This area is associated with ponds located in the northwest and eastern portions of the subdivision. These are located within no-build areas and will be avoided by future development.

Mitigation: Foundations must have a minimum 30-inch depth for frost protection. In areas where high subsurface moisture conditions are anticipated periodically, subsurface drains are recommended to help prevent the intrusion of water into areas below grade. Subsurface perimeter drains are recommended for portions of structures which will have useable space located below the finished ground surface, typical perimeter drain details are shown in Figure 9. Shallow groundwater conditions are not anticipated for majority of the filing, however, if areas of shallow groundwater are encountered, underslab drains or interceptor drains may be necessary. Typical drain details are shown in Figures 10 and 11. Specific recommendations should be made after additional investigation and site grading has been completed.

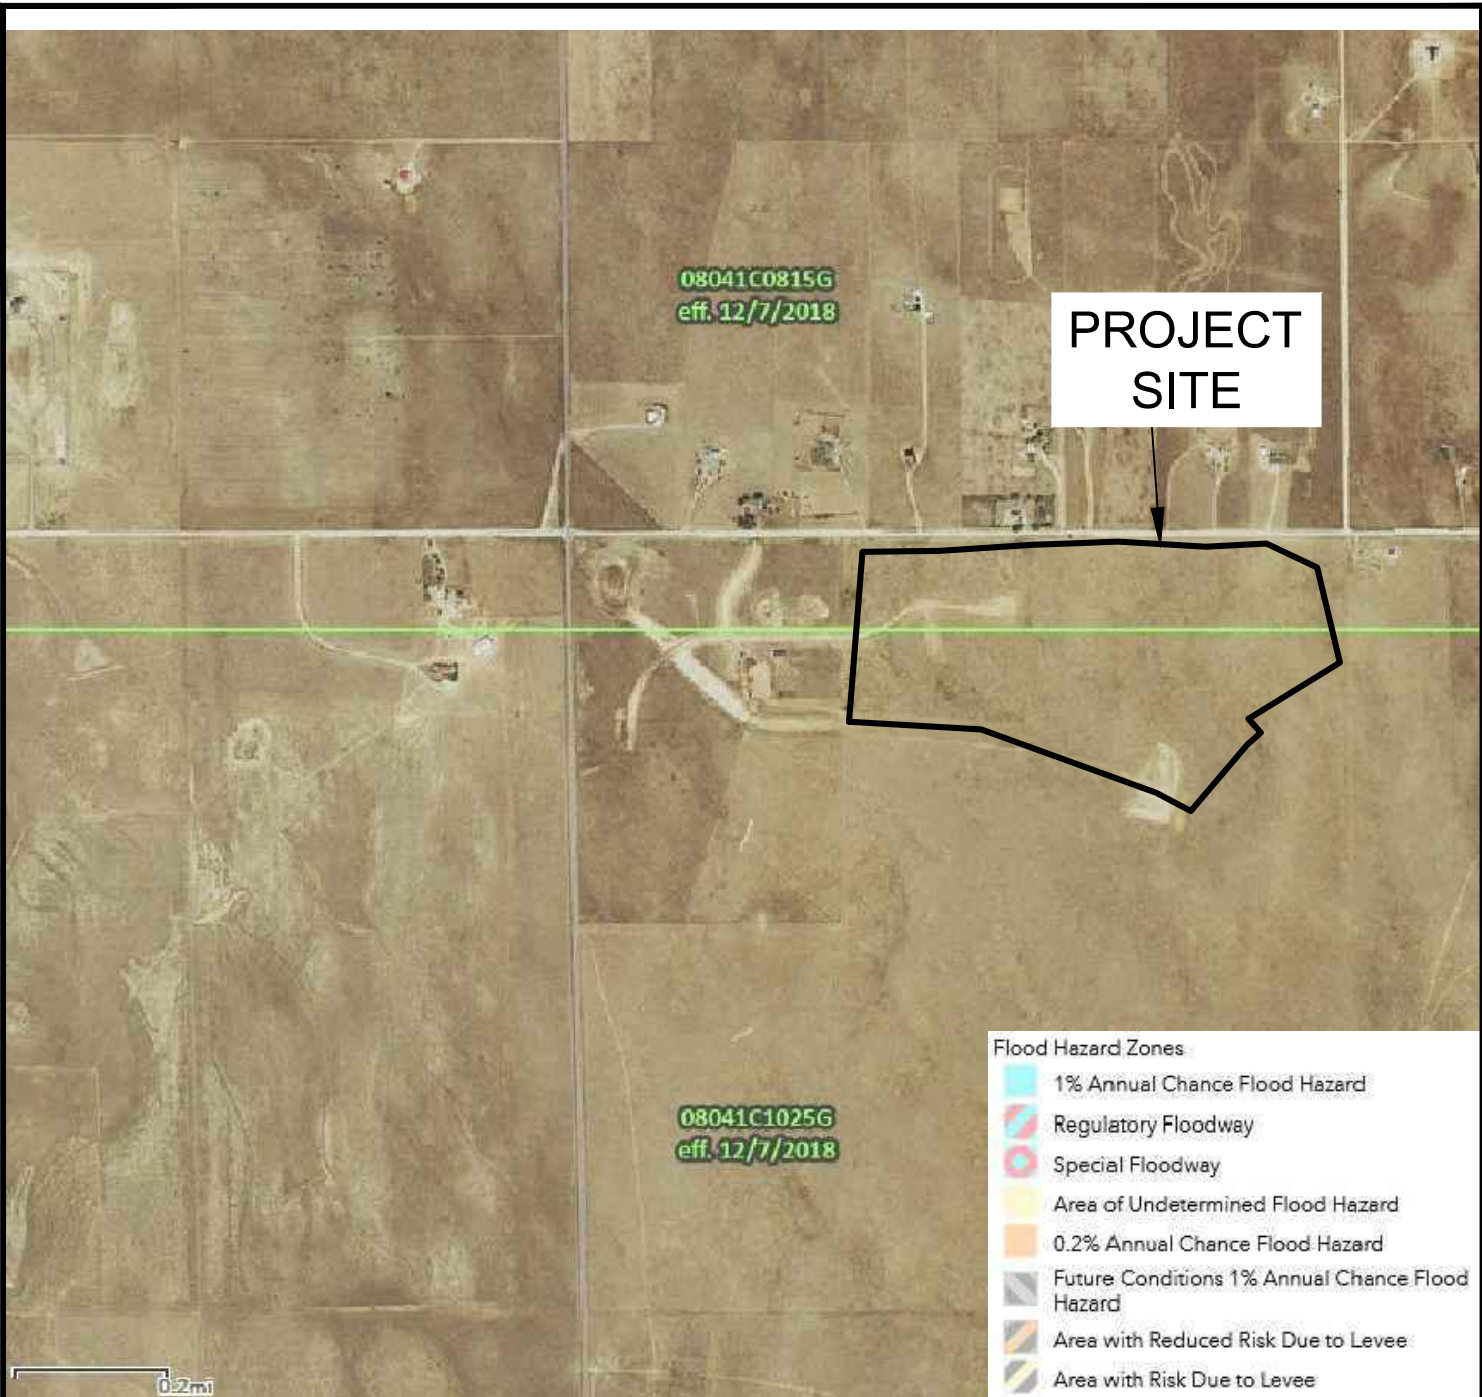
FIG. 7

The site is not mapped within floodplain zones according to the FEMA Map Nos. 08041C0815G and 08041C1025G, Figure 7 (Reference 8). The topography of the site is gradually sloping to the southeast with two existing ponds located in the northwest corner of the subdivision and the eastern portion of the subdivision. These ponds are associated with blowout within the eolian sand deposits on the site and typically consist of poorly drained soils. The ponds were dry at the time of our site observation, and no areas of flowing or ponded water were observed within the subdivision. The ponds have been identified as a potentially seasonal shallow groundwater area and is shown on the Geology/Engineering Geology Map, Figure 6.

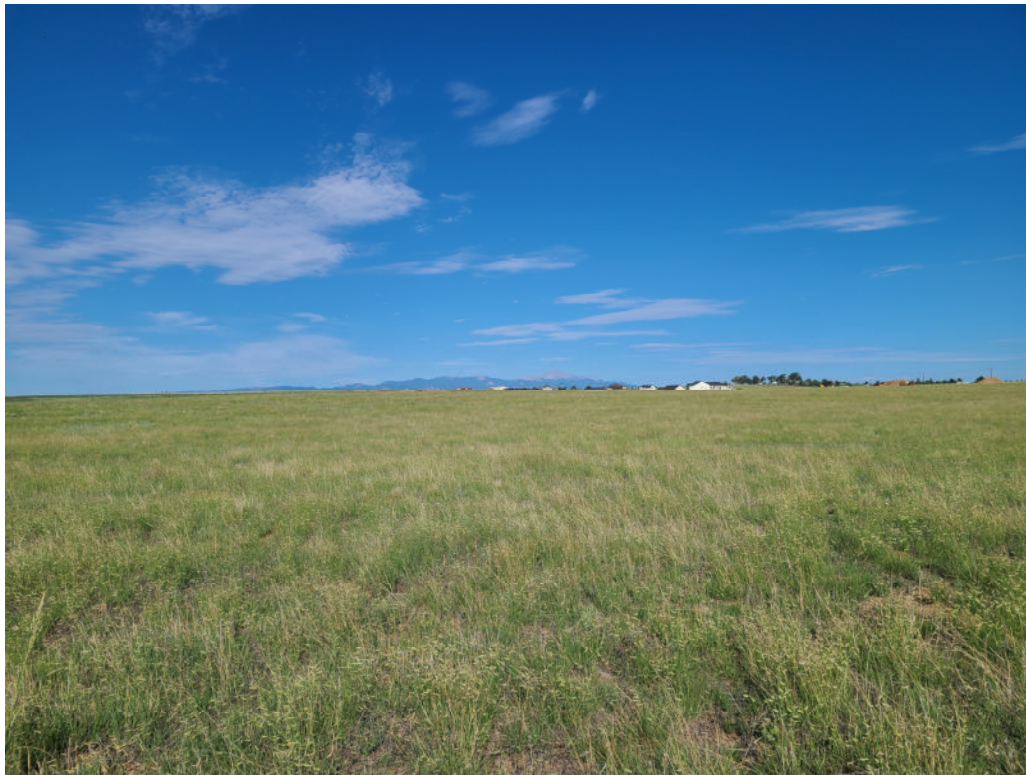
Looking west from the southeastern portion of the site.

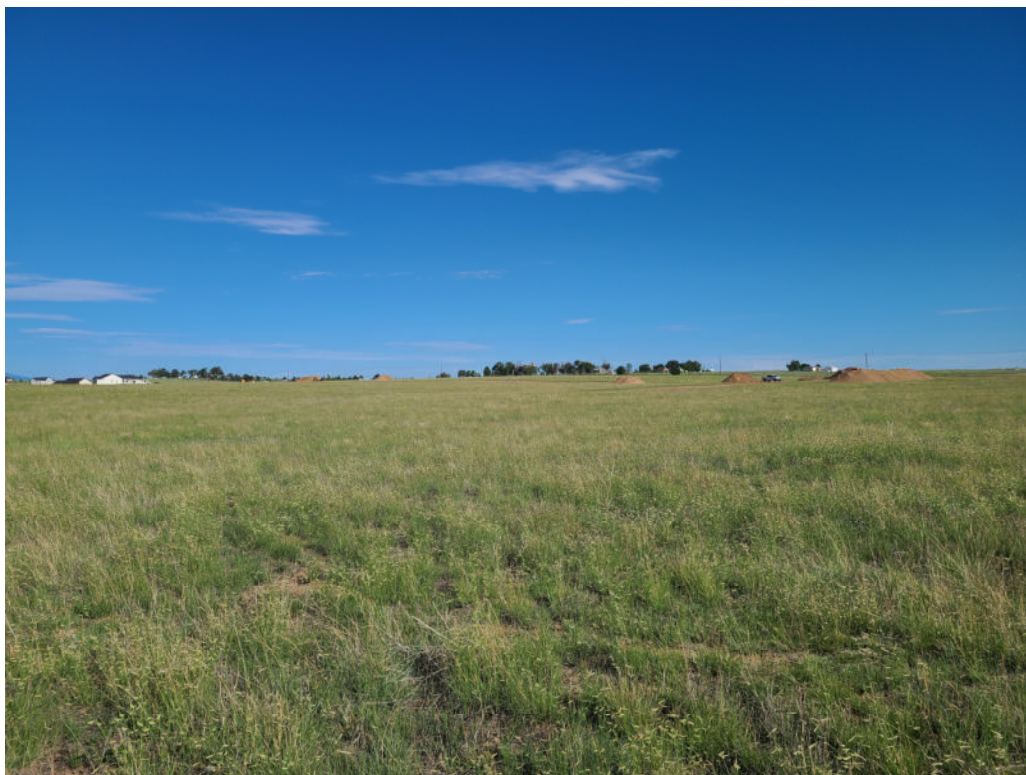
Looking north from the southeastern portion of the site.

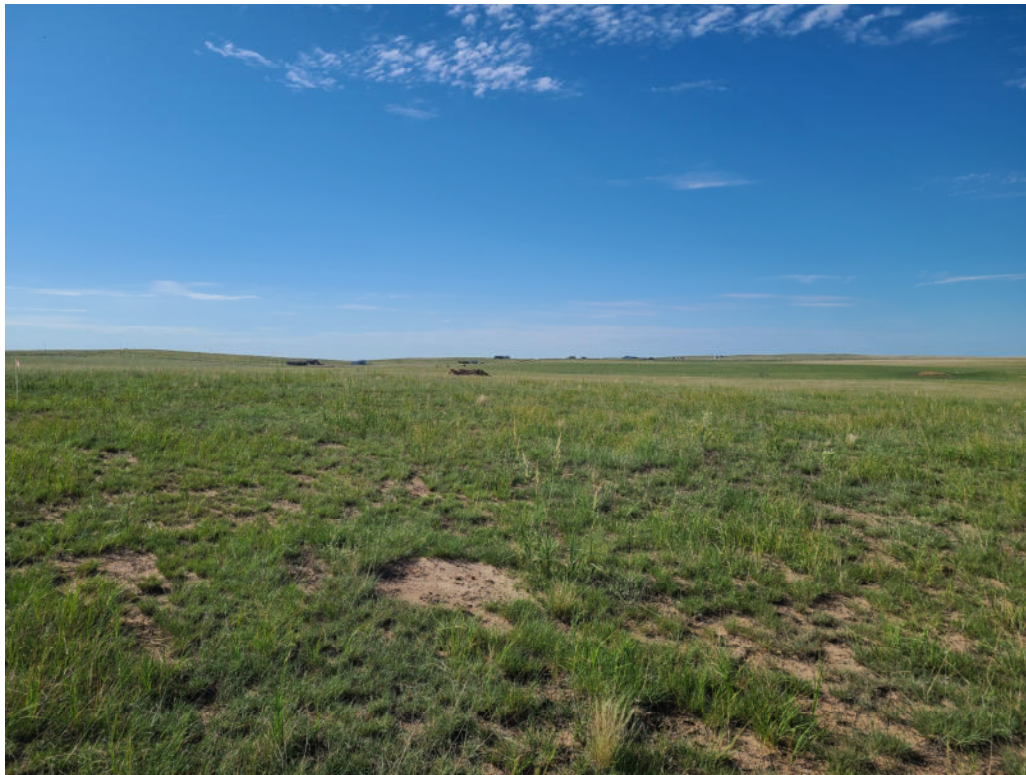
**Looking south from
eastern portion of the
site.**

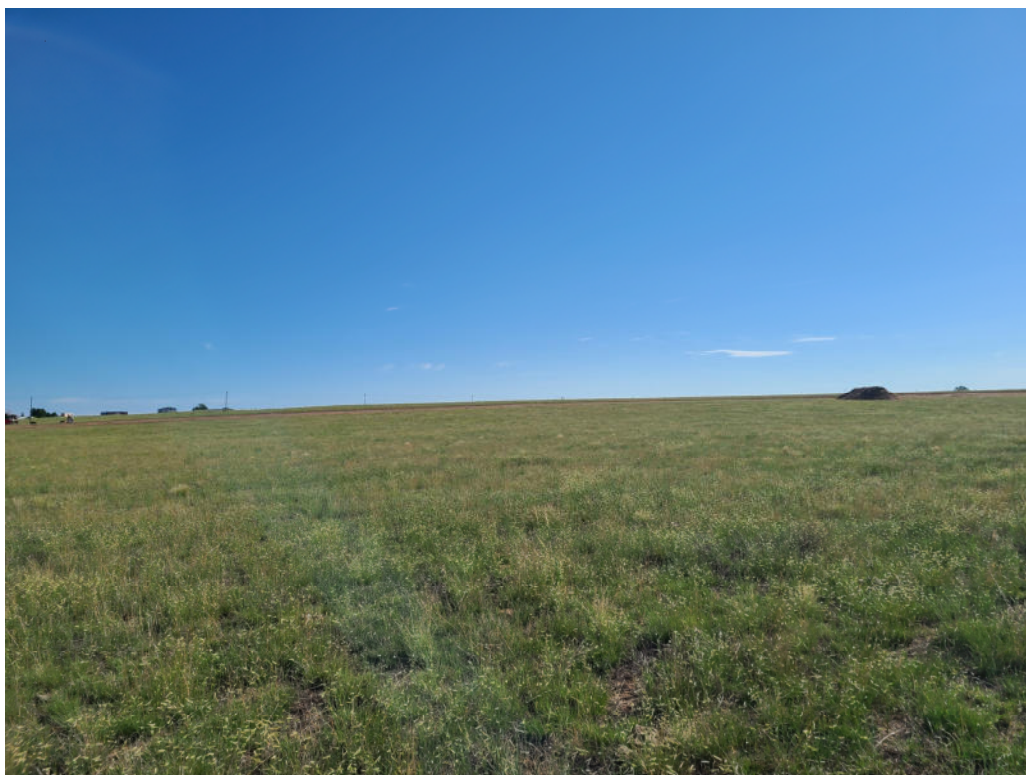
**Looking northeast
from the western
portion of the site.**
