**SOIL, GEOLOGY, AND GEOLOGIC HAZARD STUDY
THE VILLAS AT CLAREMONT RANCH
CLAREMONT RANCH FILING NO. 7
1250 MEADOWBROOK PARKWAY
EL PASO COUNTY, COLORADO**

September 22, 2017
Revised April 16, 2020

Entech Job No. 171247
AAprojects/2017/171247 countysoil/geo

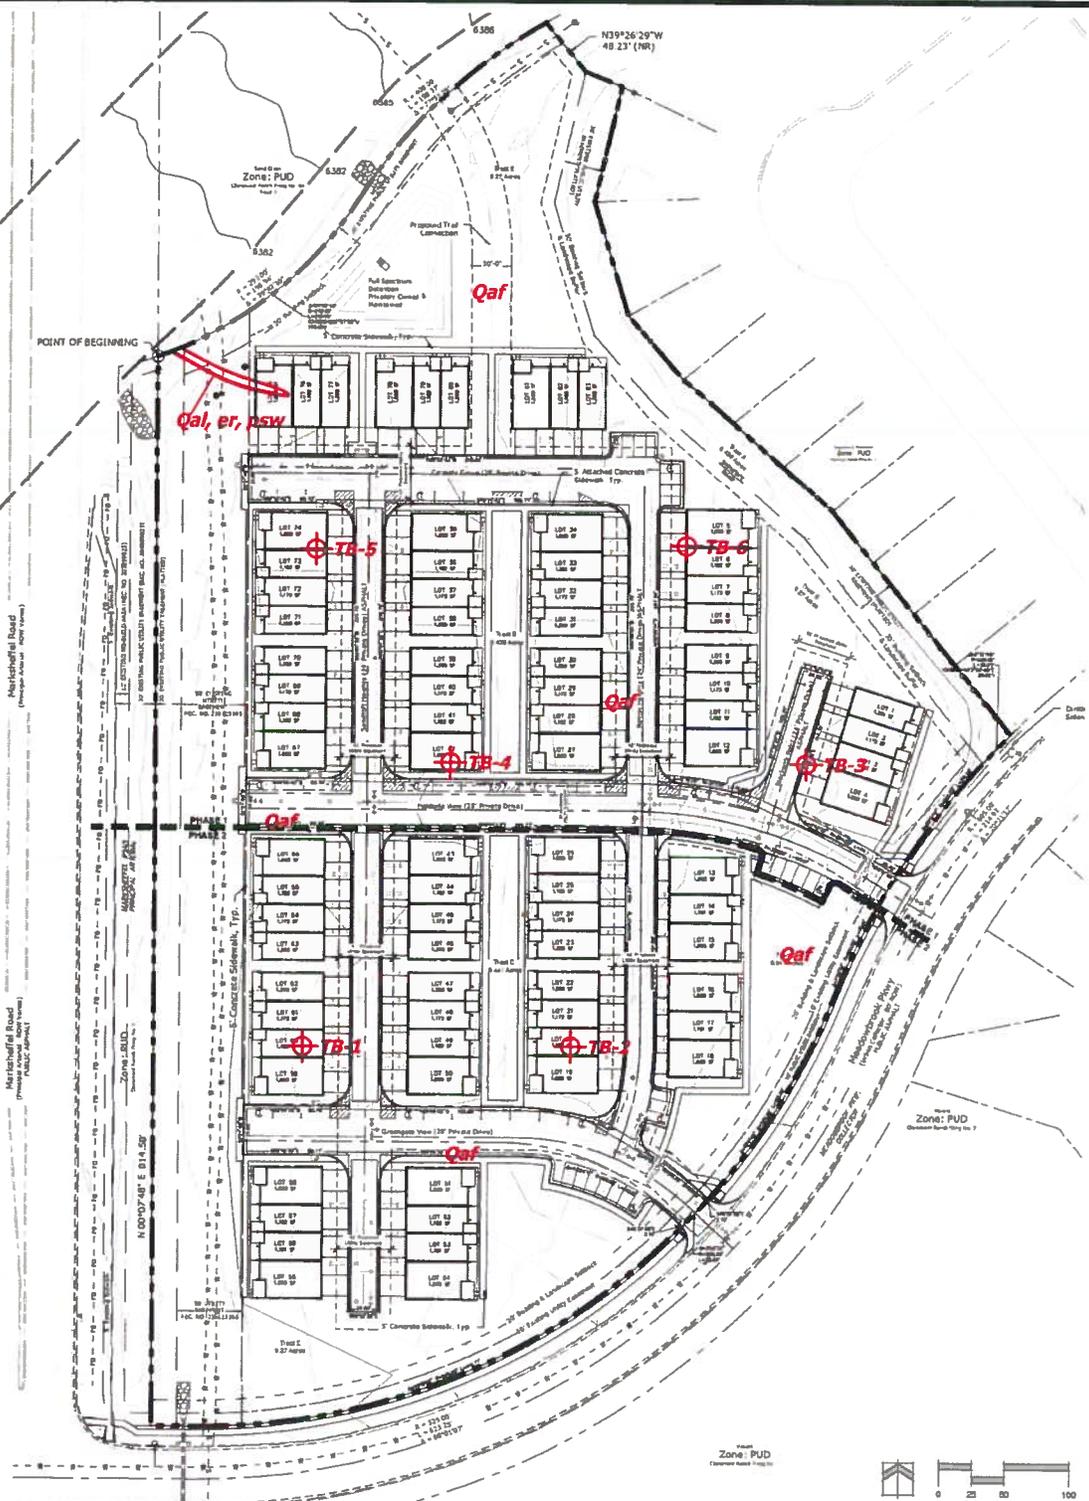
FIG NO.:
6

As mentioned previously, detailed mapping has been performed on this site to produce an Engineering Geology Map Figure 7. This map shows the location of various geologic conditions of which the developers should be cognizant during the planning, design and construction stages of the project. These hazards and the recommended mitigation techniques are as follows:

These are recent man-made fill deposits associated with overlot fill encountered across the site, and small fill piles observed in the northern and western portions of the site. It is our understanding the fill was placed during the site grading for the nearby residential development. The fill was encountered at medium dense states and moist conditions.

The majority of the soils encountered on-site do not exhibit collapsible characteristics, however, areas of loose soils were encountered in the test borings drilled on site. The soil underlying the fill on the site consist of eolian sands of Quaternary age. These soils may be subject to hydrocompaction, additionally walls of trenches may collapse if not supported.

Areas within the drainage on-site have been identified as areas of potentially seasonally high groundwater areas. Water was not observed in the small drainage on-site, and water was observed flowing in the East Fork of Sand Creek located north of the site. The northern portion of site is mapped within floodplain zones according to the FEMA Map No. 08041CO756G,

In these areas, we would anticipate the potential for periodically high subsurface moisture conditions, frost heave potential and highly organic soils. This area is associated with the small drainage in the northwestern portion of the site which can likely be mitigated during the proposed site development. The same mitigation recommendations for the seasonal shallow groundwater areas apply to the potentially seasonal shallow groundwater areas.

Mitigation: The fill on this site appears to have been placed in a controlled manor; however, records for the fill placement should be obtained. If records cannot be obtained the fill should be considered uncontrolled. Any uncontrolled fill encountered beneath foundations will require removal and recompaction at a minimum of 95% of its maximum Modified Proctor Dry Density, ASTM D-1557.

Mitigation: Should loose or collapsible soils be encountered beneath foundations, recompaction and moisture conditioning of the upper 2 to 3 feet of soil at 95% of its maximum Modified Proctor Dry Density ASTM D-1557 will be required. Exterior flatwork and parking areas may also experience movement. Proofrolling and recompaction of soft areas should be performed during site work.

Mitigation: Foundations must have a minimum 30-inch depth for frost protection. In areas where high subsurface moisture conditions are anticipated periodically, subsurface perimeter drains are recommended to help prevent the intrusion of water into areas below grade. Typical drain details are presented in Figure 9. Any grading in these areas should be done to direct surface flow around construction to avoid areas of ponded water. Structures should not block drainages. All organic material should be completely removed prior to any fill placement. Finished floor levels must be located a minimum of one-foot above floodplain levels.

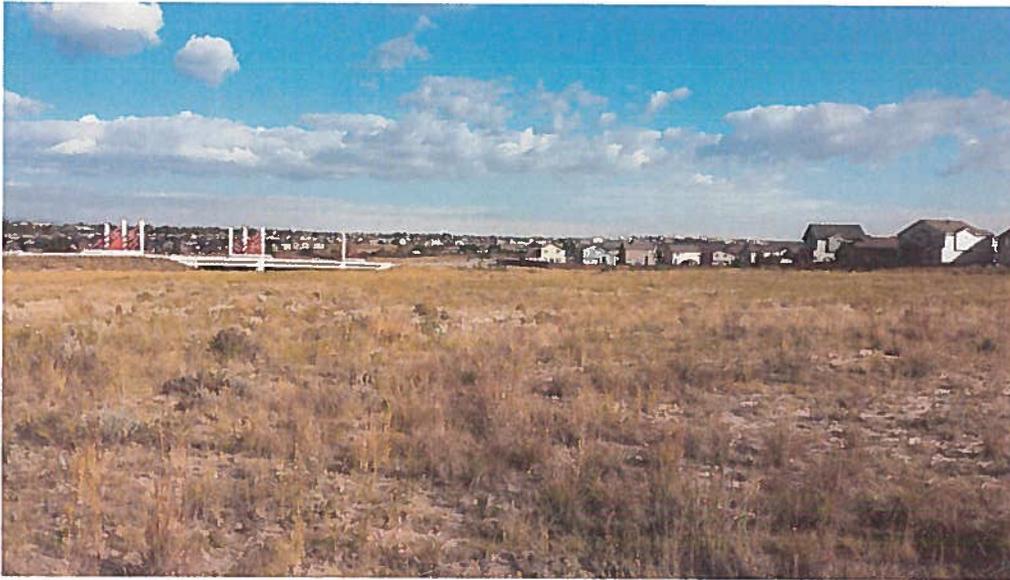
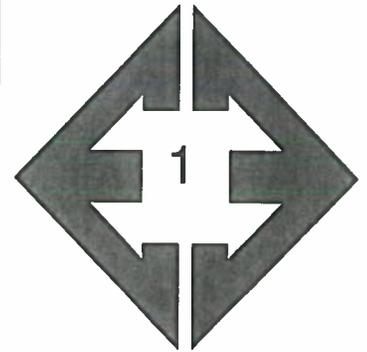
Looking north from the southern side of the site.

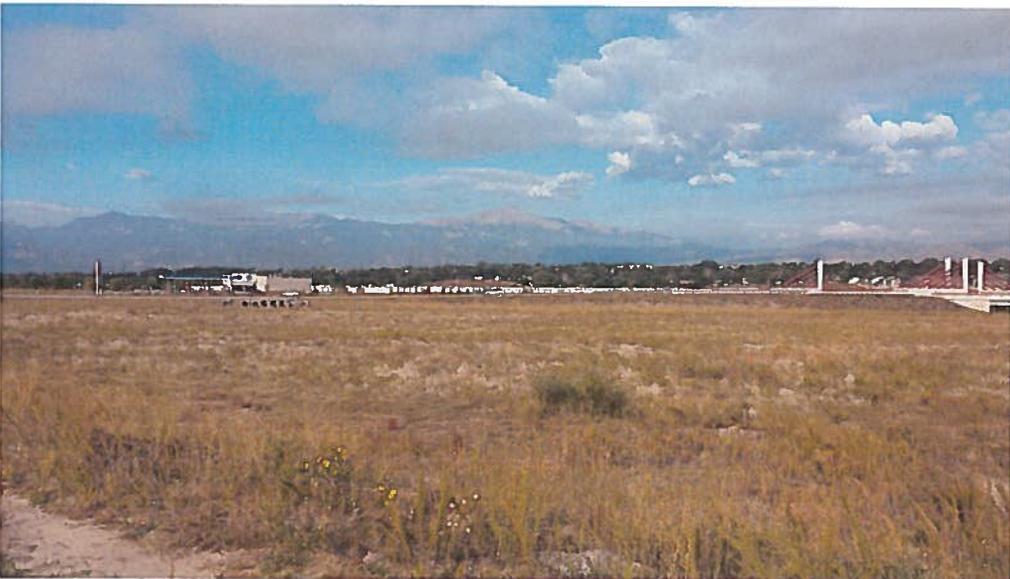
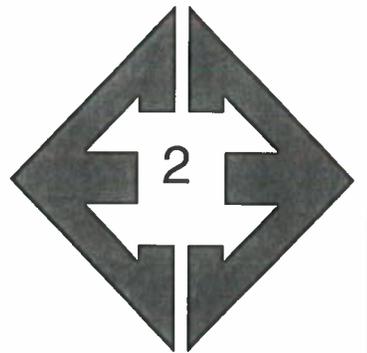
Looking northwest from the southern side of the site.

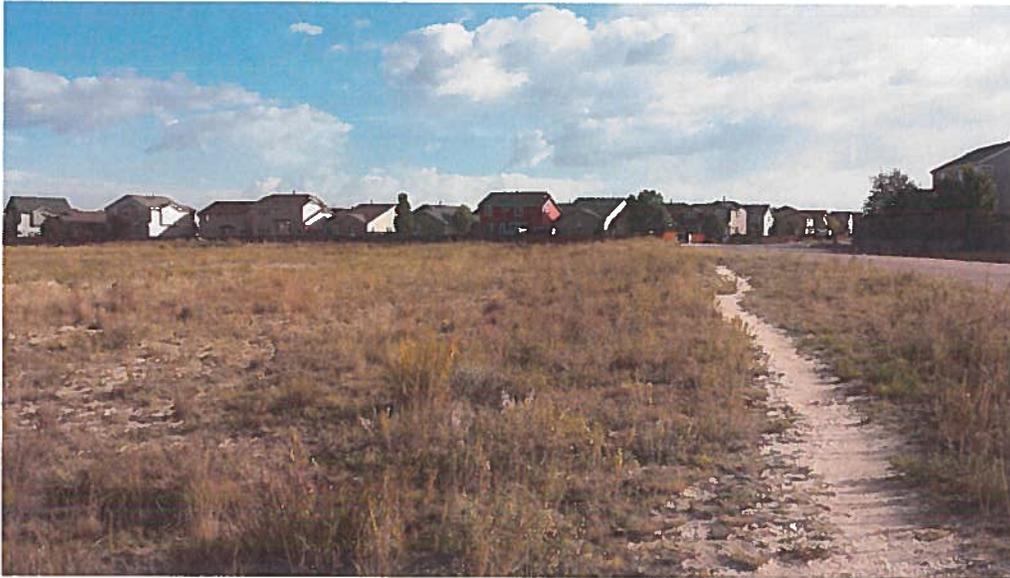
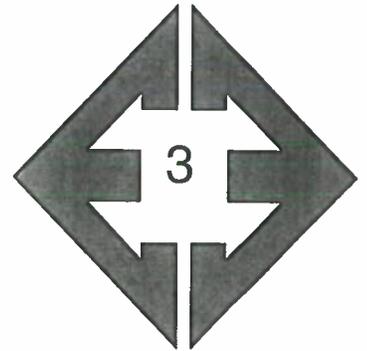
Looking east from the southern side of the site.

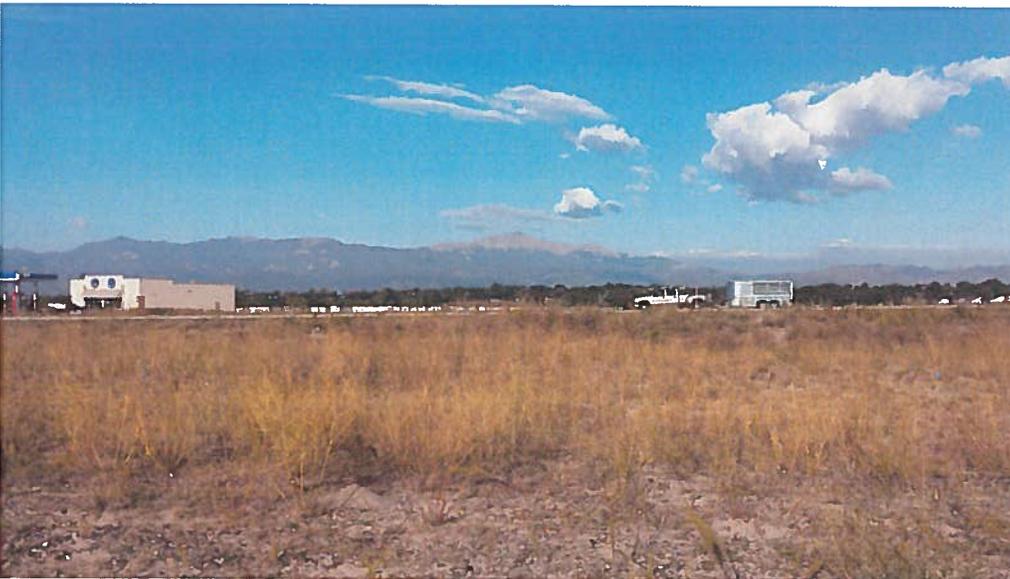
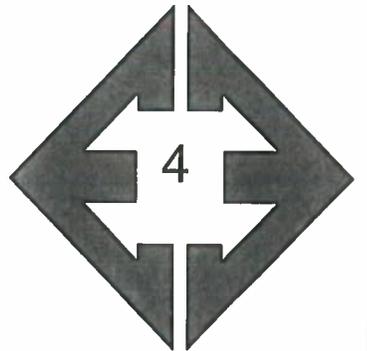
Looking west from the northwestern portion of the site.

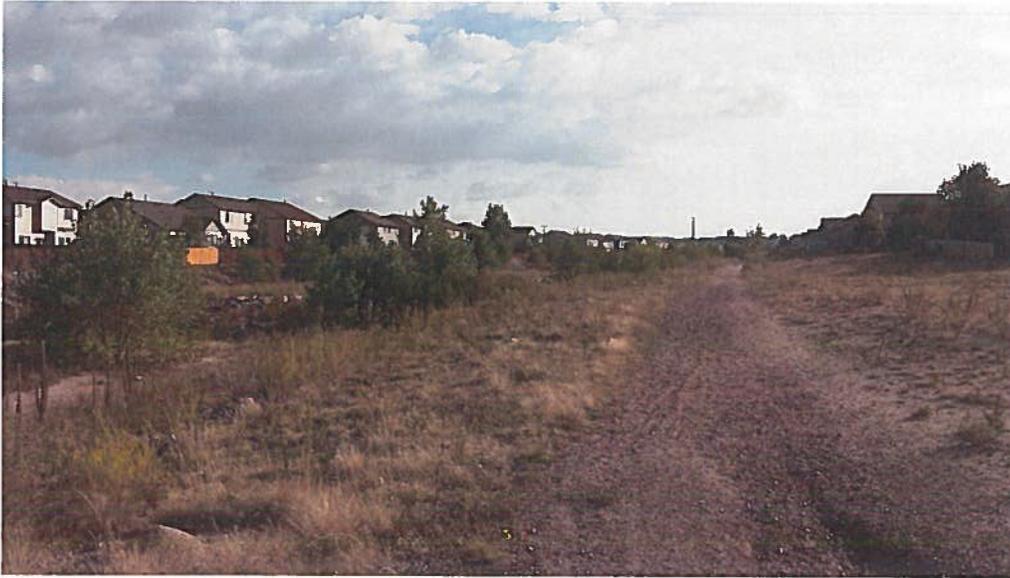
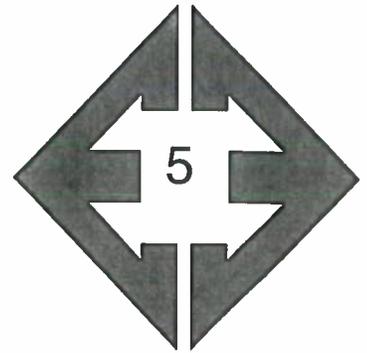
Looking east from the northern side of the site.

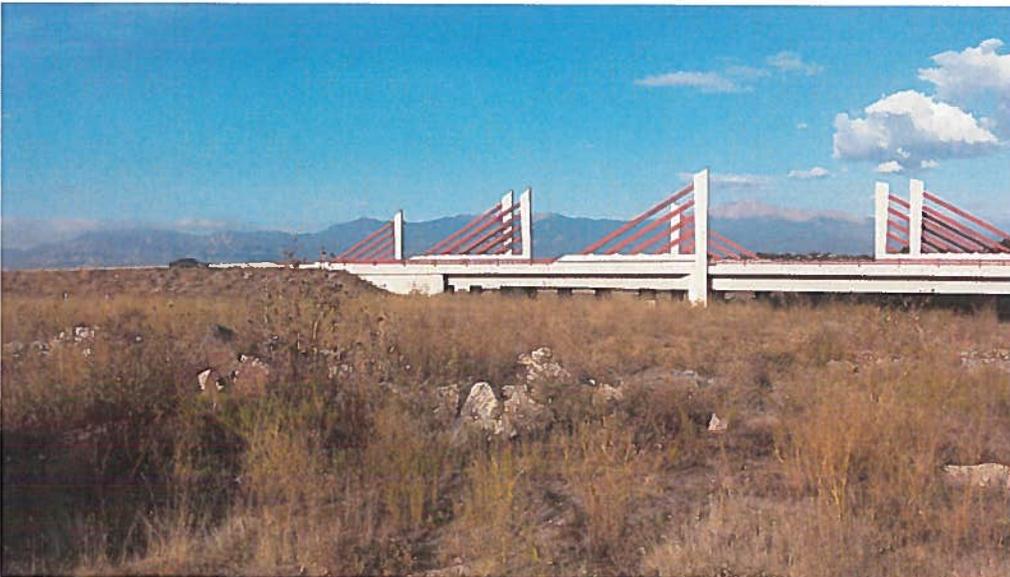
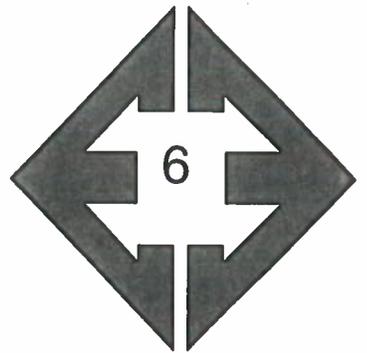
Looking west from the northern side of the site.
