**ENTECH**  
ENGINEERING, INC.

**WASTEWATER STUDY  
ROLLIN RIDGE ESTATES  
HODGEN ROAD AND HIGHWAY 83 – SOUTHWEST CORNER  
EL PASO COUNTY, COLORADO**

November 12, 2019

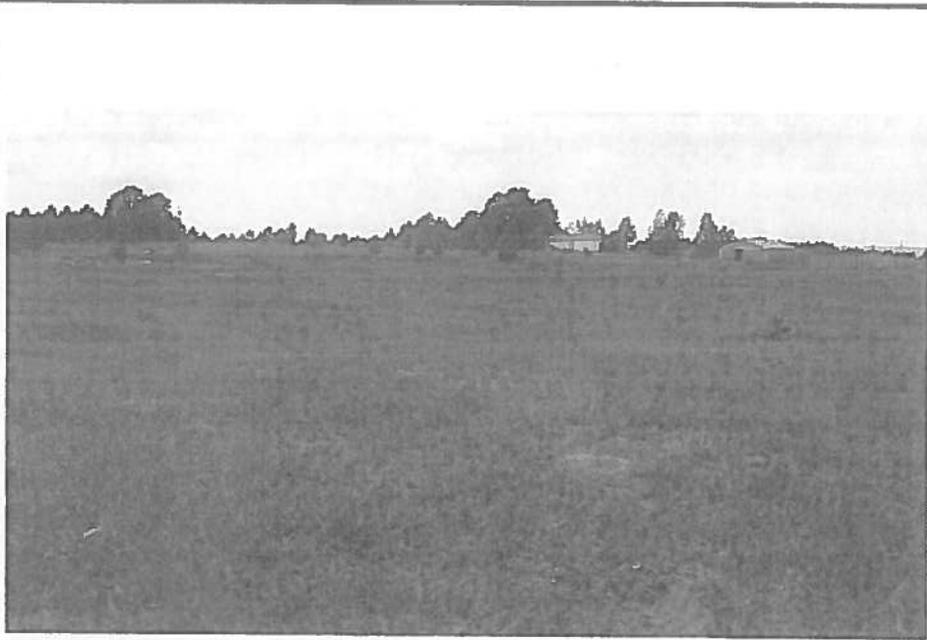
**Looking west from the southeastern portion of the site.**

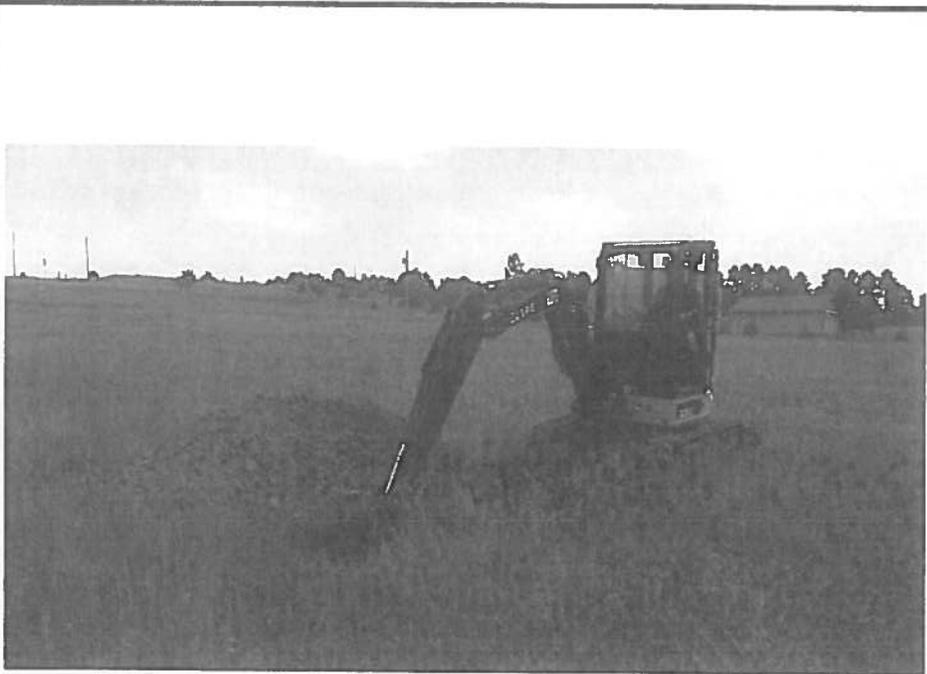
**Looking southeast from Test Pit No. 1 in the southeastern portion of the site.**

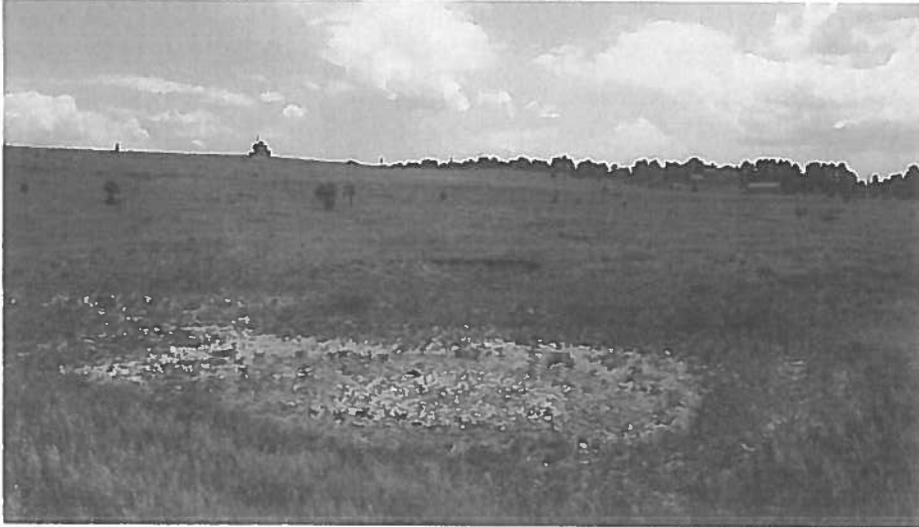
**Looking southeast  
from the pond in the  
northeastern portion of  
the site.**

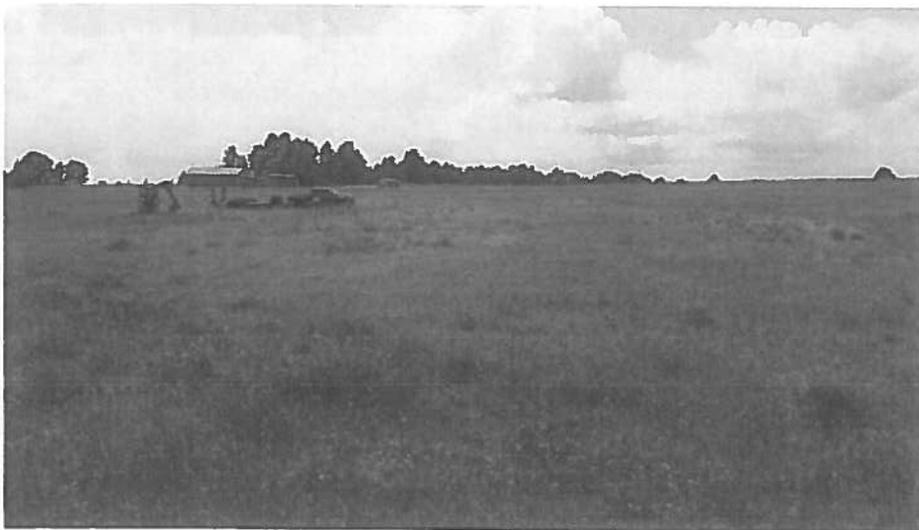
**Looking southwest  
from the northern  
portion of the site.**

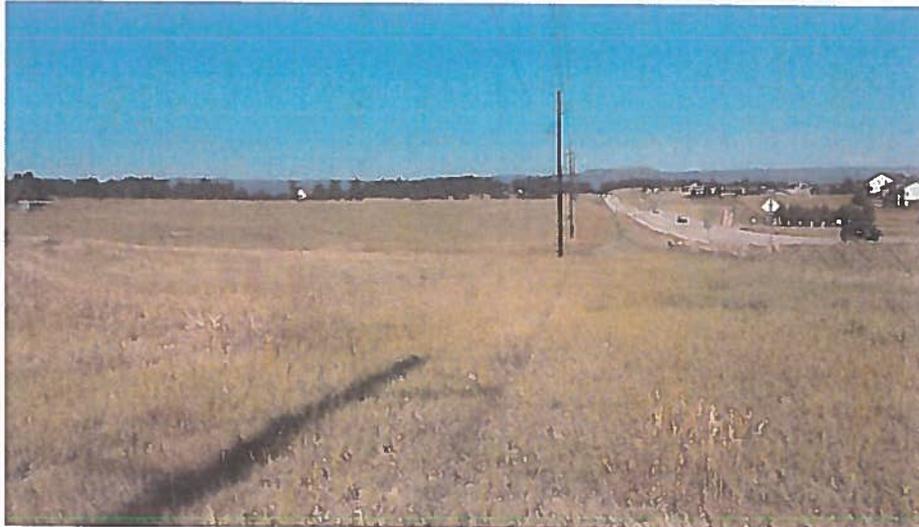
**Looking west from the northeast corner of the site.**

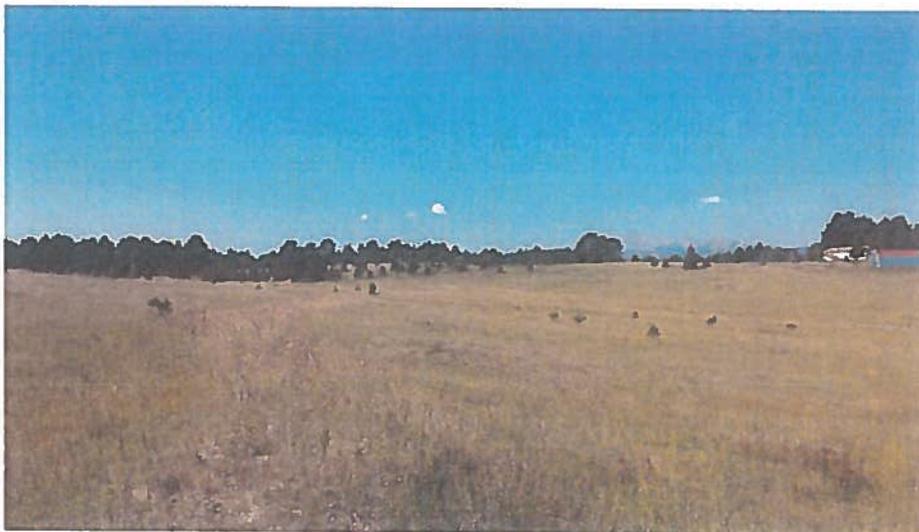
**Looking southwest from the northeast corner of the site.**

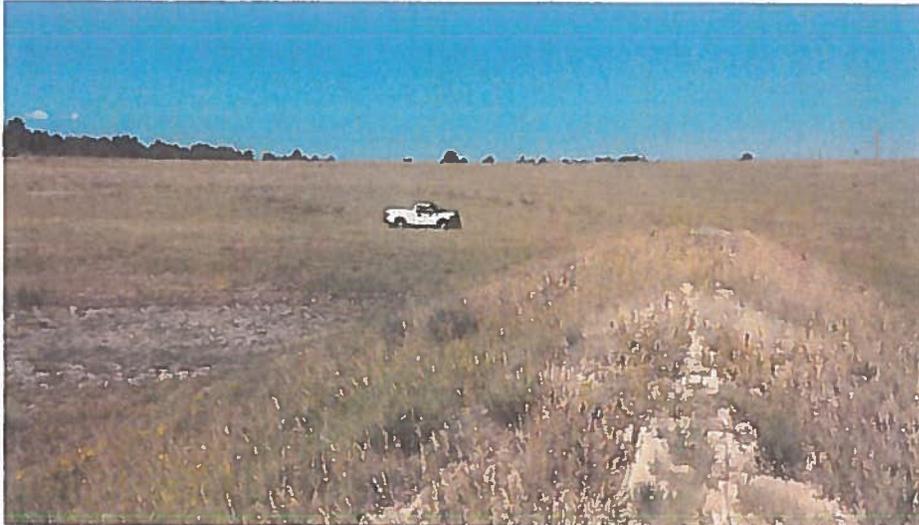
**Looking west along  
the dam located in the  
northeastern portion of  
the site.**

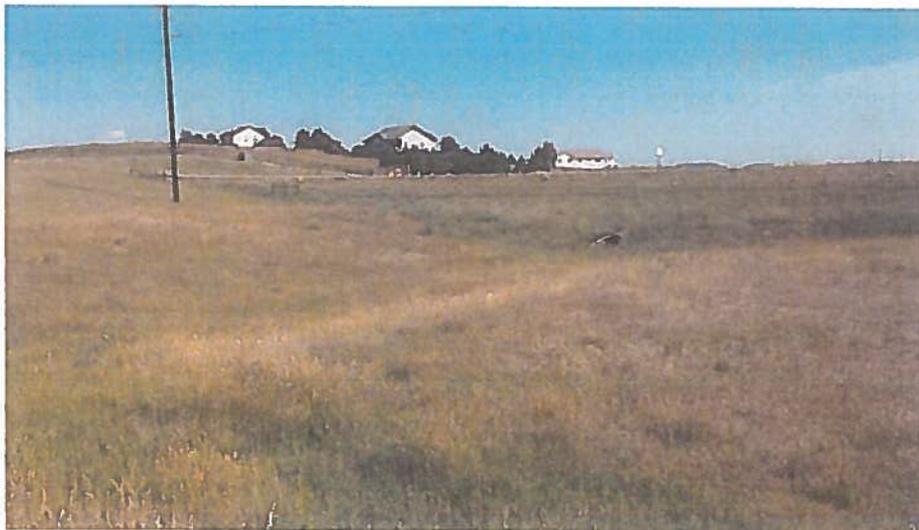
**Looking northwest  
from the northeastern  
portion of the site.**

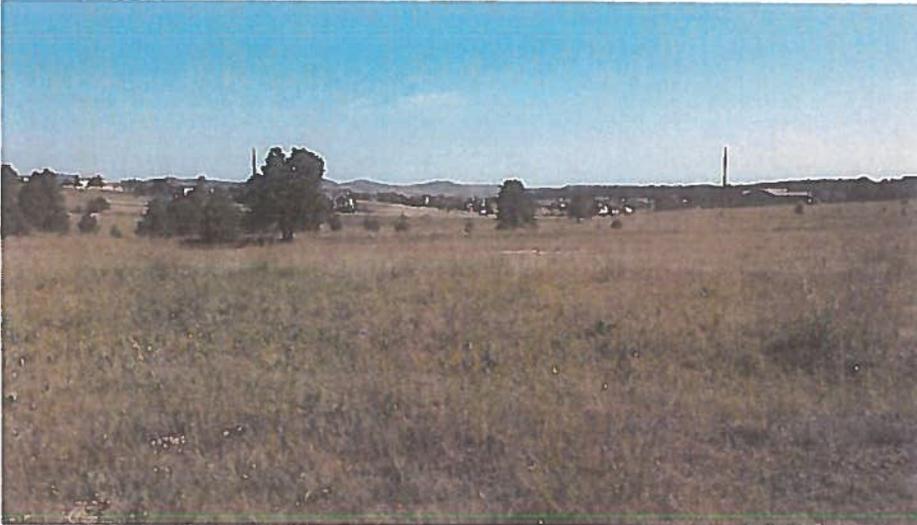
**Looking northwest  
from the western  
portion of the site.**

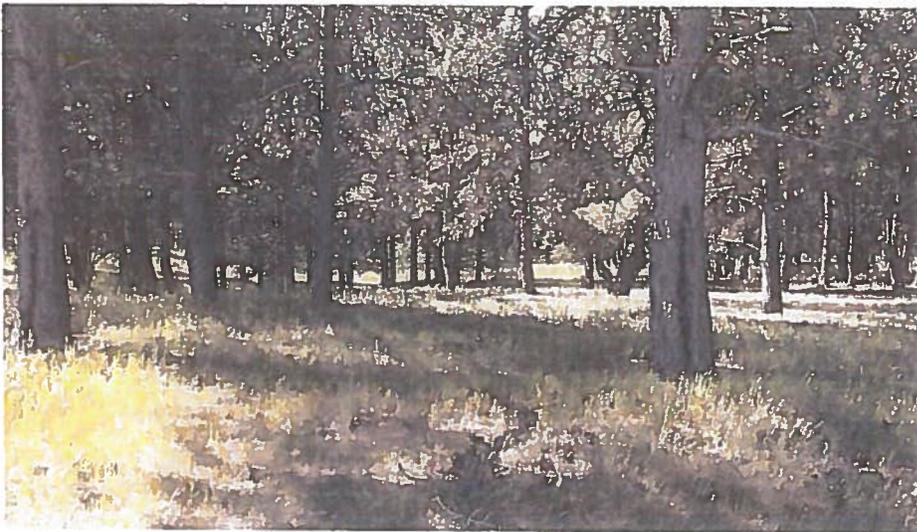
**Looking south from  
the southwestern  
portion of the site.**
