Re: Addendum to Soil, Geology and Geologic Hazard Study
Latigo Business Center
El Paso County, Colorado
Entech Job Nos. 56382 and 56392

**SOIL, GEOLOGY
AND GEOLOGIC HAZARD STUDY
LATIGO BUSINESS CENTER, LOTS 1-3
WOODMEN ROAD
EL PASO COUNTY, COLORADO**

**SOIL, GEOLOGY
AND GEOLOGIC HAZARD STUDY
LOTS 4 AND 5, LATIGO BUSINESS CENTER
A REPLAT OF LATIGO BUSINESS
AND INDUSTRIAL CENTER, FILING NO. 1
WOODMEN ROAD
EL PASO COUNTY, COLORADO**

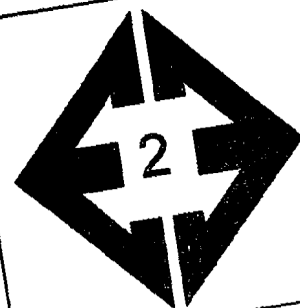
**From south-
central portion
of site, looking
west towards
seasonally wet
area.**

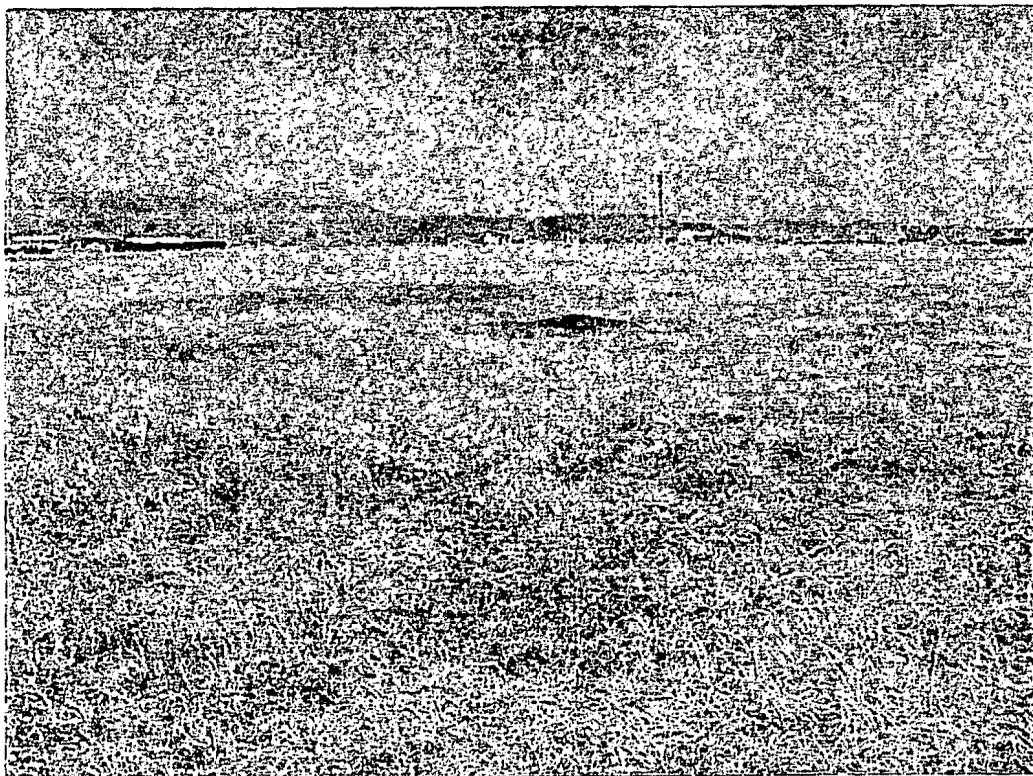
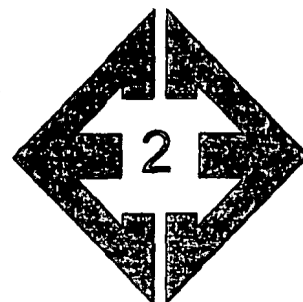
From south-
central portion
of site, looking
west towards
seasonally wet
area.
