SOIL AND GEOLOGY STUDY

**Triple H Ranch
North and East of Jones Road and Murr Road
EPC Schedule No. 3300000168 and 3300000388
El Paso County, Colorado**

JOB NO. 193940

**September 15, 2023
Amended May 29, 2026**

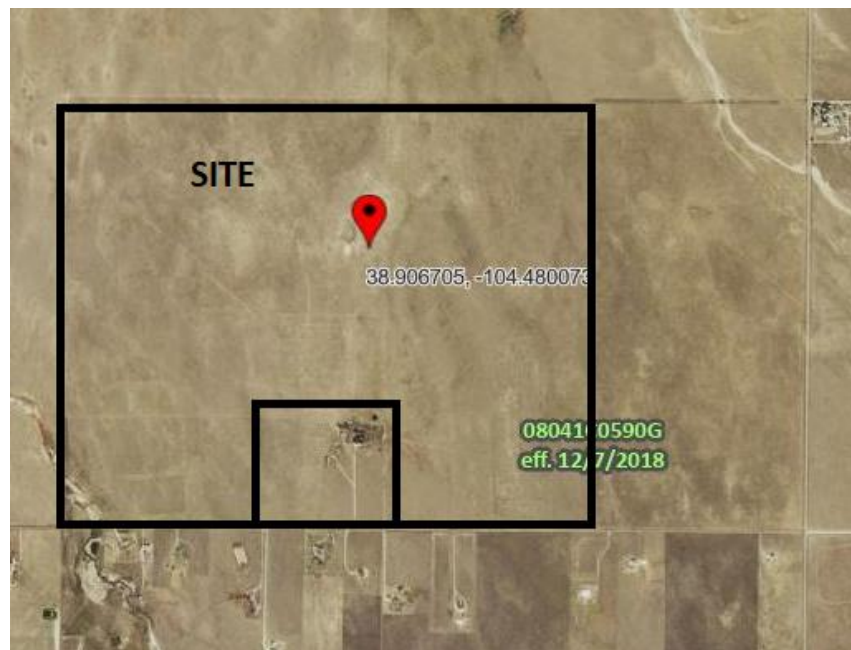
Based on our review of the Federal Emergency Management Agency (FEMA) Community Panel No. 08041C0590G and the online ArcGIS El Paso County Risk Map, the majority of the site lies outside of a 100-year floodplain. The site is within the boundaries of Zone X and Zone A.

Zone X is defined by FEMA as an area of minimal flood hazard that is determined to be outside the Special Flood Hazard Area and higher than the elevation of the 0.2-percent-annual-chance (or 500-year) flood. The majority of the site lies within Zone X. Zone A is considered a special flood hazard area with a regulatory floodway. Zone A encompasses the area around the unnamed drainageway. The Base Flood Elevations (BFE) for the drainageway have not been defined. The FEMA Map is presented below.

We recommend that the proposed residences be located outside the designated Regulatory Floodway. Based on review of the Lot Layout, provided by NES, portions of 5 lots are located within the floodway. The portion of each lot located within the floodway should be considered a No Build Zone. If new development and/or construction are proposed near the floodway, additional investigations should be performed to determine the feasibility of construction within the streamside outer buffer zone and, if necessary, develop mitigation recommendations.

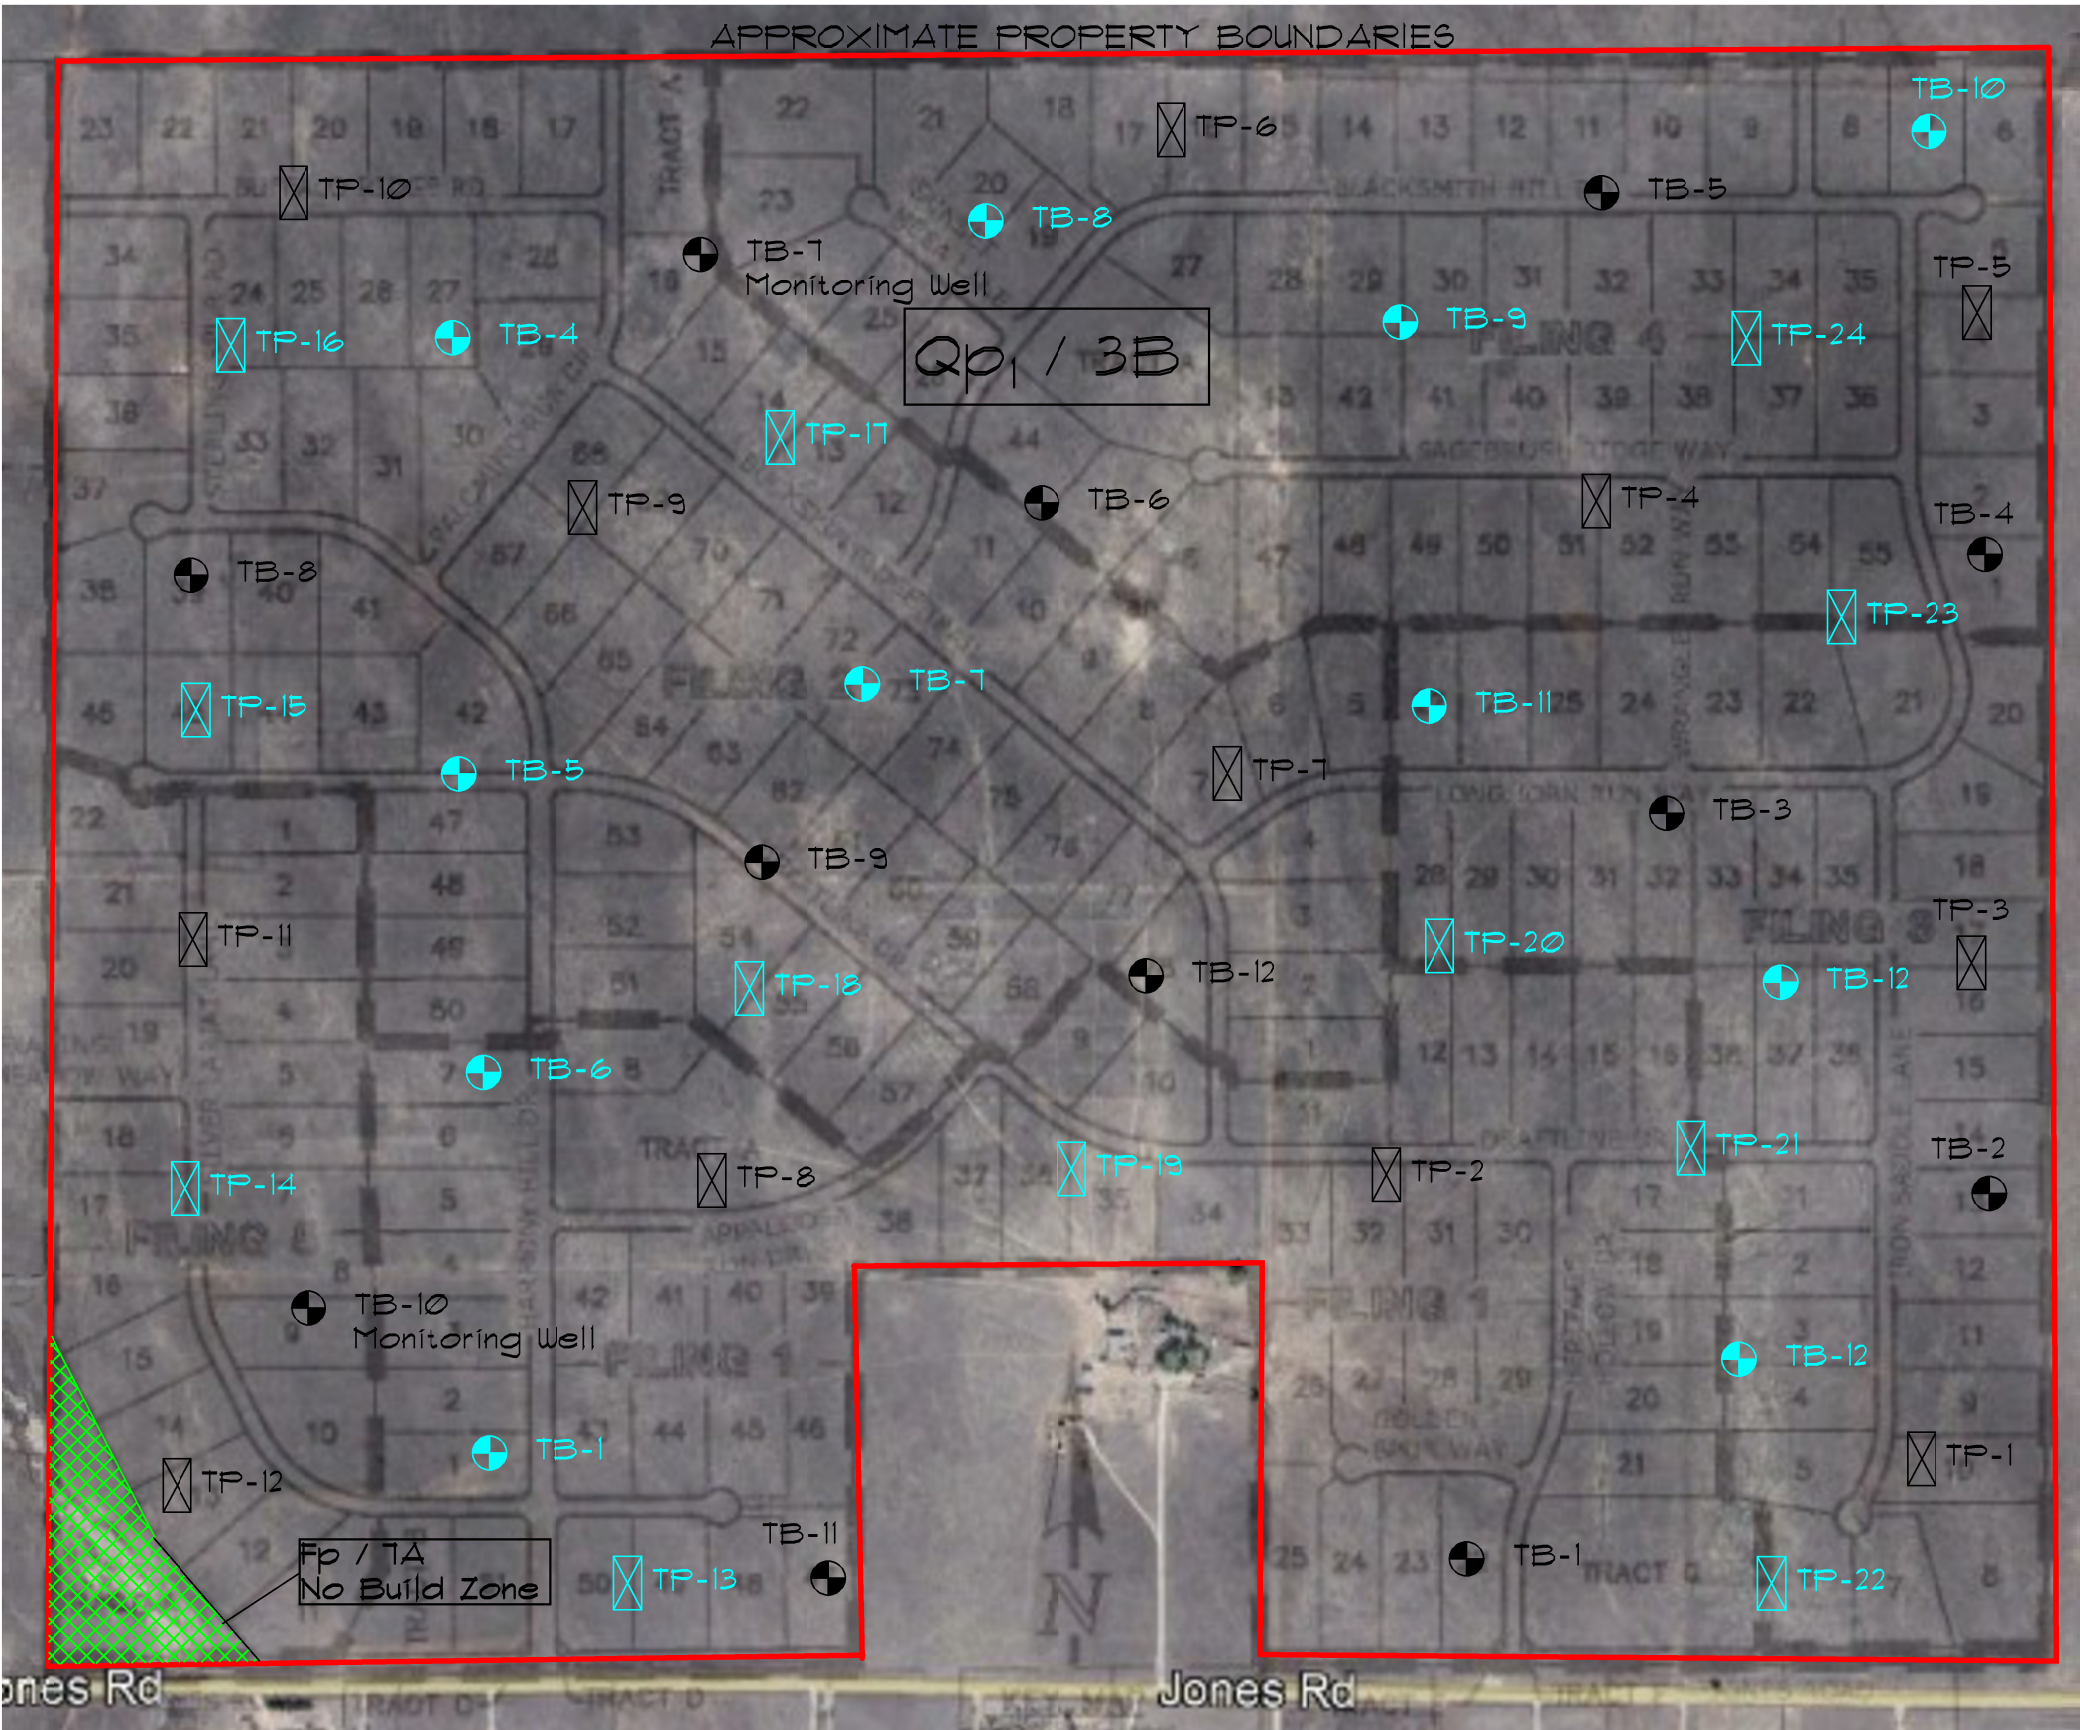
Based on our field observations and review of relevant geologic maps, we identified the geologic conditions (listed below) affecting the development, as shown on the Engineering and Geology Map, Figure 40.
