**SOIL, GEOLOGY, AND GEOLOGIC HAZARD STUDY
COPPER CHASE AND STERLING RANCH FILING NO. 2
EL PASO COUNTY, COLORADO**

Morley-Bentley Investments, LLC
20 Boulder Crescent Street, Suite 200
Colorado Springs, Colorado 80903

February 10, 2020
Revised September 25, 2020
Revised March 18, 2021

Entech Job No. 191088
F:/AAPProjects/2019/191088 Geohaz

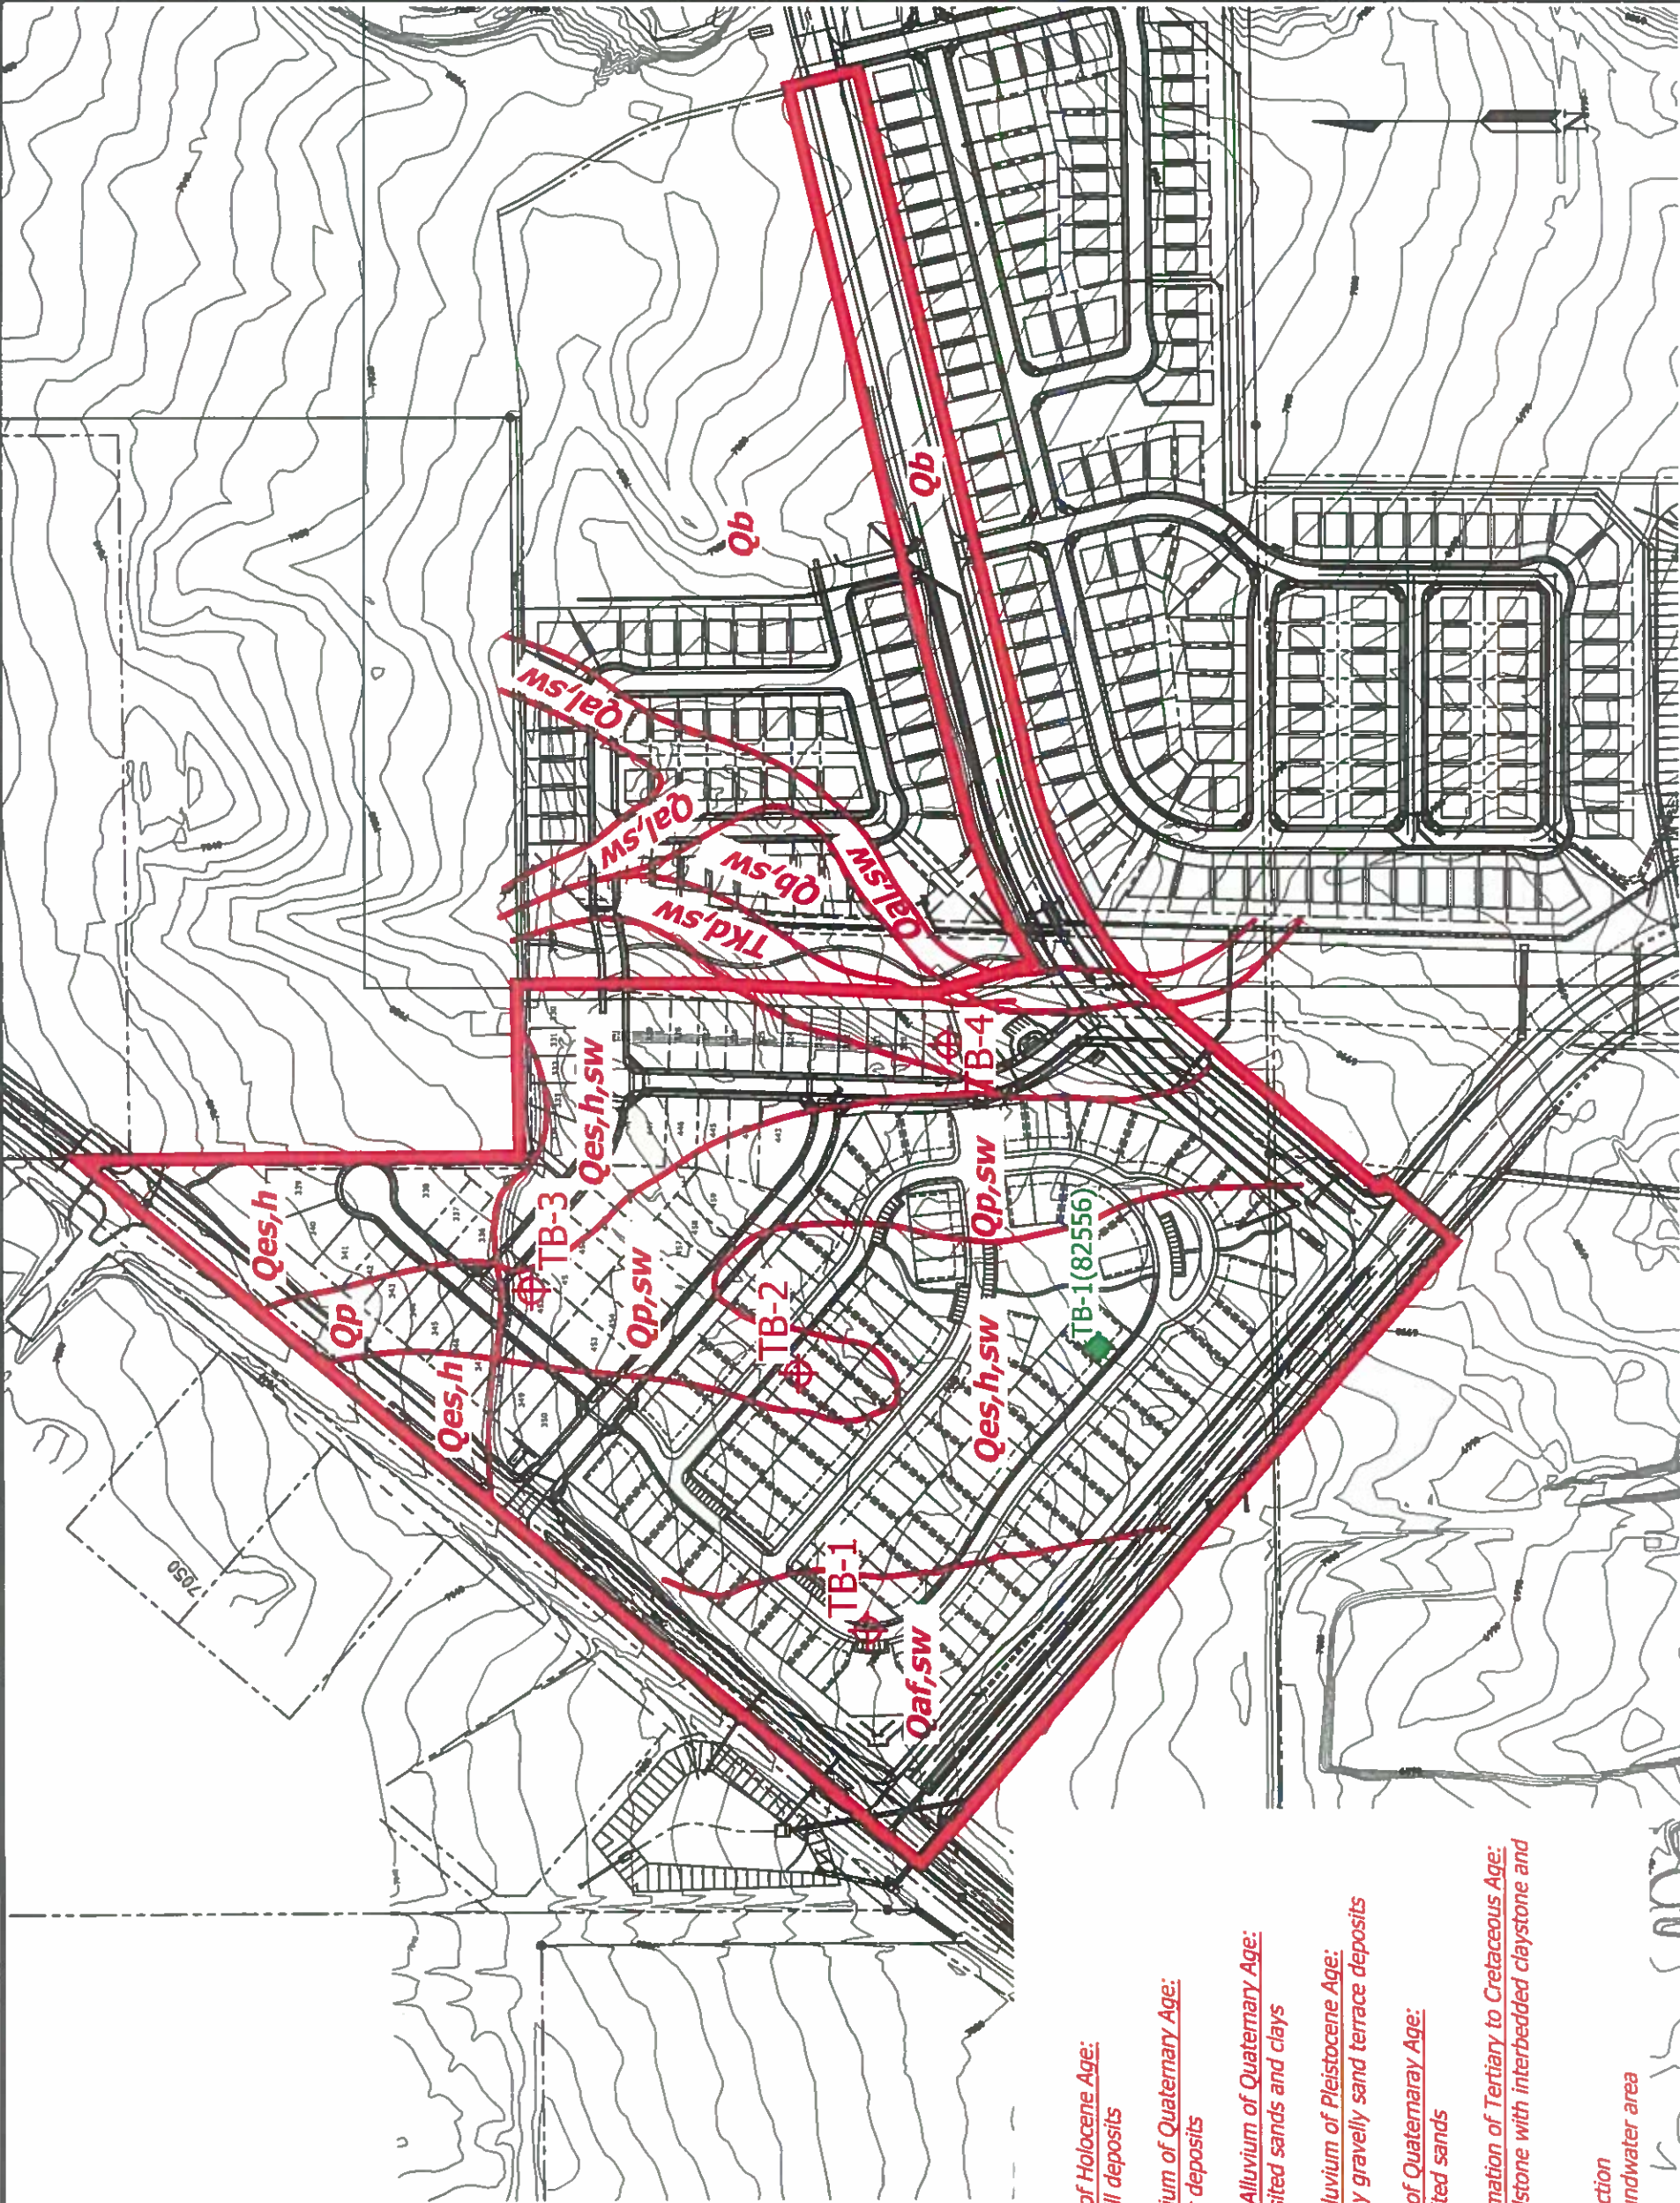
GEOLOGY/ENGINEERING GEOLOGY MAP
 COPPER CHASE & STERLING RANCH
 FIGURE 2
 EL PASO, COLORADO
 FOR: MORLEY-BENTLY INVESTMENTS

As mentioned previously, detailed mapping has been performed on this site to produce an Engineering Geology Map (Figure 7). This map shows the location of various geologic conditions of which the developers and planners should be cognizant during the planning, design and construction stages of the project. The hazards identified on this site include artificial fill, hydrocompaction, potentially expansive soils, and shallow groundwater areas. The following hazards have been addressed:

Shallow Groundwater: In these areas, we would anticipate the potential for periodically high subsurface moisture conditions and possible frost heave potential, depending on the soil conditions. A drainage swale is located along the eastern boundary of the site. Shallow

groundwater was encountered in all of the test borings at the time of drilling and following precipitation events subsequent to drilling. Groundwater depths are summarized in Table 2. Drainage from north of the site has been observed to back up onto the site from the drainage swale during periods of high runoff. According to the proposed grading plan, the drainage from the north of the site is to be intercepted, collected and piped along the eastern boundary of the site to a detention pond southeast of the site. A sewer underdrain should be considered to assist with controlling groundwater. Additionally, much of the area is to be filled, further raising the area above groundwater levels. According to the grading plans (Figure 4 and 4A), high areas in the extreme northern and western portions are to be cut 1 to 4 feet and low areas are to be filled. Fill depths up to 7 feet are proposed in the areas where shallow groundwater was encountered. Most of the proposed fill depths range from 2 to 4 feet. Areas of shallow groundwater may exhibit unstable subgrade conditions in terms of bearing support of construction equipment during overlot grading. Lots immediately adjacent to drainage may experience higher subsurface moisture conditions during periods of higher flows. Additionally, areas may experience seasonal perched groundwater conditions where water can flow through permeable sands on top of less permeable bedrock materials.

Areas of artificial fill were observed in areas of the site. The majority of these areas are associated with recent grading.

Areas in which hydrocompaction have been identified are acceptable as building sites. In areas identified for this hazard classification, however, we anticipate a potential for settlement movements upon saturation of these surficial soils. The low density, uniform grain sized, windblown sand deposits are particularly susceptible to this type of phenomenon. Additionally, loose or collapsible soils may be encountered on this site.

Mitigation: In these locations, foundations subject to severe frost heave potential should penetrate sufficient depth so as to discourage the formation of ice lenses beneath foundations. At this location and elevation, a foundation depth for frost protection of 30 inches is recommended. Foundations should be kept as high as possible. Areas may experience higher groundwater levels during period of higher precipitation where water can flow through permeable sands on top of less permeable bedrock materials. Subsurface perimeter drains may be necessary to prevent the intrusion of water into areas below grade. Typical drain details are presented in Figure 9. Where shallow groundwater is encountered, underslab drains or interceptor drains may be necessary. Typical drain details are presented in Figure 10 and 11. Where basements are considered, significant interceptor and underslab drains may be necessary. Structures should not block drainages. Swales should be created to intercept surface runoff and carry it safely around and away from structures. Specific recommendations should be made after additional investigation and site grading has been completed. Additional investigation after grading is completed is recommended to provide final foundation recommendations. The suitability of the site for below-grade areas should be evaluated after additional investigation following site grading and storm sewer construction.

Mitigation: Fill records should be obtained to determine if the fill was placed in a controlled manner. Where uncontrolled fill is encountered beneath foundations, mitigation will be necessary. Mitigation typically involves removal and recompaction at a minimum of 95 percent of its maximum Modified Proctor Dry Density, ASTM D-1557.

Mitigation: The potential for settlement movement is directly related to saturation of the soils below the foundation areas. Therefore, good surface and subsurface drainage is extremely critical in these areas in order to minimize the potential for saturation of these soils. The ground surface around all permanent structures should be positively sloped away from the structure to all points, and water must not be allowed to stand or pond anywhere on the site. We recommend that the ground surface within 10 feet of the structures be sloped away with a minimum gradient of five percent. If this is not possible on the upslope side of the structures, then a well-defined swale should be created to intercept the surface water and carry it quickly and safely around and away from the structures. Roof drains should be made to discharge well away from the structures and into areas of positive drainage. Where several structures are involved, the overall drainage design should be such that water directed away from one structure is not directed against an adjacent building. Planting and watering in the immediate vicinity of the structures, as well as general lawn irrigation, should be minimized.

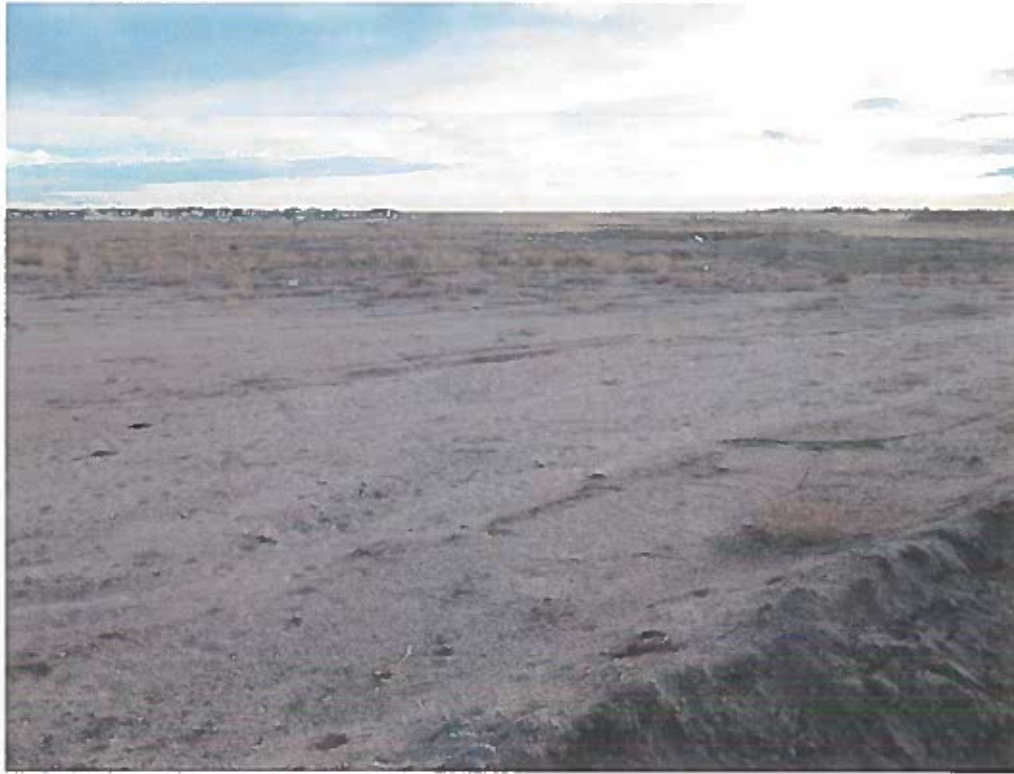
**Looking northeast
from the western
portion of the site.**

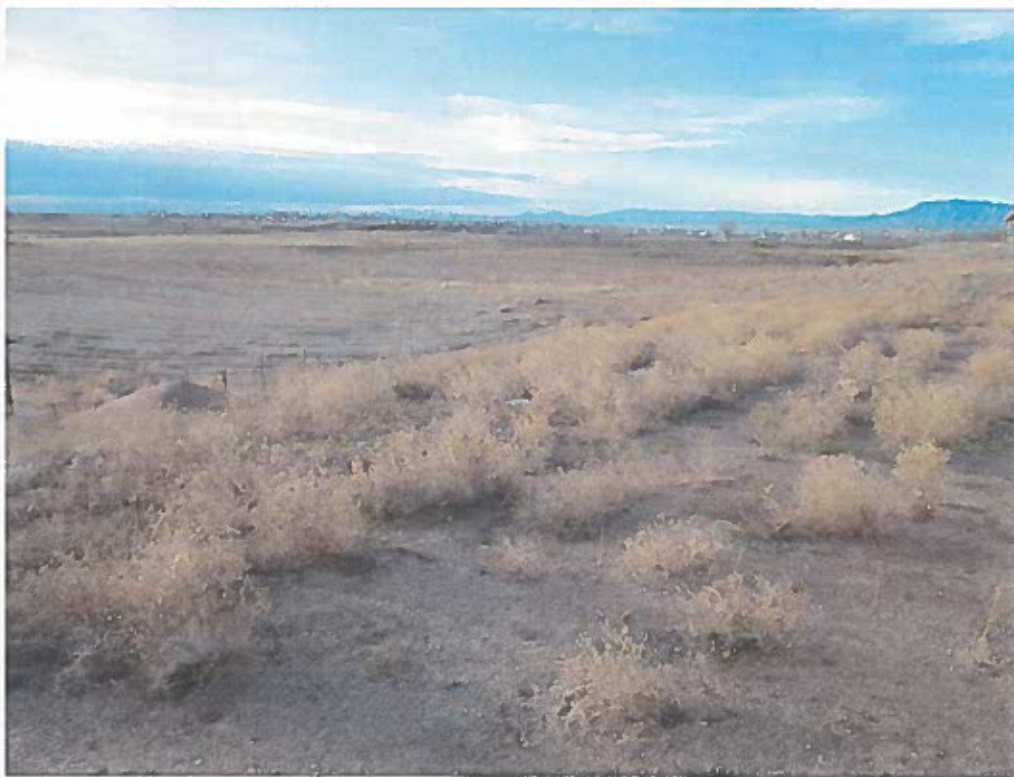
**Looking south from
the northwest portion
of the site.**

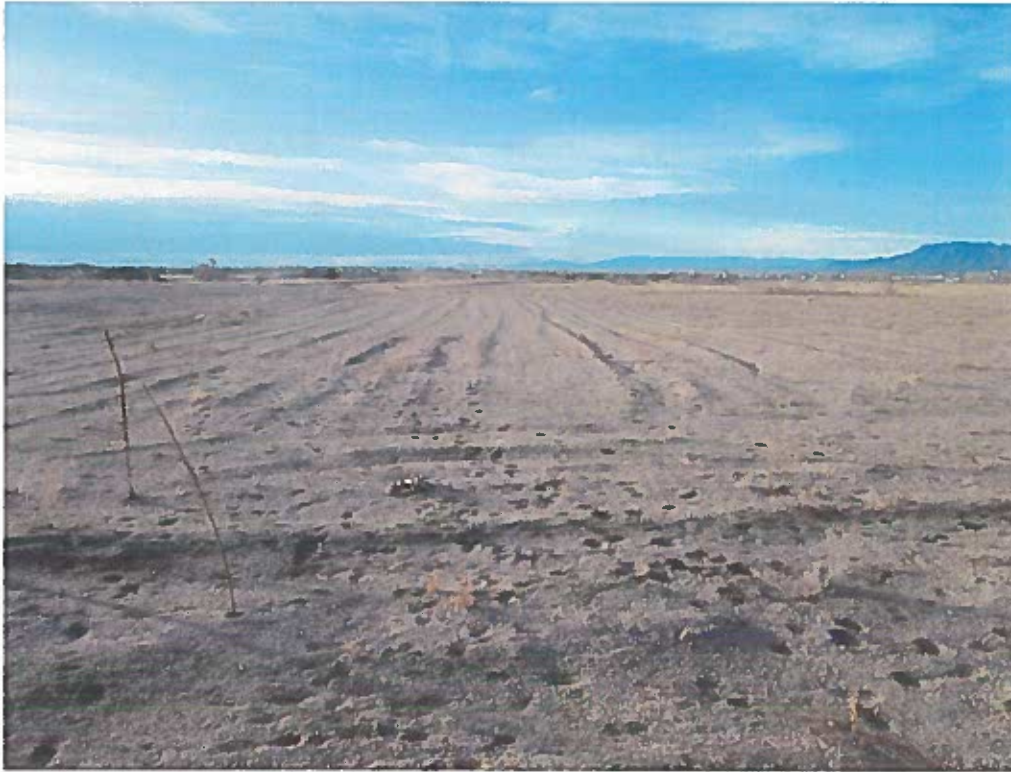
**Looking southwest
from the northeast
portion of the site.**

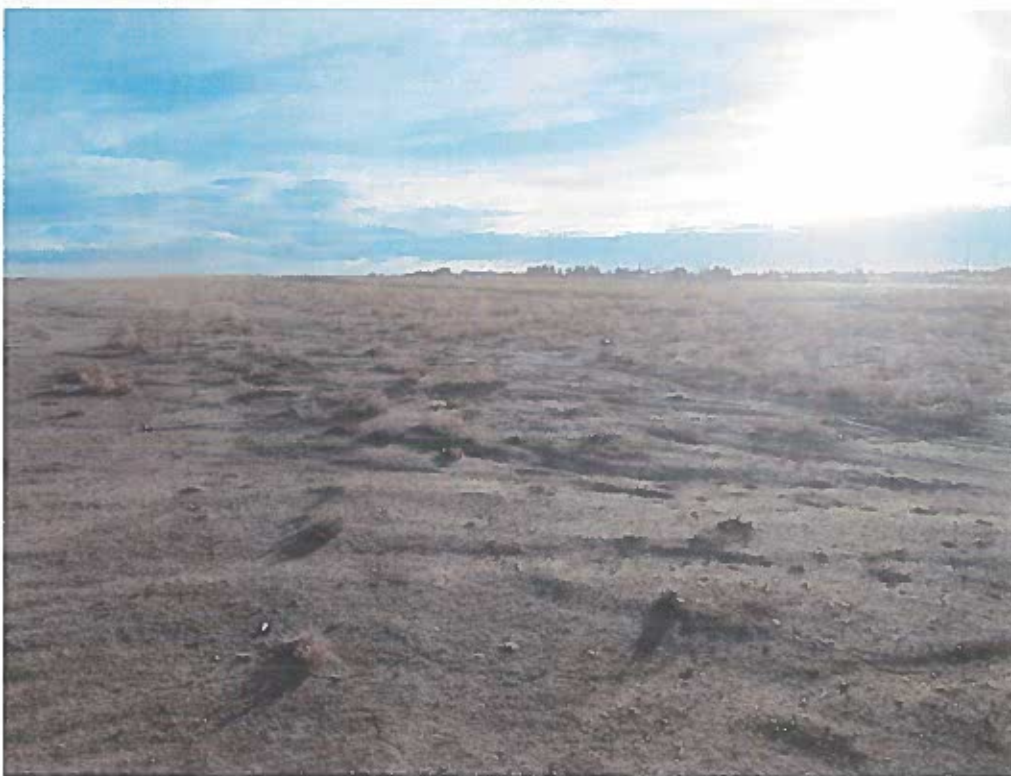
**Looking north from the
southern portion of the
site.**
