**SOIL, GEOLOGY, AND GEOLOGIC HAZARD STUDY
COPPER CHASE AND STERLING RANCH FILING NO. 2
EL PASO COUNTY, COLORADO**

February 10, 2020

Entech Job No. 191088
F:/AAPProjects/2019/191088 Geohaz

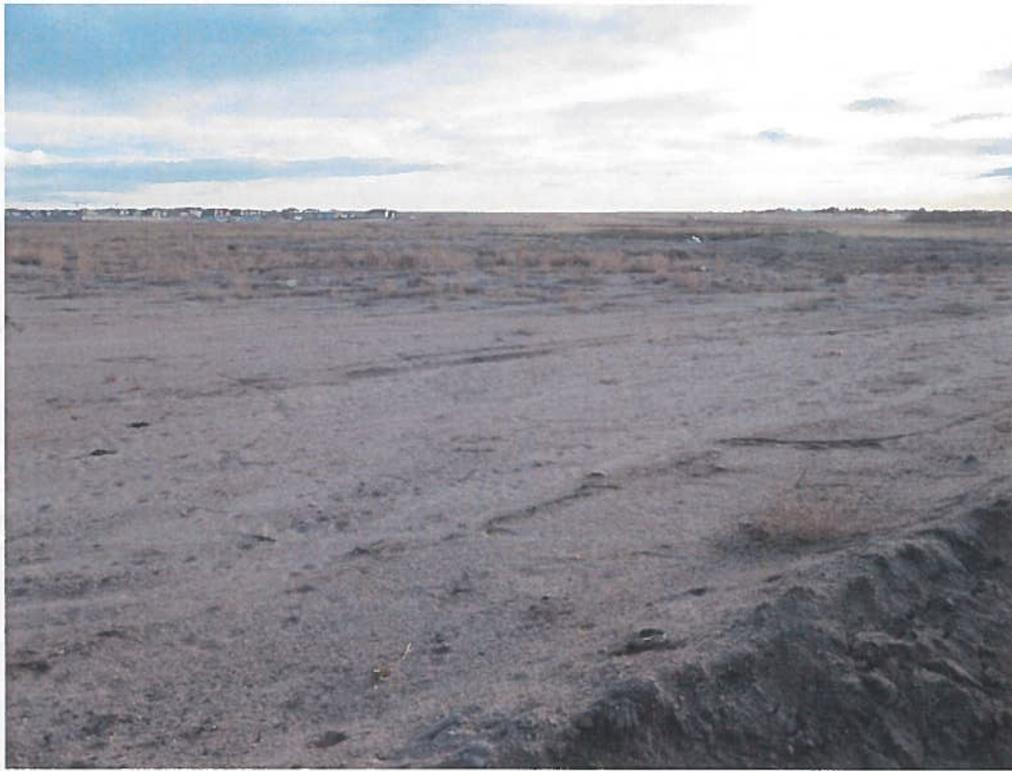
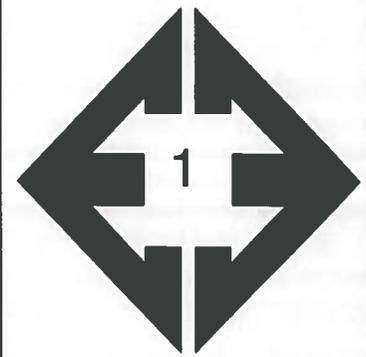
**Looking northeast
from the western
portion of the site.**

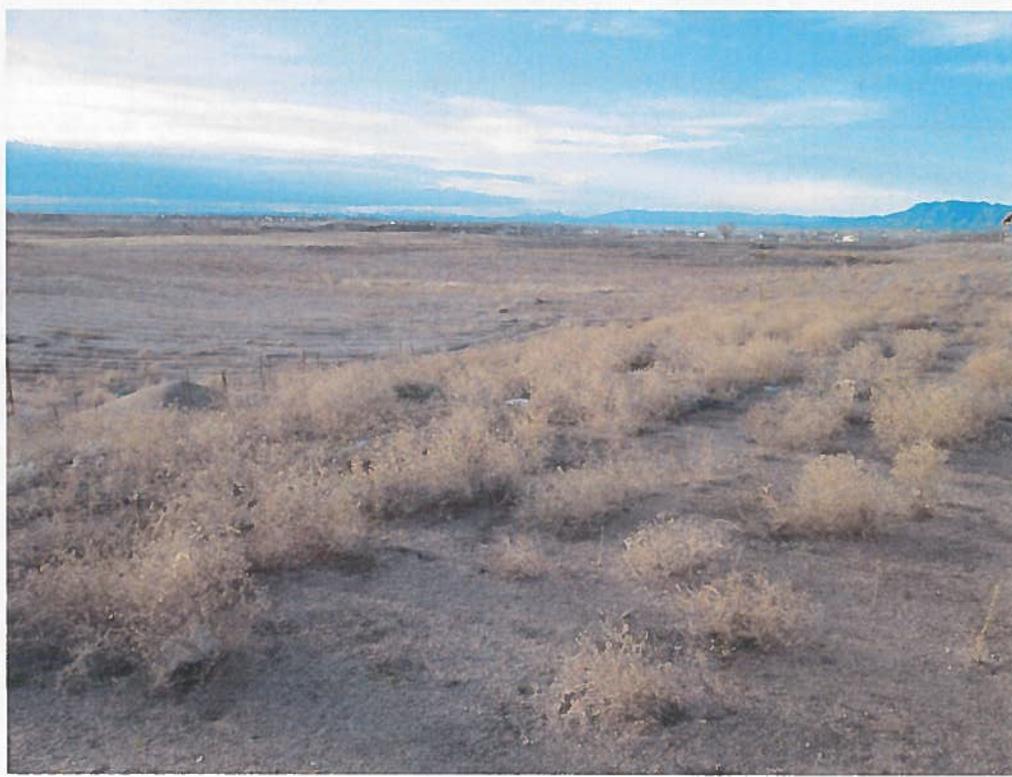
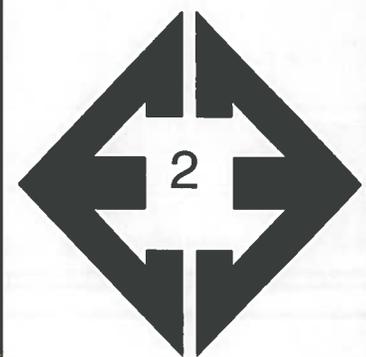
**Looking south from
the northwest portion
of the site.**

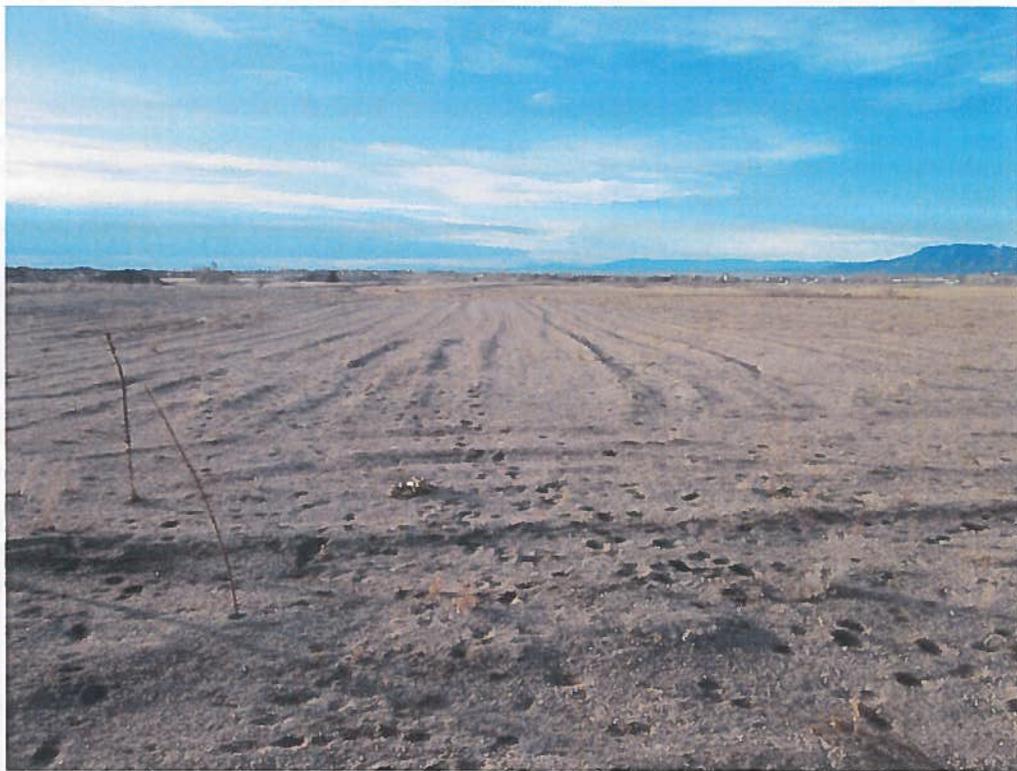
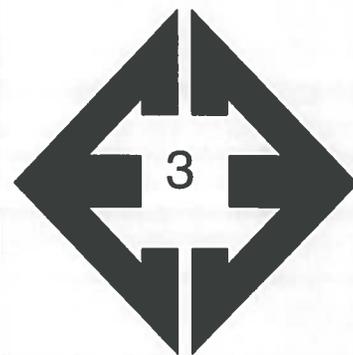
**Looking southwest
from the northeast
portion of the site.**

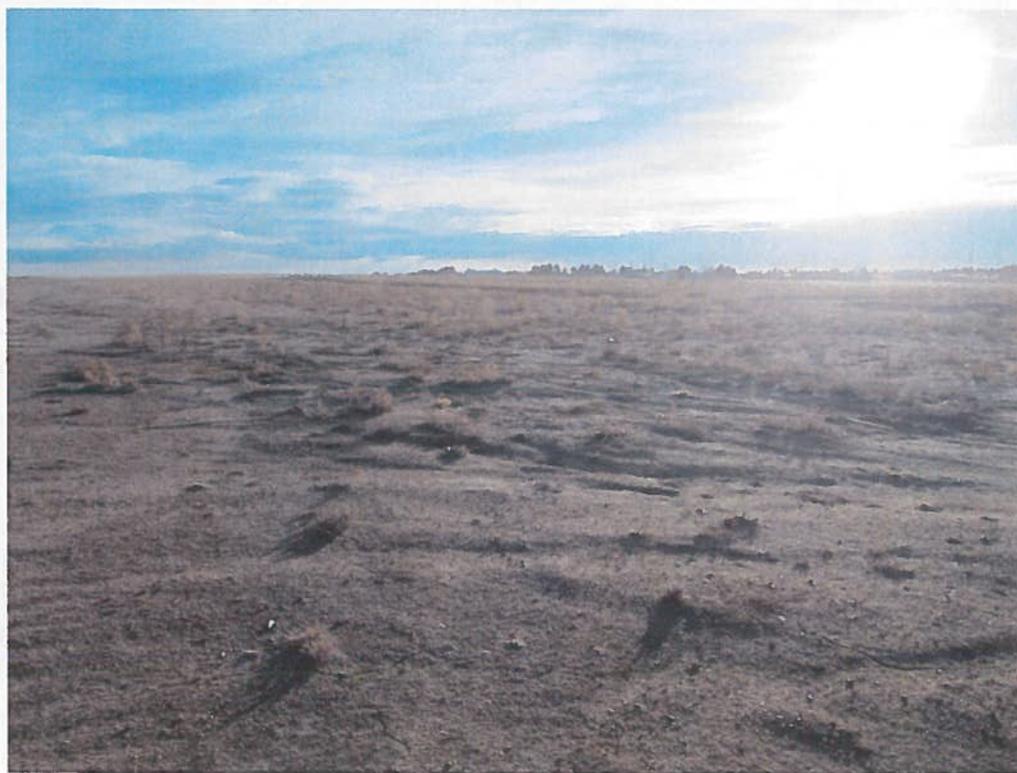
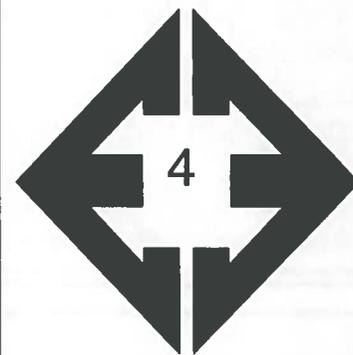
**Looking north from the
southern portion of the
site.**
