**DEBRIS FLOW/MUDFLOW ANALYSIS
FOREST LAKES SUBDIVISION (PHASE 2)
LINDBERGH ROAD AND W. BAPTIST ROAD
EL PASO COUNTY, COLORADO**

Project No. CS18916.000-105

August 6, 2018

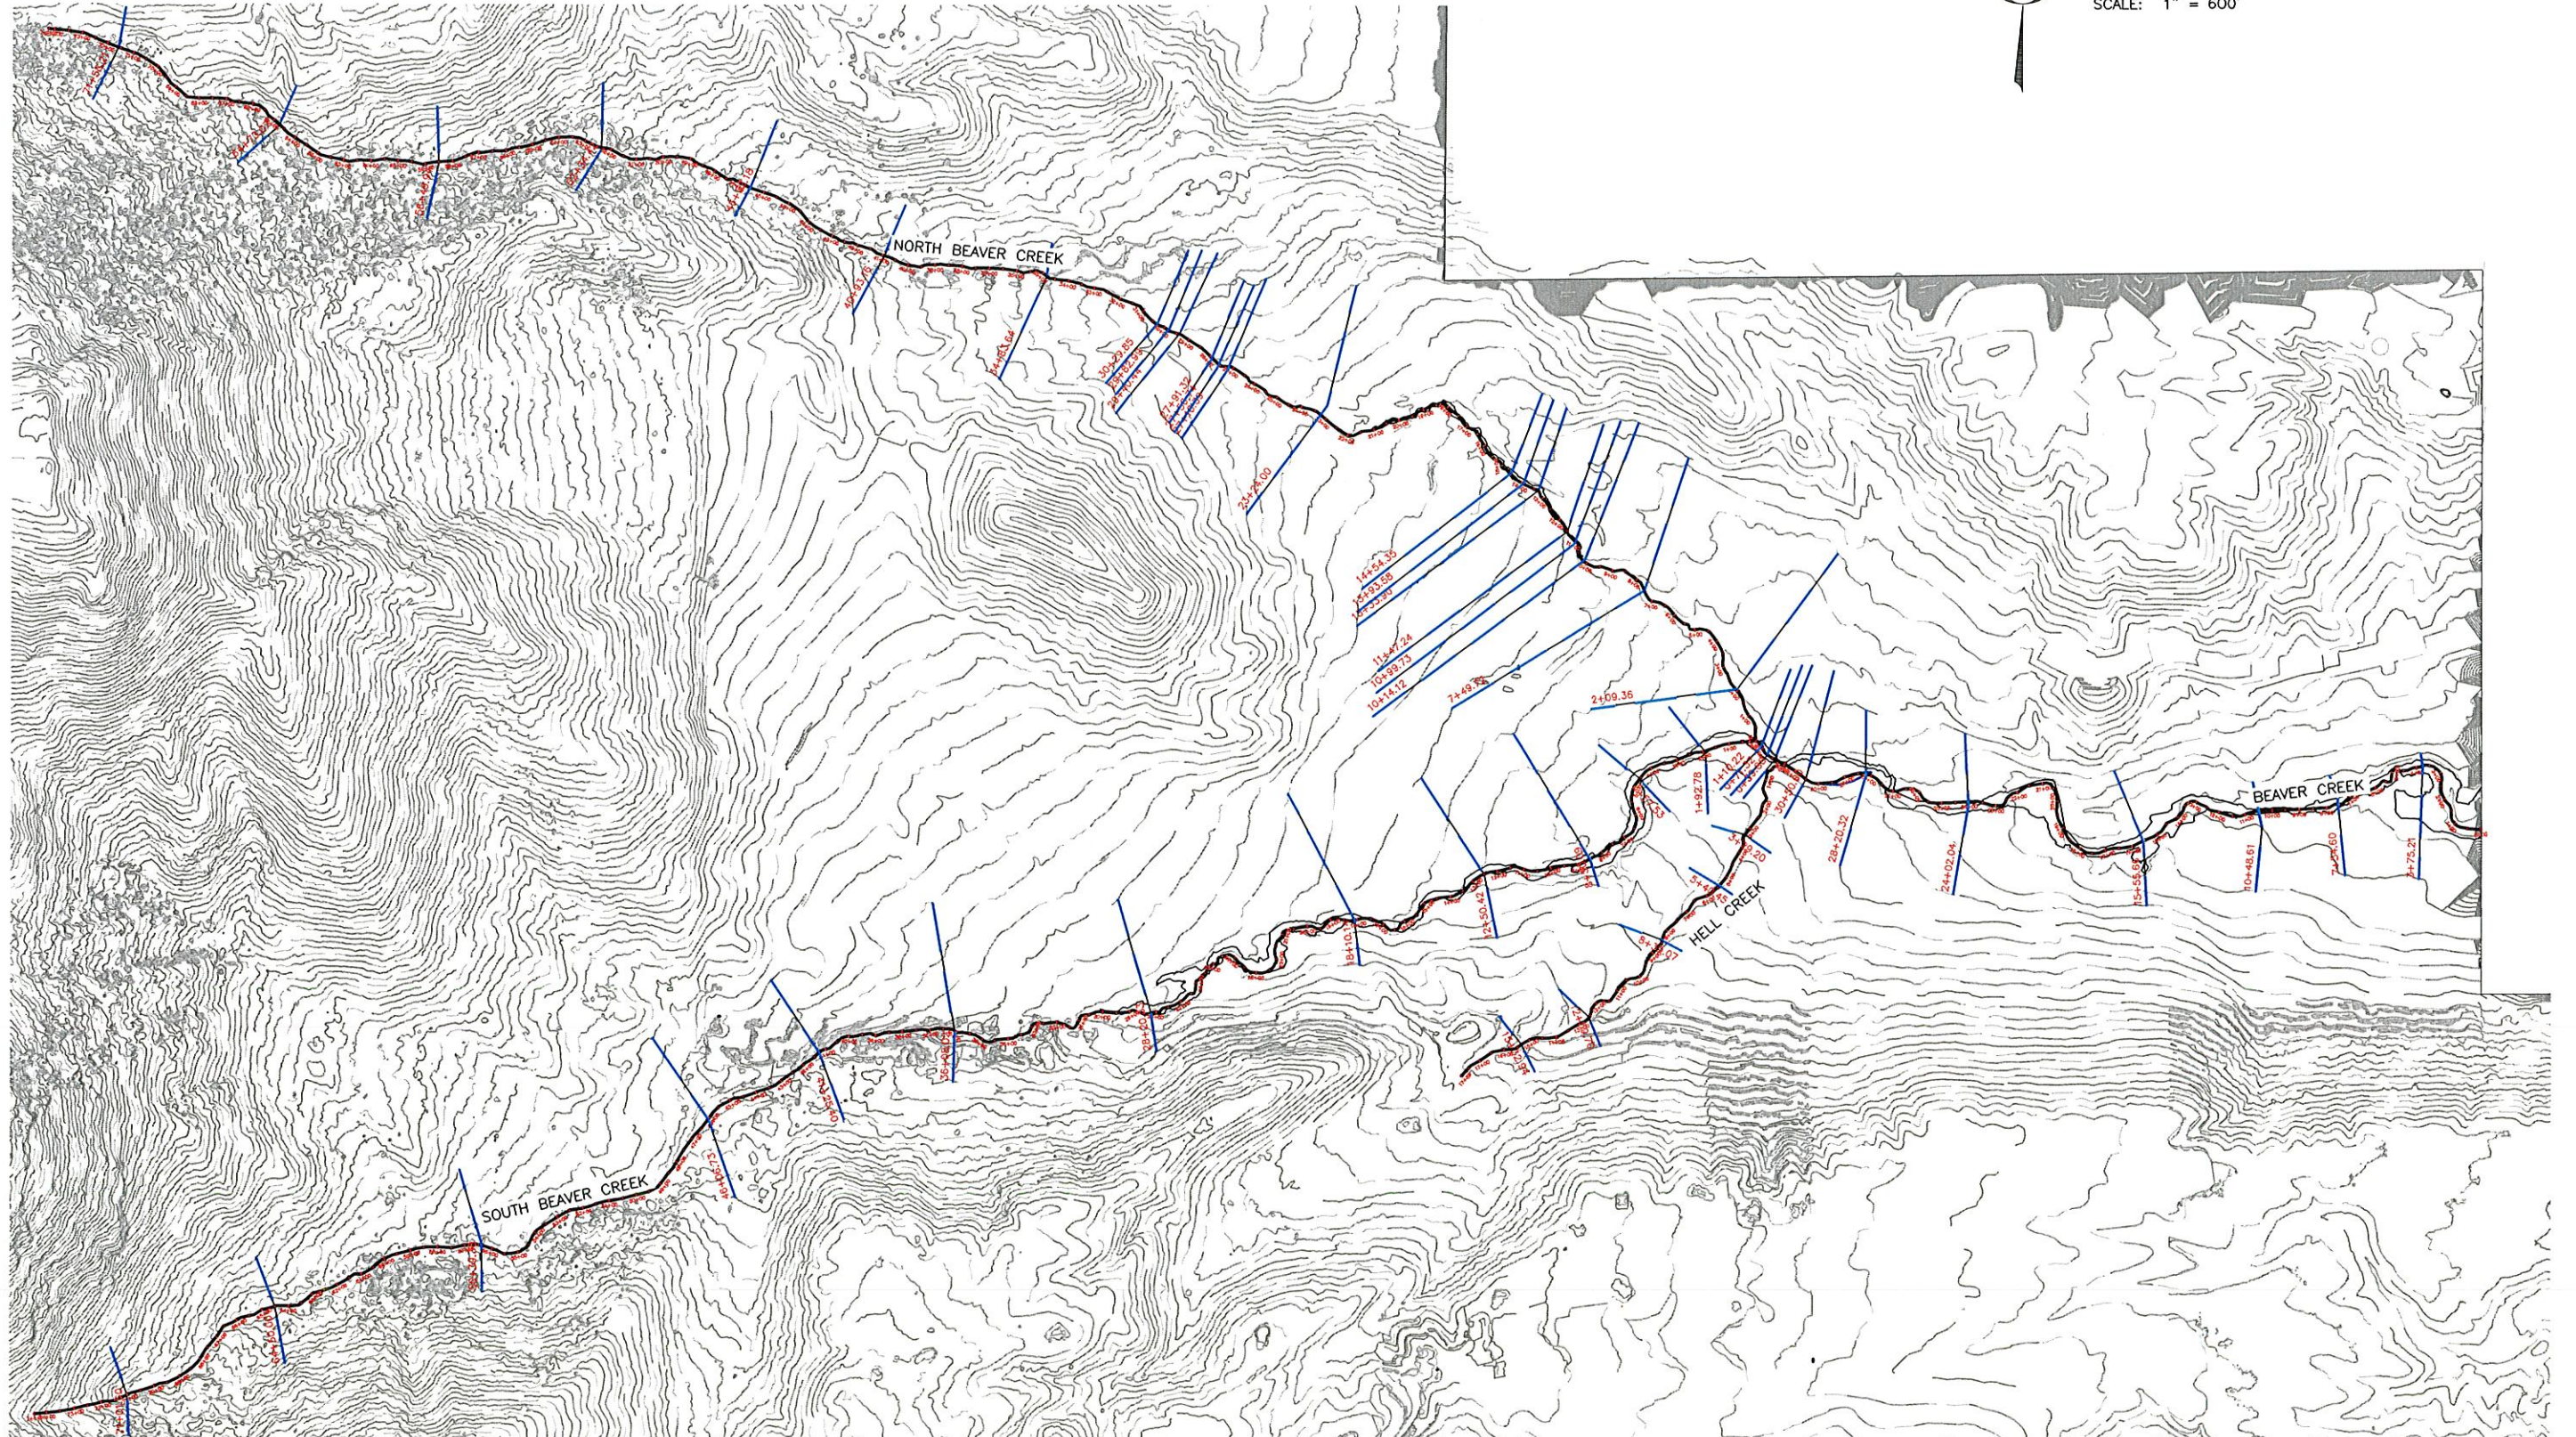
**Creek Alignment and
Cross Sections**

We estimated stream centerline alignments based on the topographic data provided to us, as well as satellite imagery. Ground surface contours were distorted in some areas, especially along North Beaver Creek. Much of this distortion appears to be due to trees and vegetation that were not stripped from the ground surface contour data. Using AutoCAD CIVIL 3D, we cut cross-sections at intervals and critical locations along the stream centerline alignments. The alignment and cross-section data were exported to HEC-RAS for hydraulic modeling and analysis. The stream centerline alignments and cross-sections that we developed are shown on Figure 2.

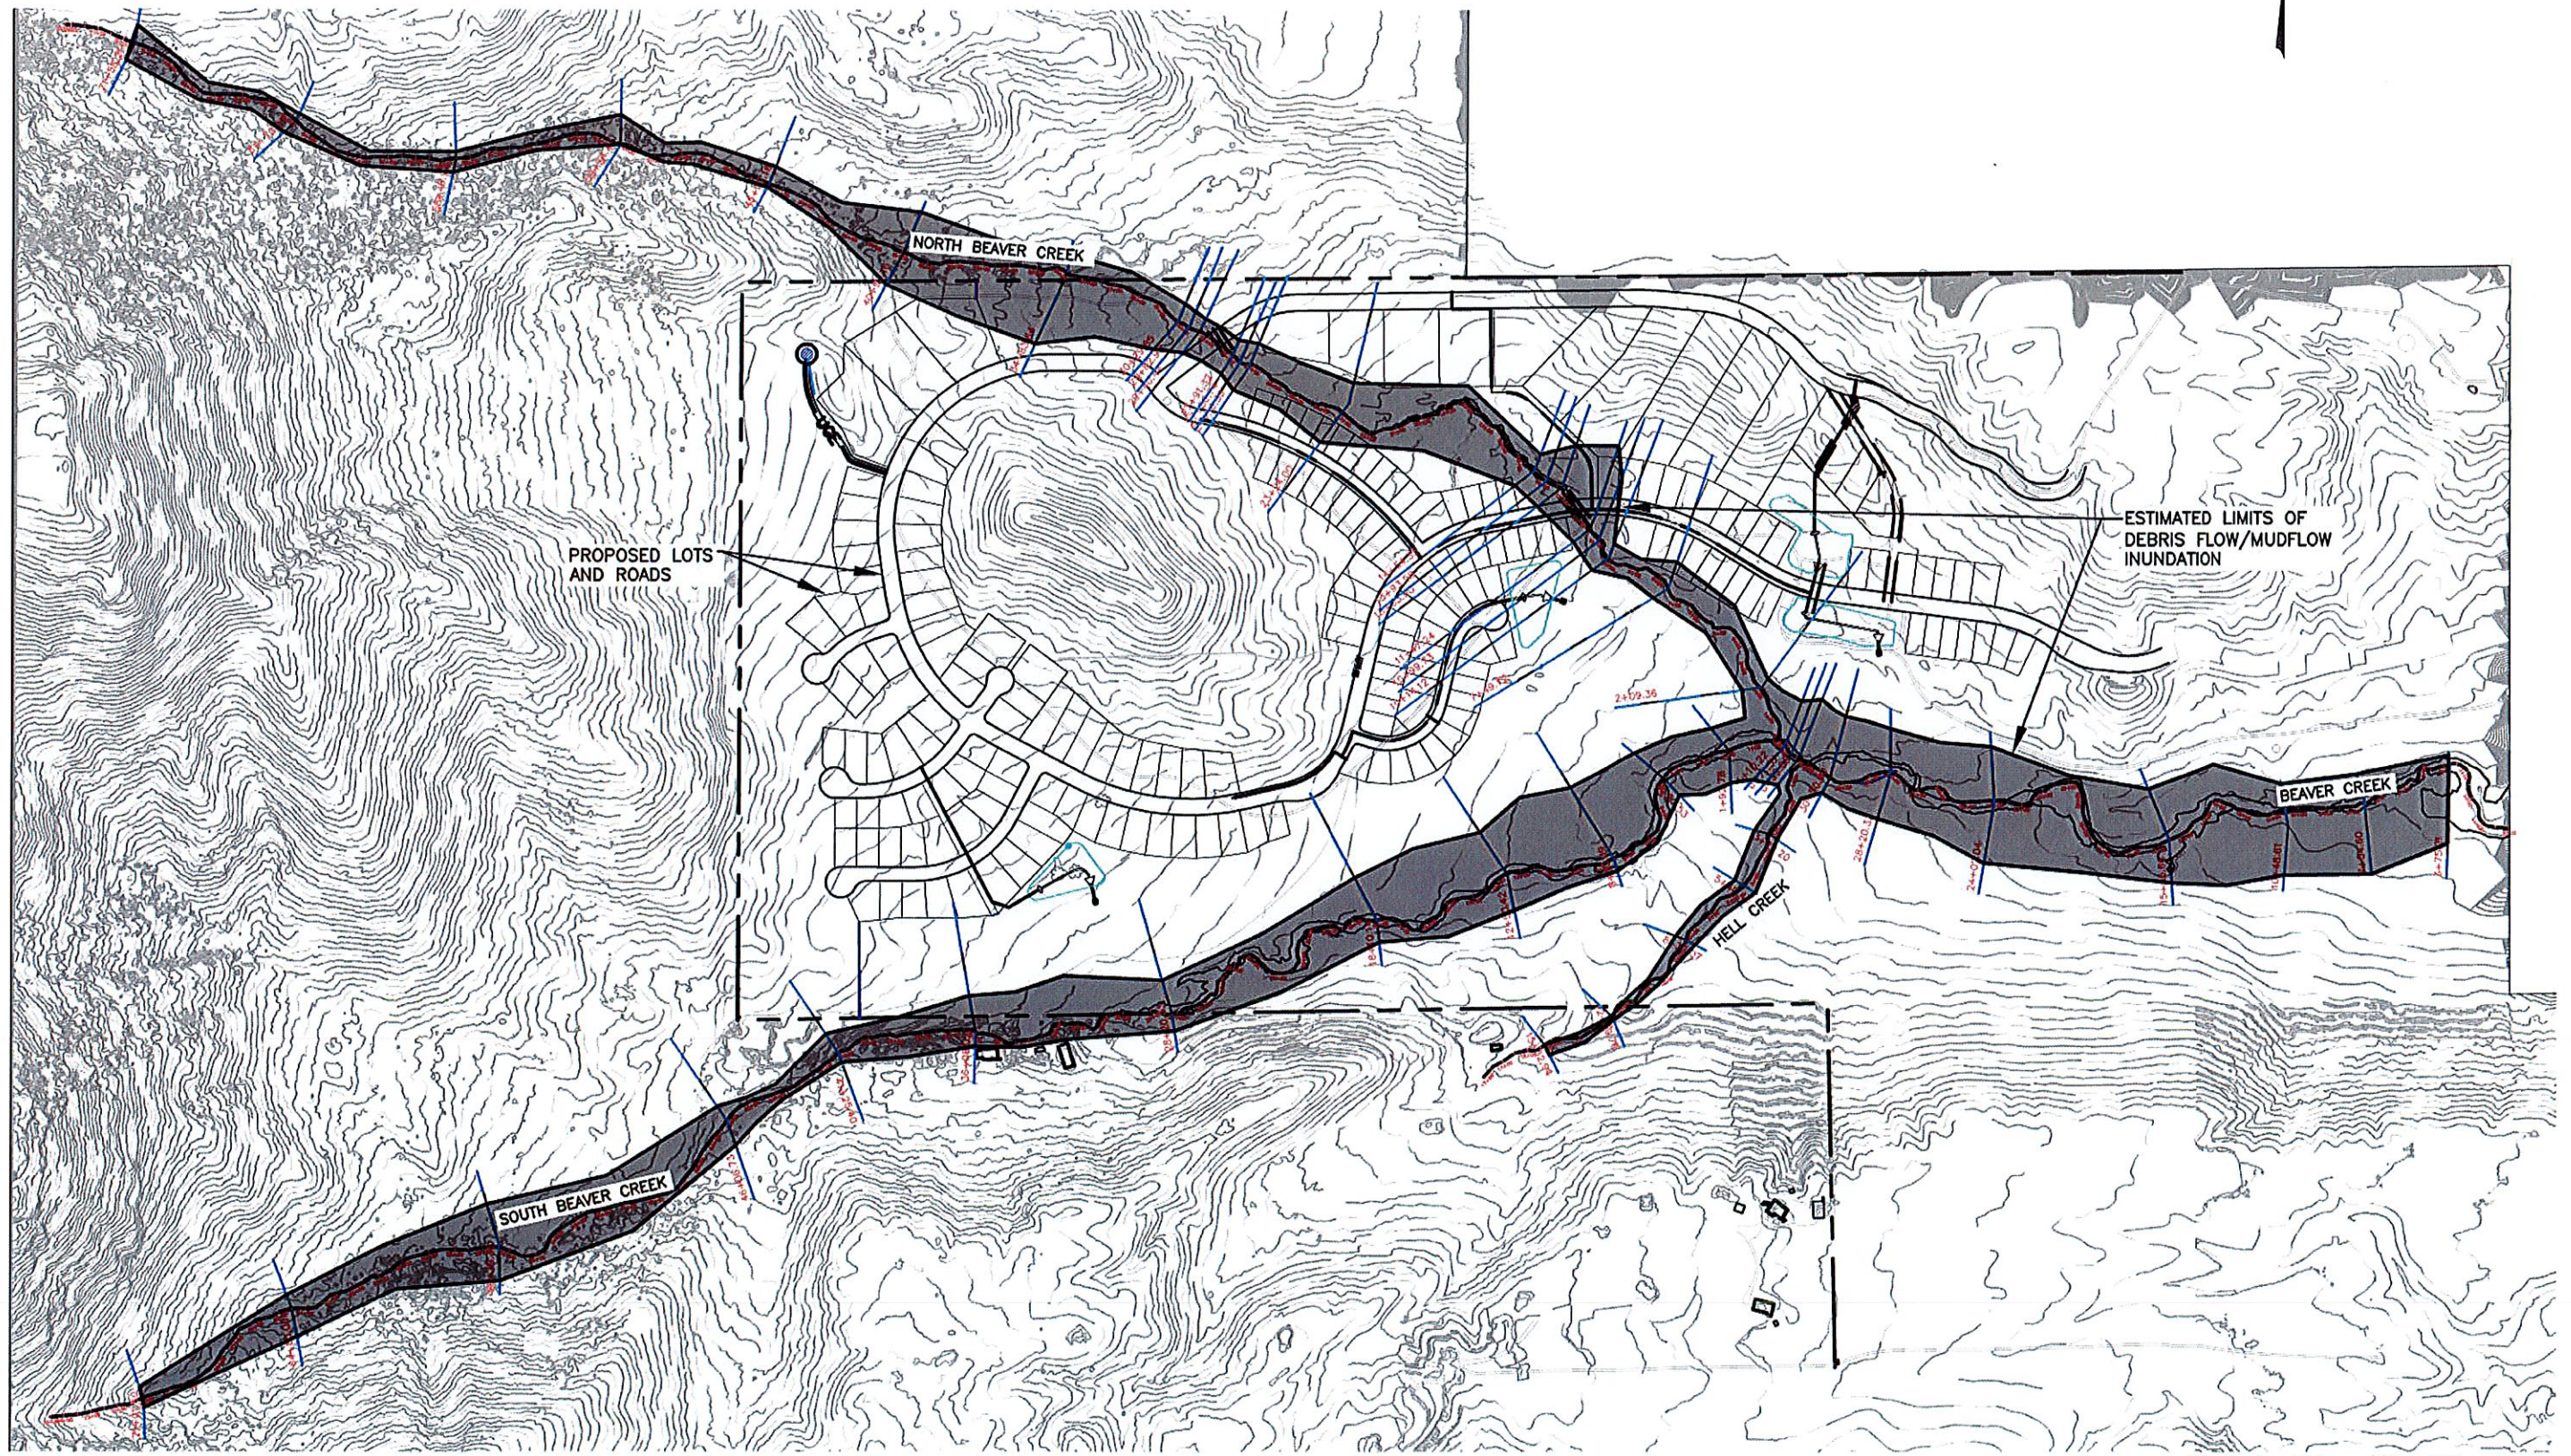
FIG. 3

The results of our hydraulic modeling and analysis were used to develop a map of debris flow/mudflow areas of inundation. The critical case occurs with a storm with a recurrence interval of 100-years. Our map of debris flow/mudflow inundation area is included as Figure 3.

The lots currently proposed along South Beaver Creek, Beaver Creek, and Hell Creek do not encroach into the mapped area of inundation. Some of the lots along North Beaver Creek encroach into the area inundated by debris flow/mudflow events resulting from the 100-year storm event. These lots will need to be replatted or mitigation will be required.

Based on the extent of the potential debris flow it appears that the proposed culverts for the road crossings over North Beaver Creek will not pass the 100-year event. A detailed culvert analysis will need to be performed by the civil

NOTE:
DEBRIS FLOW/MUDFLOW INUNDATION AREA
BASED ON PEAK DISCHARGES RESULTING FROM
100-YEAR STORM AND BULKING FACTOR OF 1.4.

The hydraulic modeling by CTL/Thompson, Inc. provides a reasonable assessment of the debris flow/mudflow risk at the site to facilitate safe development for the proposed use. Discrepancies between the old and new survey data exist. As site grading and civil engineering plans progress, our analysis should be checked. We recommend that the two surveys be combined, reconciled, and stamped by a Professional Land Surveyor (PLS). This process should produce a ground surface contour map that is geo-referenced. Detailed analysis of the culverts would then be appropriate.

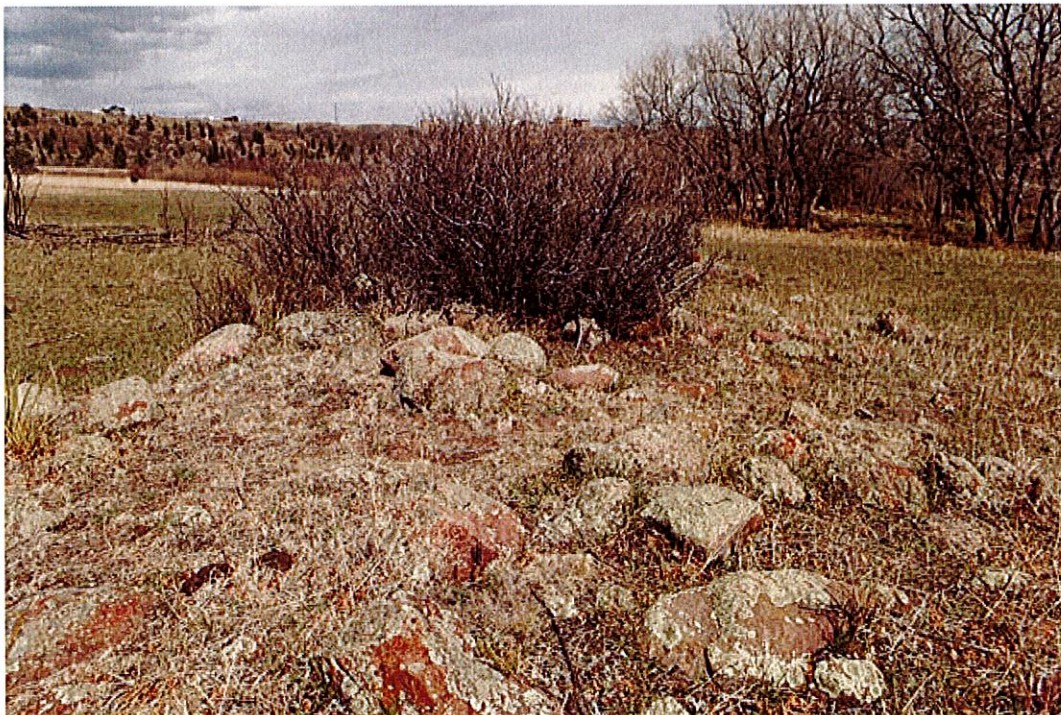
Debris levee along South Beaver Creek

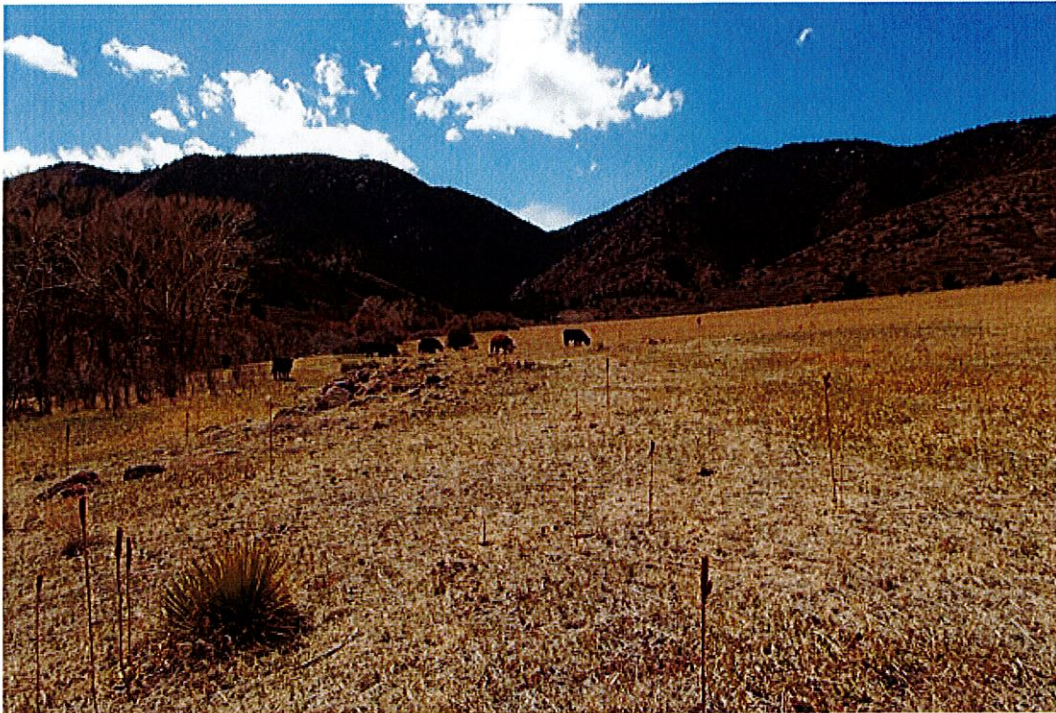
Debris levee along South Beaver Creek

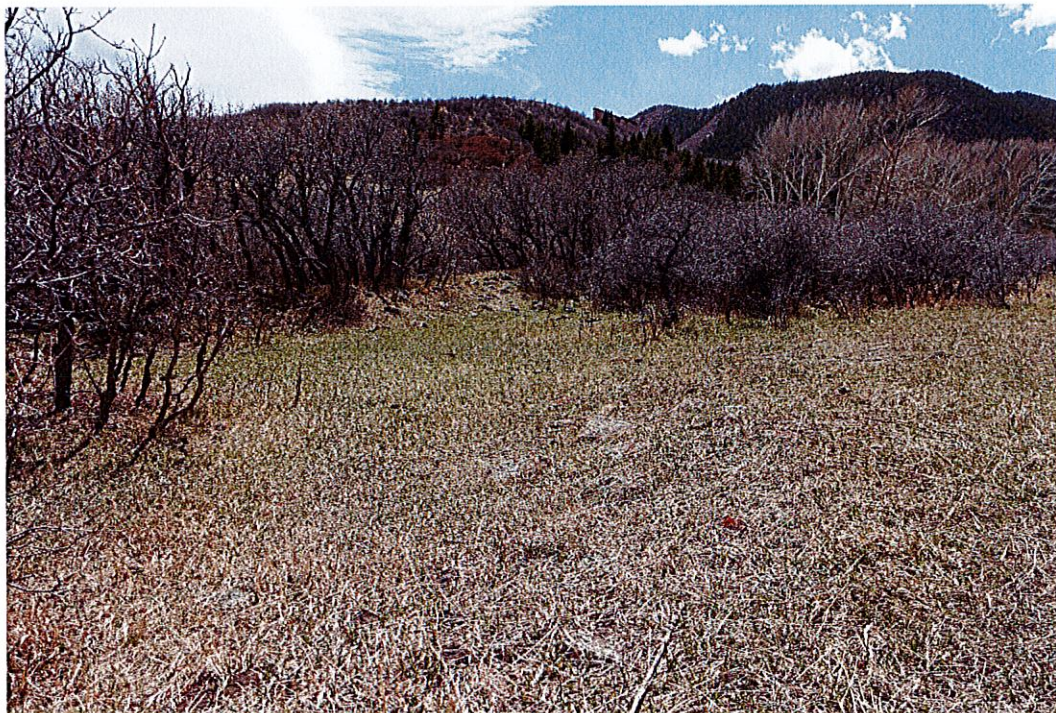
Debris levee along South Beaver Creek

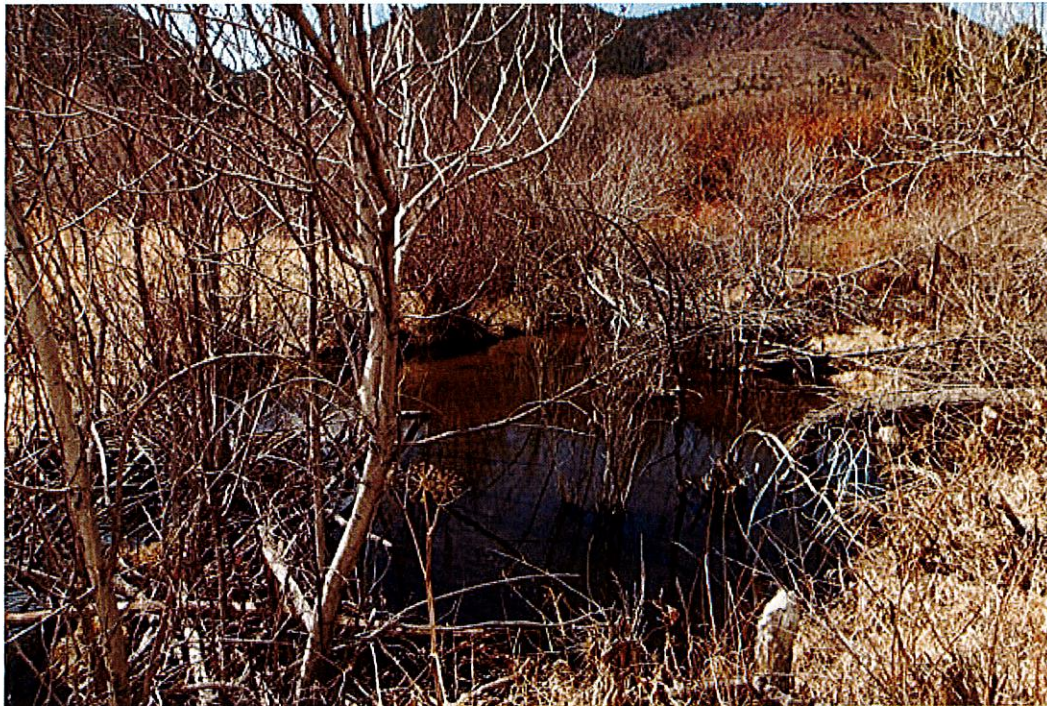
North Beaver Creek – ponded area

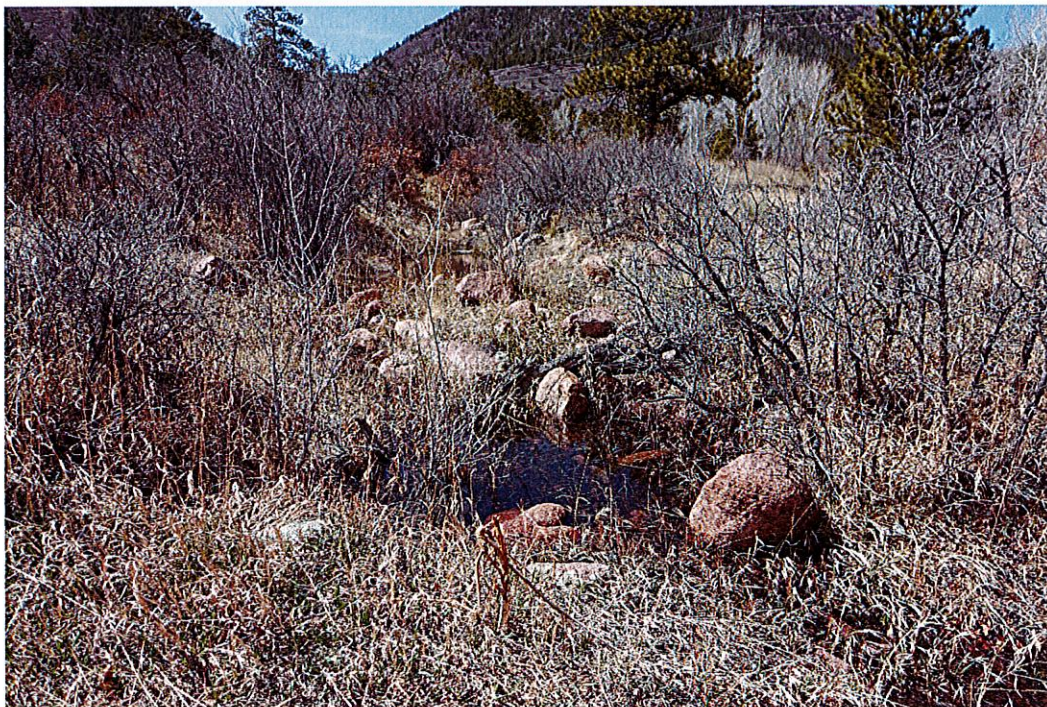
North Beaver Creek – ponded areas

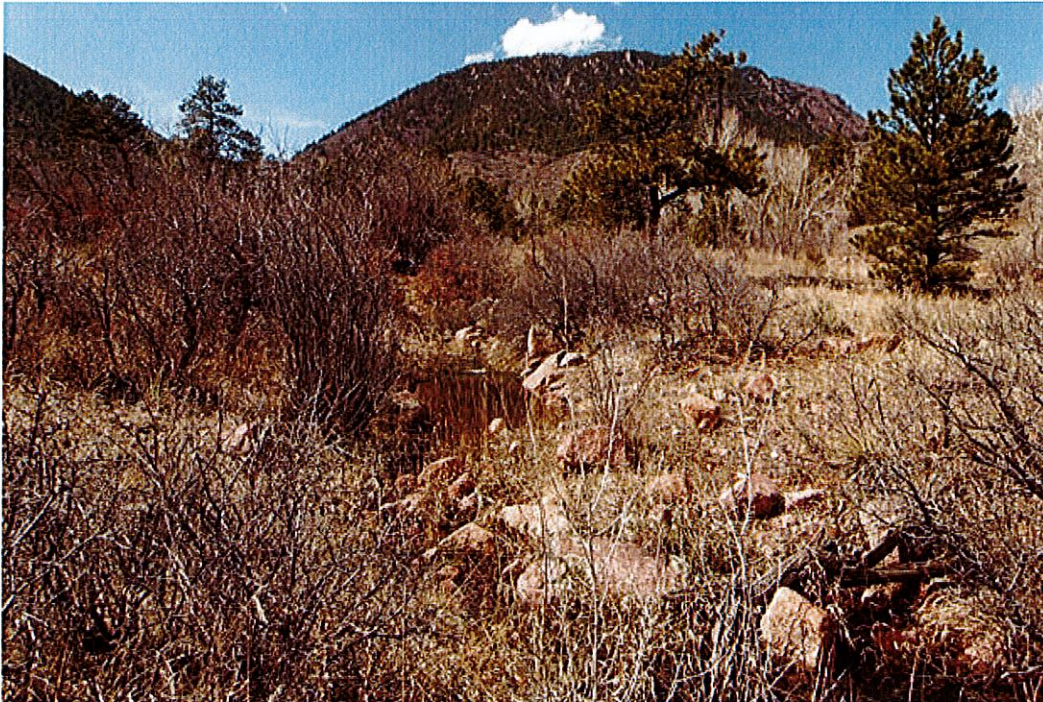
North Beaver Creek with boulder deposits

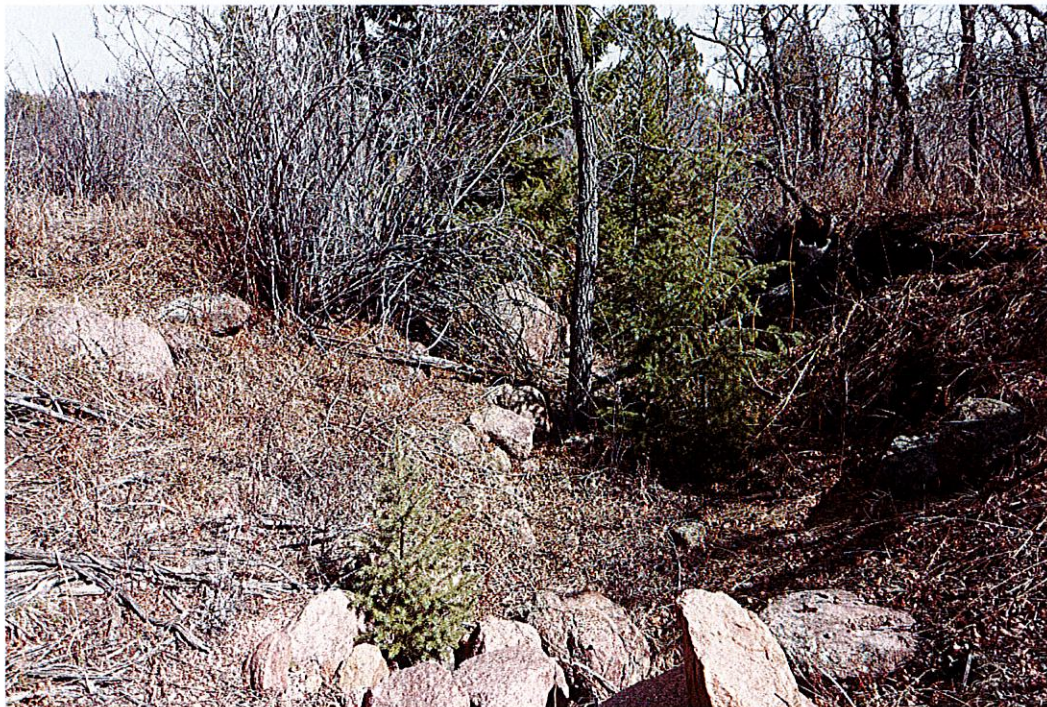
North Beaver Creek abandoned channel

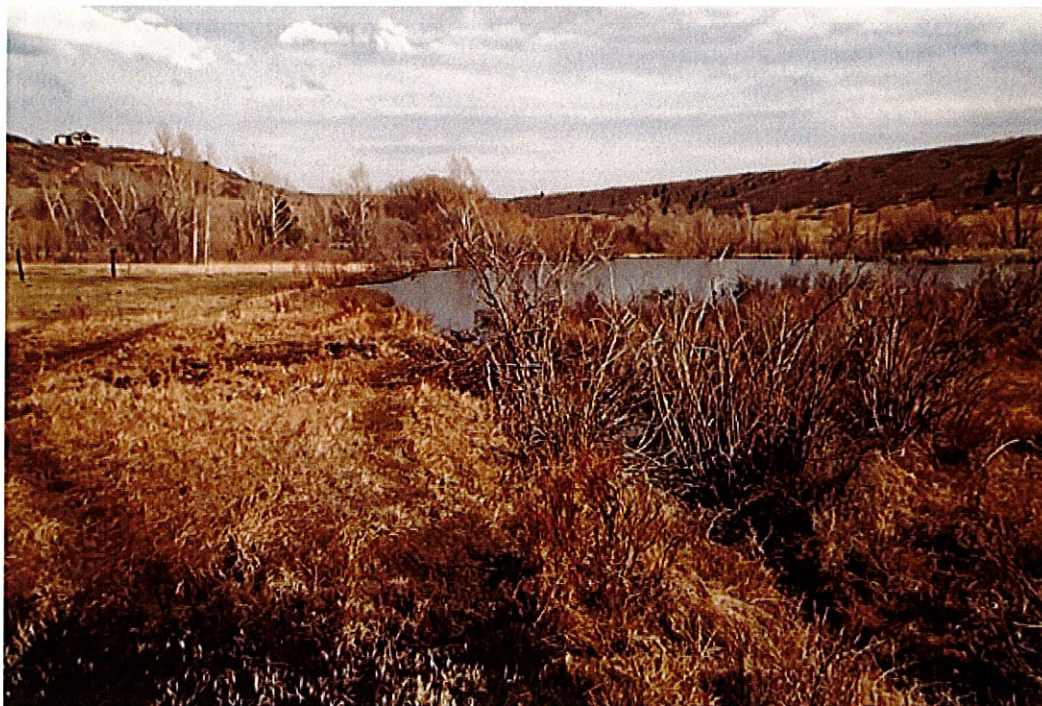
Manmade pond with beaver activity

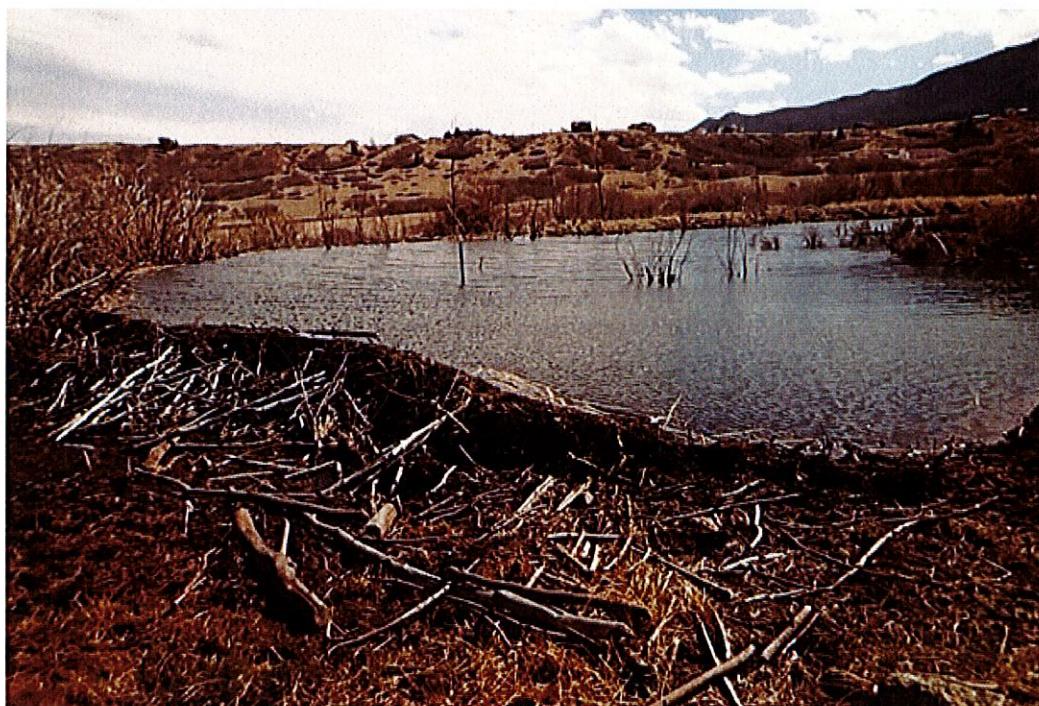
Manmade pond with beaver activity
