**PRELIMINARY SOILS INVESTIGATION/
SOIL, GEOLOGY, AND GEOLOGIC HAZARD STUDY
MERIDIAN ROAD AND STAPLETON DRIVE
PARCEL NO. 52000-00-016
EL PASO COUNTY, COLORADO**

Kyle Geditz
16022 Fox Mesa Court
Monument, Colorado 80132

March 11, 2022

Entech Job No. 220093
AAprojects/2022/220093 countysoil/geo

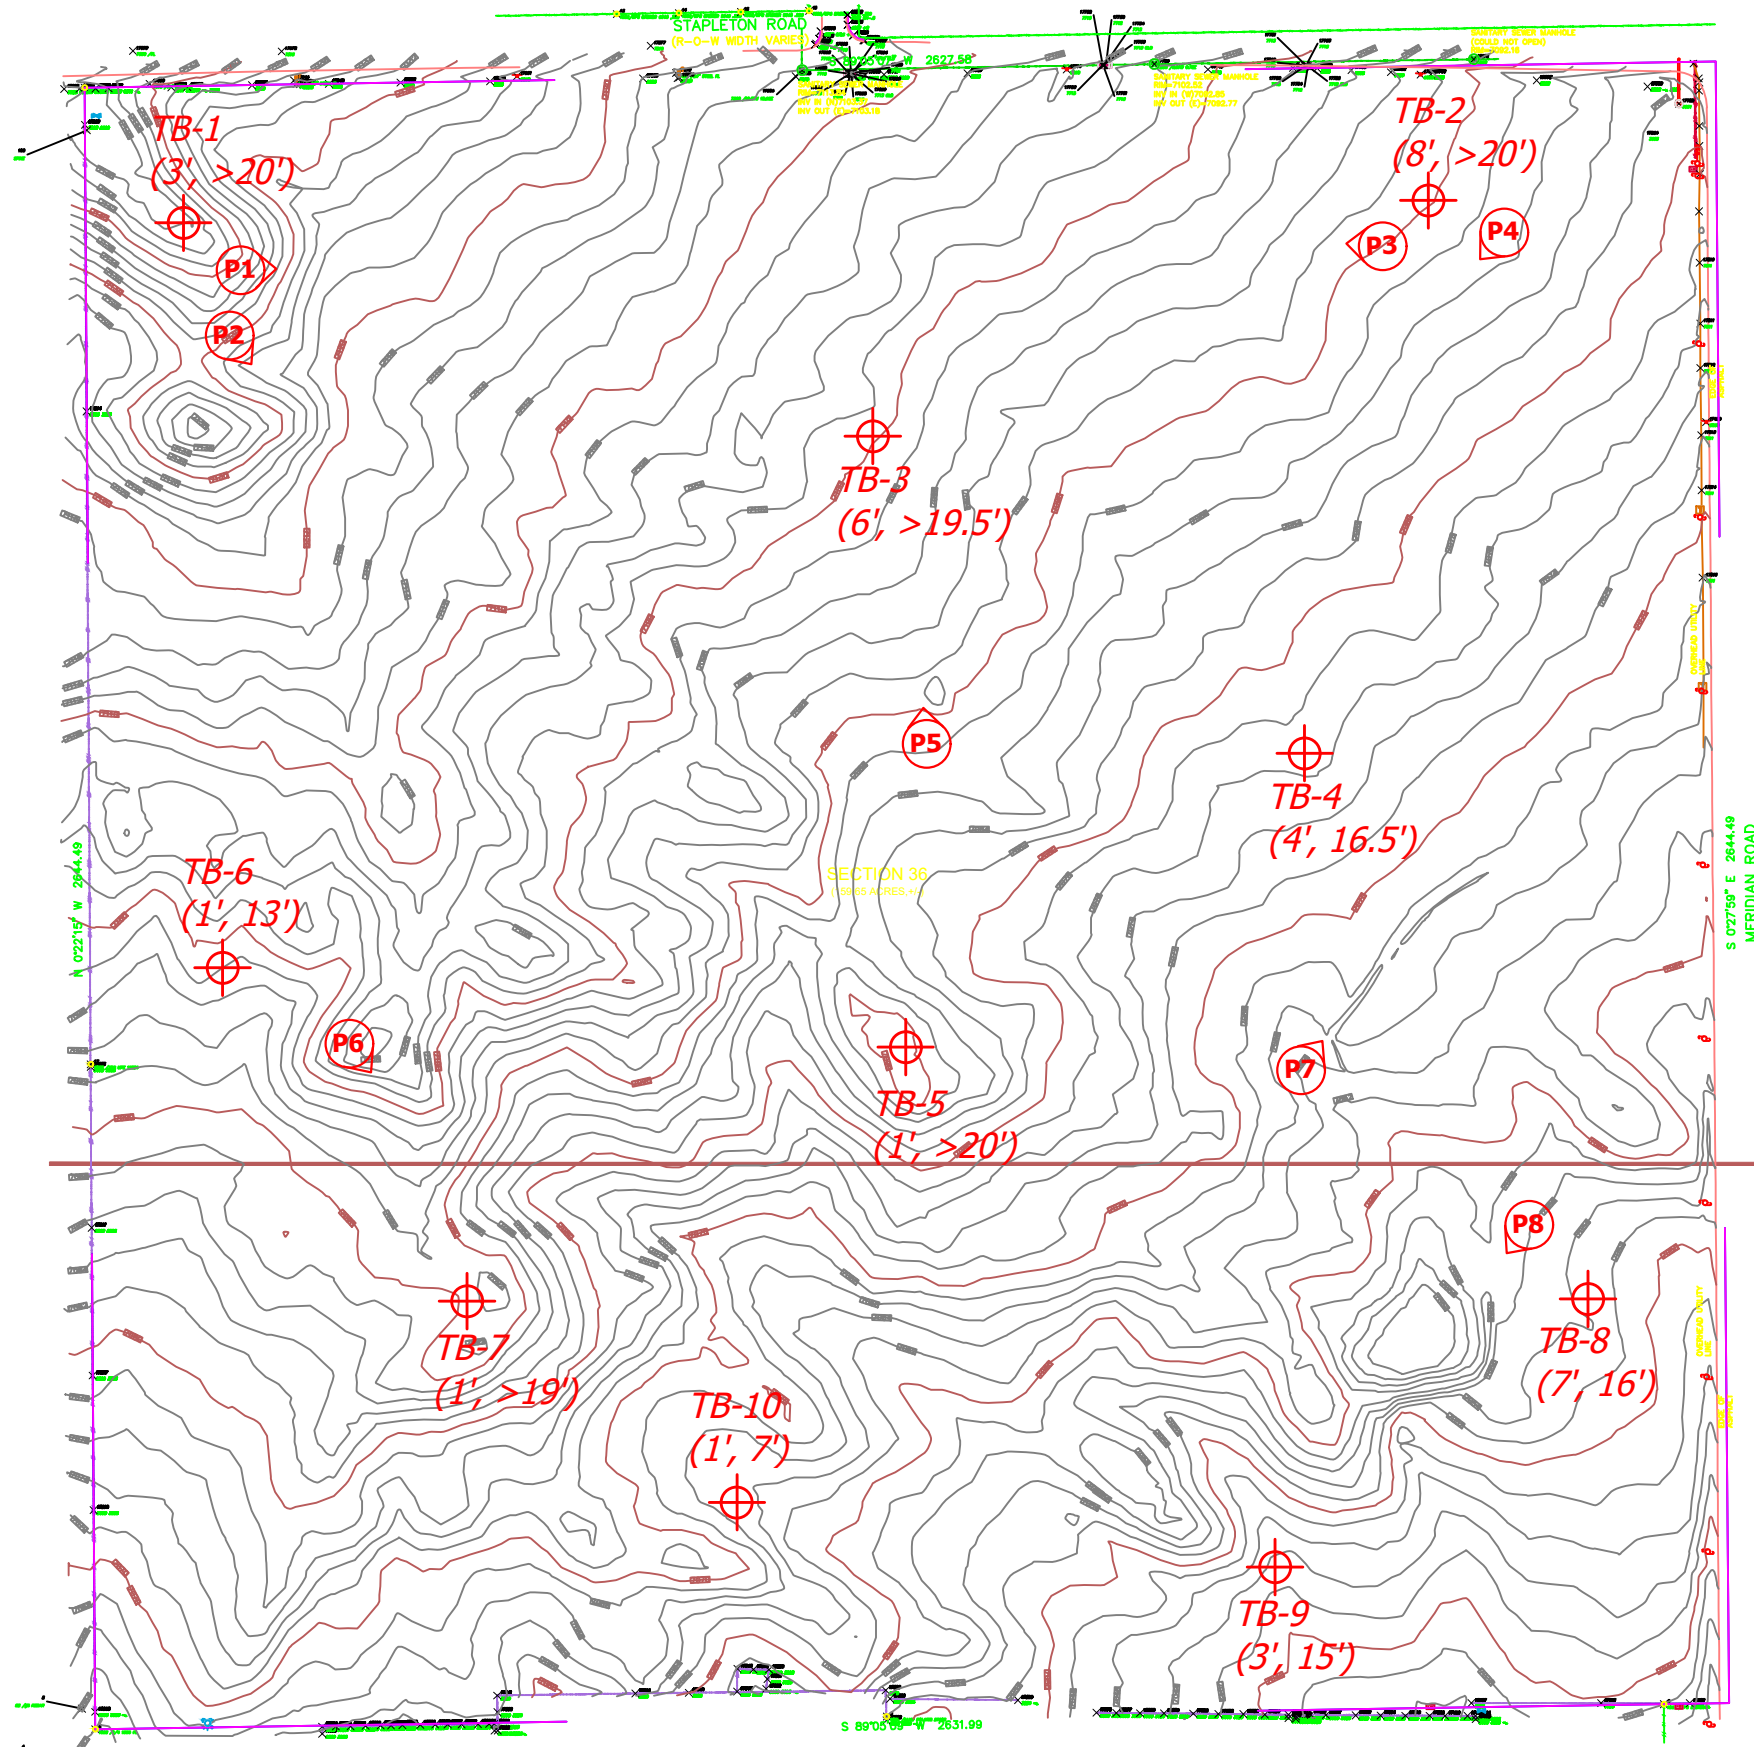
DRAWN	JHR
CHECKED	LLL
DATE	3/10/22
SCALE	AS SHOWN
JOB NO.	220093
FIGURE No.	3

Groundwater was encountered in Test Boring Nos. 4, 6, 8, 9, and 10 at depths of 7 to 16.5 feet below existing ground surface. Groundwater depths are shown on the Test Boring Map, Figure 3, and on Table 2. Areas of seasonal and potentially seasonal shallow groundwater have been mapped in low-lying areas and in the drainages on-site. These areas are discussed in the following section. Fluctuation in groundwater conditions may occur due to variations in rainfall and other factors not readily apparent at this time.

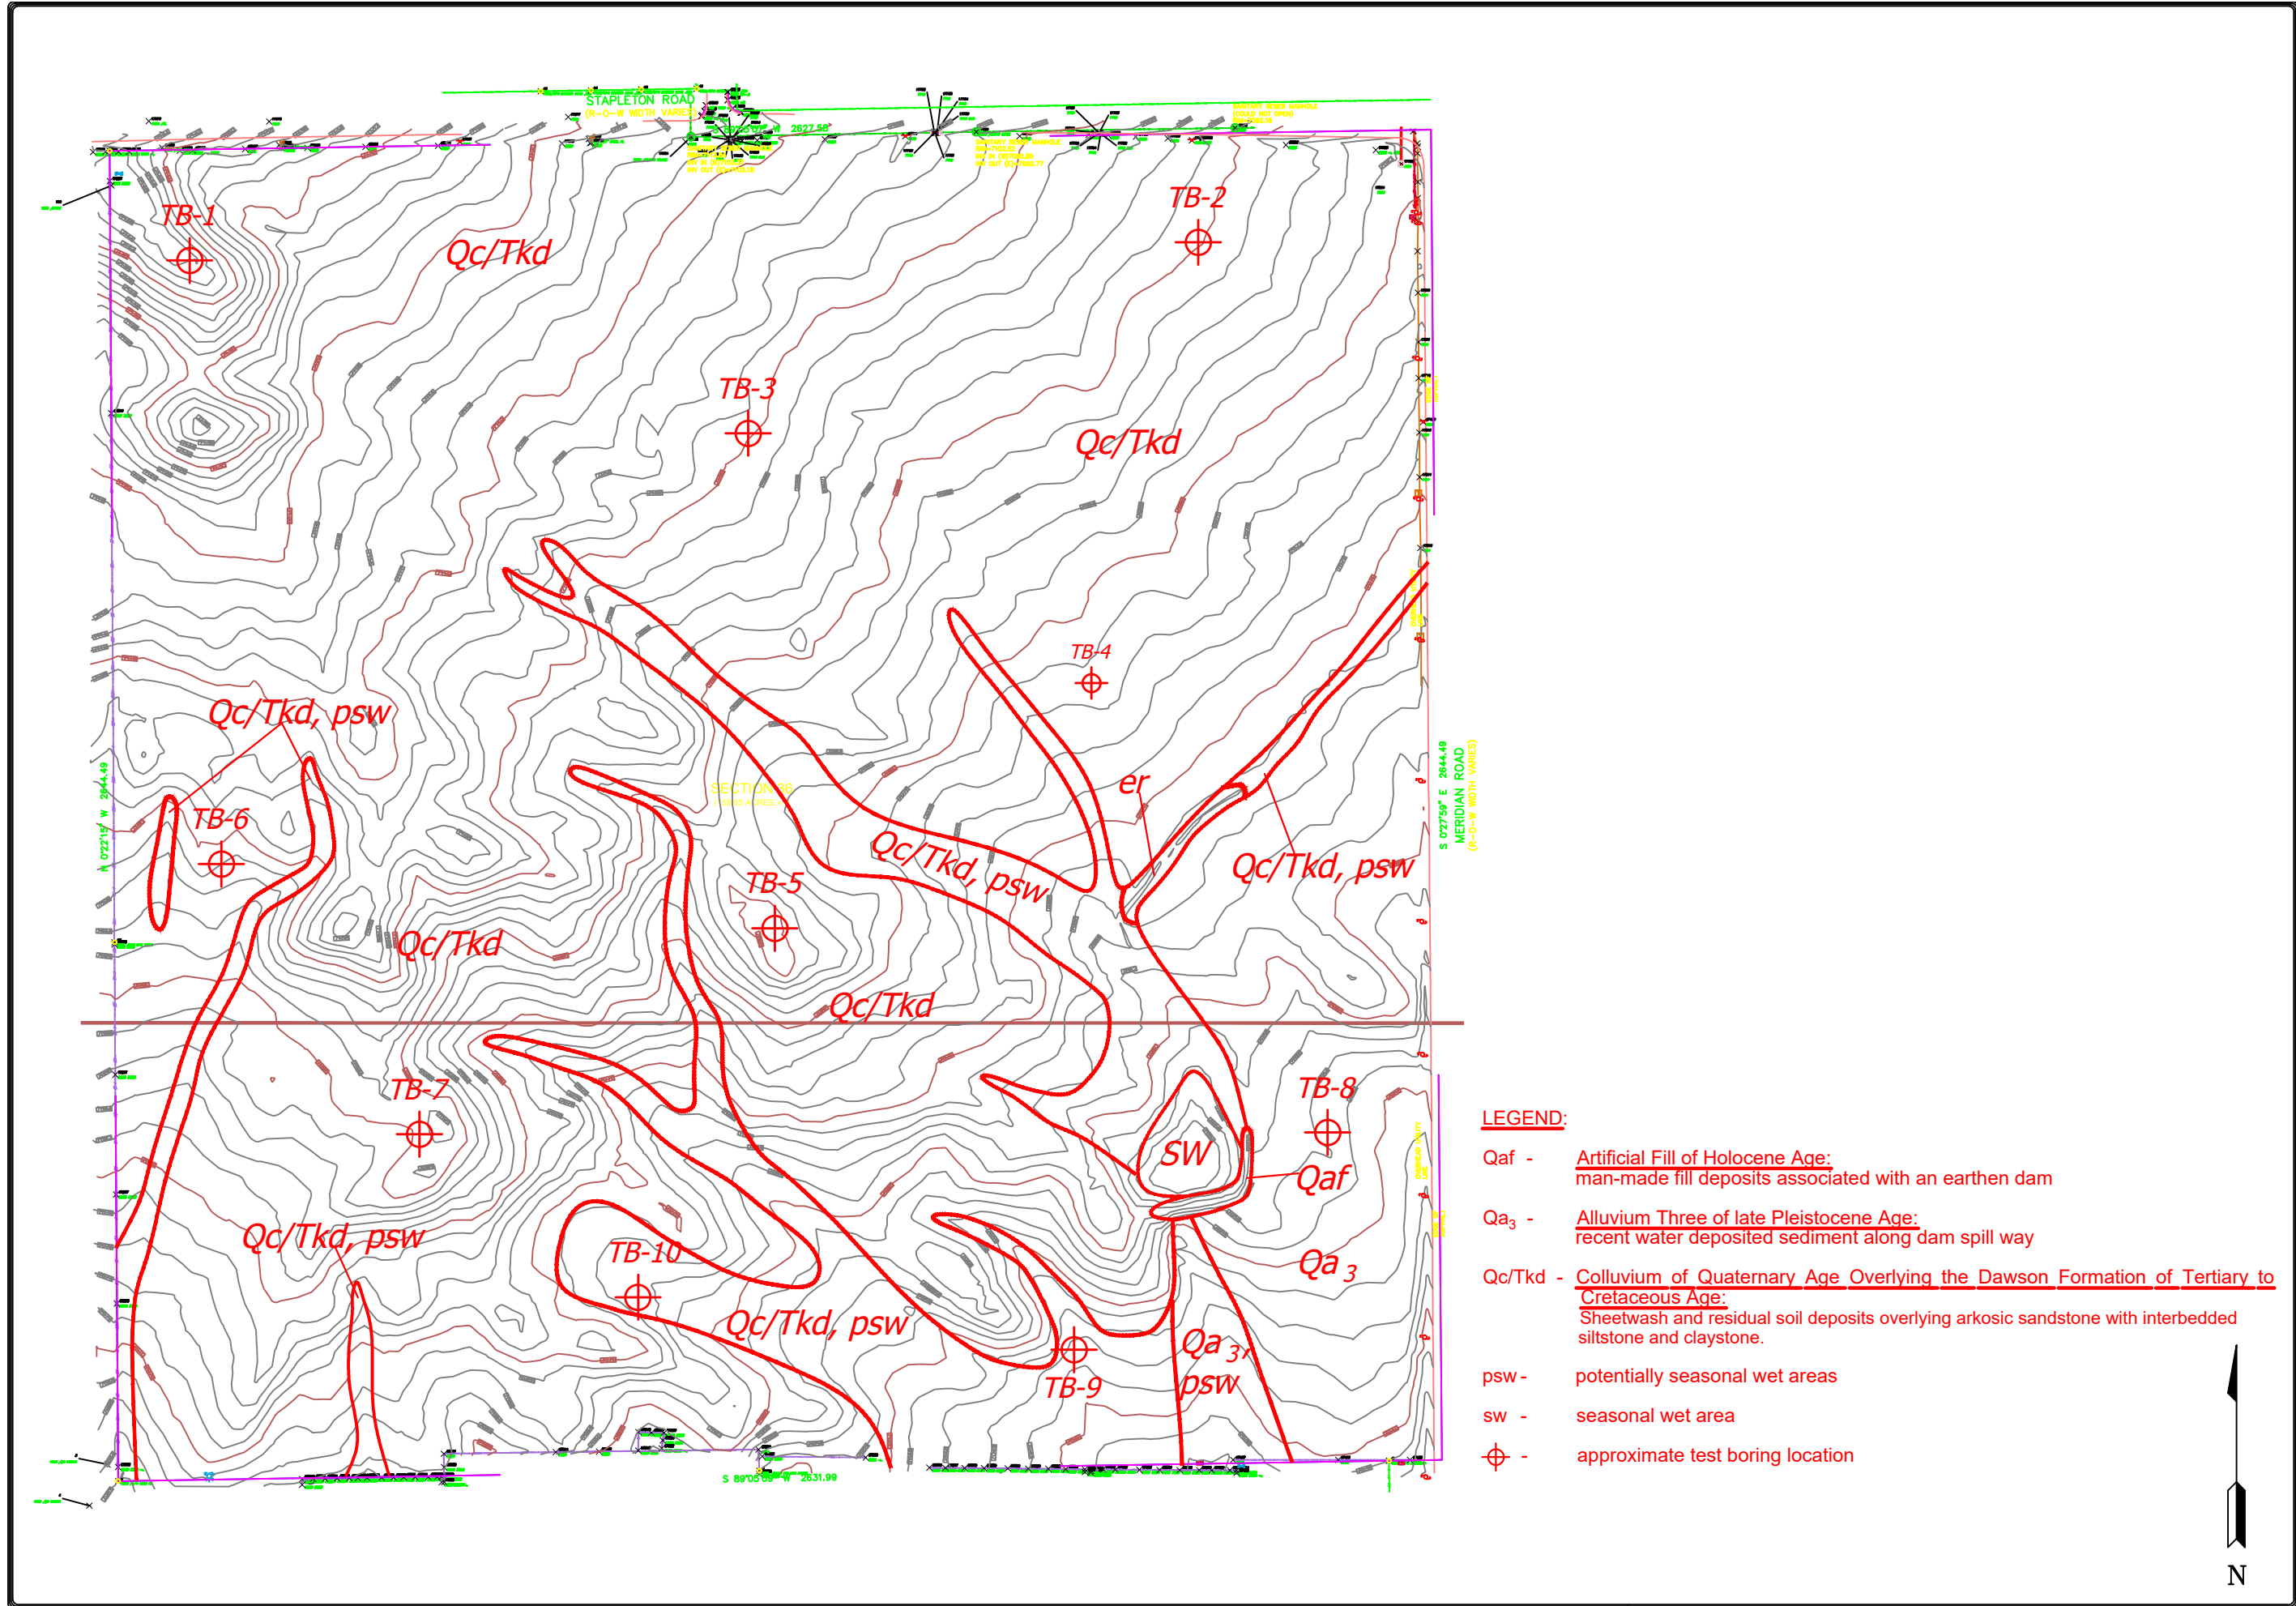
DRAWN	JHR
CHECKED	L.L.
DATE	3/10/22
SCALE	AS SHOWN
JOB NO.	220093
FIGURE No.	6

As mentioned previously, detailed mapping has been performed on this site to produce a Geology/Engineering Geology Map (Figure 6). This map shows the location of various geologic conditions of which the developers should be cognizant during the planning, design and construction stages of the project. These hazards and the recommended mitigation techniques are as follows:

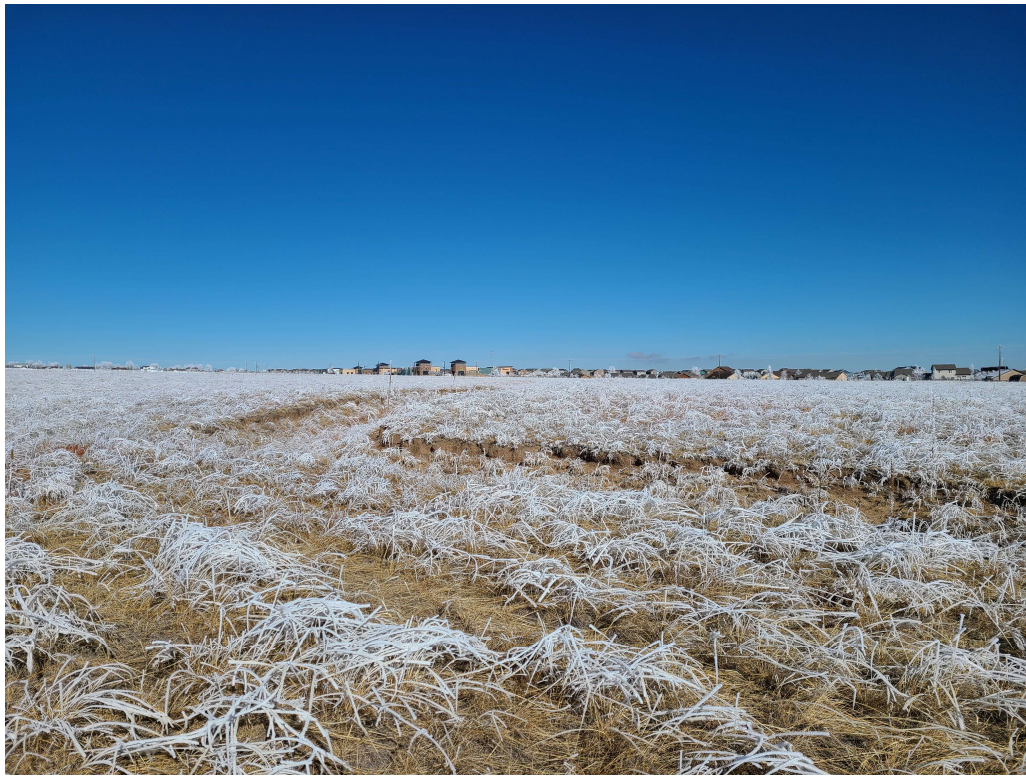
**Looking northeast
towards area of
erosion in the east-
central portion of the
site.**

Mitigation: Due to the nature of the soils on this site, virtually all the soils are subject to erosion by wind and water. Areas of erosion can occur across the entire site, particularly if the soils are disturbed during construction. Vegetation reduces the potential for erosion. The areas identified where erosion is actually taking place may require check dams, regrading and revegetation using channel lining mats to anchor vegetation. Further recommendations for erosion control are discussed under Section 8.0 "Erosion Control" of this report. Recommendations pertaining to revegetation may require input from a qualified landscape architect and/or the Natural Resource Conservation Service (previously Soil Conservation Service).

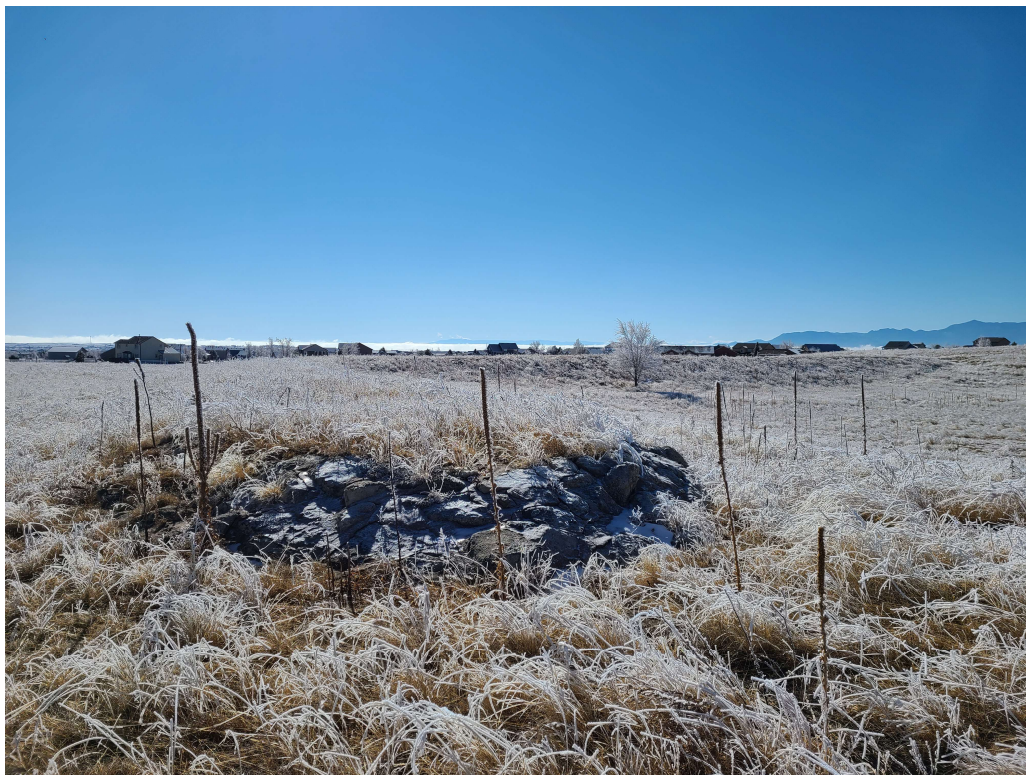
**Looking at the earthen
dam in the
southeastern portion
of the site.**

Mitigation: The earthen dams lie within defined drainages and should be avoided as building sites. Foundations may penetrate smaller berms on site. Should any uncontrolled fill be encountered in other portions of the site beneath foundations, removal and recompaction at 95% of its maximum Modified Procter Dry Density, ASTM D-1557 will be required.
