**SOIL, GEOLOGY, & GEOLOGIC HAZARD STUDY  
SADDLEHORN RANCH – FILING NO. 4  
CURTIS ROAD & JUDGE ORR ROAD  
EL PASO COUNTY, COLORADO**

December 5, 2022

Entech Job No. 222006  
AAprojects/2022/222006 countysoil/geo

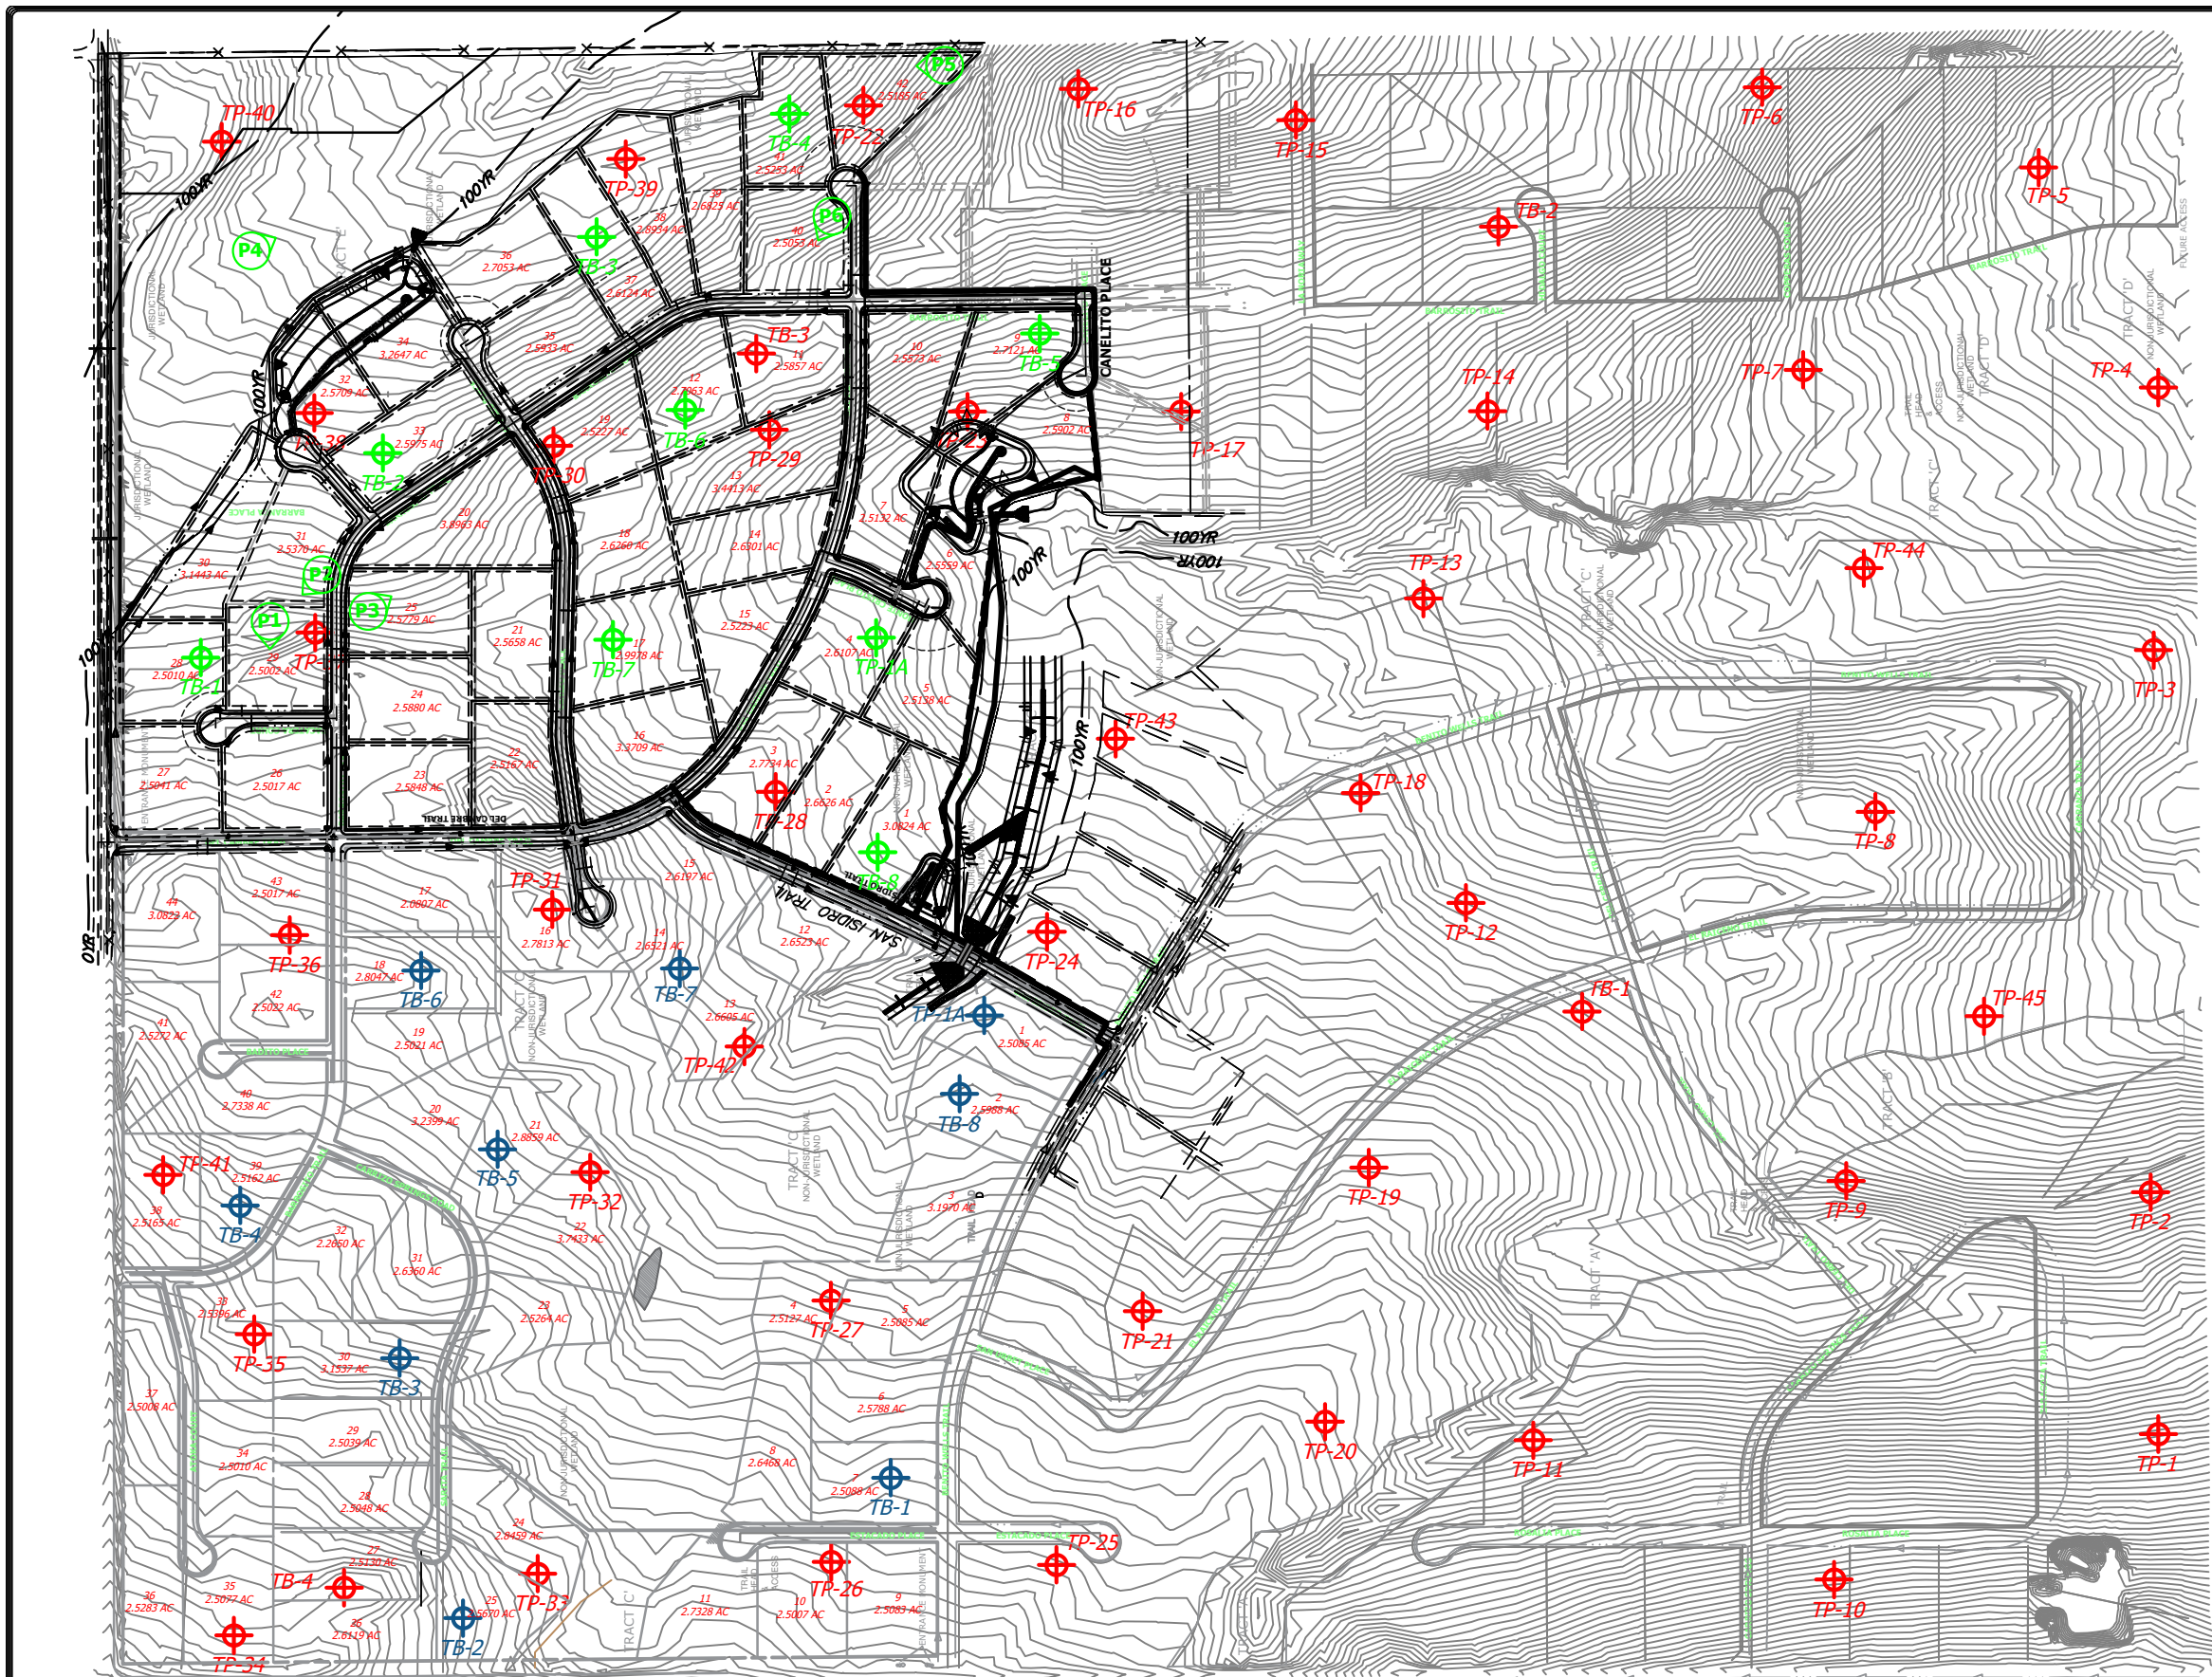
DRAWN L.L.
CHECKED
DATE 11/8/22
SCALE AS SHOWN
JOB NO. 222006
FIGURE No. 3

Four (4) test borings, and forty-five (45) tactile test pits were previously performed on the site to verify general soil conditions and the suitability of the site for the use of on-site wastewater treatment systems (Reference 1). One Test Boring (TB-3), and nine (9) of the previous Test Pits (TP-22, TP-23, TP-28, TP-29, TP-30, TP-37, TP-38, TP-39, & TP-40) were used as part of the Saddlehorn Ranch – Filing No. 4 investigation. Eight (8) additional test borings and one (1) test pit were completed for Saddlehorn Ranch – Filing No. 4. The locations of the test pits are indicated on the Site Plan/Testing Location Map, Figure 3. The Test Pit Logs are included in Appendix B, the Laboratory Testing Results are included in Appendix C, and a Summary of the Laboratory Testing Results is presented in Table 1. Results of this testing will be discussed later in this report.

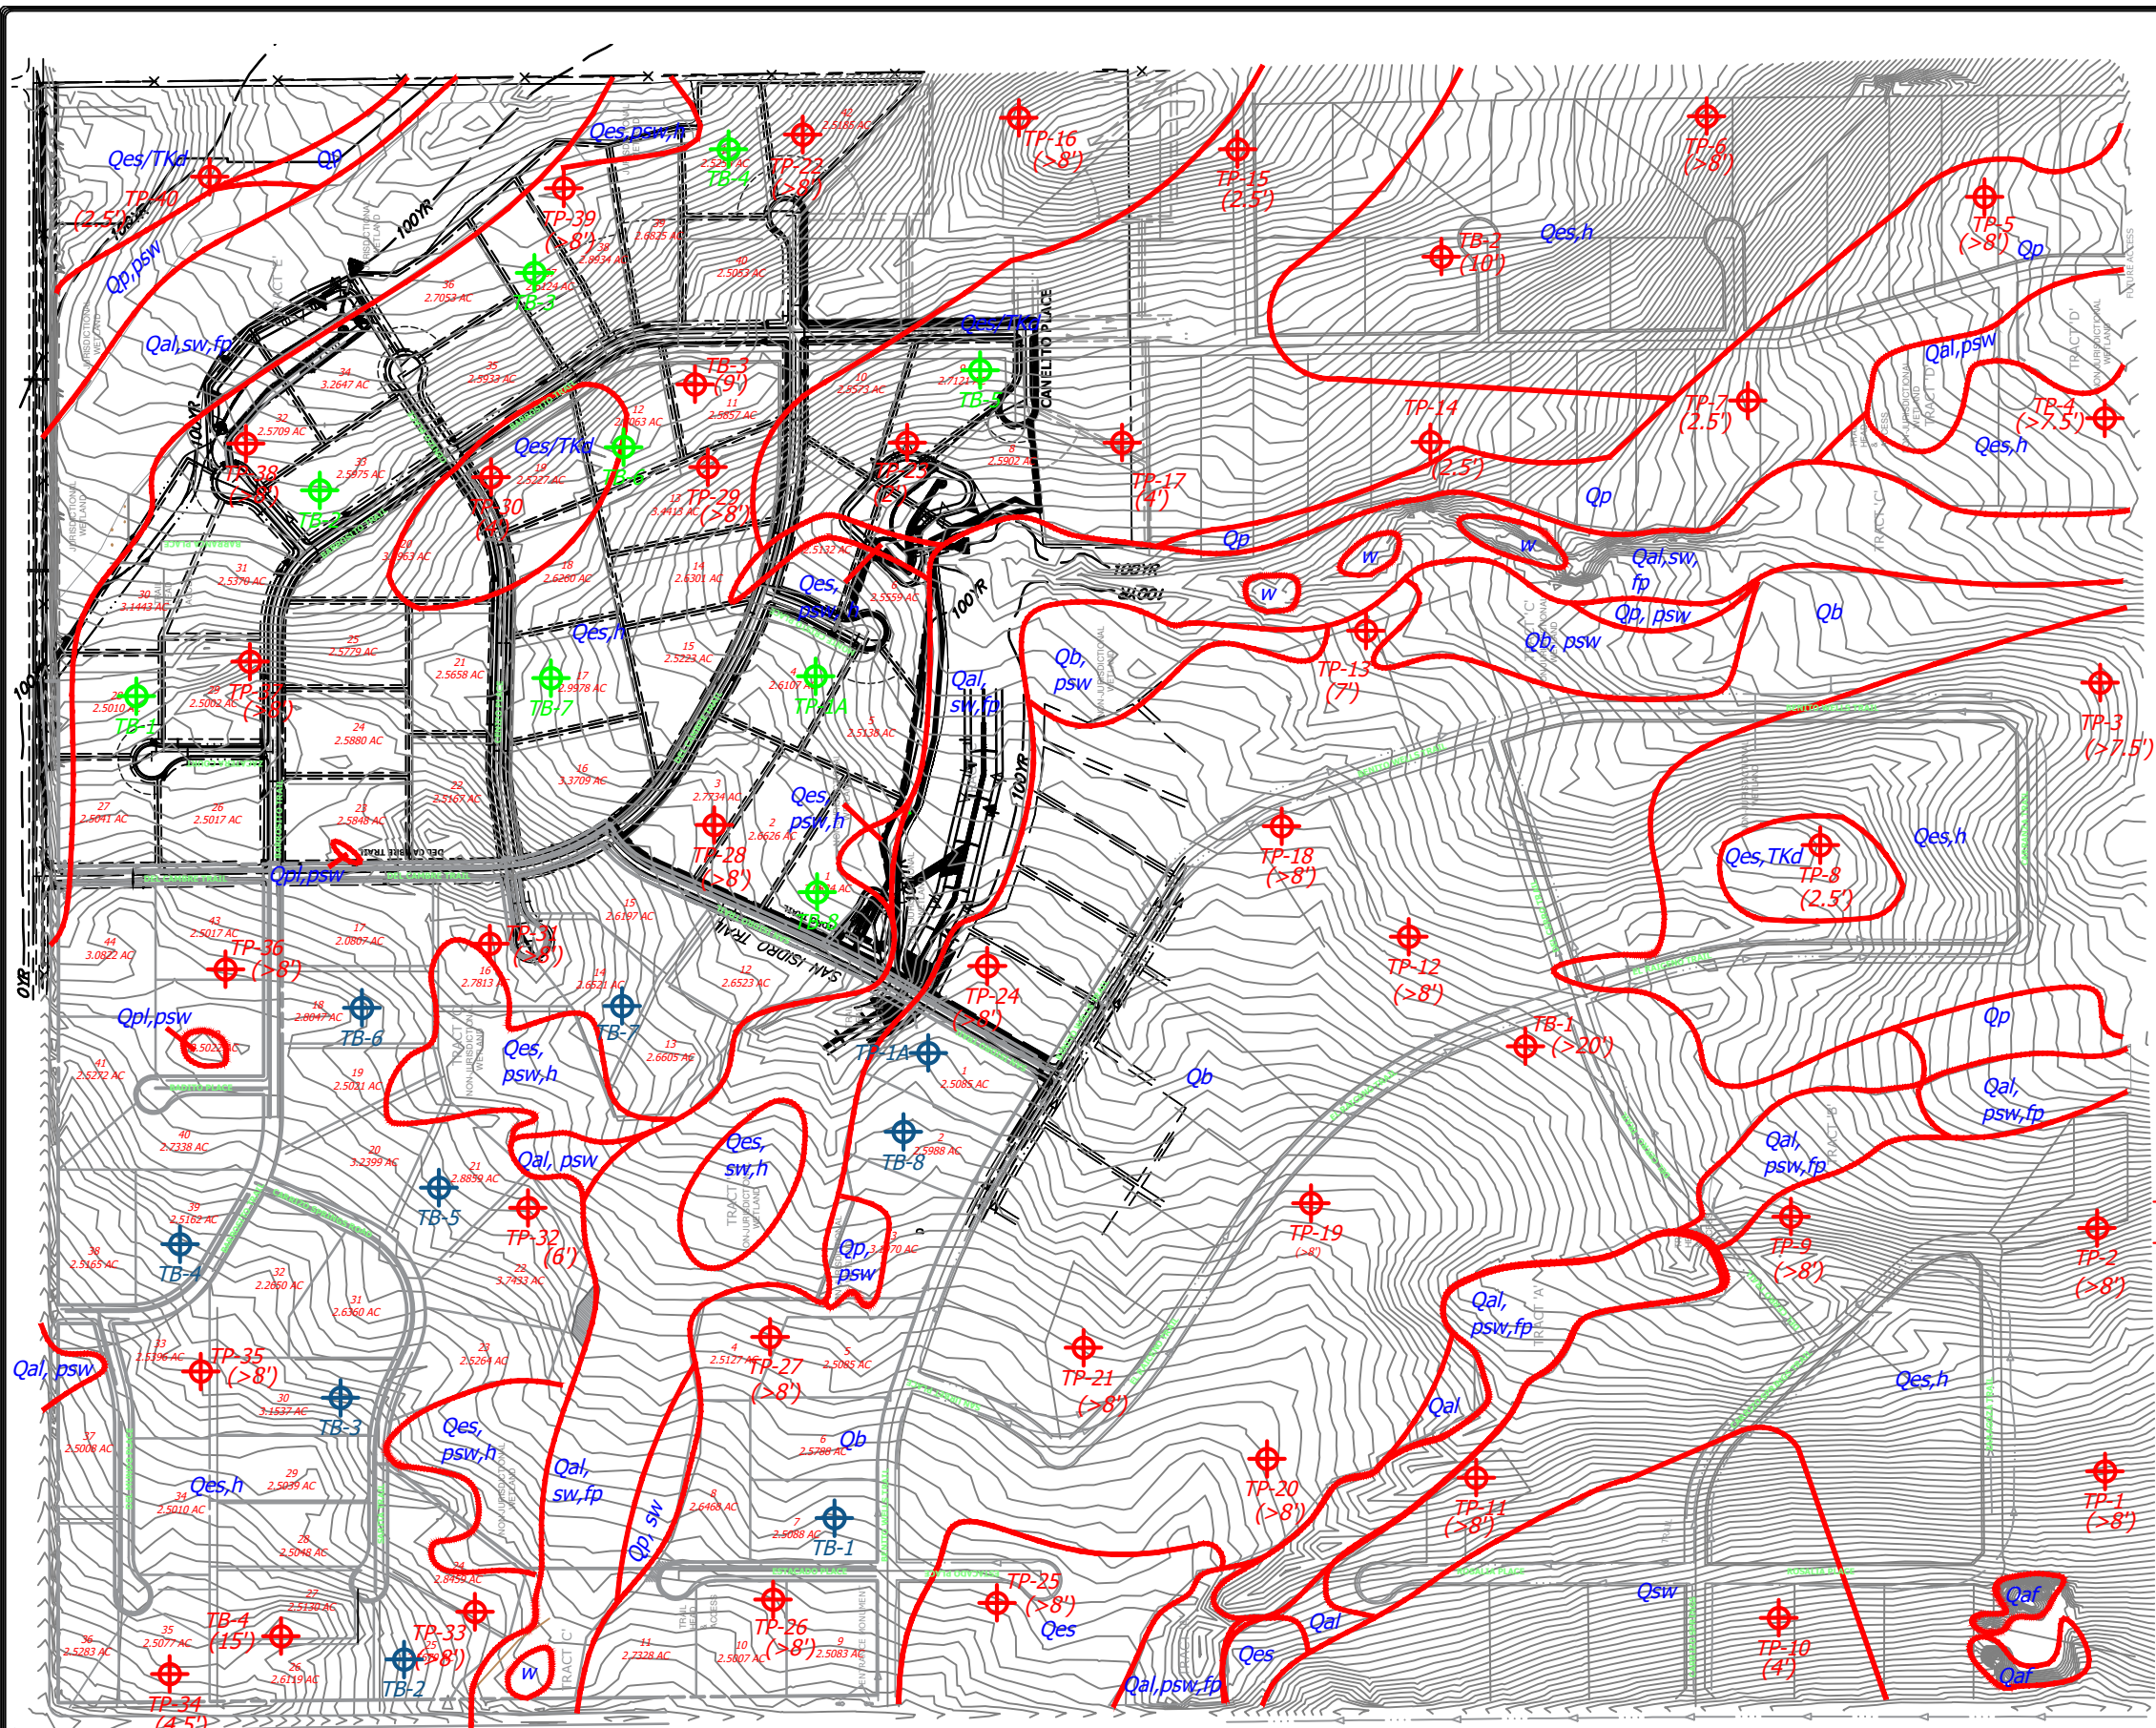
Detailed mapping has been performed on this site to produce a Geology/Engineering Geology Map (Figure 6). This map shows the location of various geologic conditions of which the developers should be cognizant during the planning, design and construction stages of the project. These hazards and the recommended mitigation techniques are as follows:

sw, psw – Seasonal and Potentially Seasonal shallow groundwater areas: In these areas, we would anticipate the potential for periodically high subsurface moisture conditions, frost heave potential, and highly organic soils. Areas where perched water conditions are encountered should also follow these recommendations. Construction proposed in or adjacent to these areas, should follow these precautions:

Mitigation: In these locations, foundations are subject to severe frost heave and should penetrate to a sufficient depth so as to prevent the formation of ice lenses beneath foundations. At this location and elevation, a foundation depth for frost protection of 30-inches is recommended. In areas where high subsurface moisture conditions are anticipated periodically, a subsurface perimeter drain will be necessary to help prevent the seepage of water into areas below grade. A typical perimeter drain detail is presented in Figure 8. Any grading in these areas should be done in a manner that directs surface flow around construction to avoid areas of ponded water. Areas of organic material will require removal prior to any fill placement. Unstable soil conditions should be expected in areas of shallow groundwater. Where foundations approach the groundwater level, stabilization of the excavations utilizing shot rock may be necessary. Underslab drains or capillary breaks, and interceptor drains may be necessary to prevent intrusion of water into areas below grade. Typical drain details are presented in Figures 9 and 10.

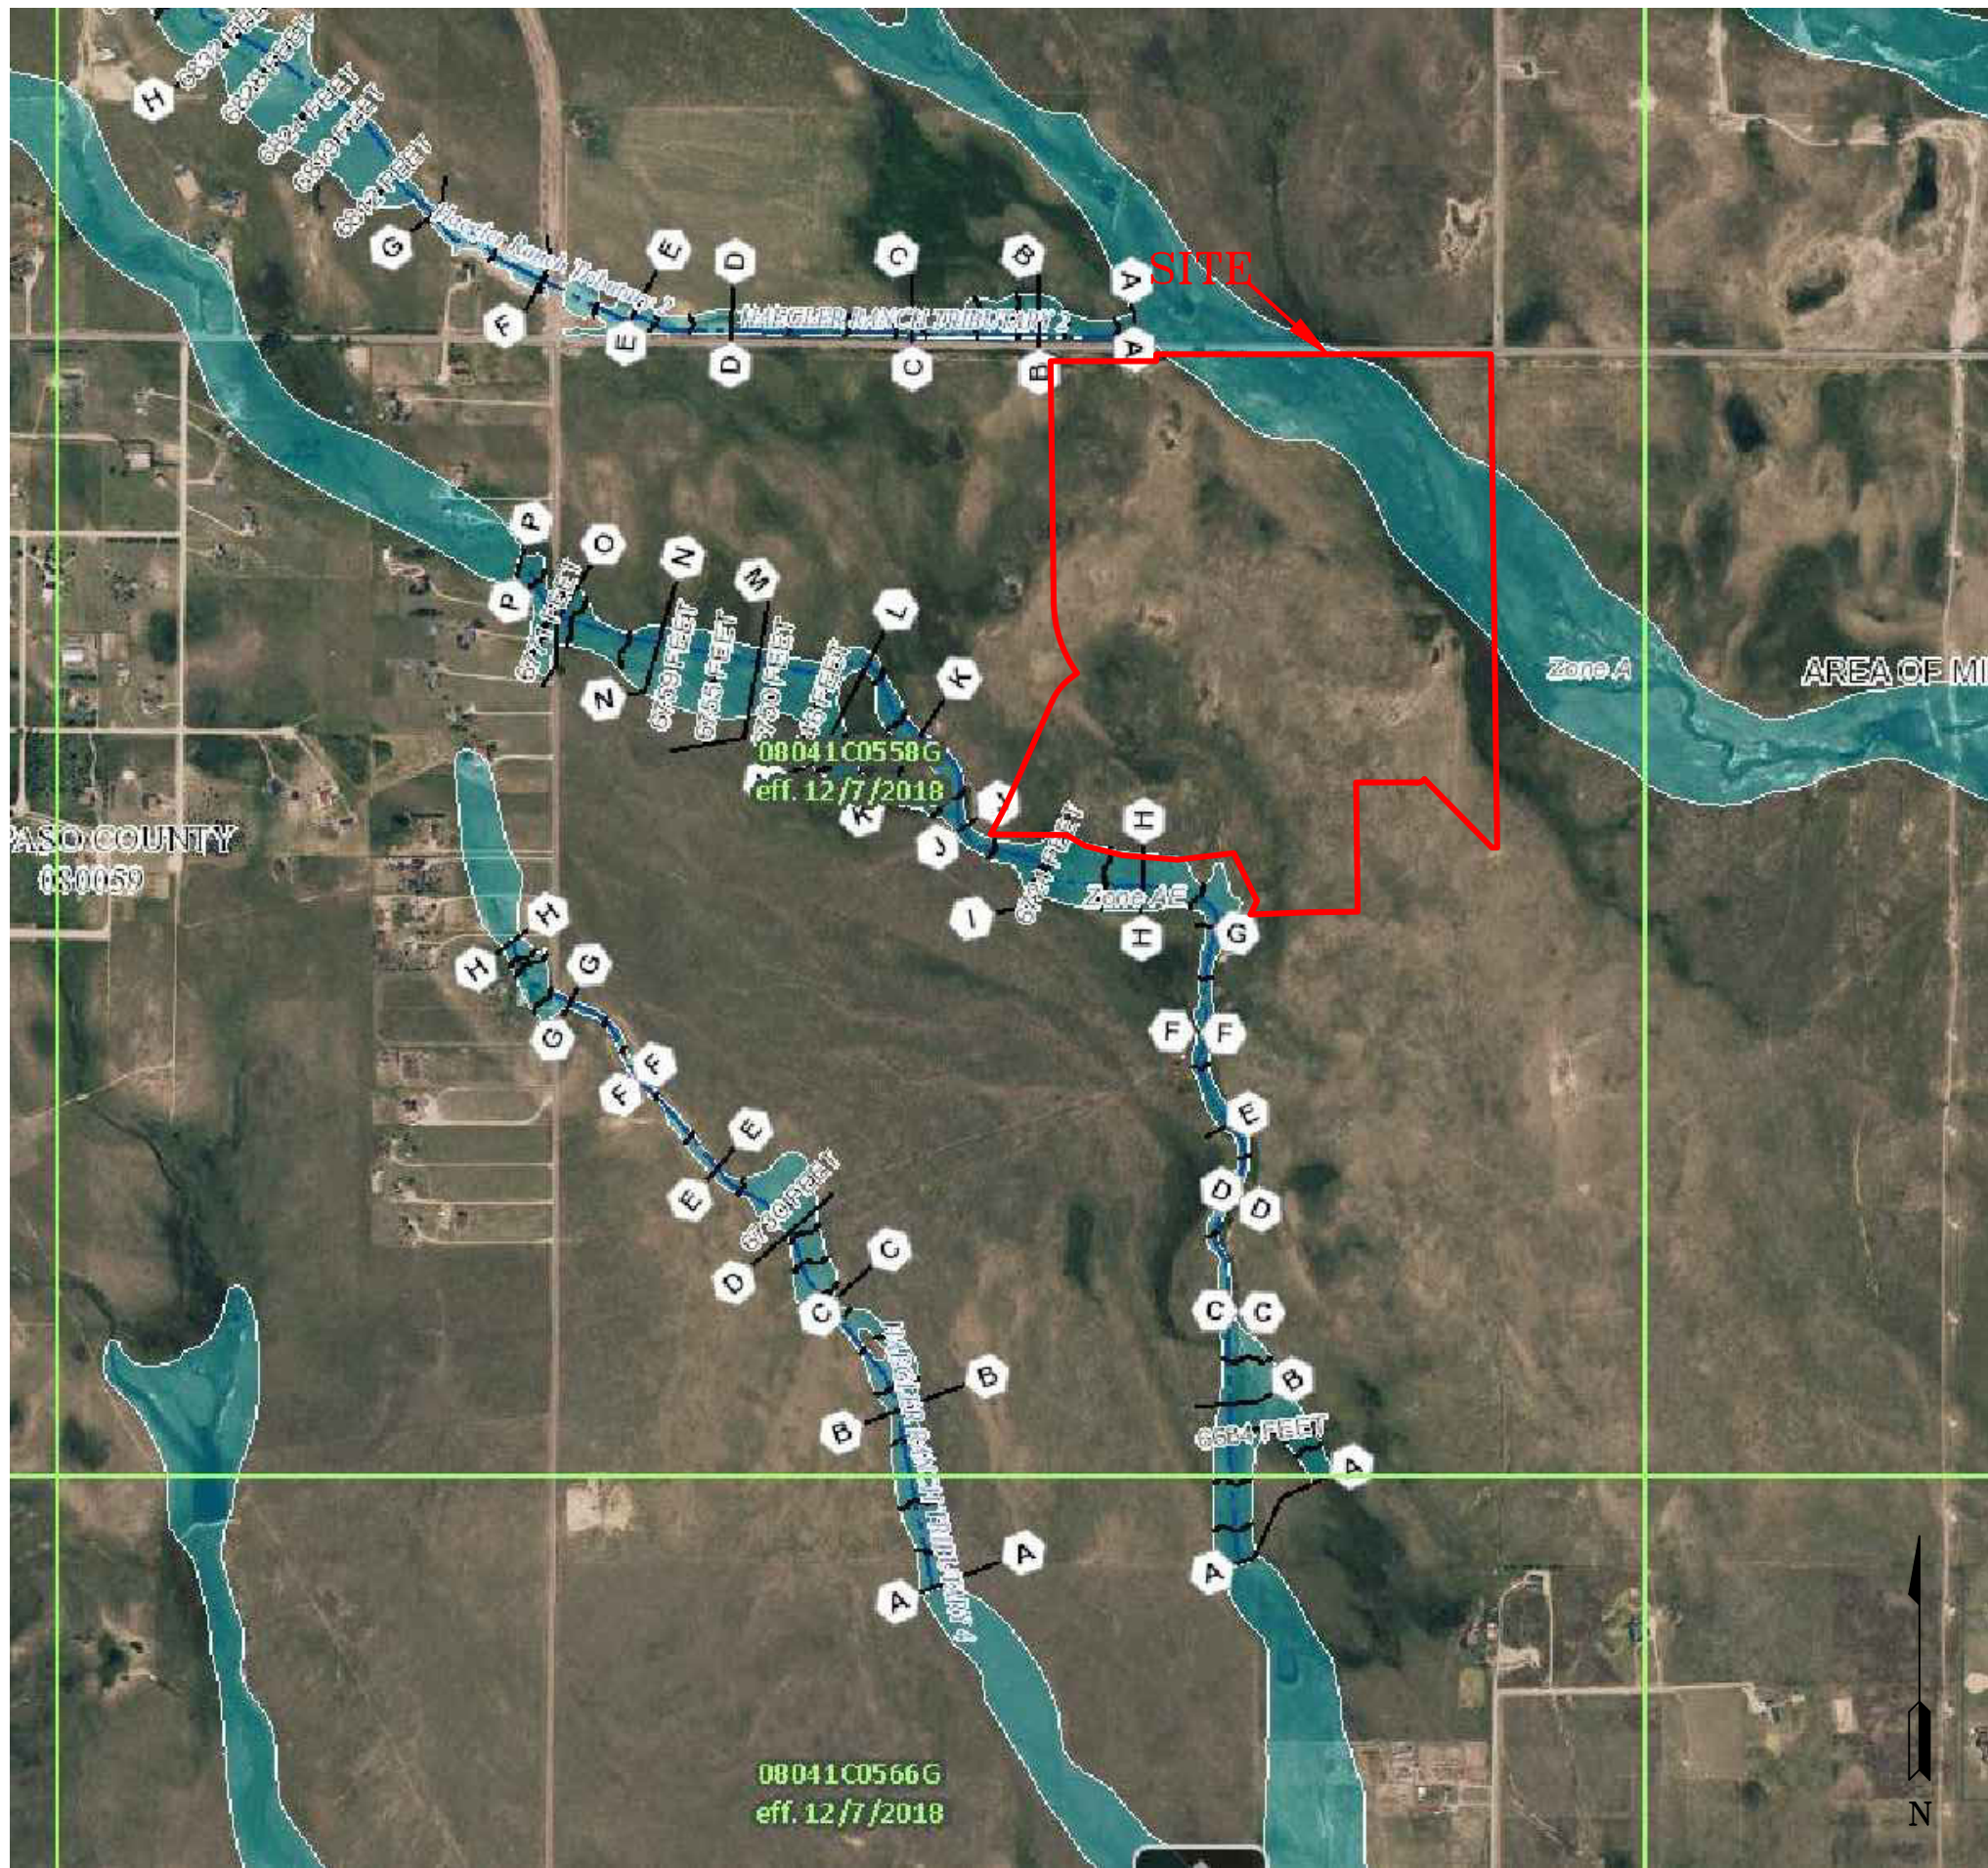
DRAWN	L.L.
CHECKED	
DATE	11/8/22
SCALE	AS SHOWN
JOB NO.	222006
FIGURE NO.	7

Portions of the site associated with tributaries of the Black Squirrel Creek drainage are mapped within a floodplain zone according to the FEMA Map No. 08041C0558G, dated December 7, 2018 (Figure 7, Reference 7). Areas of ponded water were observed in the central portion of the site near the windmill. The floodplain areas have been designated as open space and/or can be avoided by construction. Additionally, areas of seasonal and potentially seasonal shallow groundwater were observed across the site. In these areas, we would anticipate the potential for periodically high subsurface moisture conditions and frost heave potential. These are low-lying areas along the drainage in the southern and northeastern portions of Filing 4 and in the low-lying areas and minor drainages across the site. These areas can likely be avoided or properly mitigated by development. Perched water conditions could be encountered across the entire site where water can flow within permeable sand layers overlying impermeable bedrock. These areas should be identified on an individual basis at the time of construction. Where perched water conditions are encountered, the mitigation recommendations for seasonal and potentially seasonal shallow groundwater should be followed. Foundations should maintain a minimum separation of 3 feet between the foundation grade and the maximum anticipated groundwater level. The floodplain should be avoided by construction unless site-specific floodplain determination and drainage studies are performed. These areas are discussed below.

Areas of seasonal and potentially seasonal shallow groundwater, ponded water, and floodplains exist on this site. The floodplains and areas of ponded water are to be avoided by development and preserved as open space in drainage easements. Finished floor levels must be a minimum of one foot above the floodplain level. Exact floodplain locations are beyond the scope of this report. According to the site plan (Figure 6), some of the minor drainages can be avoided or filled which will mitigate the hazard.
