Geology and Soils Reports
Performed For
A VACATION AND REPLAT OF LOT 1,
V I L FILING No. 1
PORTION OF THE NORTHWEST QUARTER OF
SECTION 30, TOWNSHIP 13 SOUTH,
RANGE 63 WEST OF THE 6TH M.M., EL PASO
COUNTY, COLORADO

Allison Engineering
(719) 331-6538

June 1, 2023

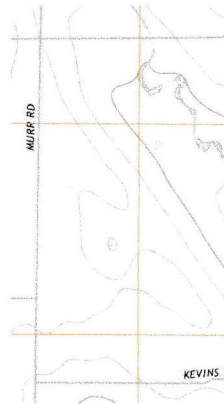
Figure 1: Property lines are rectilinear with the roads with the north boundary extending from the intersection then slightly into the FEMA Zone 'A'.

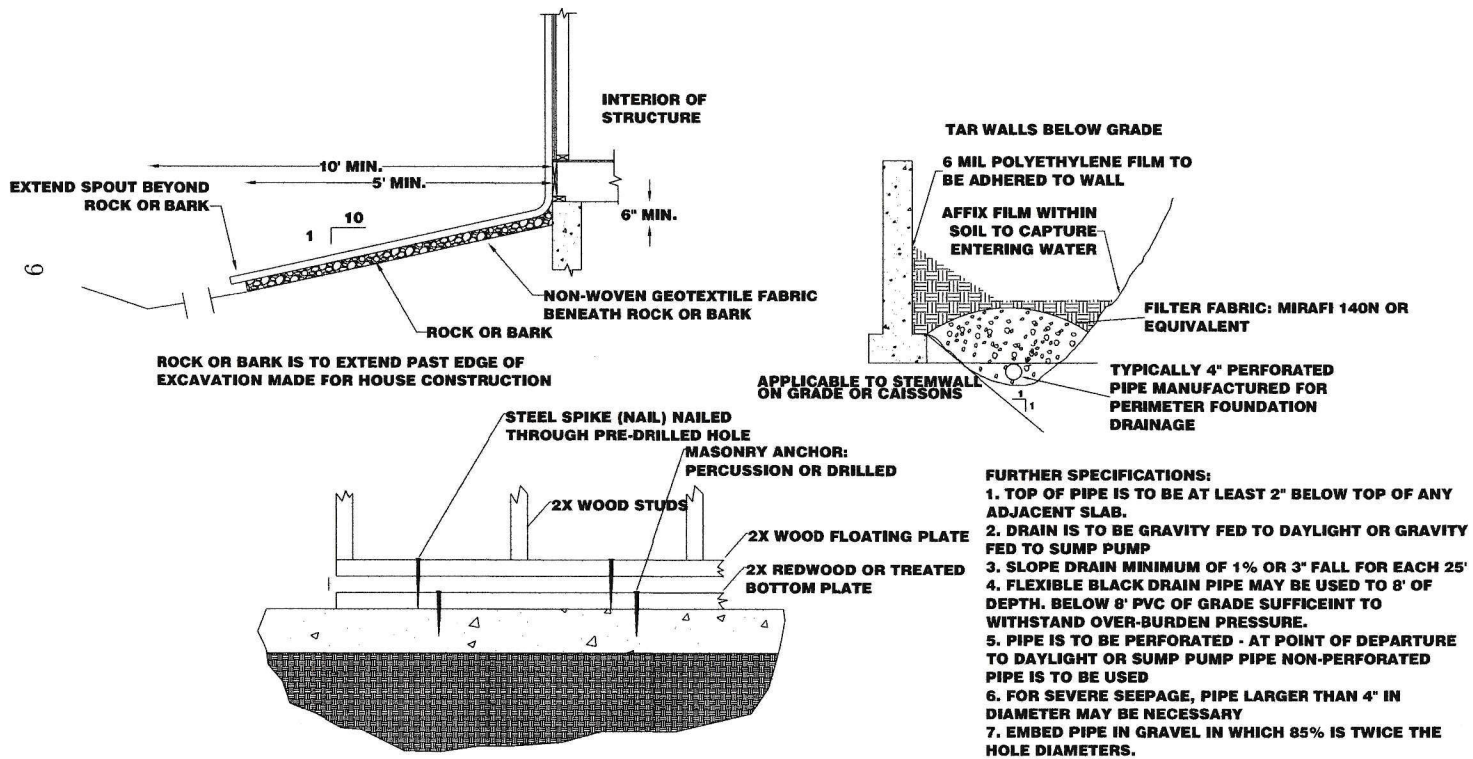
Figure 2: Engineering Details.

downspouts from rain gutters and maintenance of grade against the house. Prudent is the structure where the grade drops uniformly one foot for the first 10 feet perpendicular to the home and that water not be retained but conveyed further from the structure. Figure 2 depicts proper downspout maintenance and perimeter drain details.

In our professional opinion, as precautionary measures, slabs should have sufficient control joints with approximate limits of 120 square-feet and with limited horizontal extents of 12 feet. Also, non-load-bearing partition walls should be floating per the detail provided in Figure 2. If foundation elements are not placed directly on sandstone as

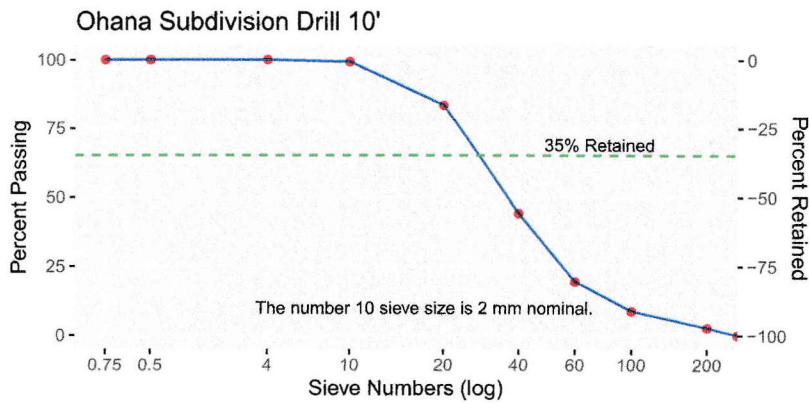
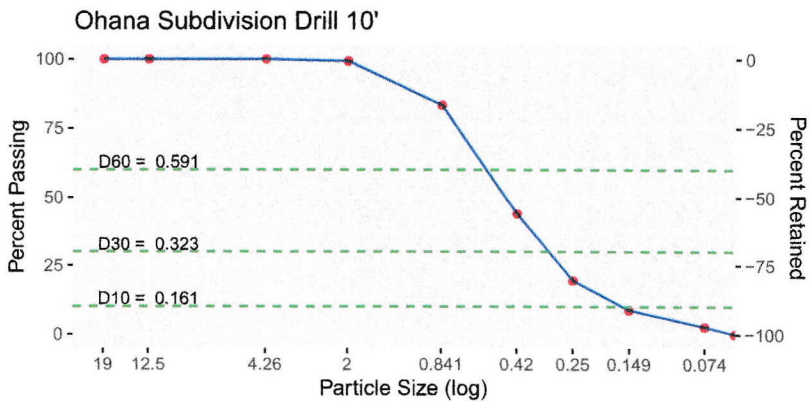
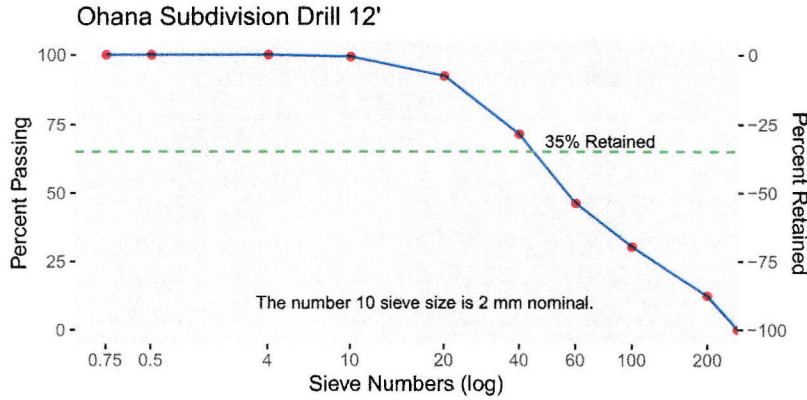
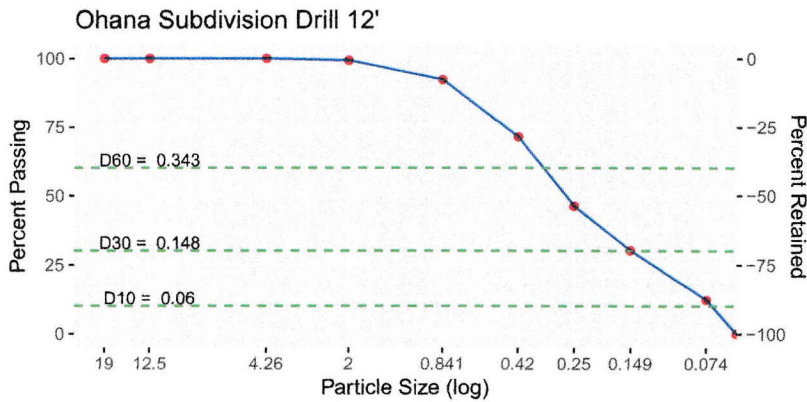
The soil within the zone of influence for a typical residential structure with or without a basement is not of a character for which significant expansion is expected and the soil is too granular for a reliable swell-consolidation test. Three drill borings made using a trailer-mounted Giddings, Inc., geotechnical exploration drill found sandstone among the three holes at depths between 10 and 12 feet below grade. The locations are shown on Figure ?? and the drill logs in the tables immediately following this paragraph. Atterberg limits tests of the soil just below the beginning at which sandstone was encountered found a plasticity index less than 4, indicating a low expansive soil. From surface to beginning of sandstone the soil per D2487 is classified as SP and that within the sandstone is classified as SP-SM. Grain-size distribution curves are provided in Figures ?? and ?? for drill location #2. Curves for the other two locations are graphically not different.

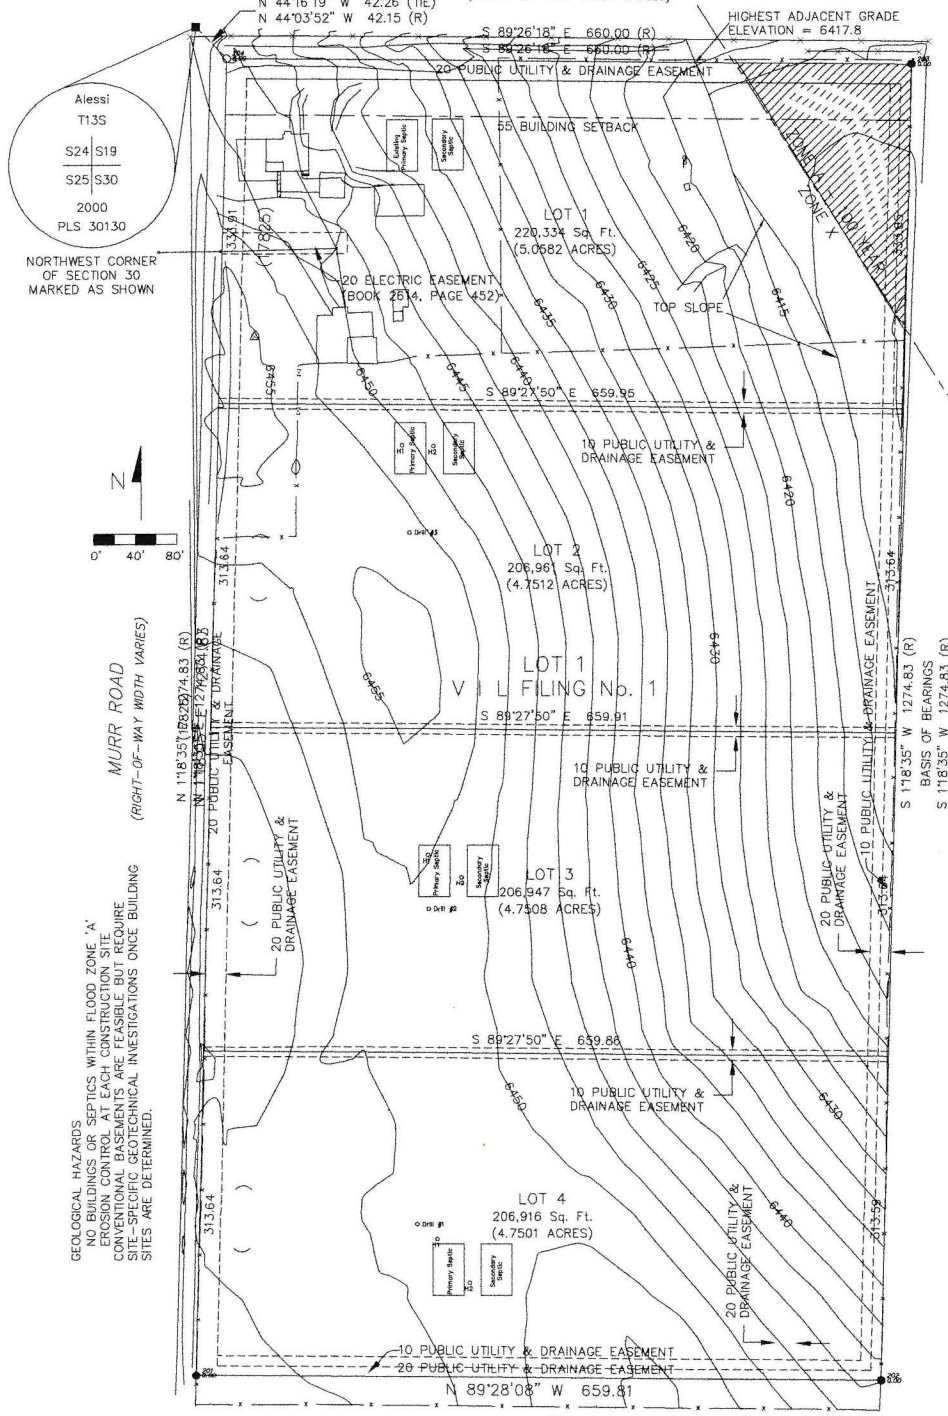
GEOLOGICAL HAZARDS
OF UNLINED SEPTICS WITHIN FLOOD ZONE 'A'
NO CONSTRUCTION AT EACH CONSTRUCTION SITE
EROSION CONTROL AT EACH CONSTRUCTION SITE
CONVENTIONAL BASEMENTS ARE FEASIBLE BUT REQUIRE
SITE-SPECIFIC GEOTECHNICAL INVESTIGATIONS ONCE BUILDING
SITES ARE DETERMINED.
