June 12, 2007

Re: Soil, Geology and Geologic Hazard Study
Rolling Thunder Business Park
Woodmen Road and Golden Sage Road
El Paso County, Colorado

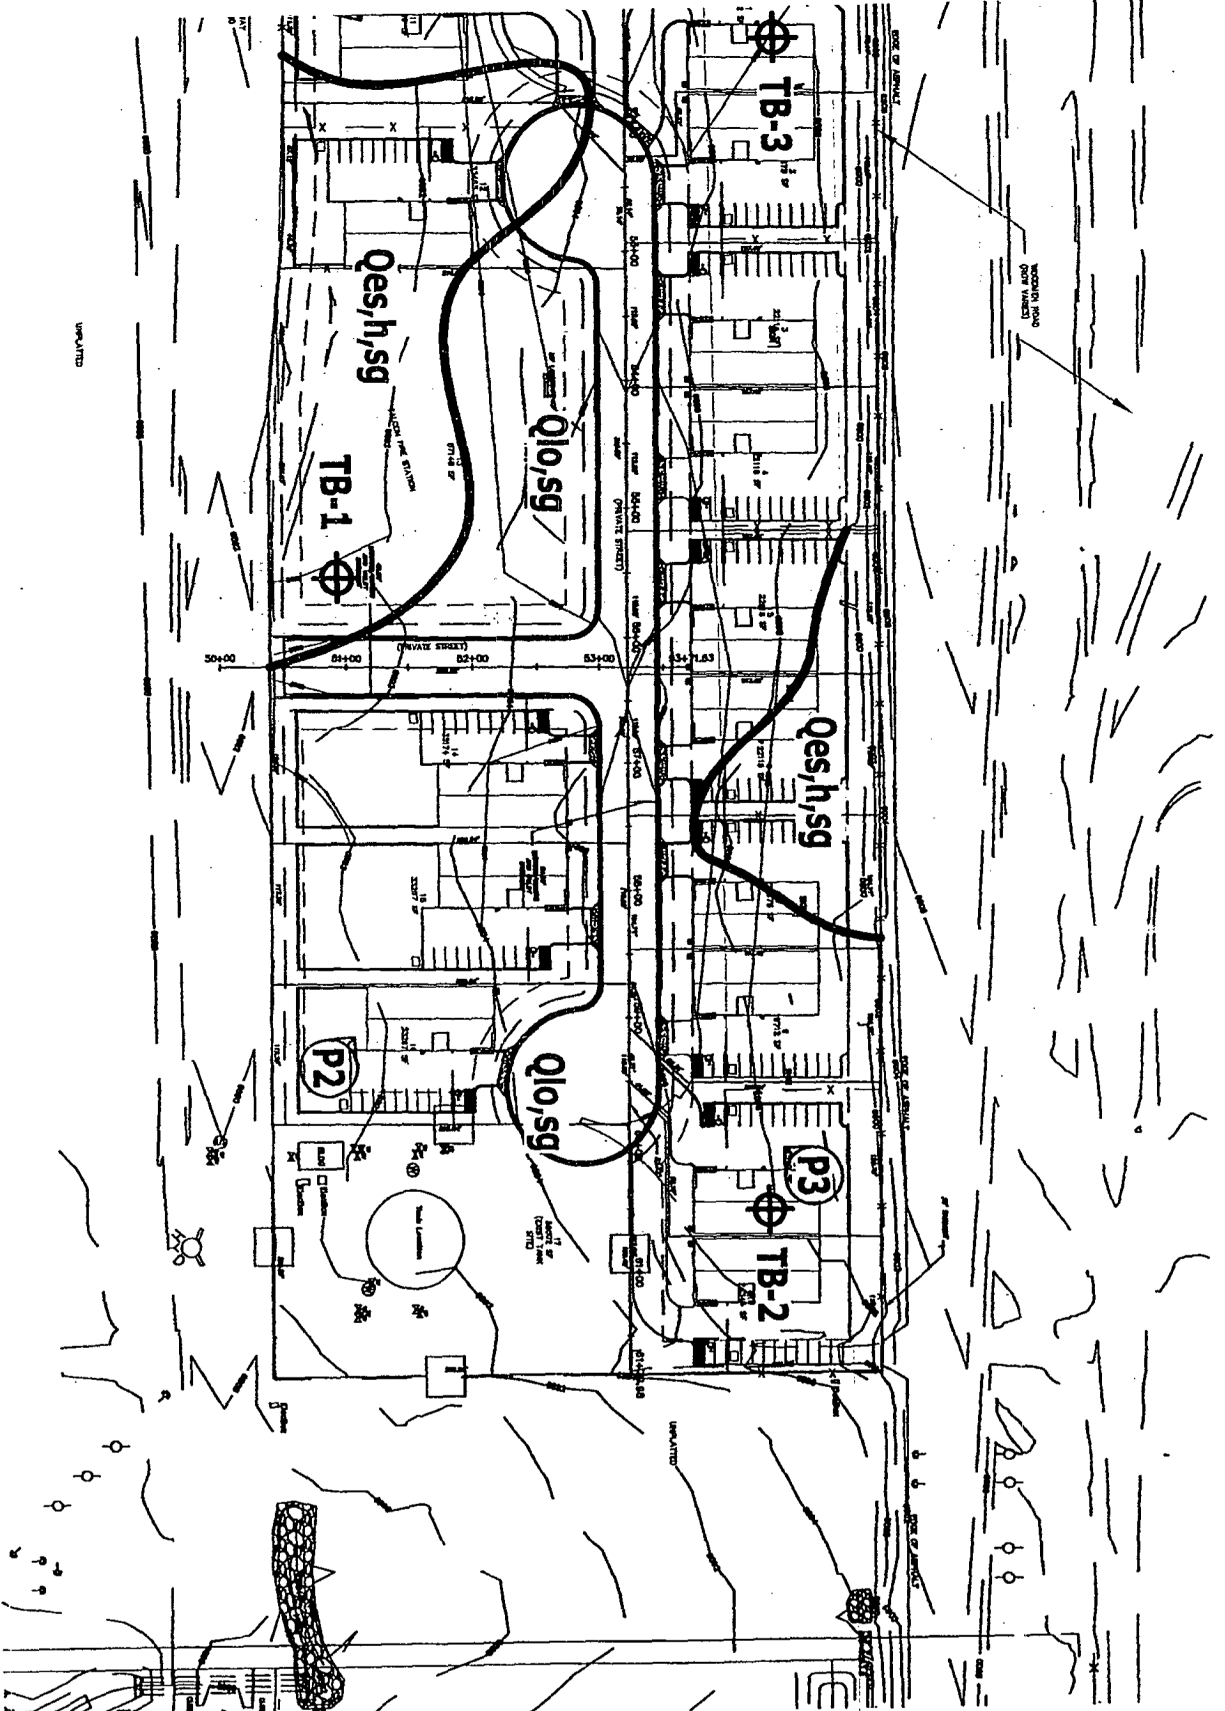
Detailed mapping has been performed on this site to identify areas where various geologic conditions exist of which developers should be cognizant during the panning, design and construction stages of the project (Figure 7). The engineering geologic hazards identified on this site include shallow groundwater, hydrocompaction, the potential for expansive soils and bedrock, and loose soils. These hazards and recommended mitigation techniques are discussed as follows:

sg - Shallow Groundwater Area

Groundwater was encountered at 7 and 6.5 feet in the test borings drilled on site. The site does not lie within any floodplain zones according to the FEMA Map No. 08041CO535F (Figure 8, Reference 10). The groundwater encountered may be associated with perched groundwater conditions. This is extremely common in the area, particularly where permeable sands associated with alluvial and eolian deposits exist over impermeable clayey sandstone or claystone.

h Hydrocompaction

Areas in which this hazard has been identified are acceptable as building sites. However, in areas identified for this hazard classification, we anticipate a potential for settlement movements upon saturation of these surficial soils. The low density, uniform grain sized, windblown sand deposits are particularly susceptible to this type of phenomenon.

Mitigation: Foundations must have a minimum 30-inch depth for frost protection. Overlot grading to raise the site will help to reduce the effects of groundwater on the development. Cuts in shallow water areas are not recommended. In areas where high subsurface moisture conditions are anticipated periodically, subsurface perimeter drains are recommended to help prevent the intrusion of water into areas below grade. Typical drain details are presented in Figure 9. Where high groundwater conditions are encountered, underslab drains or capillary breaks may be necessary to dewater the excavation. Typical drain details are shown on Figures 10 and 11. Dewatering of the building areas may be necessary. An underdrain system can be used for the outfall of the individual lot drain systems. Drain stubs shall be placed on each lot adjacent to sewer service stub. This type of drain system is common practice in areas of high groundwater. Dewatering and controlling groundwater will likely be required for utility installation. Utility trenches may affect the groundwater flow across this site. A utility underdrain may be recommended for the sanitary sewer line. A typical drain detail is presented in Figure 12.

Mitigation: The potential for settlement movement is directly related to saturation of the soils below the foundation areas. Therefore, good surface and subsurface drainage is extremely critical in these areas in order to minimize the potential for saturation of these soils. The ground surface around all permanent structures should be positively sloped away from the structure to all points, and water must not be allowed to stand or pond anywhere on the site. We recommend that the ground surface within 10 feet of the structures be sloped away with a minimum gradient of five percent. If this is not possible on the upslope side of the structures, then a well-defined swale should be created to intercept the surface water and carry it quickly and safely around and away from the structures. Roof drains should be made to discharge well away from the structures and into areas of positive drainage. Where several structures are involved, the overall drainage design should be such that water directed away from one structure is not directed against an adjacent building. Planting and watering in the immediate vicinity of the structures, as well as general lawn irrigation, should be minimized.
