May 26, 2021
Revised: September 21, 2021

ENTECH
ENGINEERING, INC.

Re: Soil, Geology, and Geologic Hazard Study
Koinonia Ranch
Parcel No. 52190-00-059
6170 Old Ranch Road
El Paso County, Colorado

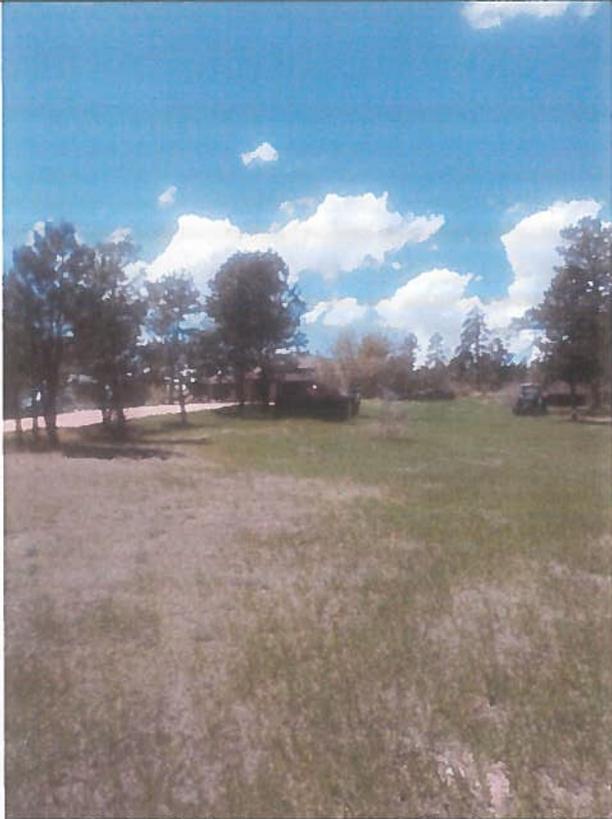
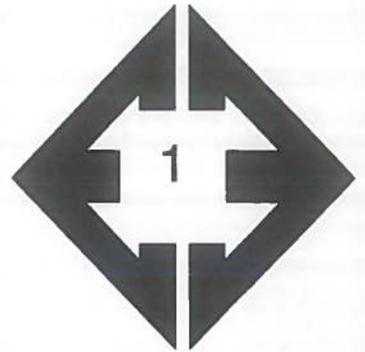
**Looking west from the
east-central portion of
the site.**

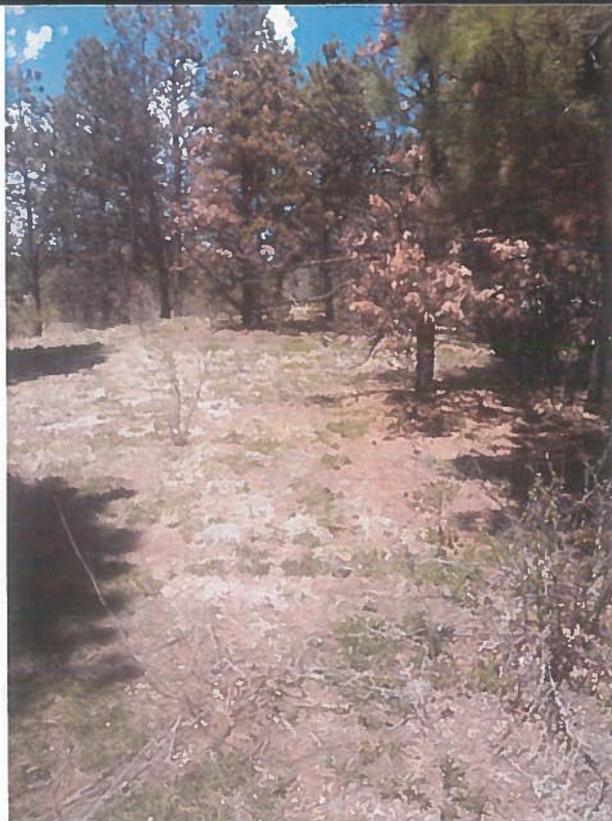
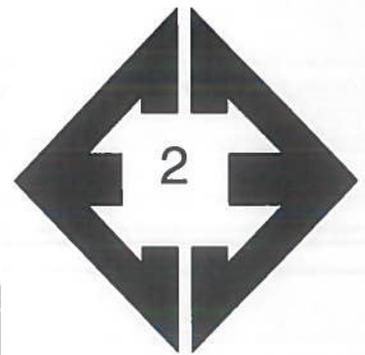
**Looking northeast from
the western portion of
the site.**

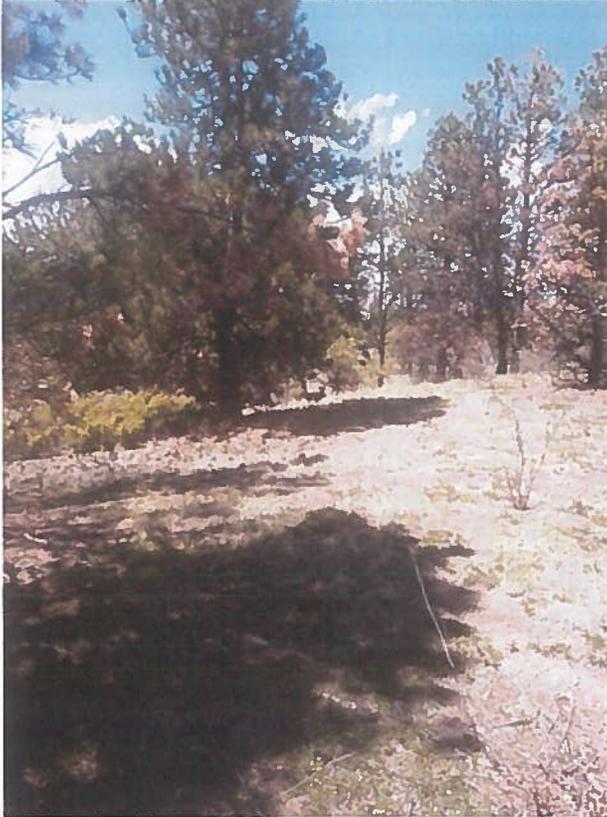
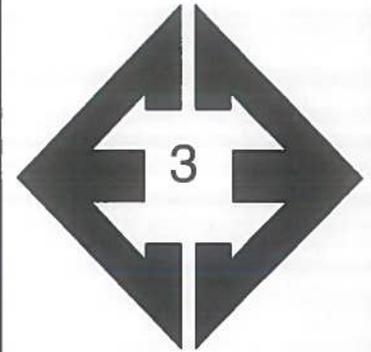
**Looking southeast
from the western
portion of the site.**

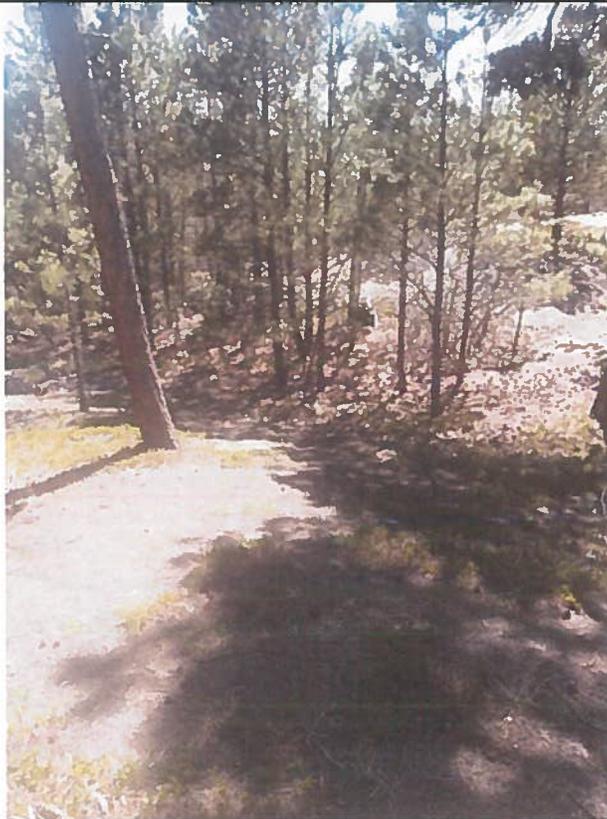
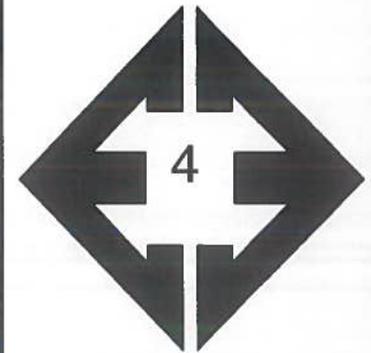
A minor drainage area exists in the northern portion of the site. No water was observed flowing in the drainage at the time of the investigation, however, these areas have the potential for seasonal shallow groundwater. These areas are indicated in the Geology/Engineering Geology Map (Figure 6) and are discussed below. Due to the size of the proposed lots these areas can be avoided or redirected around proposed structures or proposed soil treatment areas. The proposed building areas are not affected by these areas. The site does not lie within any floodplain zones according to the FEMA Map No. 08041CO527G dated December 7, 2018 (Figure 7, Reference 7). Exact locations of floodplain and specific drainage studies are beyond the scope of this report.

**Looking southeast
down drainage in the
northern portion of the
site.**

Mitigation: Foundations must have a minimum 30-inch depth for frost protection. In areas where high subsurface moisture conditions are anticipated periodically, subsurface perimeter drains are recommended to help prevent the intrusion of water into areas below grade. Typical drain details are presented in Figure 8. Any grading in these areas should be done to direct surface flow around construction to avoid areas of ponded water. All organic material would be completely removed prior to any fill placement. **Specific drainage studies are beyond the scope of this report.**

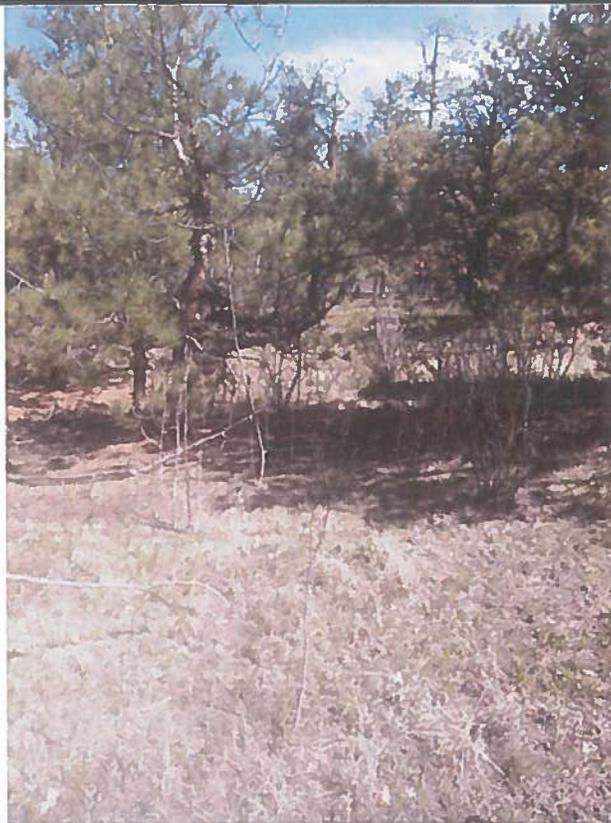
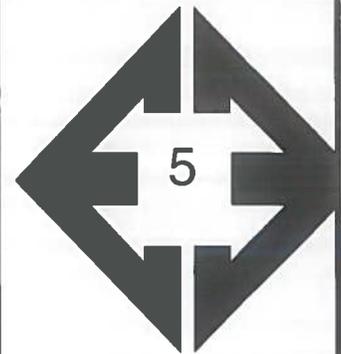
**Looking south from
the north-central
portion of the site.**

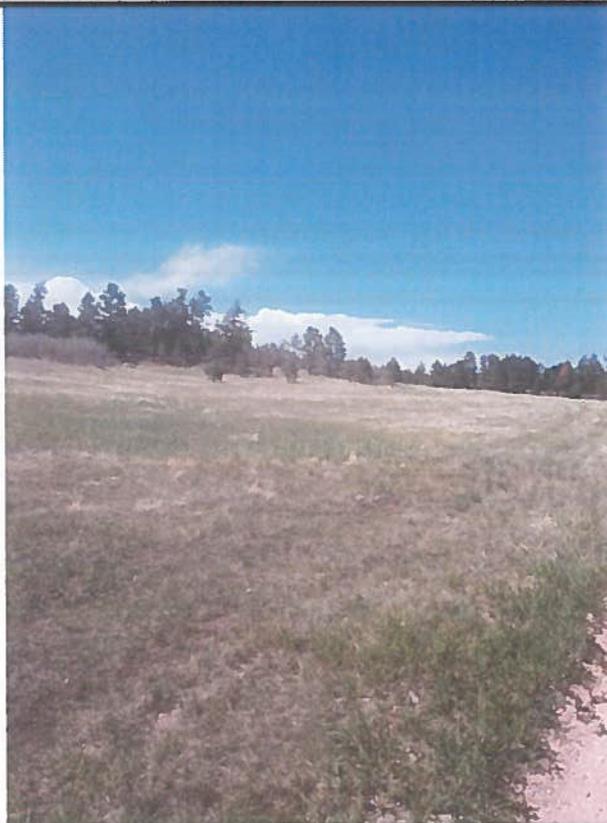
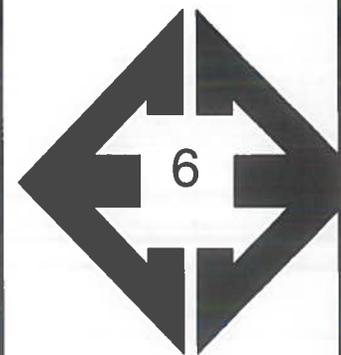
**Looking north from
the south-central
portion of the site.**
