ENTECH
ENGINEERING, INC.

Re: Soils and Geology Study
305 Pine Oaks Road
Parcel No. 75250-00-014
El Paso County, Colorado
Entech Job No. 231440

The project consists of subdividing 17-acres into two rural residential lots. The existing home and out buildings on Lot 1 will remain, and a new residence is proposed for Lot 2. The site is located west of the intersection of Pine Oaks Road and Highway 115, in El Paso County, Colorado.

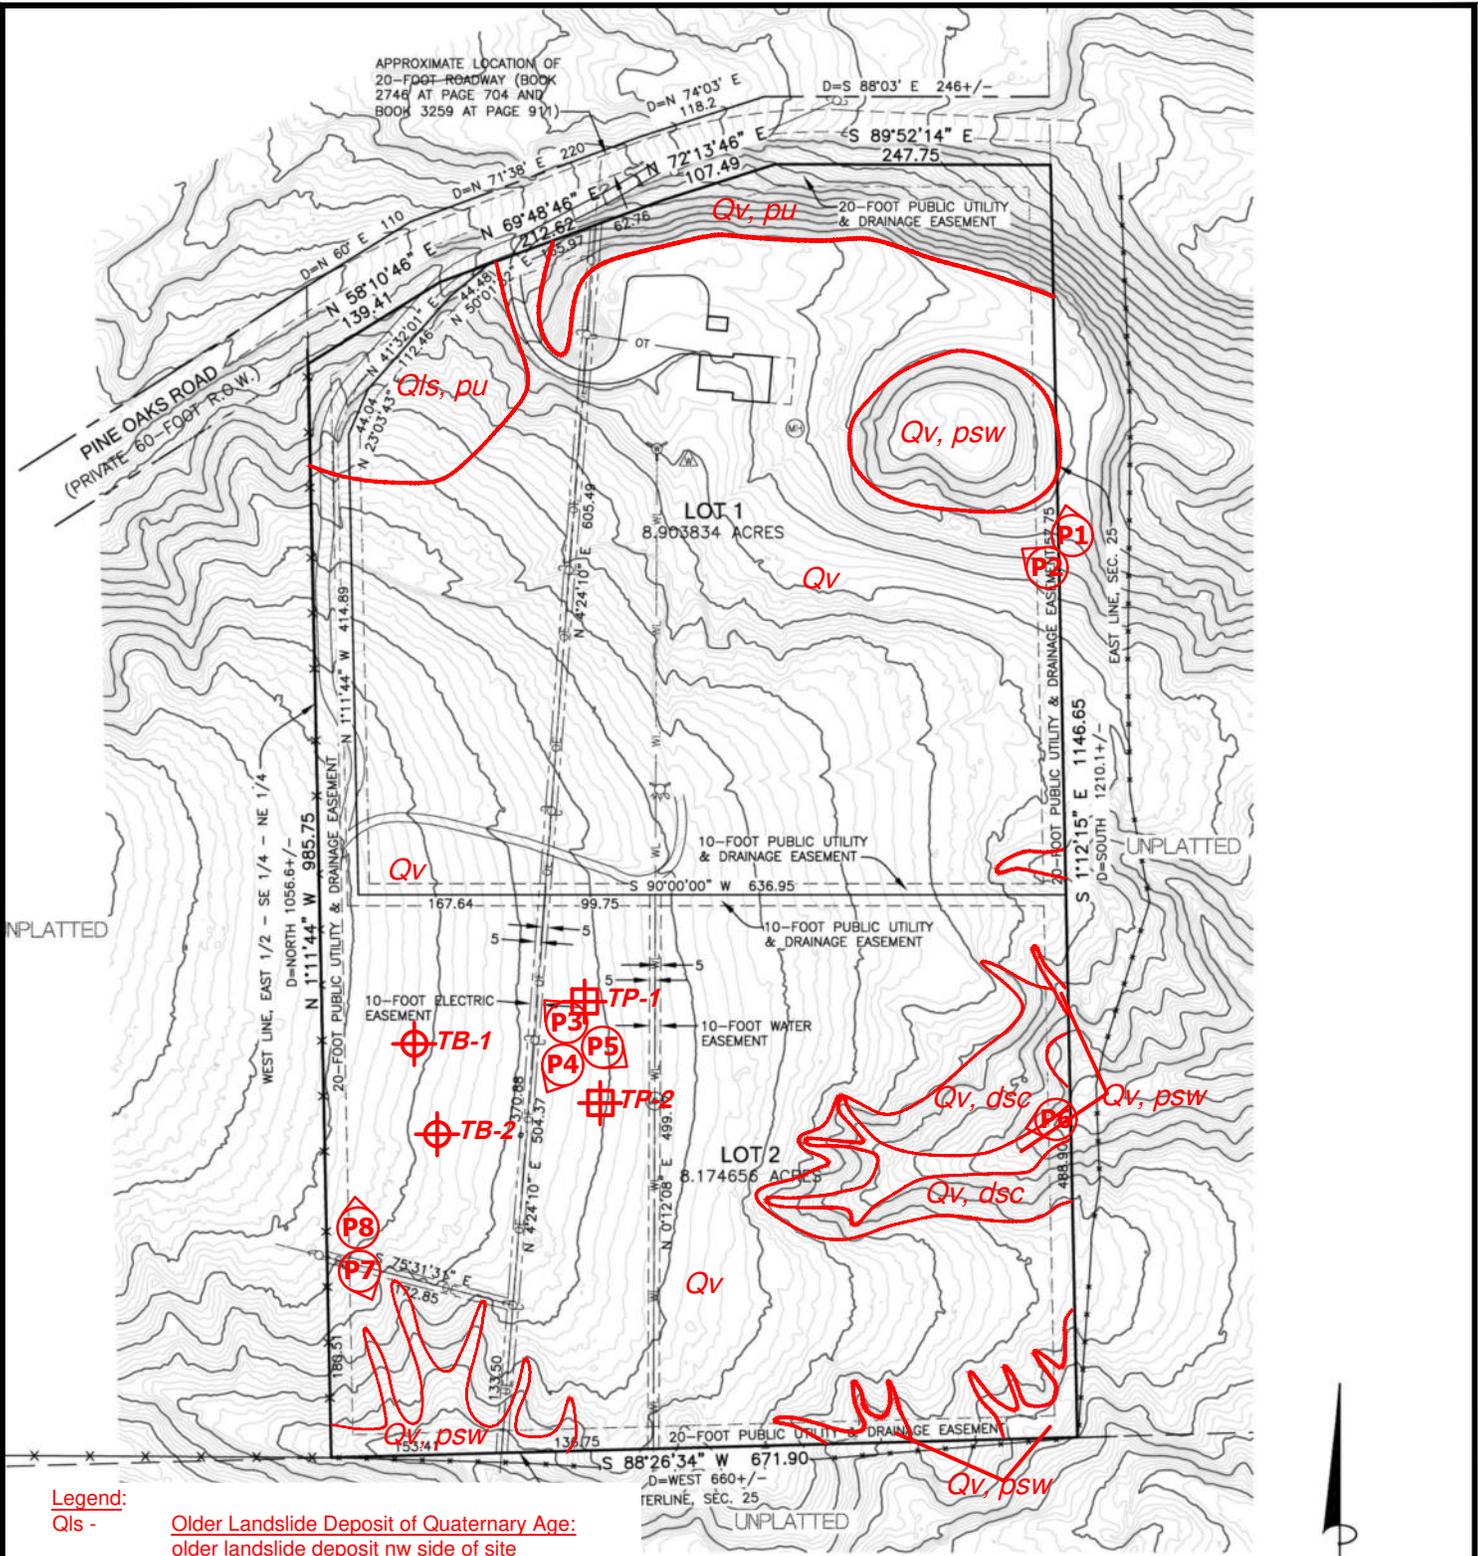
FIG. 6

The site is not mapped within any floodplains according to the FEMA Map No. 08041CO905G, dated December 7, 2018 (Figure 7, Reference 7). Areas of potential seasonally shallow groundwater were observed on the site (Figure 6). In these areas, we would anticipate the potential for periodically high subsurface moisture conditions and frost heave potential. These areas lie along minor drainage swales located in the eastern and southern portions of the site. Water was not observed in any of the drainages at the time of our site investigation. These areas can likely be avoided by development. The potential exists for high groundwater levels during high moisture periods and should structures encroach on these areas the following precautions should be followed.

The slopes in the western portion of the lot have been identified as downslope creep areas on the Geology/Engineering Geology Map, Figure 6. This area is located in the eastern portion of the site and will be avoided by future site development. The slopes were traversed to observe any signs of recent movement or failures. The slopes appeared to be stable in their current state based on our site observations. In areas within and adjacent to the area mapped as downslope creep we would anticipate to potential for accelerated lateral and vertical movement of the near surface soils in a downslope direction.

The slopes in the northern portion of the site have been identified as potentially unstable areas on the Geology/Engineering Geology Map, Figure 6. The slopes were traversed to observe any signs of recent movement or failures. The slopes appeared to be stable in their current state based on our site observations. An older landslide deposits has been mapped in the northwestern portion of the site (Reference 4, Figure 5). These areas should be avoided by future development unless analyzed for slope stability.

Mitigation: The design of the foundation in this area should account for the sloping conditions. A lateral pressure diagram for the design of walls in sloping areas is included in Figure 7. Foundation stiffeners such as tie-beams, buttresses or additional reinforcement are recommended. The excavation and any fill placed on the site should be benched into the slope and native soils. Slopes in the building area should be constructed at no steeper than 3:1 unless held by engineer-designed retaining walls designed for the global slope stability.

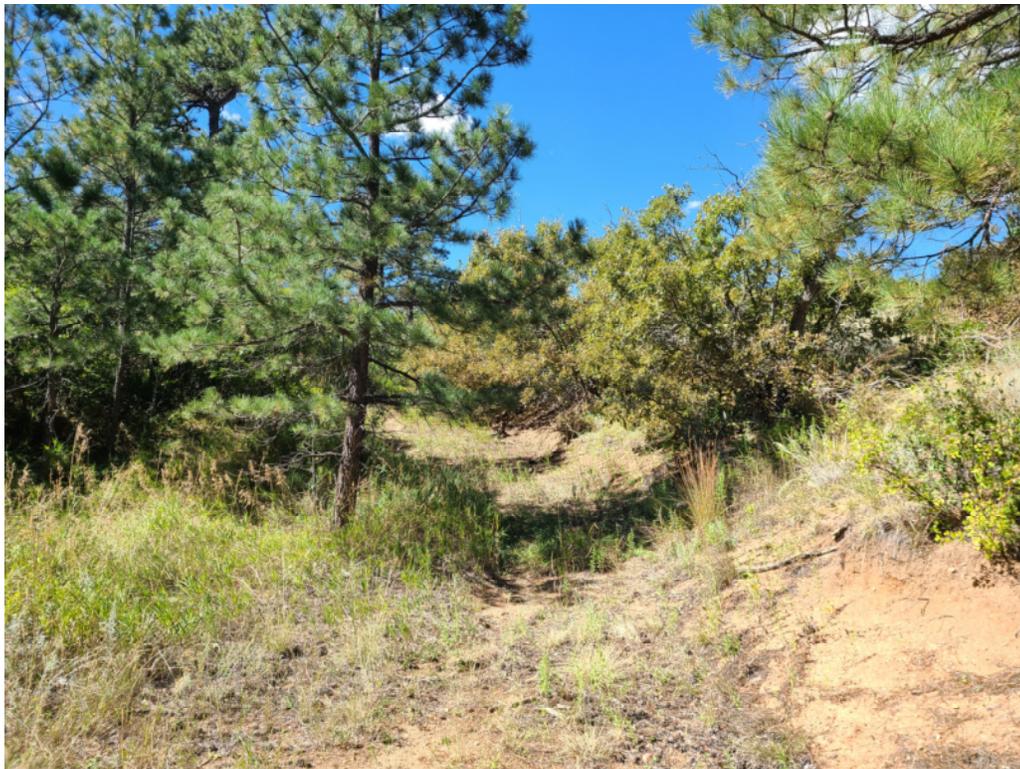
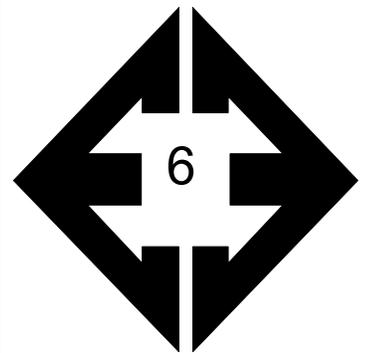
**Looking west towards
minor drainage area
from the southeastern
side of the site.**
