Danering Wolf  
Estates

**GEOLOGIC HAZARD INVESTIGATION**

**40 ACRE SUBDIVISION  
N.E. CORNER OF HWY 83 AND HODGEN ROAD  
PART OF THE SOUTH 1/2 OF THE SOUTHEAST 1/4 OF SECTION 22,  
TOWNSHIP 11 SOUTH, RANGE 66 WEST  
EL PASO COUNTY, COLORADO**

Job No. 26710GEO

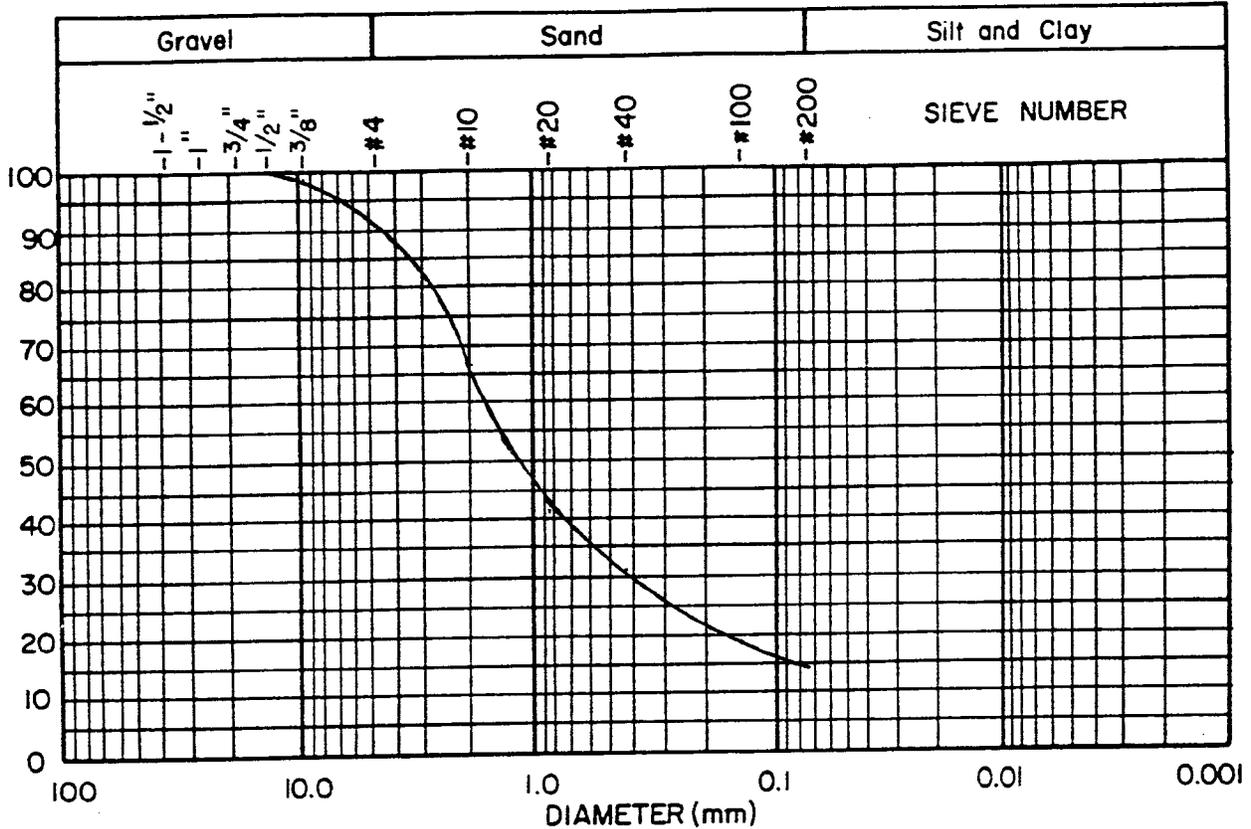
Job No.  
26710  
 Fig. No.  
11

SOIL TYPE NO. I P2 @ 9' UNIFIED CLASSIFICATION SM TEST BY KBS

SIEVE SIZE	% PASSING
1-1/2"	_____
1"	_____
3/4"	_____
1/2"	<u>100</u>
3/8"	<u>99.4</u>
#4	<u>90.2</u>
#10	<u>66.9</u>
#20	<u>41.1</u>
#40	<u>30.8</u>
#100	<u>19.4</u>
#200	<u>14.5</u>
_____	_____
_____	_____
_____	_____

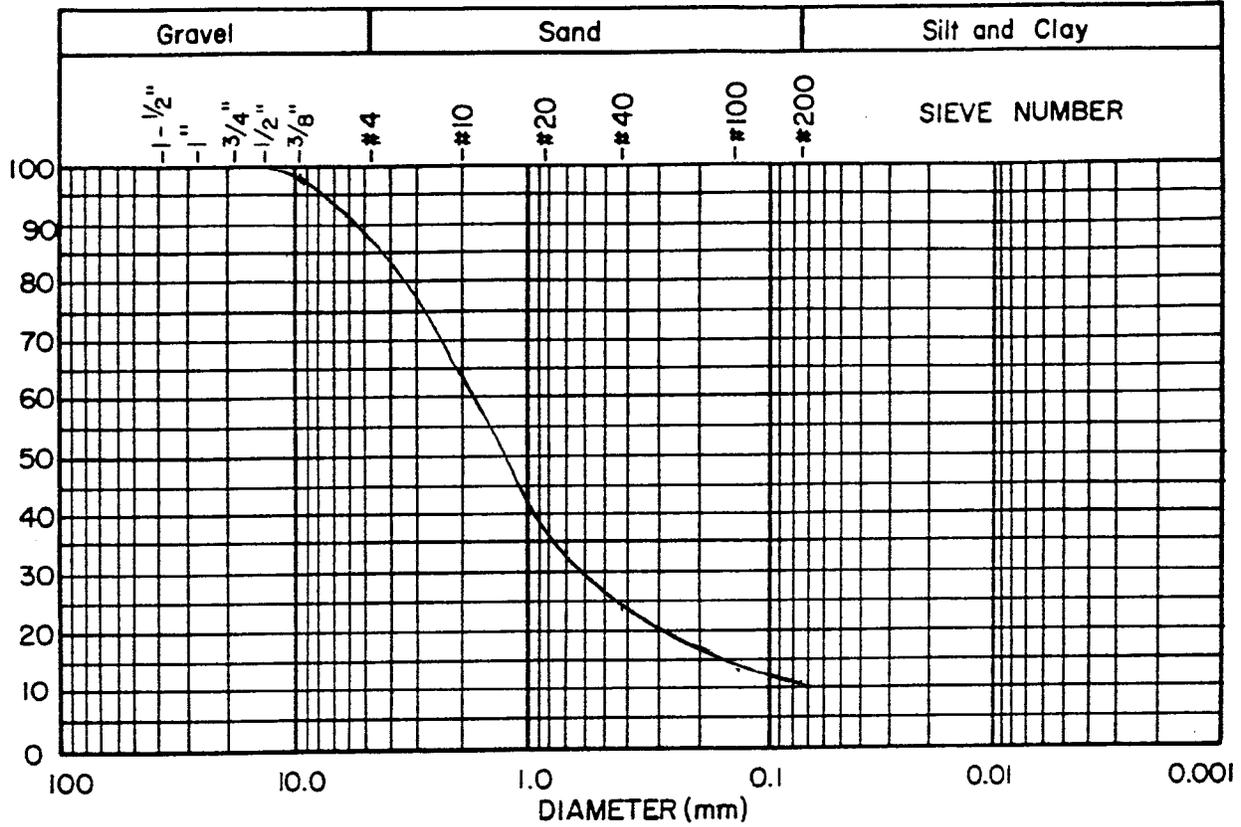
Job No.  
26710  
Fig. No.  
12

SOIL TYPE NO. 2 P409' UNIFIED CLASSIFICATION SP/SM TEST BY KBS

1-1/2"	_____
1"	_____
3/4"	_____
1/2"	100
3/8"	98.9
# 4	86.8
# 10	63.0
# 20	37.3
# 40	23.9
# 100	13.1
# 200	10.8
	_____
	_____
	_____

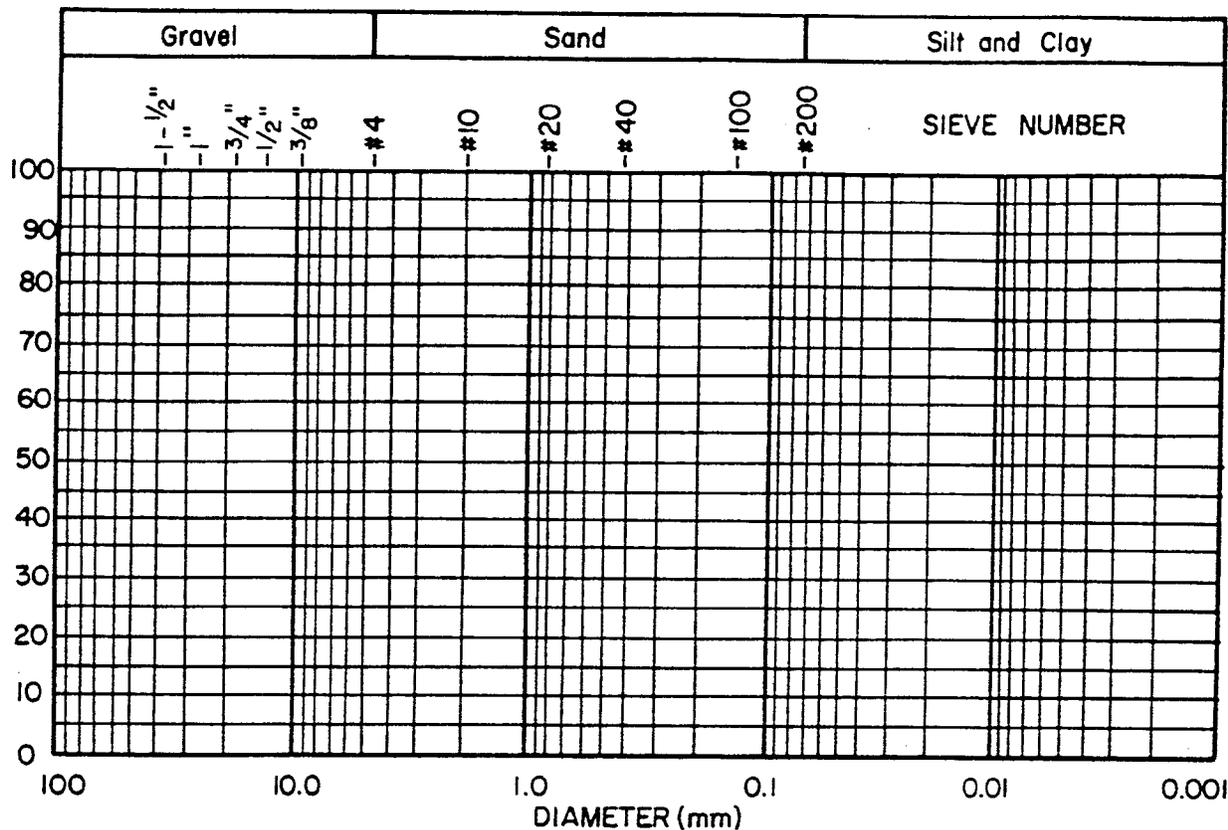
Job No.  
26710  
 Fig. No.

SOIL TYPE NO. 3 P3 @ 4' UNIFIED CLASSIFICATION CL TEST BY KBS

SIEVE SIZE	% PASSING
1-1/2"	_____
1"	_____
3/4"	_____
1/2"	_____
3/8"	_____
# 4	_____
# 10	<u>100</u>
# 20	<u>98.5</u>
# 40	<u>98.0</u>
# 100	<u>95.9</u>
# 200	<u>88.8</u>
_____	_____
_____	_____
_____	_____

13.5 % Moisture at start  
24.3 % Moisture at finish  
10.8 % Moisture increase  
0.20 % Volume change  
99 pcf Initial dry density  
616 psf Swell
